Bridge Inspection Report

M0982
SH53 S-0 LM 7.44
over
HOLLYWOOD CREEK

Structure Number: M0982

Facility Carried: SH53 S-0 LM 7.44

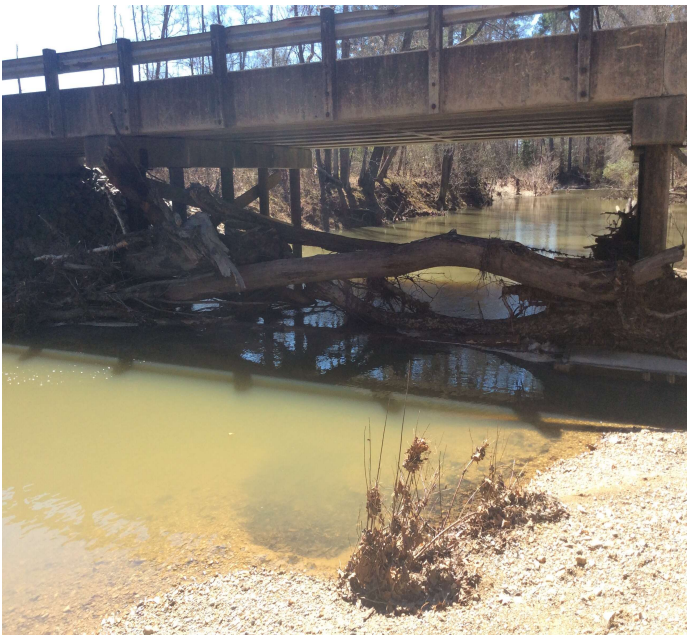
03/06/2018 JPR -- Bents 3 and 4 have heavy drift built up against them @ pile 1.

PHOTO 1 Description Drift bents 3 and 4.

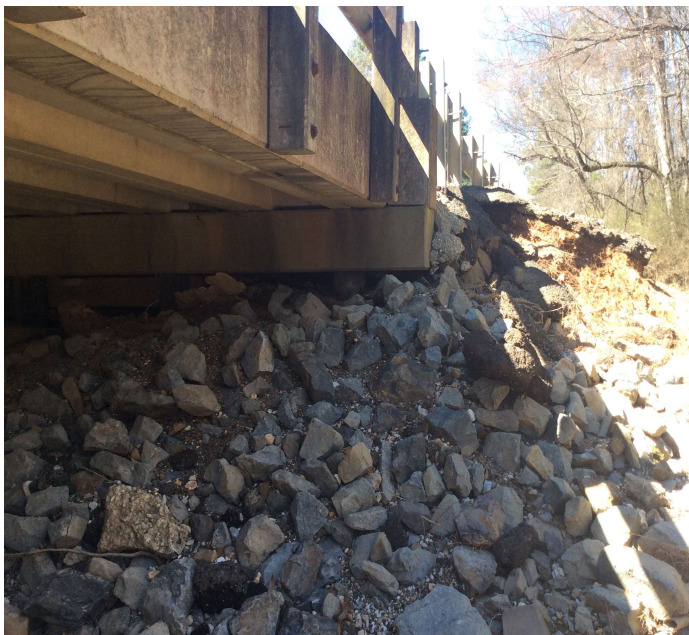
03/06/2018 JPR -- There is scour under Rt. approach guardrail at abutment 1. Also scoured up to back of guardrail on Lt. @ abutment 1.

PHOTO 1 Description Scour at abutment 1.

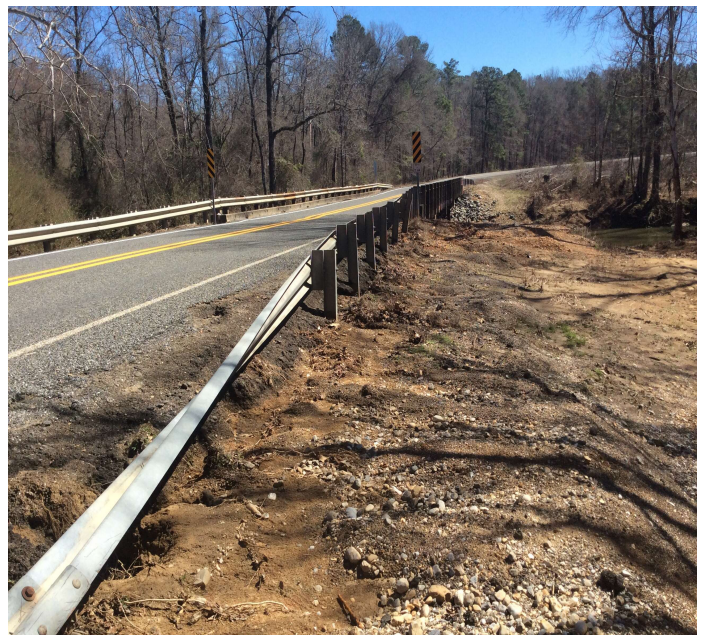
PHOTO 2 Description Erosion right side at abutment 1

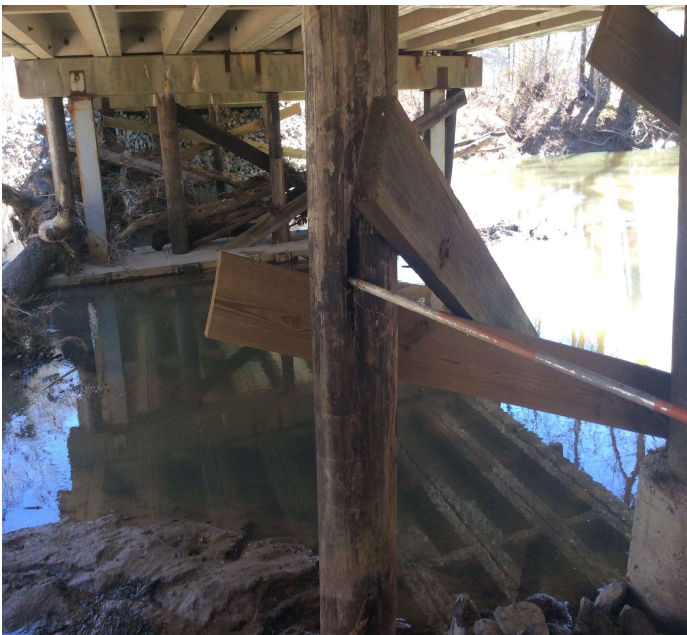
Environment	Total Quantity	Units	Condition State 1	Condition State 2	Condition State 3	Condition State 4
16 - Reinforced Concrete Top Flange	1- Ben.	3261	sq. ft.	3261			
	03/06/2018 JPR -- Chip Seal overlay wearing surface. PC Units all look good from soffit.						
510 - Wearing Surfaces		3013	sq. ft.	3013			
110 - Reinforced Concrete Open Girder/Beam	1- Ben.	868	ft.	868			
202 - Steel Column	1- Ben.	3	each	3			
	Supplemental piles, 2 bent 3 & 1 bent 4. Rust with some loss of paint. Column in bent 4 has paint failure with some minor section loss.						
515 - Steel Protective Coating		75	sq. ft.	0	50	25	
215 - Reinforced Concrete Abutment	1- Ben.	52	ft.	50	2	0	0
	03/06/2018 JPR -- Abutment 1 has scoured out back to backwall in the center of the abutment and is down to the bottom of the backwall boards.						
1130 - Cracking (RC and Other)		2			2		
228 - Timber Pile	1- Ben.	22	each	21	1	0	0
	03/06/2018 JPR -- Bent 2 Pile 2 rotten spot.

03/06/2018 JPR -- Bent 2 pile 2 has a rotten spot.

PHOTO 1 Description Bent 2 Pile 2 rotten spot
