# Bridge Inspection Report

**M0983**  
**SH 53 S-0 LM 9.54**  
**over**  
**NORTH BOAT DITCH**

Structure Number: M0983

Facility Carried: SH 53 S-0 LM 9.54

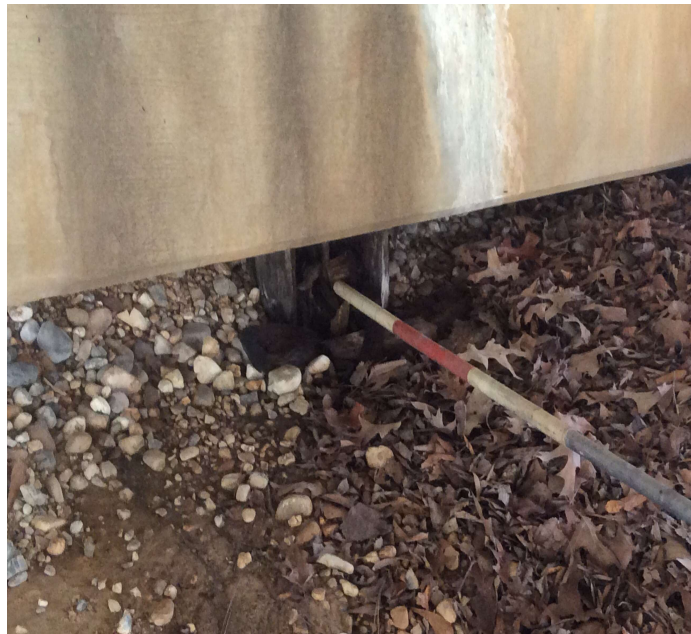
Bent 1 Pile 2  
Rotten and crushing  
Bent 1 Pile 5 rotten.

PHOTO 1      Description      No bearing Bt 1 pile 2

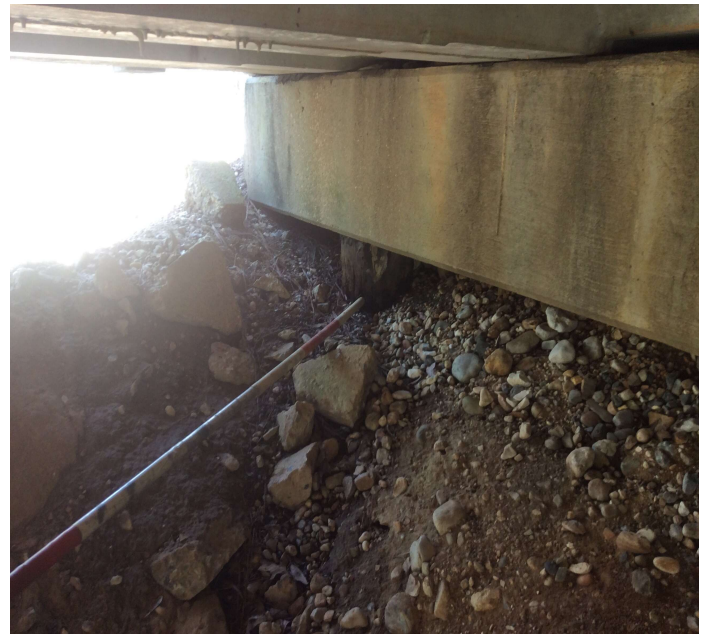
PHOTO 2      Description      Pile 5 Bt 1
