Bridge #M3994(Routine)

SH 212 S-1 LM 2.63 over BAYOU DERRISEAUX

Location: 2.63 MI E JCT SH 35

Team Lead: Rickie Bratton Inspection Date: July 22, 2020

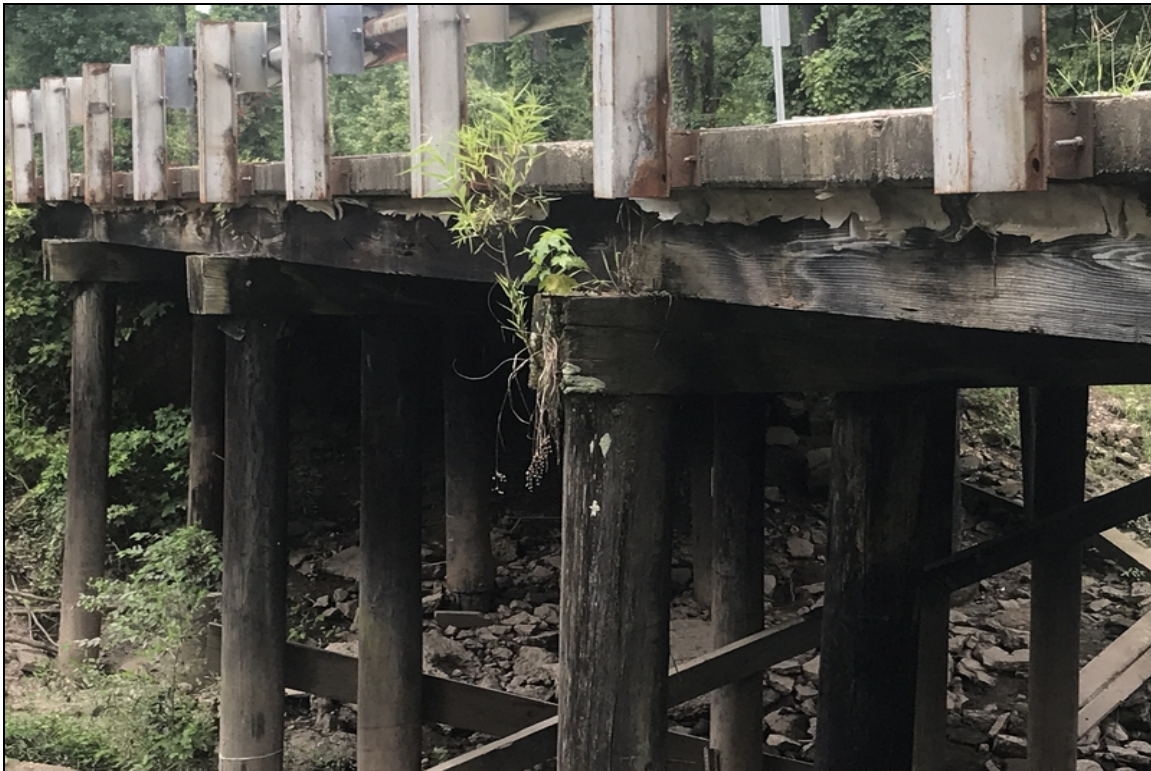
(235)	Ends exposed to the elements have decay and section loss.						
330	Metal Bridge Railing	LF	194	0	194	0	0
1000	Corrosion	LF	194	0	194	0	0
515	Steel Protective Coating	SF	388	388	0	0	0

Bent 4 right side cap has decay on outside 1 foot

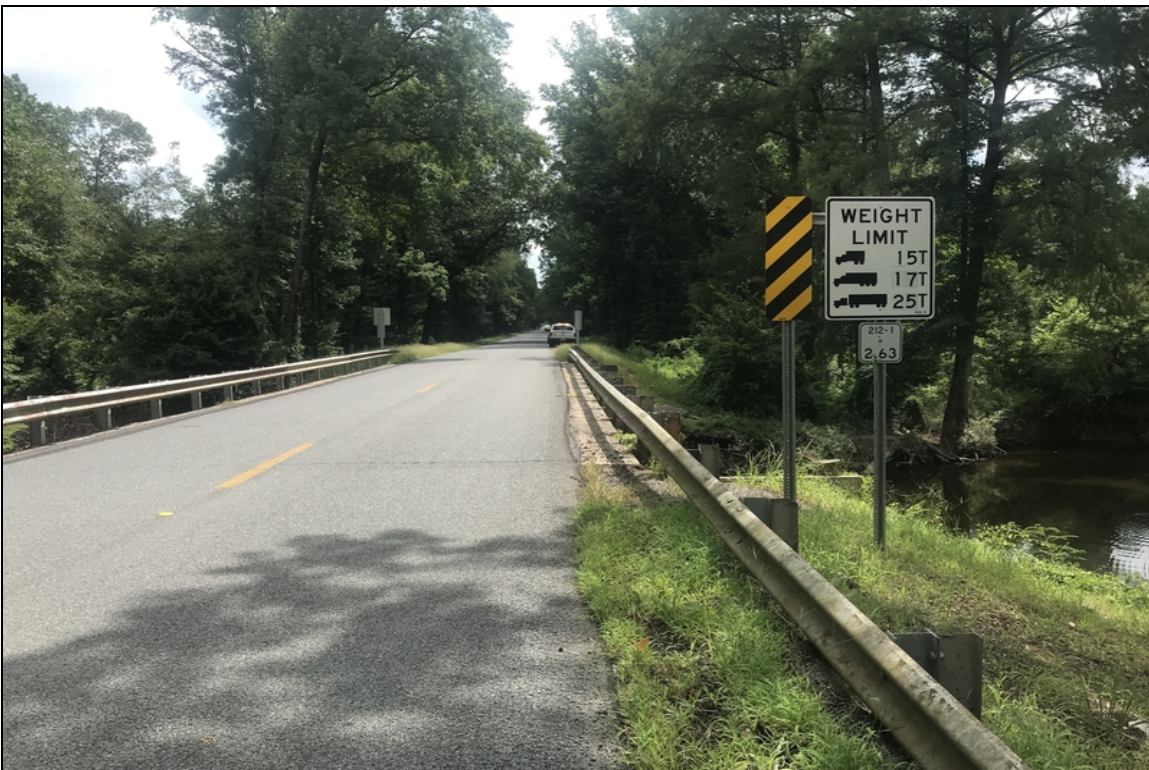
Posting sign

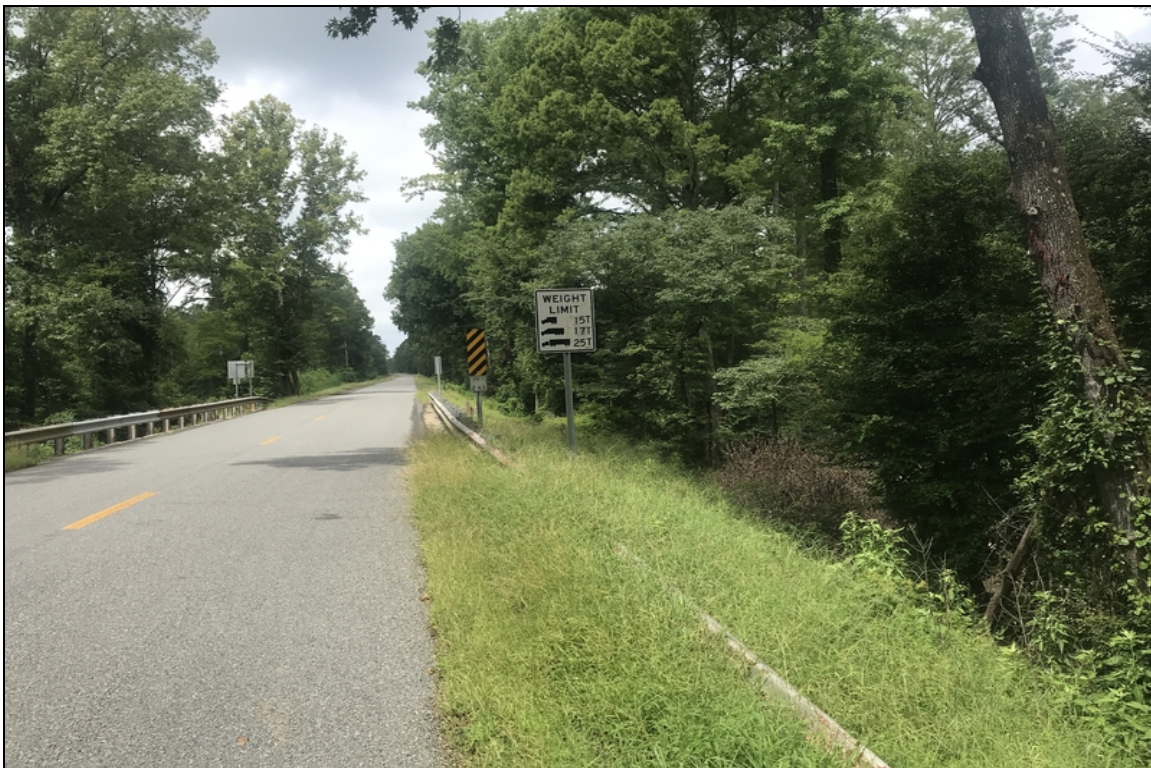
End weight limit posting

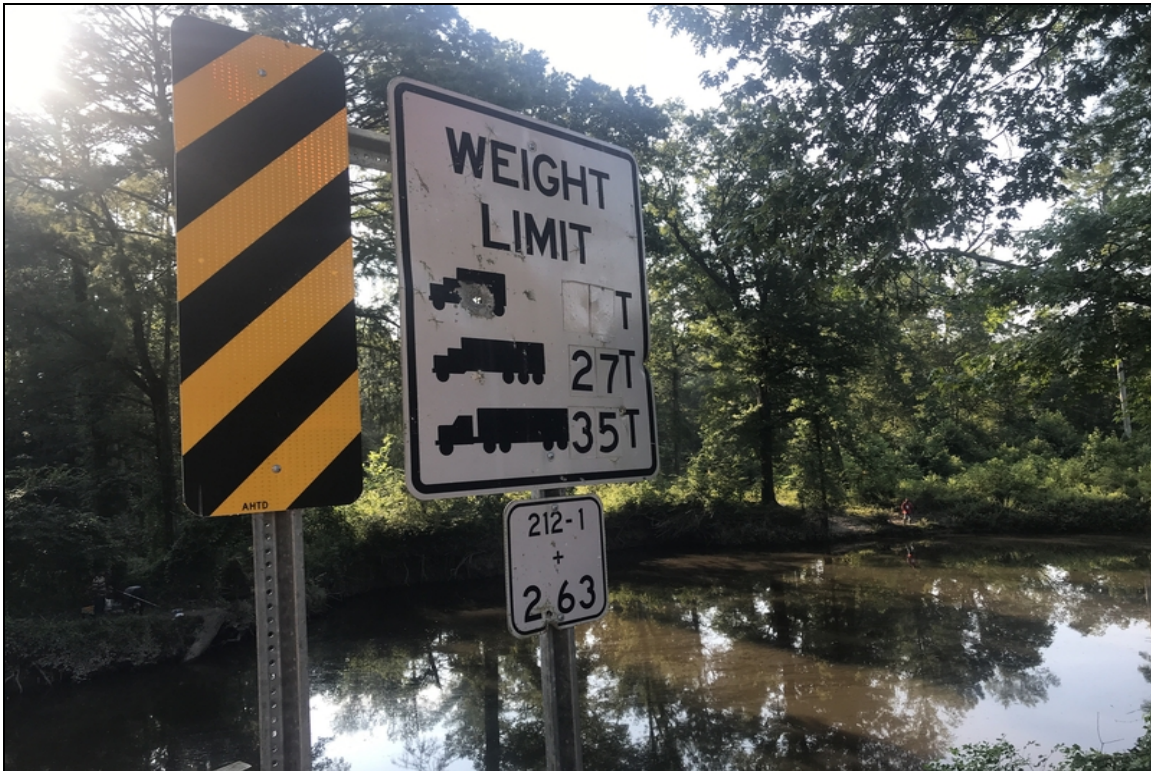
Load posting sign beginning of structure.

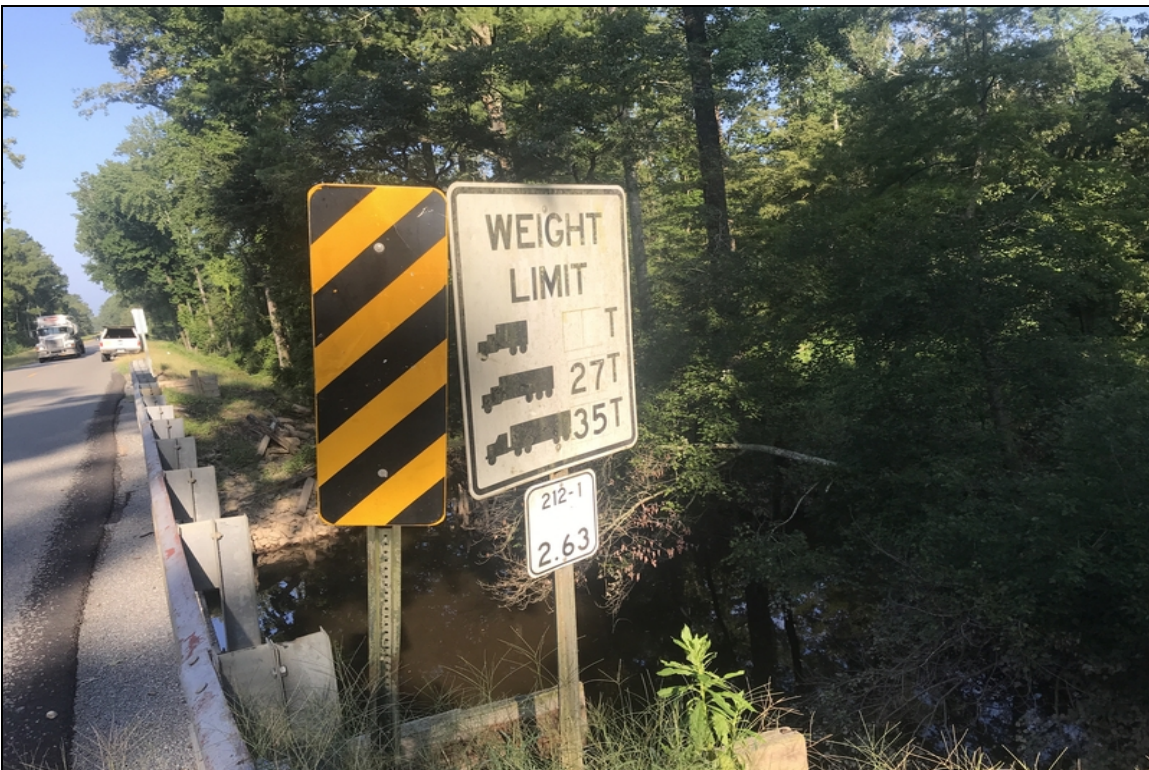
Load posting sign end of structure.

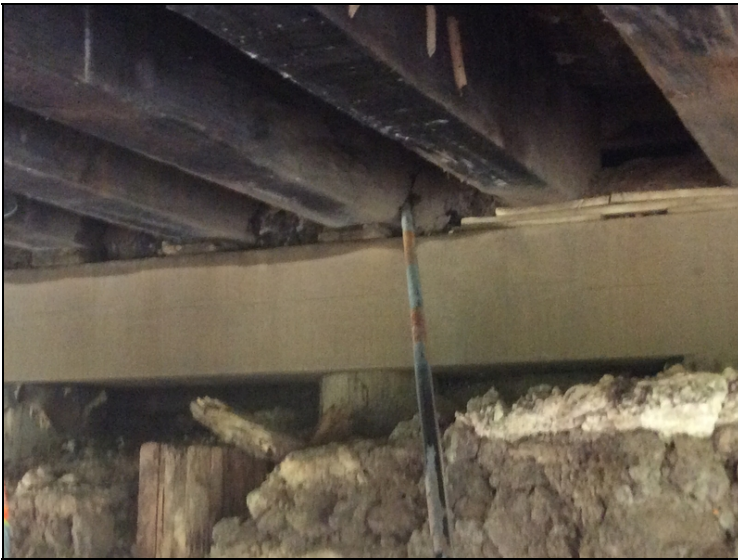
Girders rotten on ends at abutment 2
