Bridge #M3995(Routine)  
SH212 S1 LM 2.77 over BAYOU DERRISEAUX

Location: 2.78 MI E JCT SH 35

Team Lead: Rickie Bratton Inspection Date: June 10, 2020

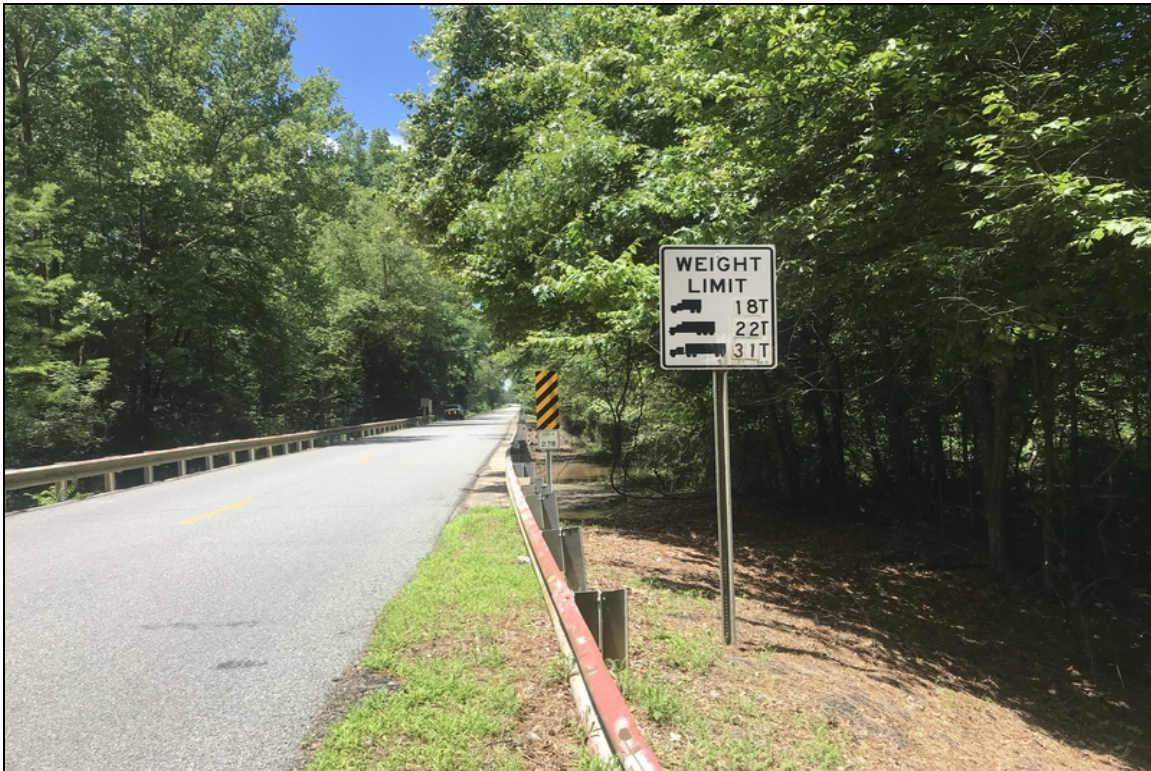
End weight limit posting

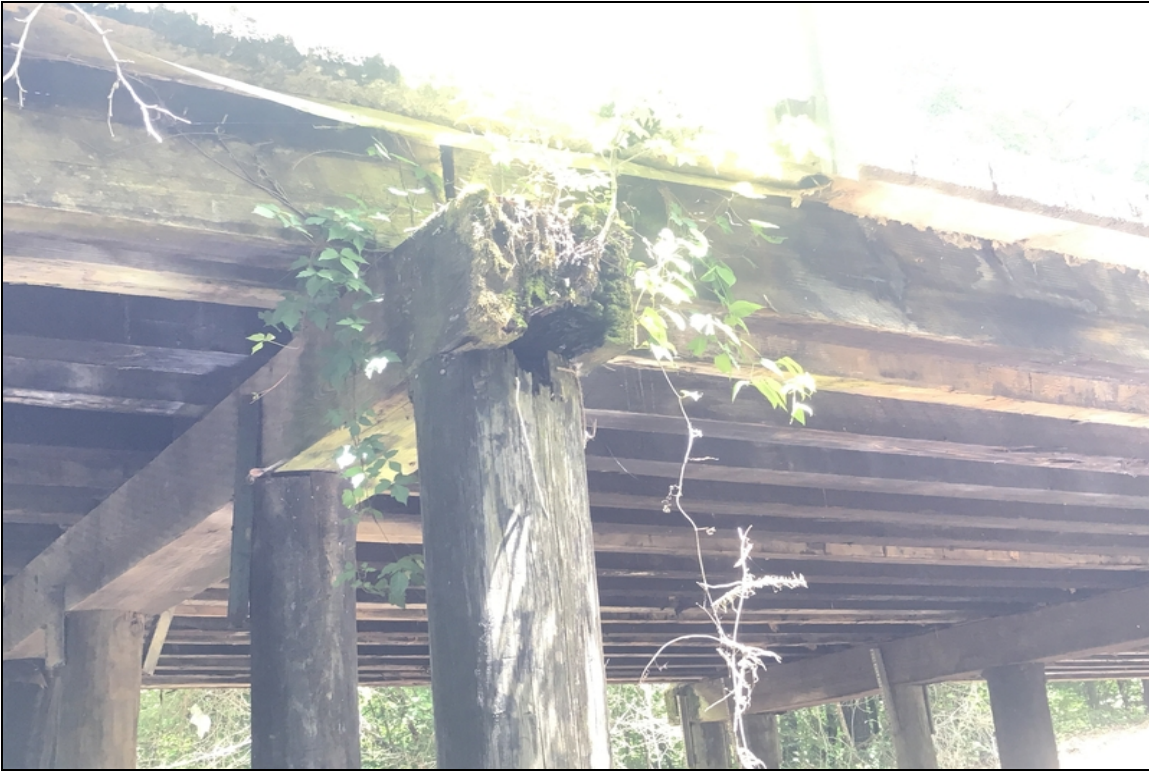
Bent 9 cap right end decayed and top of pile 7

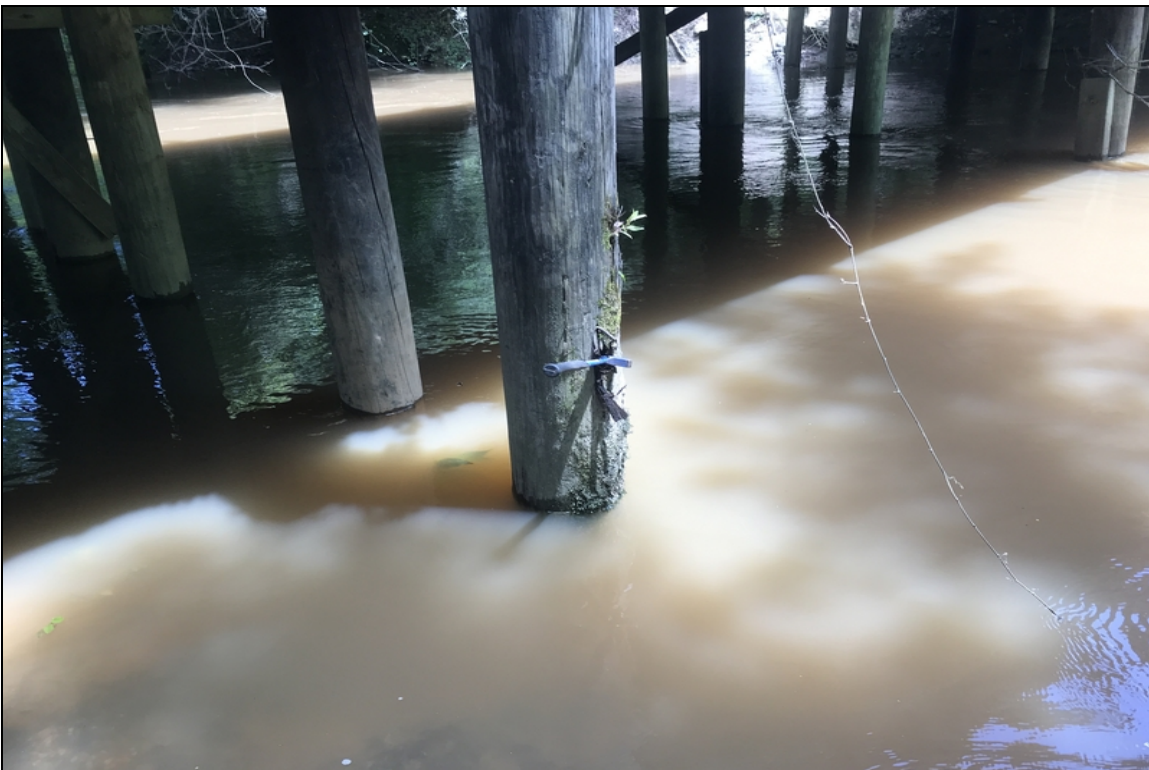
Bent 9 pile 7, decayed at cap and 3 feet from ground line

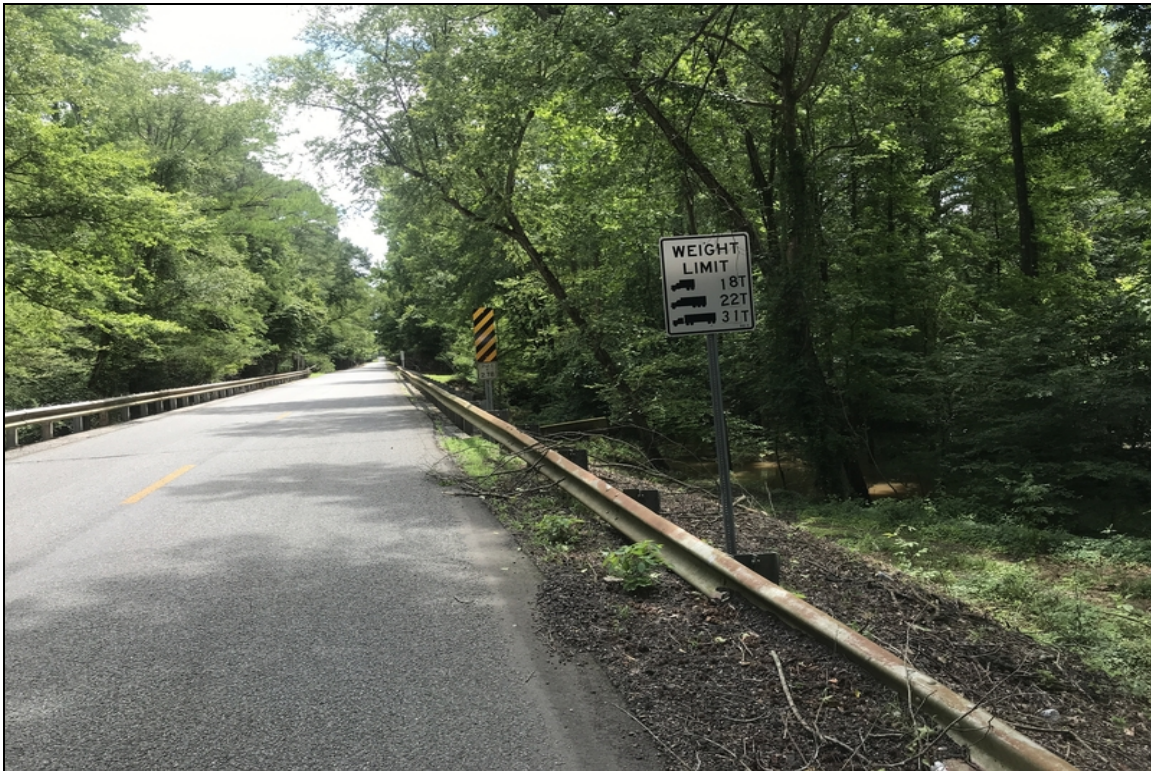
Beginning weight limit posting

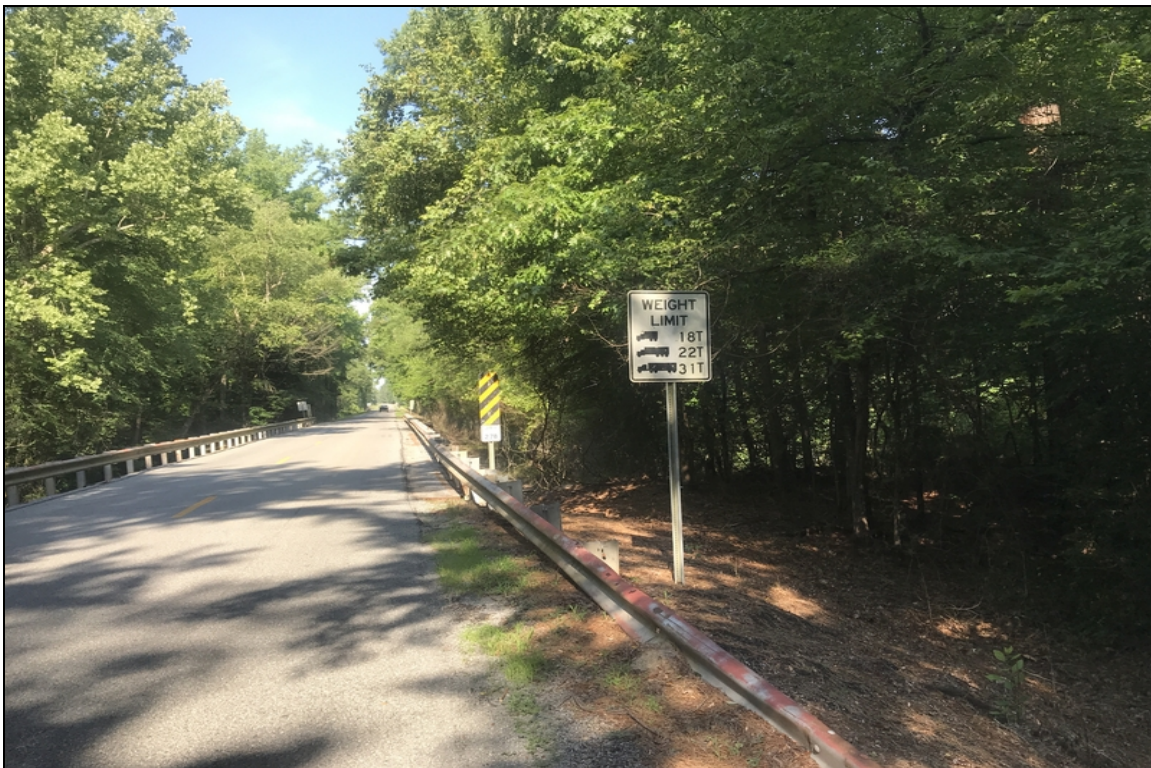
End weight limit posting.

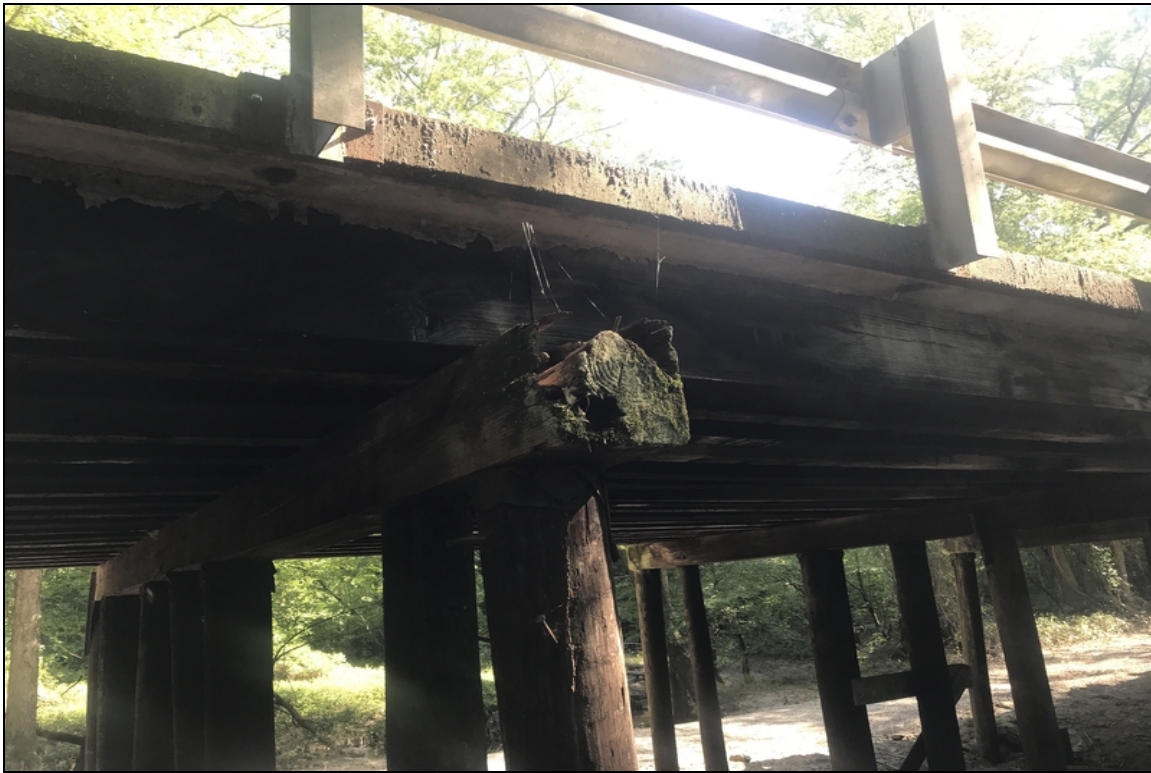
Bt 3 cap right end, decayed.

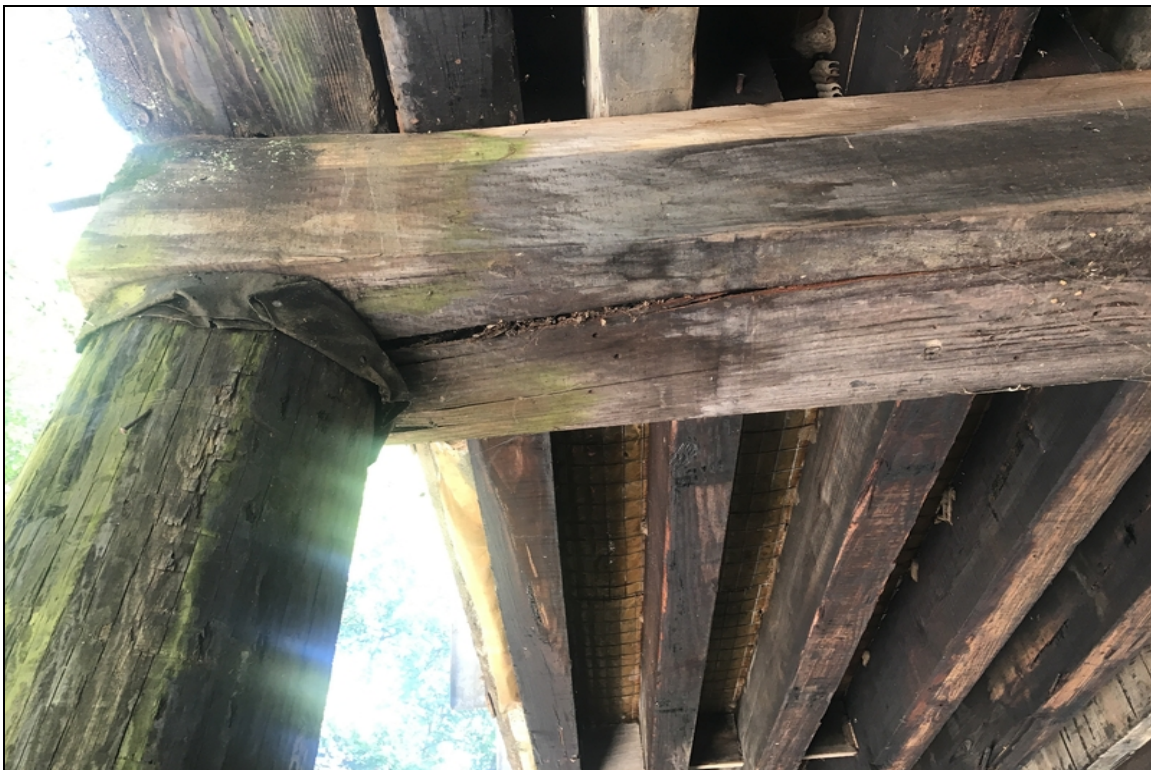
(235) Bt cap 2 left end rotten. See picture. Both sides of all interior bents have 2' of decay and section loss. Bent 8 cap crushing over Pile 1							
304	Open Expansion Joint	LF	204	0	204	0	0
2360	Adjacent Deck or Header	LF	204	0	204	0	0
330	Metal Bridge Railing	LF	458	0	458	0	0
1000	Corrosion	LF	458	0	458	0	0

Bent 8, left end of cap crushing over pile 1.

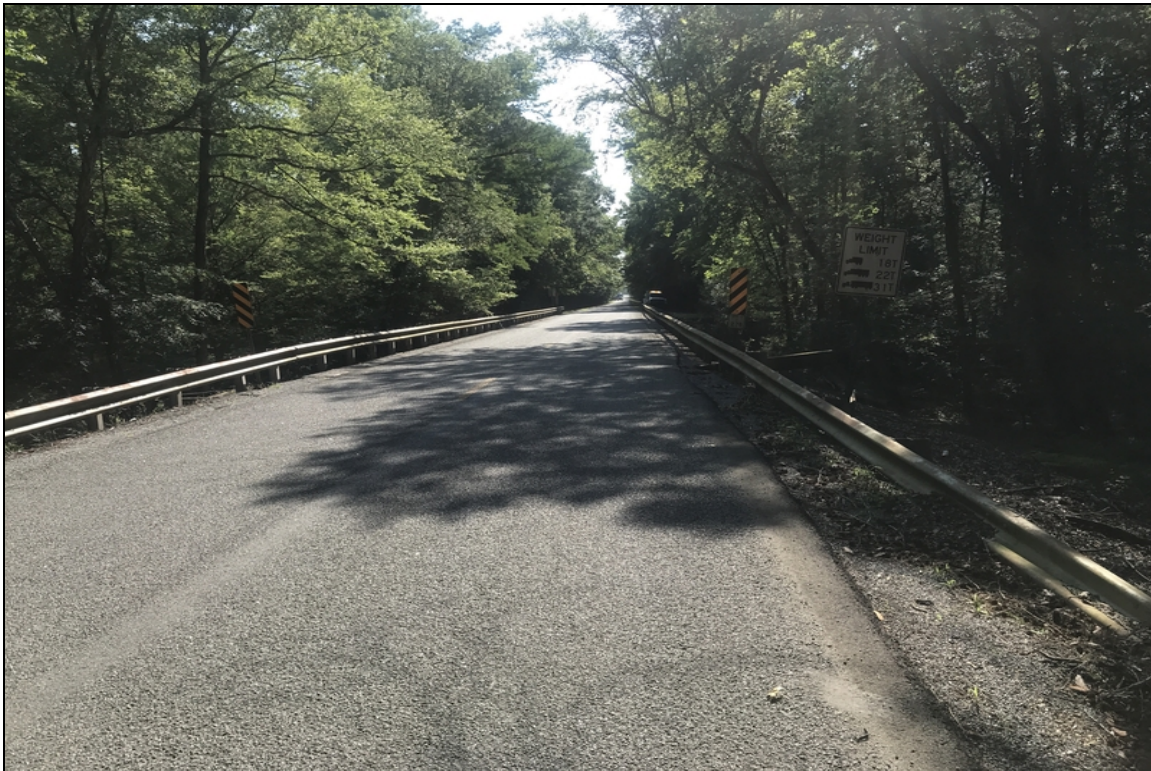
Approach with load posting sign

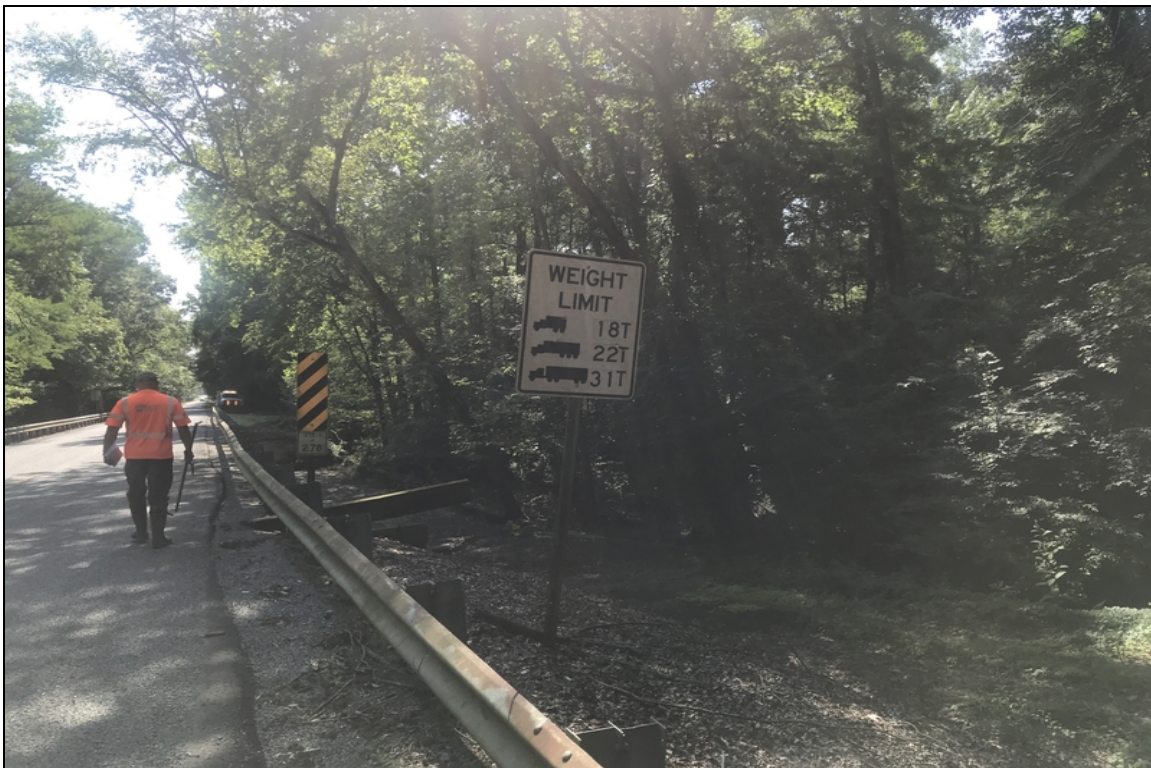
Beginning weight limit posting.

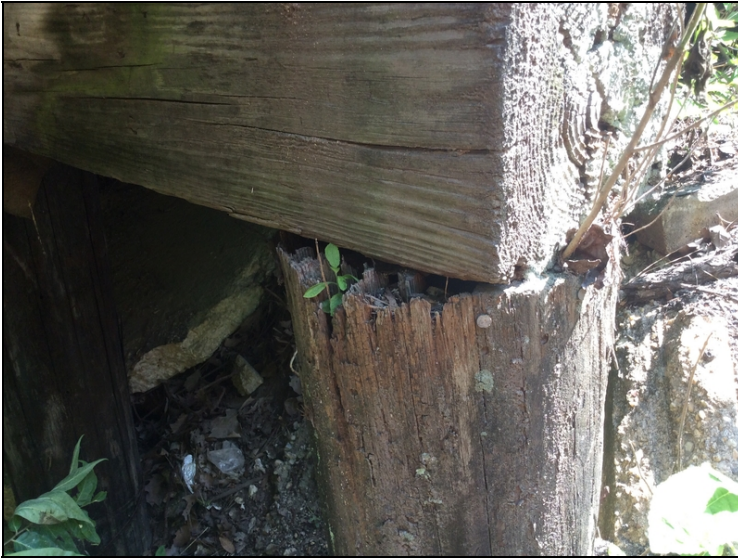
(228) Several stub repaired piling are not braced. Rotten piling have been repaired / replaced. Bent 12 Pile 7 is beginning to rot and has vegetation growing out of the top.							
235	Timber Pier Cap	LF	280	225	45	10	0
1140	Decay/Section Loss	LF	55	0	45	10	0

Bent 12 Pile 7, is beginning to rot on the top and has vegetation growing out of it.

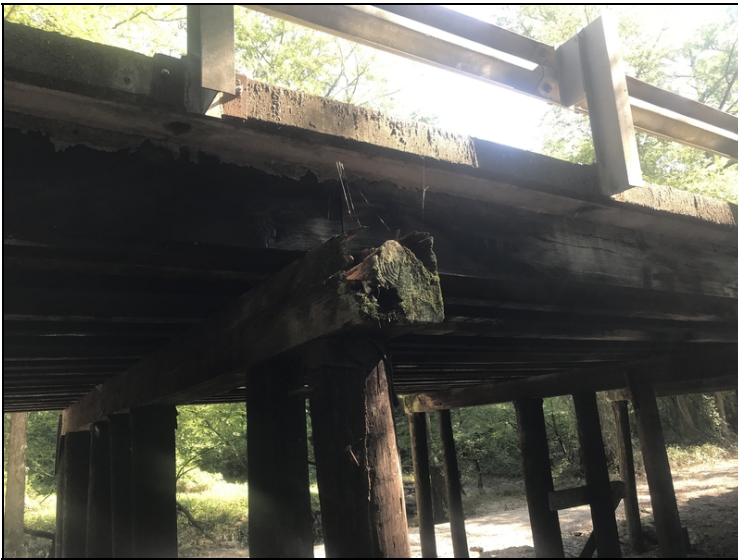
All interior bents, ends of caps are decaying.

Bt 3 cap right end, decayed.

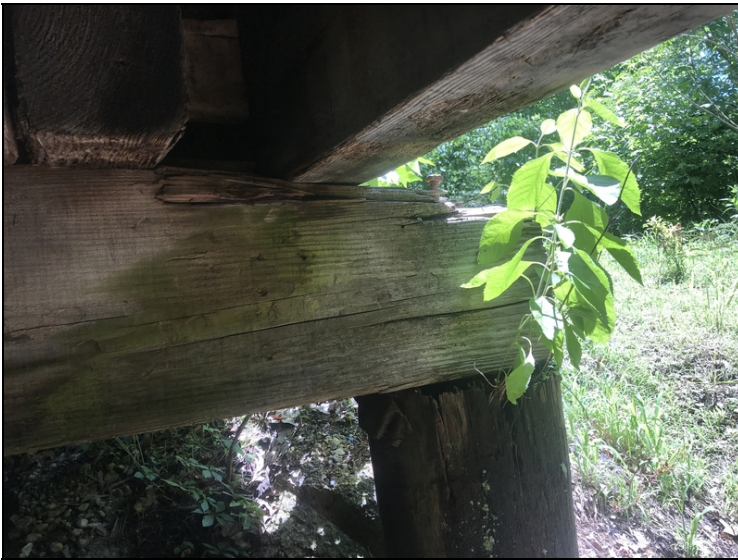
Bent 12 cap, right end is starting to crush, and pile 7 under cap is decayed at top of pile.

Bent 12, cap is crushing, and pile 7 is decayed

**Date Reported:** 06/11/2020  
**Priority:** B - Pressing; 6 month completion goal  
**Type of Work:** Replace  
**Status:** Open  
**Component:** Substructure

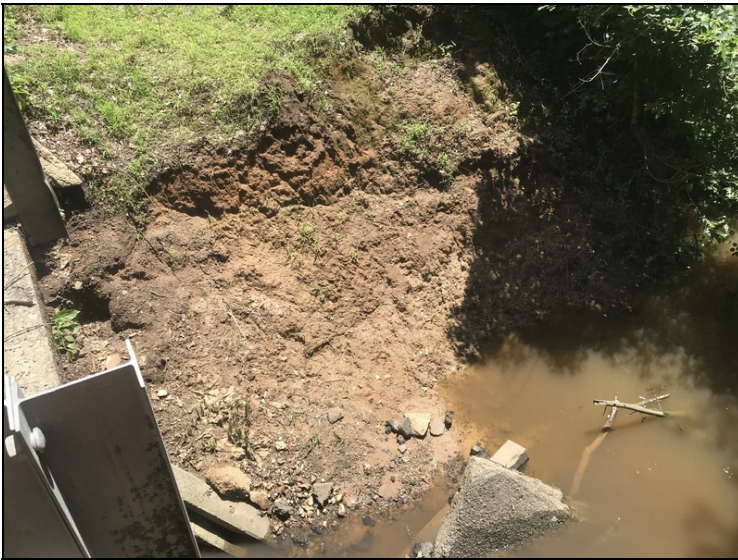
End of bridge right side, active erosion to bank.

Right side end of bridge, active erosion to slope

Date Reported: 06/11/2020  
Priority: C - Important  
Type of Work: Repair  
Status: Open  
Component:
