# Bridge Inspection Report

**M0228**  
**SH 8 S-6 LM 5.13**  
**over**  
**CYPRESS CR**

Structure Number: M0228

Facility Carried: SH 8 S-6 LM 5.13

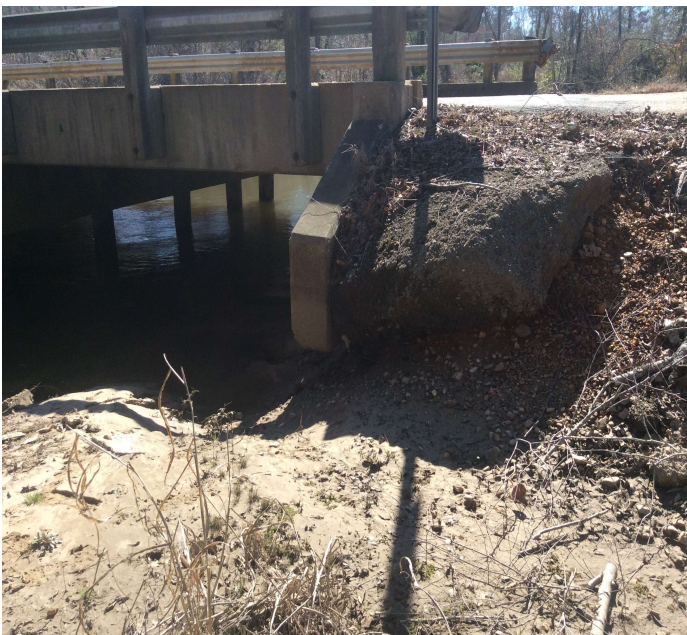
Bent 1 scour along and under cap with roadway settlement.

PHOTO 1      Description      Abutment 1 left

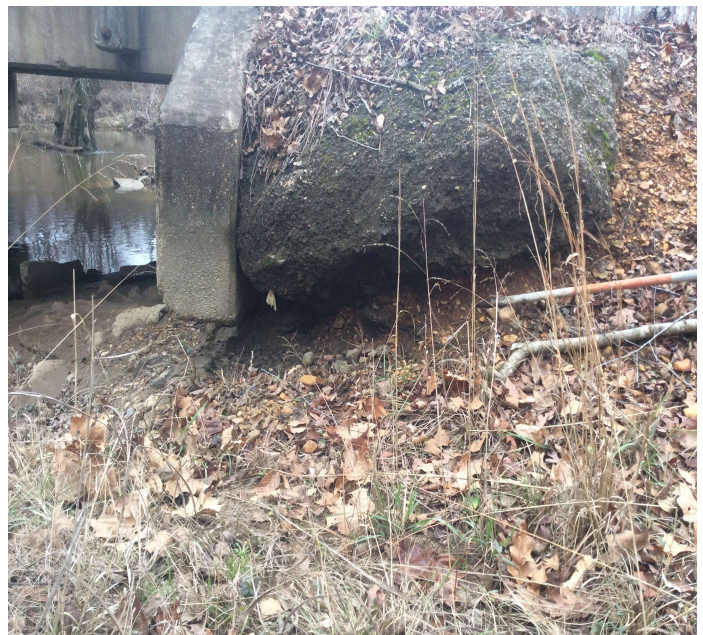
PHOTO 2      Description      Abutment 1 left side scour under wing

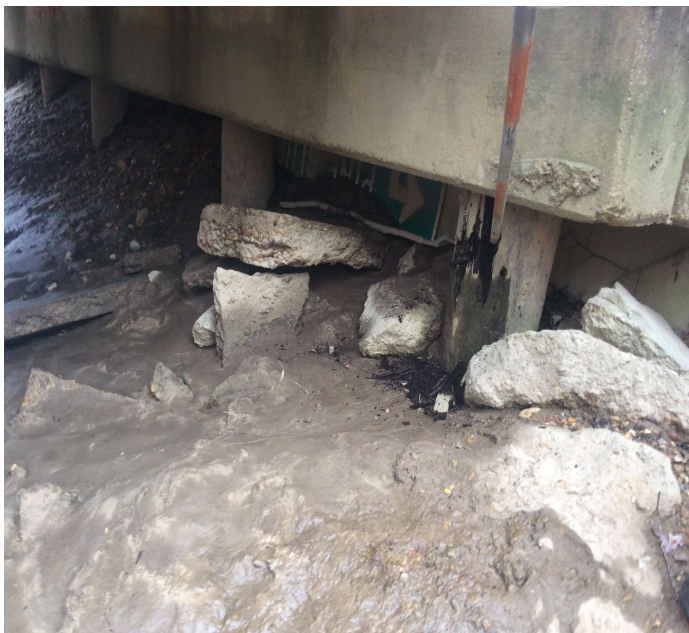
PHOTO 3      Description      Abutment 1 scour back under the abutment.

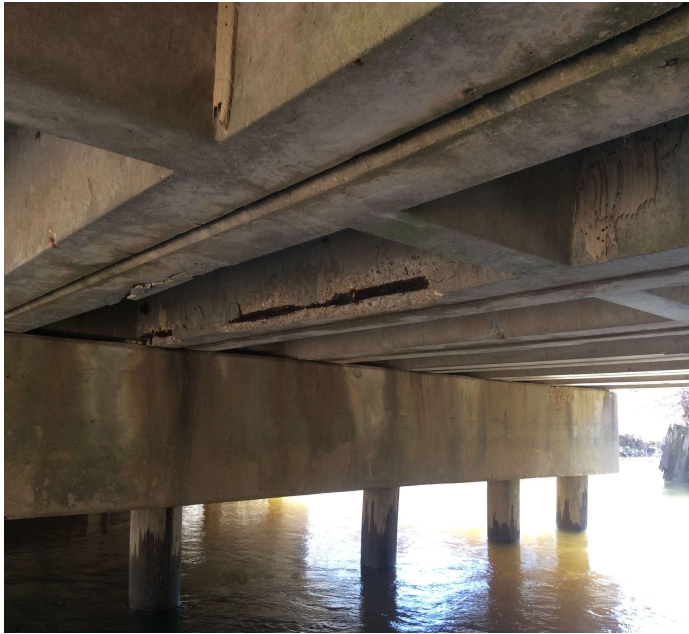
Span 1 PC Units 1 & 2 cracks and spalls with exposed steel, Mod. sec. loss. Span 4 PC Units 6 & 7 cracks and spalls with exposed steel. Minor sec. loss. Span 2 units 2-5 cracks and spalls Mod. sec. loss.

PHOTO 1 Description M0228 PC ut 2 span 1

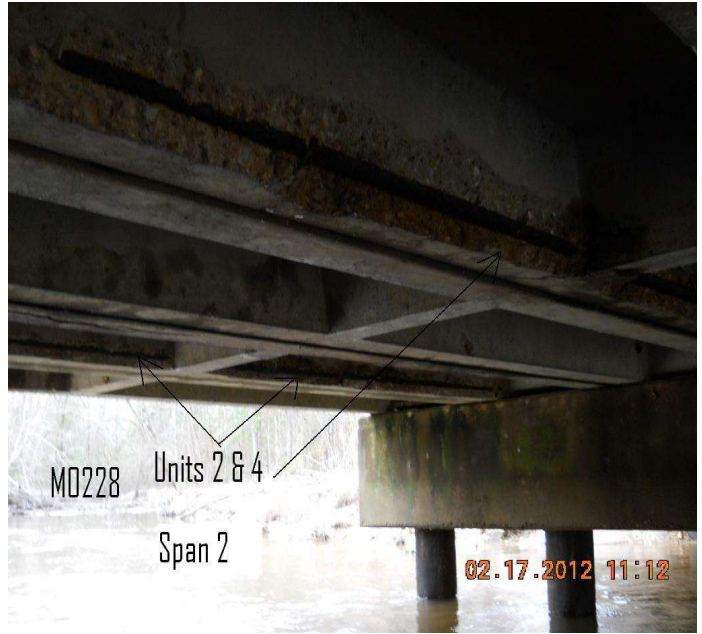
PHOTO 2 Description Span 2 PC units 2 & 4 have spalls with exposed steel.

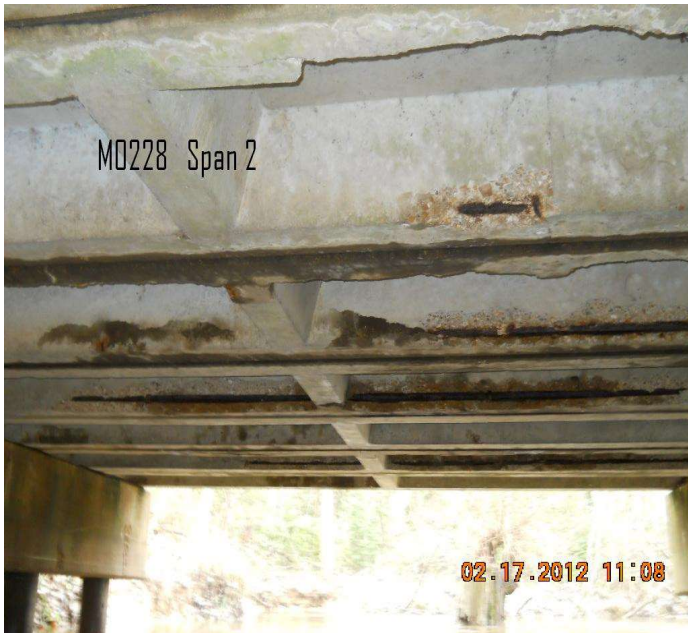
PHOTO 3	Description	Span 2 PC units 2 - 5 with spalls and exposed steel.
---------	-------------	--

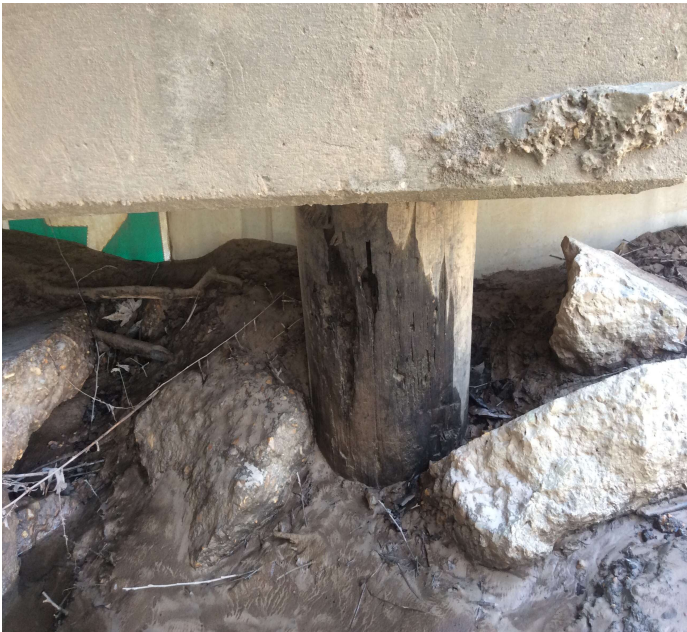
Pile 1 bent 1

Rotten

PHOTO 1 Description M0228 pile 1 bent 1 rotten with hole.

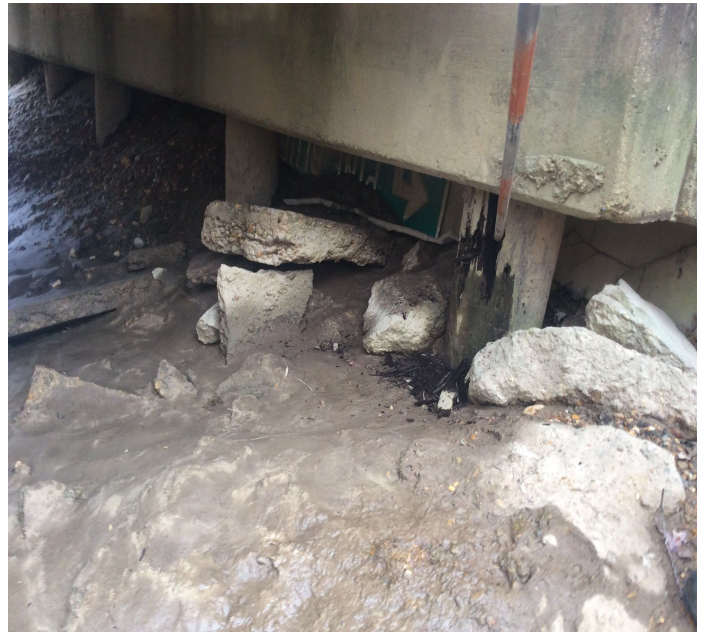
PHOTO 2 Description Pile 1 bent 1 rotten

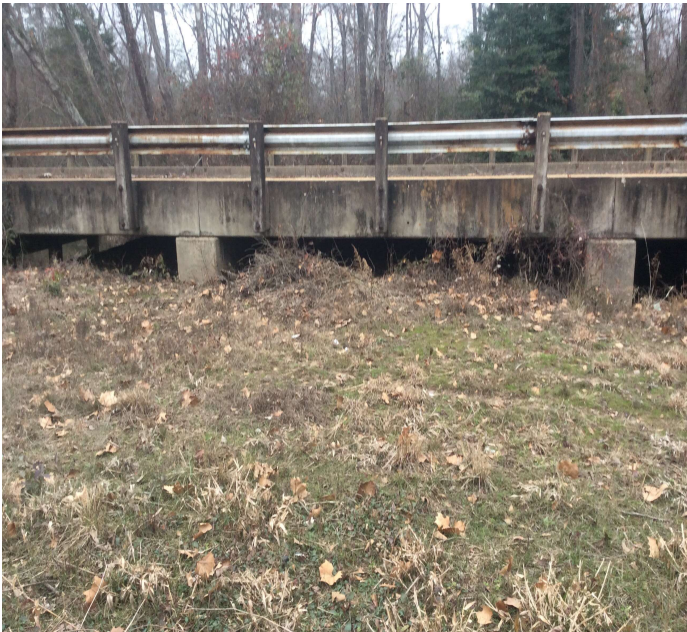
Spans 3,4 and 5 have severe degradation with 3 & 4 being the worst, thus this is causing the channel to scour abutment 1. There is little or no flow under spans 3 & 4.

PHOTO 1	Description	Spans 3,4 and 5 have severe degradation with 3 & 4 being the worst, thus this is causing the channel to scour abutment 1. There is little or no flow under spans 3 & 4.
---------	-------------	---
