Bridge Inspection Report

M0229
SH 8 S-6 LM 5.24
over
BUTLER BRANCH

Structure Number: M0229

Facility Carried: SH 8 S-6 LM 5.24

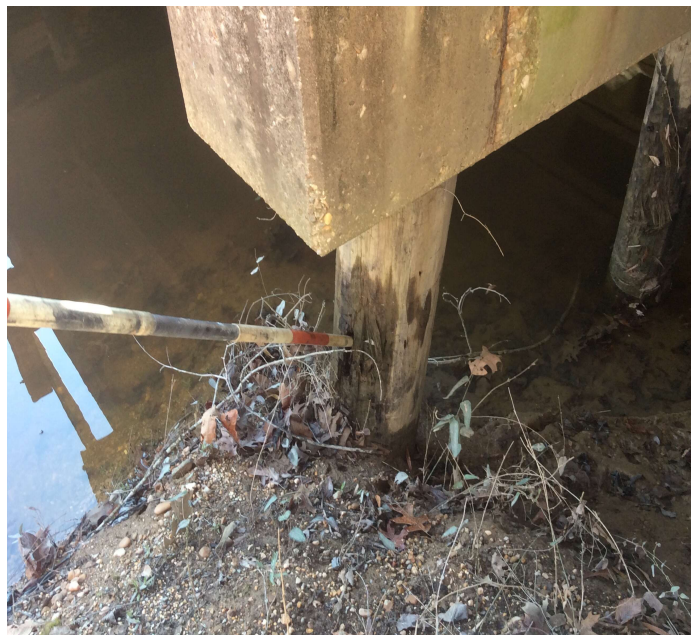
PHOTO 1 Description Pile 1 Bt 2

Pile 1 Bent 2

Rotten, piles 2 & 5 bent 5 are rotten. Pile 5 is beginning to mushroom.

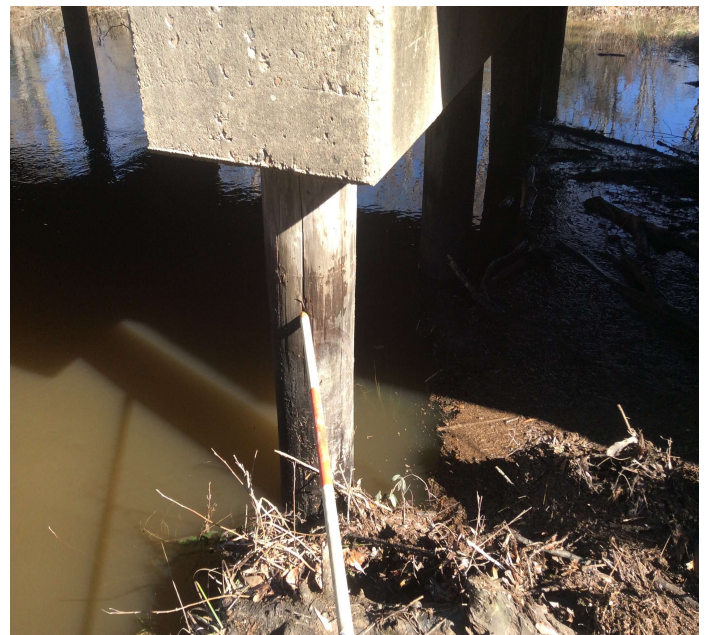
PHOTO 2 Description M0229 pile 5 bent 5 beginning to mushroom.

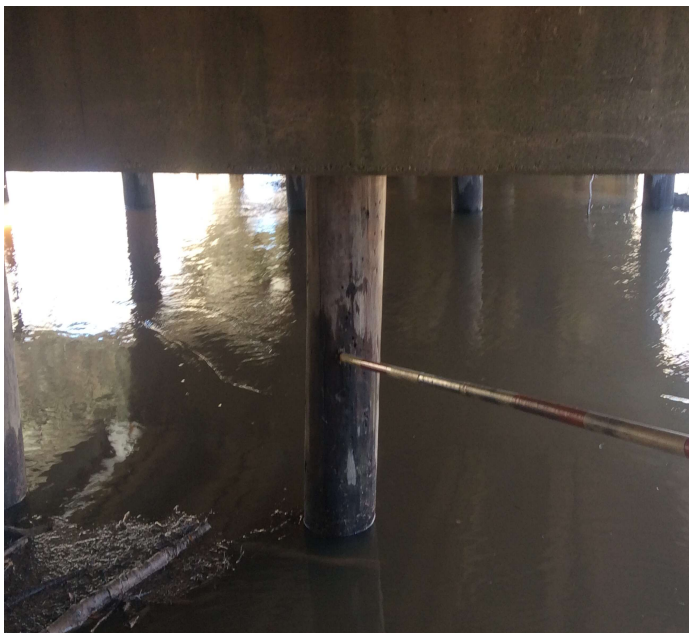
PHOTO 3 Description M0229 pile 2 Bt 5 rotten.

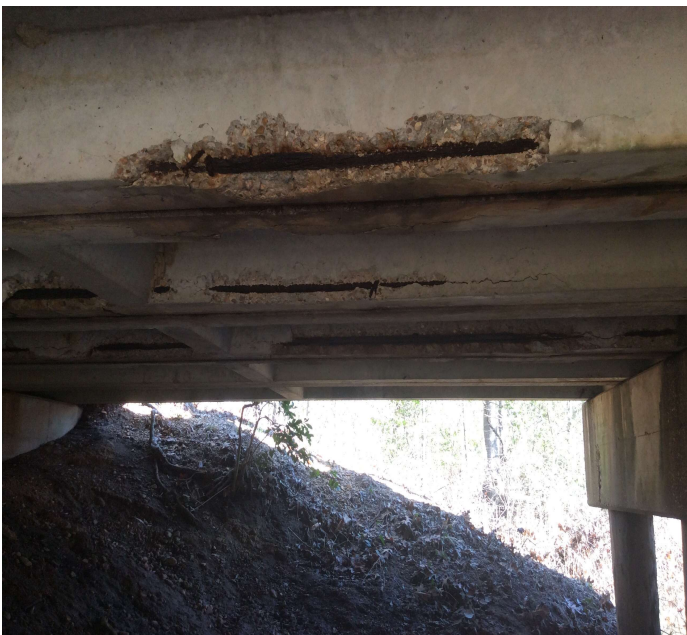
PHOTO 1 Description M0299 span 1 units 3-4-5

PC units spans 1-2-3-4

Numerous cracks and spalls with exposed steel. Minor to moderate sec. loss.
