# Bridge Inspection Report

00899

US67SEC6Lm3.73Clar  
over  
CADDO RIVER

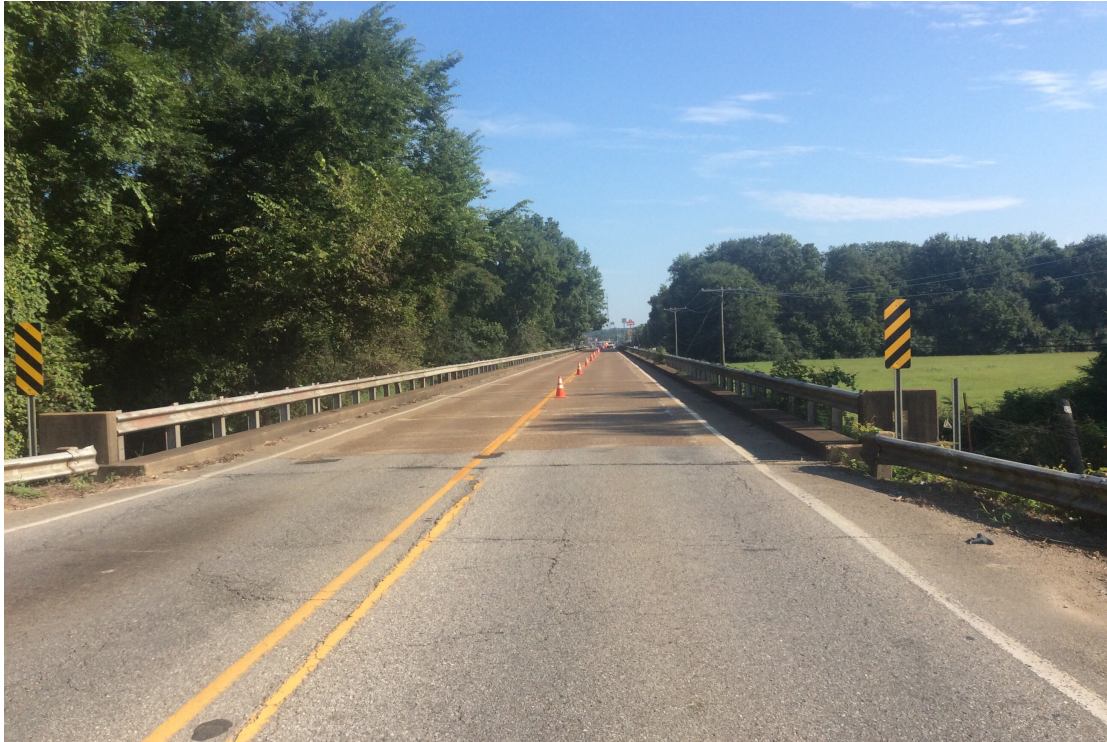
No overlay on bridge deck

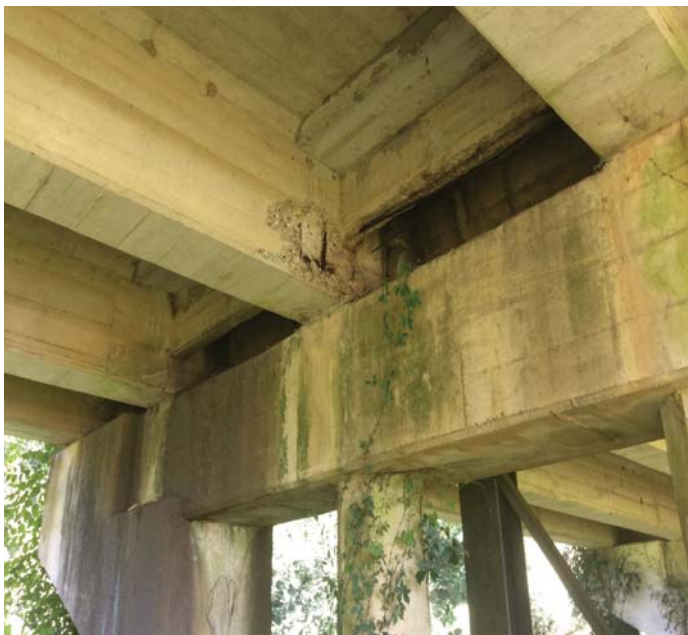
PHOTO 1 Description

Fresh spalls noted since last inspection. Girder 3 bent 11 (back) Girder 6 bent 15 (ahead) and Girders 3-4 bent 21 (back) . Also the bent 21 cap (ahead) is spalled under girders 5-6.
