Bridge Inspection Report

00911
US 67 SEC 6
over
MILL CREEK

Structure Number: 00911

Facility Carried: US 67 SEC 6

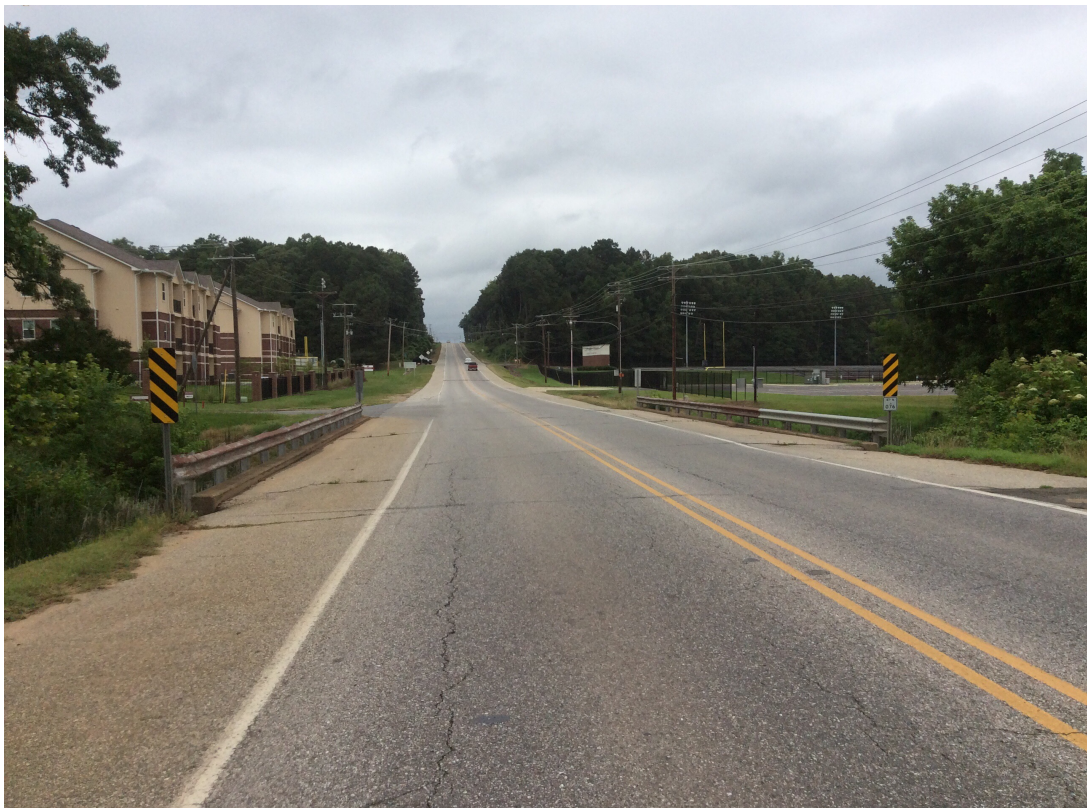
9 inch's of asphalt overlay on bridge deck
