# Bridge Inspection Report

**06165**  
**SH 51 S-2 LM1.40**  
**over**  
**SALINE BAYOU**

Structure Number: 06165

Facility Carried: SH 51 S-2 LM1.40

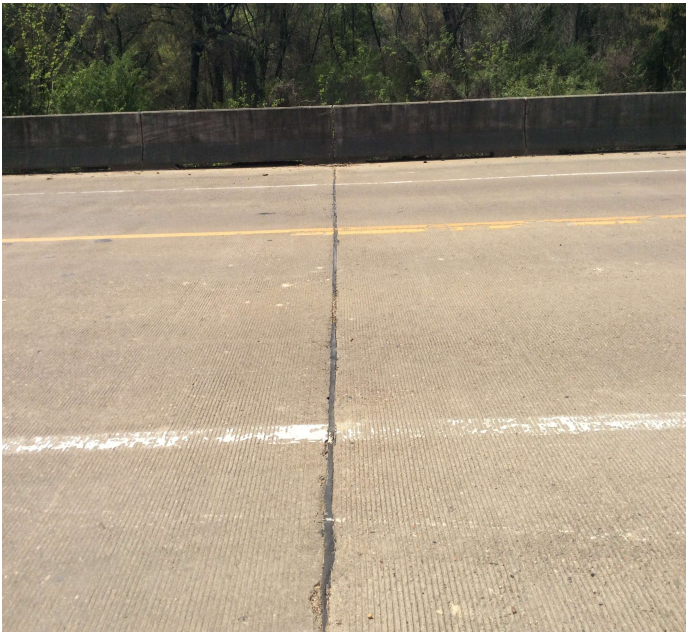
Joint material all bents is worn and tattered. 03/22/2017 Bent 6 joint material is beginning to loose contact with the concrete, this is typical of all joints.

PHOTO 1      Description      Bent 6 joint material is beginning to loose contact with the concrete, this is typical of all joints.

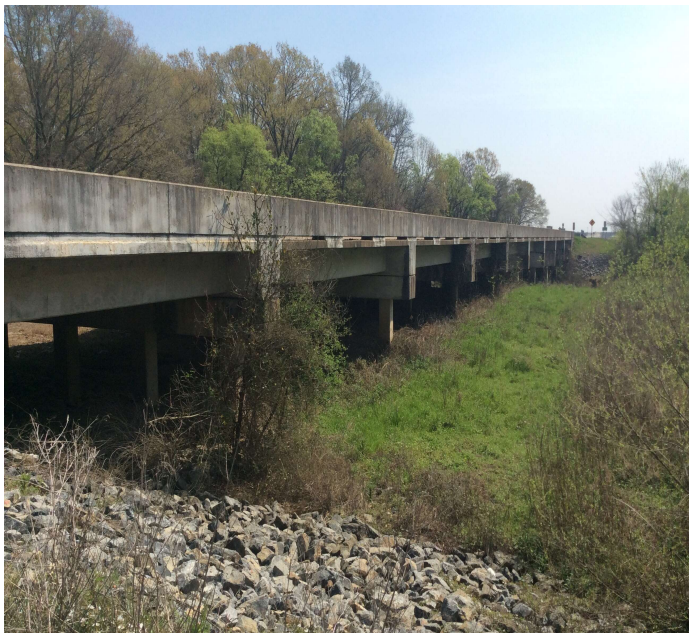
There is vegetation growing up beside the bridge in several places.

PHOTO 1      Description      Vegetation growing up beside the bridge.

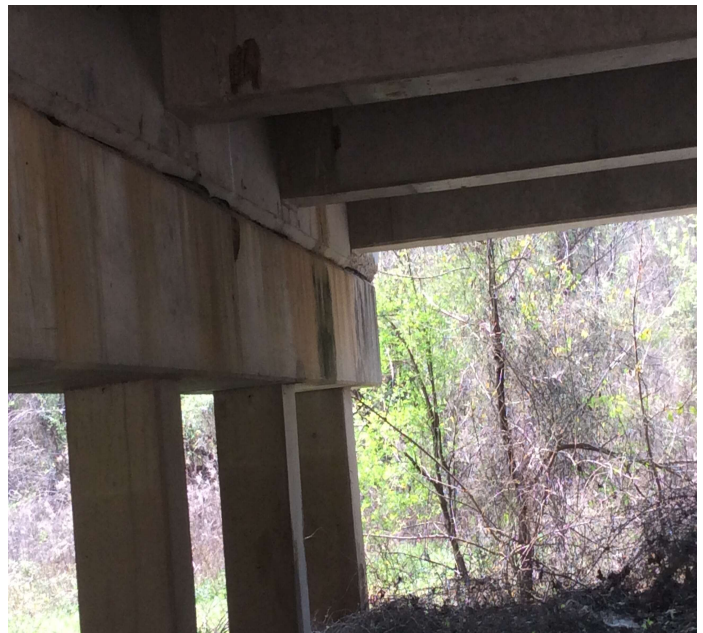
PHOTO 2      Description      Vegetation growing up beside the bridge.

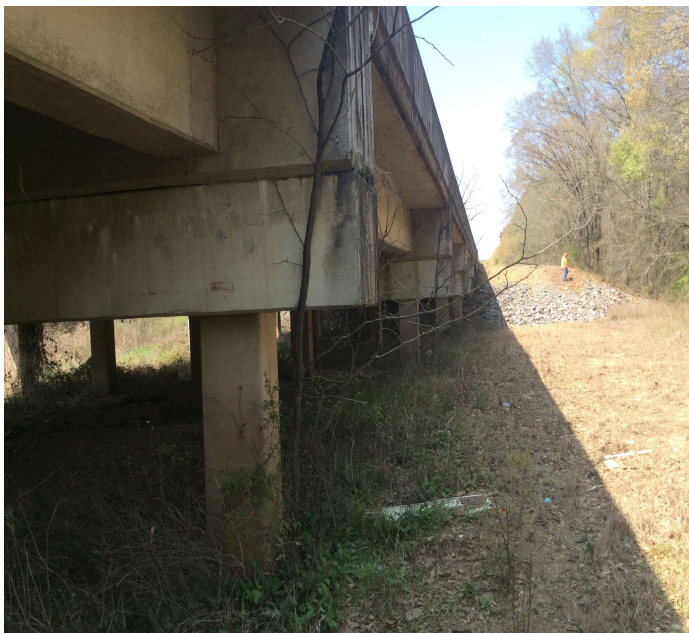
PHOTO 3      Description      Bent 5 looking back, minor vegetation growing under & up beside the bridge.
