Bridge Inspection Report

01570
US 82 S-7 LM 2.89
over
CANNON CREEK

Structure Number: 01570

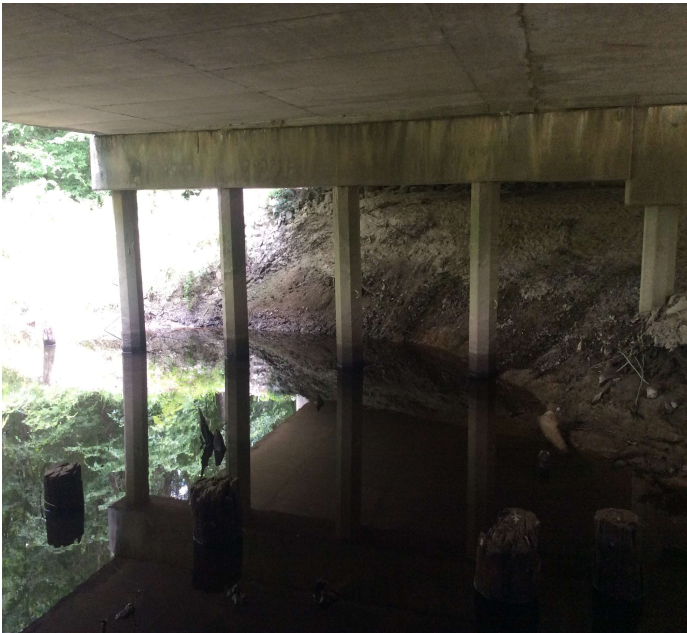
PHOTO 1 Description

Local scour hole has developed around piles 1-4 of bent 3.
