Bridge Inspection Report

02912
US 82 S-6 LM 16.17
over
LAPILE CREEK

Structure Number: 02912

Facility Carried: US 82 S-6 LM 16.17

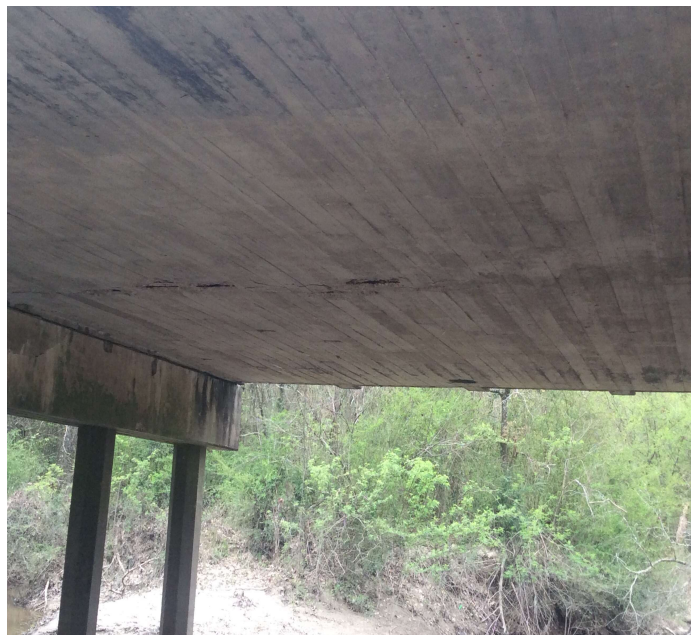
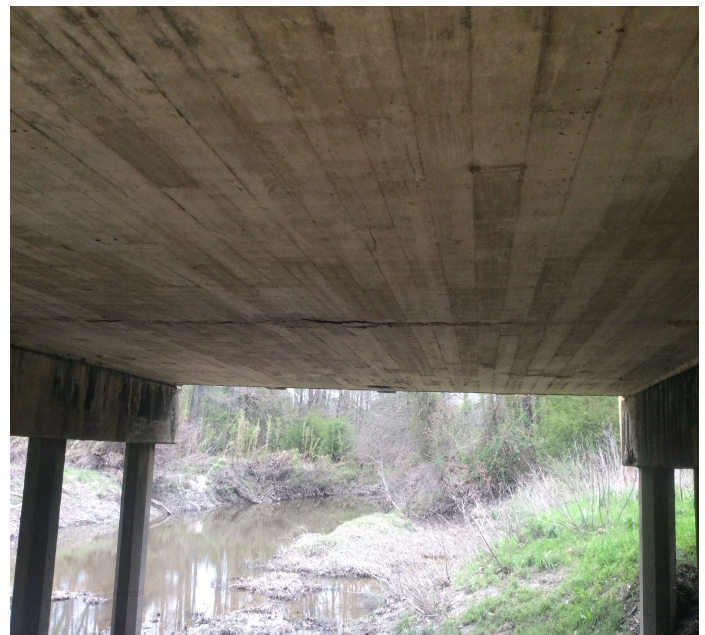
Deck - Soffit, Spans 3 & 5.

Longitudinal cracking and spalling off with some steel exposed (1-2 bars exposed).

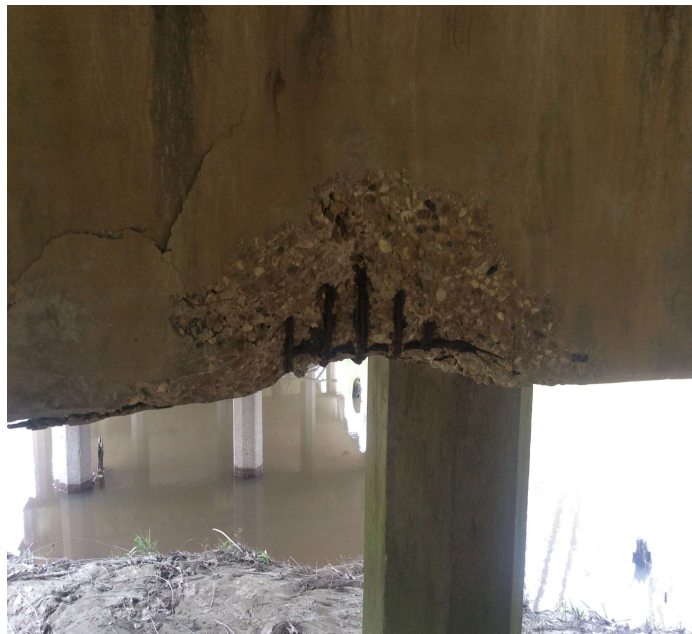
Cap, bent 2 back. spalls with exposed steel.

PHOTO 1 Description Bent 2 cap spalled with exposed steel.

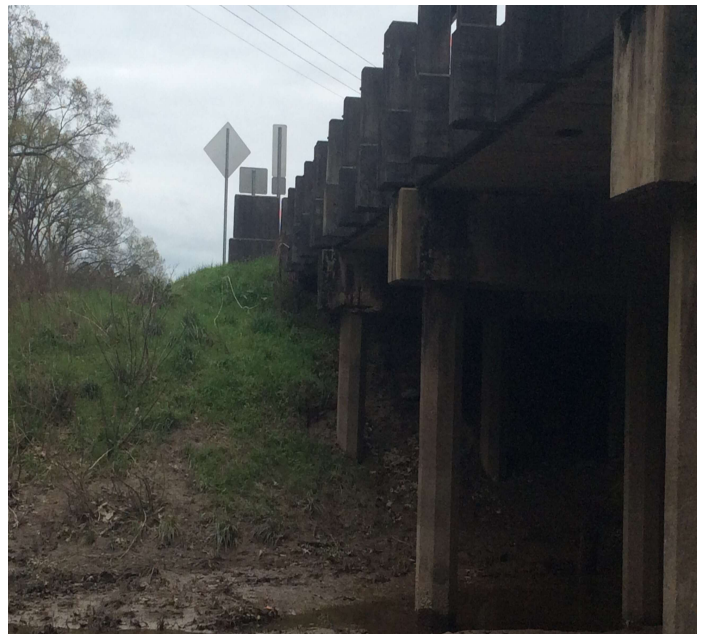
Cap, bent 6 back (left). Spalls with exposed steel.

PHOTO 2 Description Bent 6 cap spalled

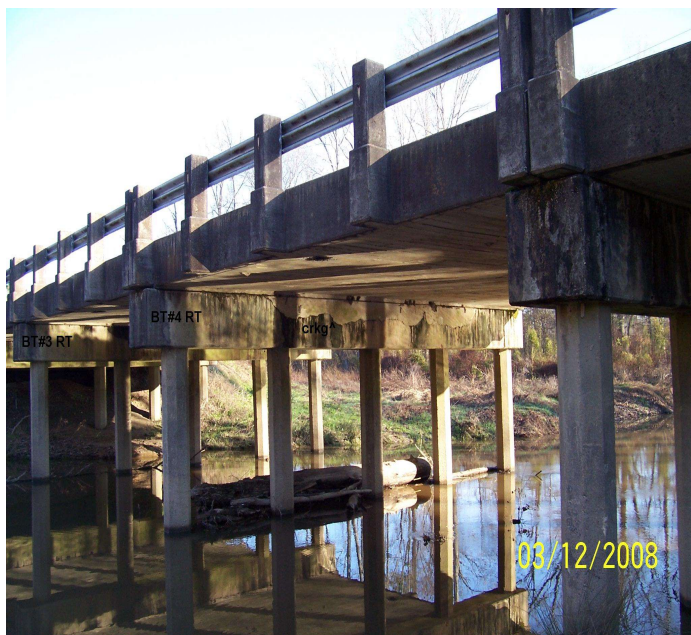
Cap, bent 4 (ahead). 15' crack.
Spalls (3 feet) with exposed steel (some section loss).

PHOTO 3	Description	Bent 4 ahead, cap is cracked with 3' spall
---------	-------------	--------------------------------------------

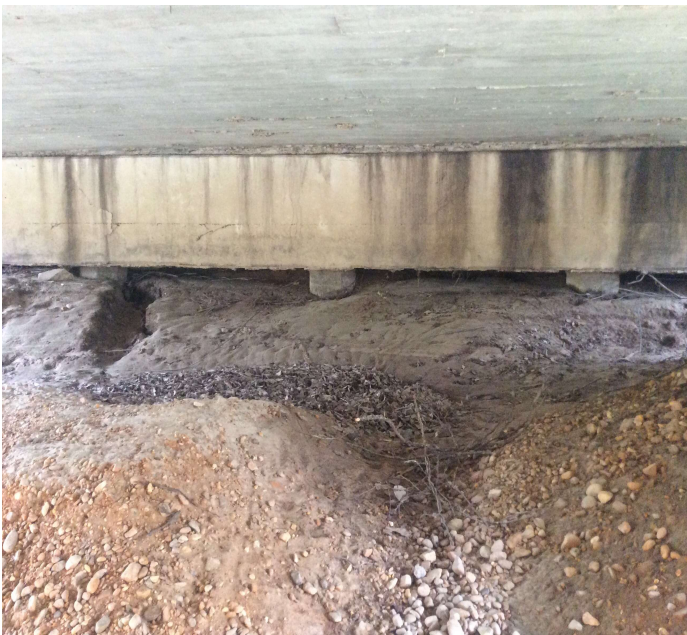
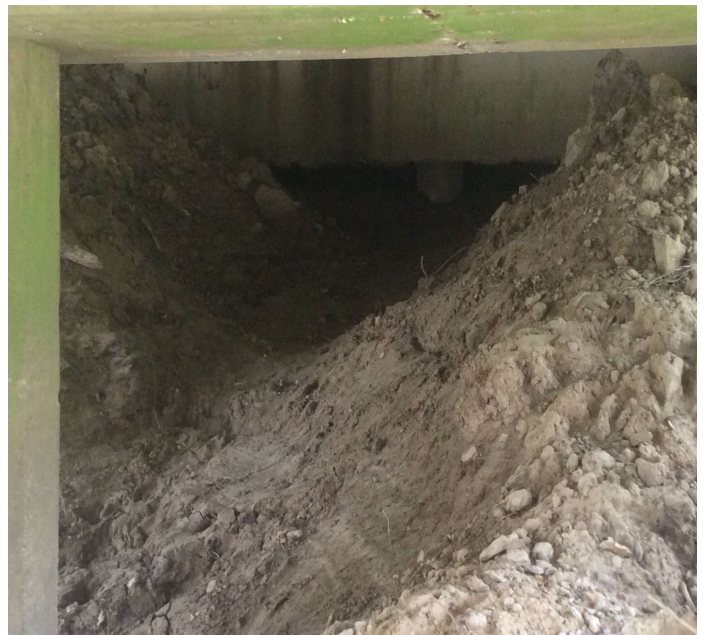
Abutments 1 & 2 have scour holes that go back and under the abutment caps.
