# Bridge Inspection Report

05743

US 82 S-7 LM1.06

OUACHITA RR COMPANY

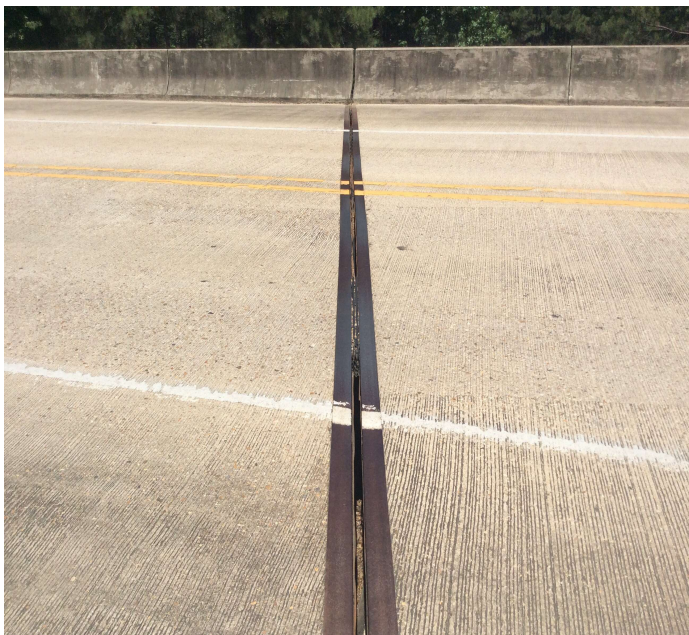
Bent 2, all of joint material missing,  
Bent 4 left 15' of joint material missing.

PHOTO 1 Description Bent 2, 8' of joint material missing.
