Bridge Inspection Report

05364
SH 229 S-O LM 1.25
over
COOKS CREEK

Structure Number: 05364

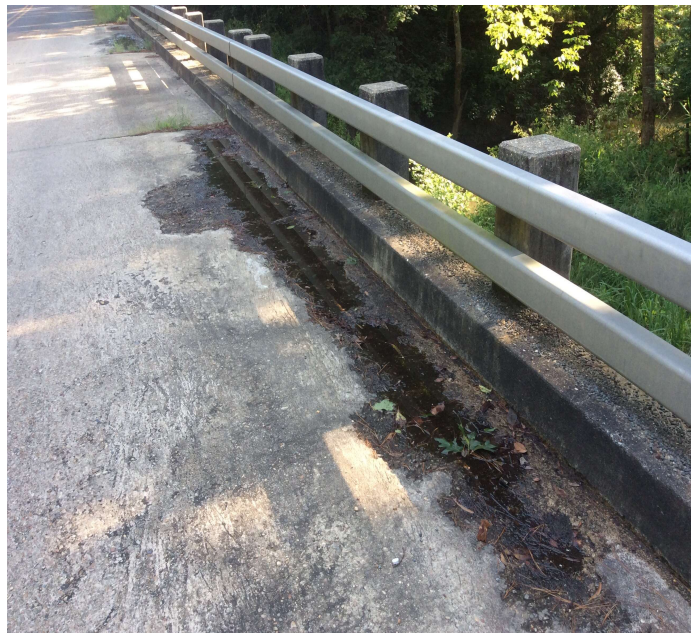
PHOTO 1 Description

Large deck spalls along right gutter line span 1 and span 3. These are up to 2 feet wide and are full length of the spans.

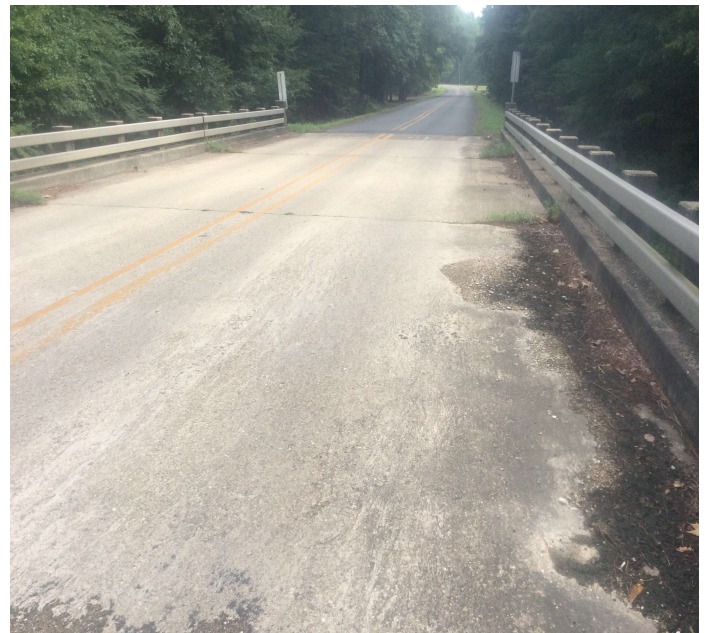
PHOTO 2 Description Deck

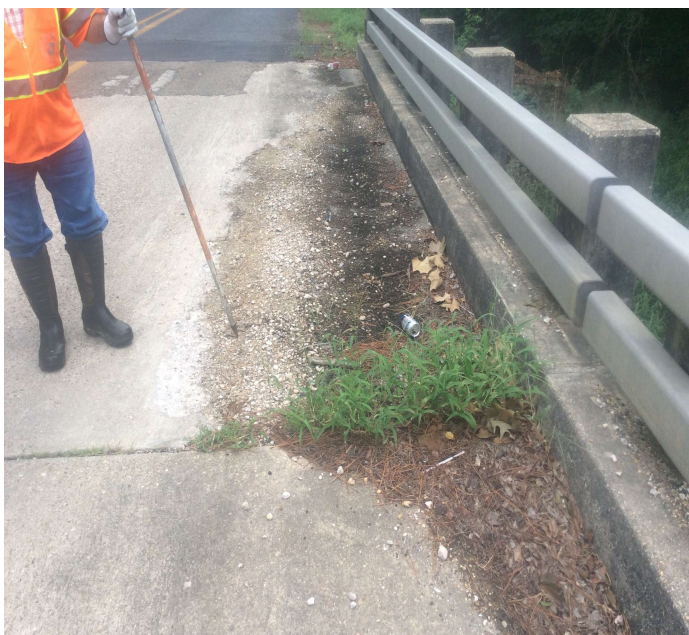
PHOTO 3 Description Spall span 3 right side

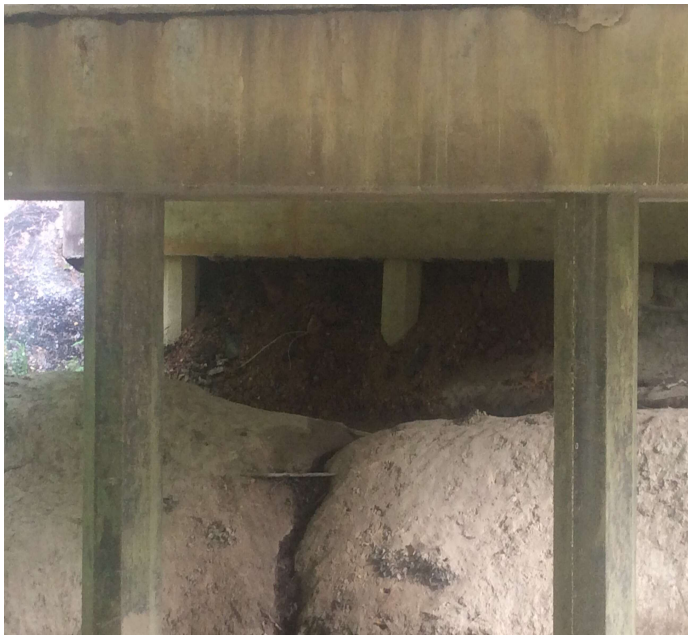
Abutment 2 entire length of abutment cap, has scoured back and under abutment cap and there is no slope protection. There is 3' - 4' of piling exposed on abutment 2. The area under and back of the abutment has eroded and the void is undercutting the load path and approach roadway. 08/14/2018 JPR -- Looking @ Photo 1 it appears that maintenance has added millings or ACHM from ahead side of the abutment, but there is still some scouring below the bottom of abutment cap. There is also a ACHM patch @ BR end abutment 2, for roadway settlement.

PHOTO 1 Description Scour under abutment 2

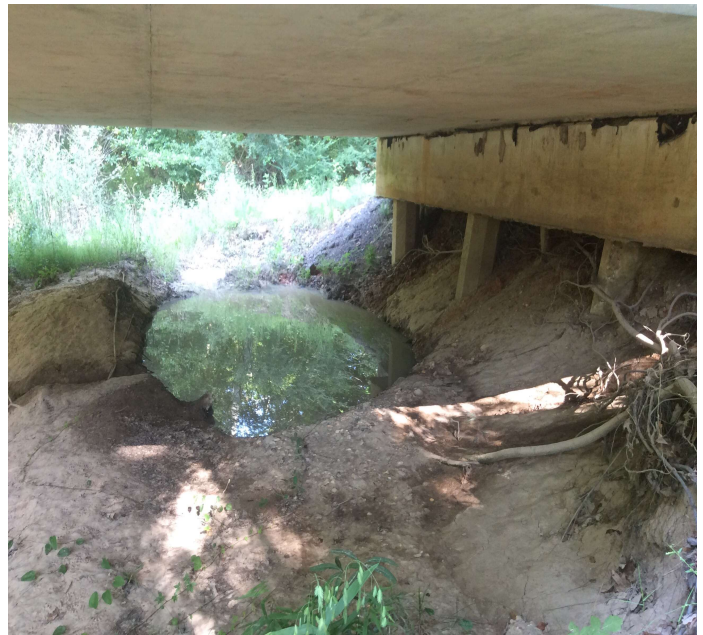
PHOTO 2 Description 05364 scour hole under span 3 columns 1-3 shown .

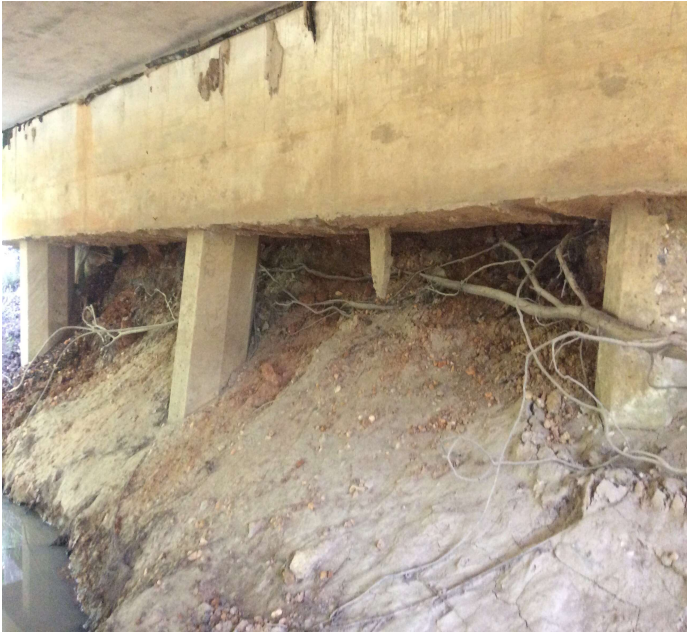
PHOTO 3 Description Abutment 2 erosion

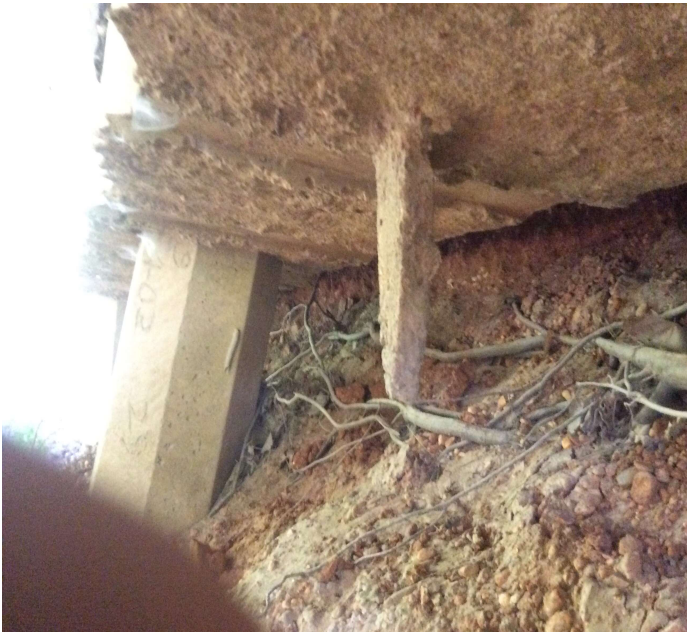
PHOTO 4 Description Erosion abutment 2

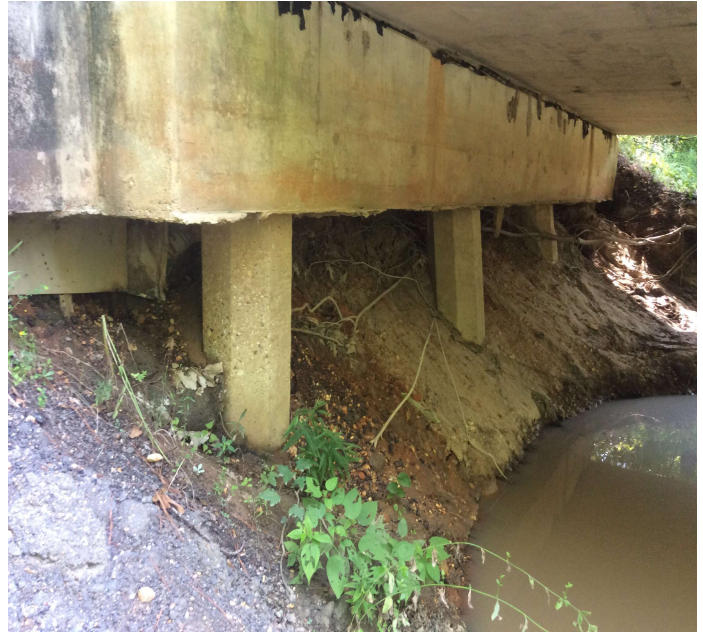
PHOTO 5 Description Abutment and slope erosion note visible aggregates column 1
