Bridge Inspection Report

05365

SH 229 S-0 LM 3.13

HURRICANE CREEK

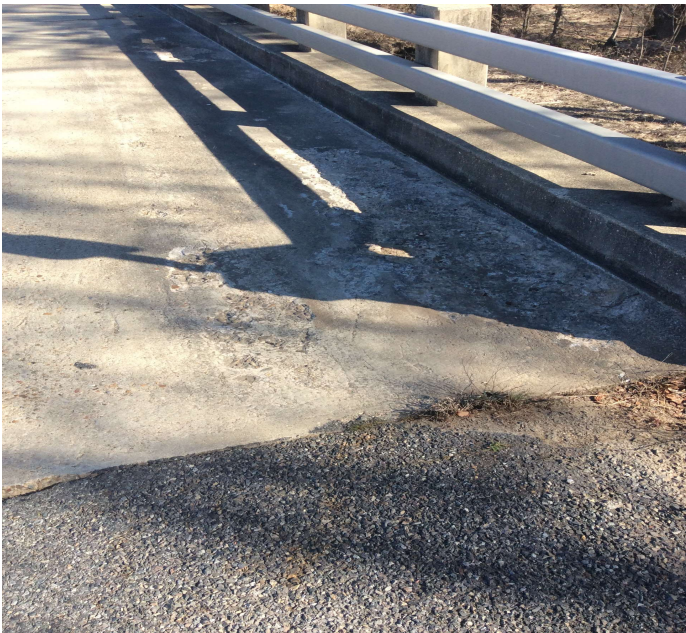
Span 1 Rt. deck spalls, from gutter line and starting about 1' off beginning of bridge, there is about 6' - 8' of deck spalling from roadway salts. This spall is about 1" deep, there is no steel exposed now. Span 1 Rt. about midspan and from gutter line out there is deck spalling that is about 4' long.

PHOTO 1 Description Spall span 1 right.

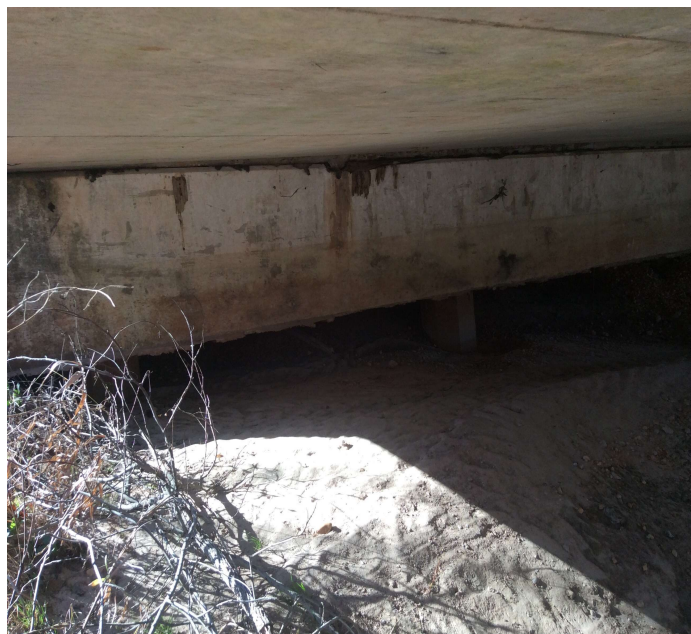
Abutment Scour, abutment 1 Rt. side from C/L Rt. there is scouring below bottom of abutment cap about 1 1/2 ft, and scour goes to backside of cap, with minor roadway settlement. Abutment 2 slope is scouring back towards abutment from about C/L Lt. with minor scouring under abutment 2 cap. Neither abutment slopes have any slope protection. 02/07/2018 JPR -- the scour under the abutment cap is about 3/4 of the abutment cap length from Rt. to Lt.

PHOTO 1 Description Minor washing abutment 1

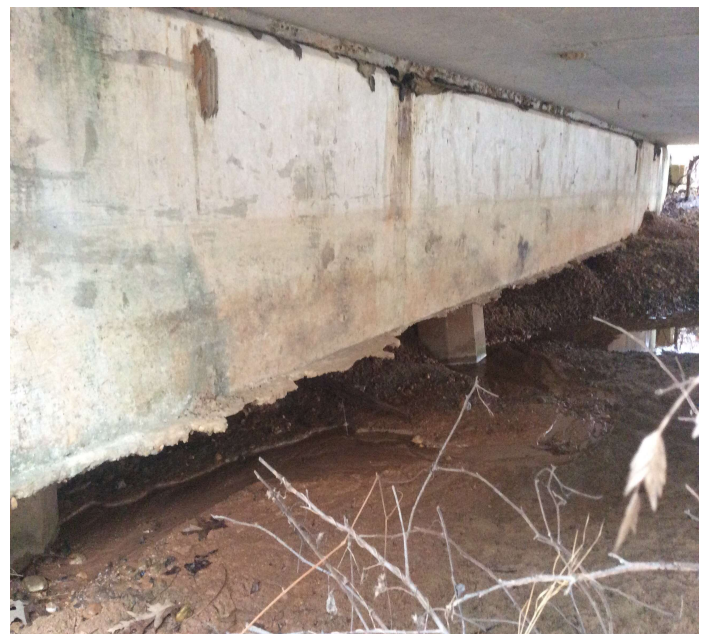
PHOTO 2 Description Abutment 1 cap, scour back under the abutment cap with minor roadway settlement.

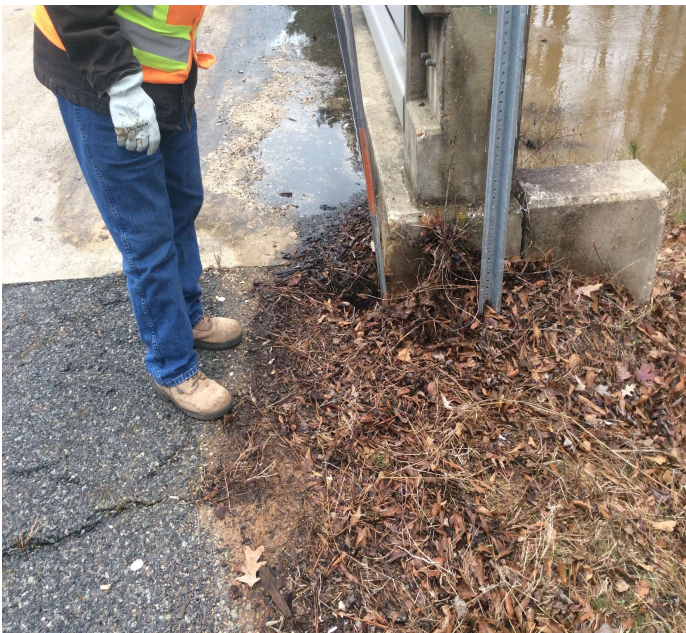
02/07/2018 JPR -- There is a small hole at abutment 1 right side @ abutment.

PHOTO 1 Description Hole at abutment 1 right side @ BR end.
