Bridge Inspection Report

03794

SH 7-S-3 LM 15.06

US 79-SEC 4 LOG MI 0.60

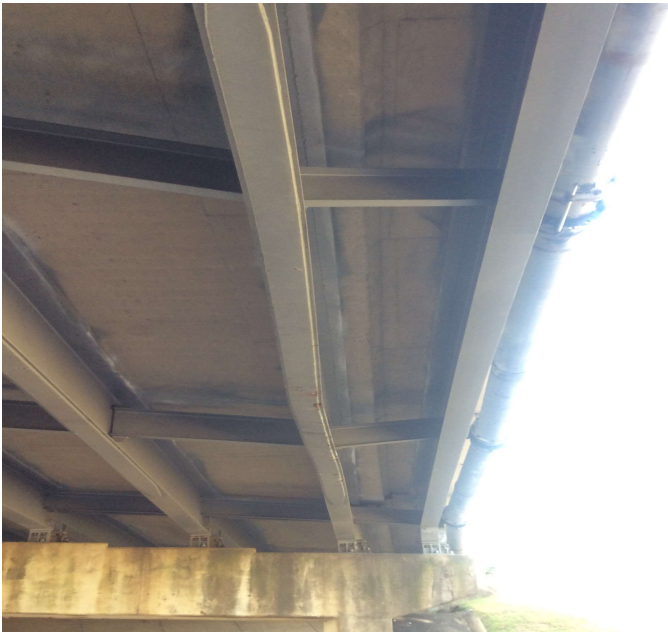
Diaphragm connecting plates #2 & #3 of girders 2 & 3 cracked from traffic impact. Girder 2 span 2 bent by traffic.

PHOTO 1 Description 03794 Girder 2 span 2 showing bending from traffic impact.

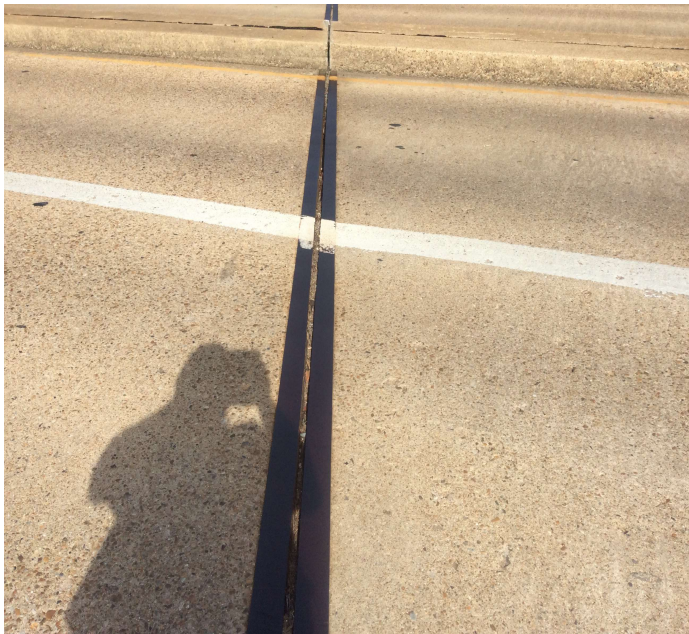
Joint material has failed, all joints. 06/28/2017 Joint material is leaking and letting water and road salts to get through to the caps thus allowing for more spalls on the caps and more rust on the girder ends and bearings.

PHOTO 1 Description 03794 joint material @ Bt 2 joint.

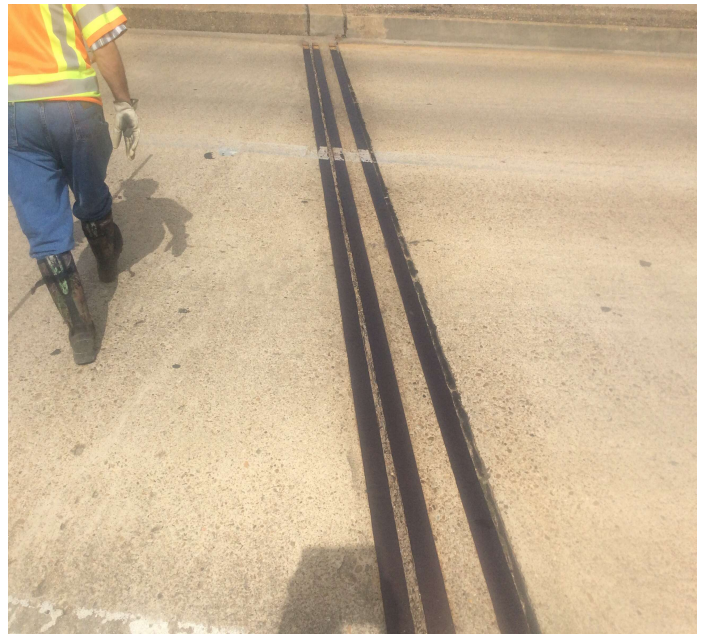
PHOTO 2 Description Joint at abutment 2, this is typical of all joints.

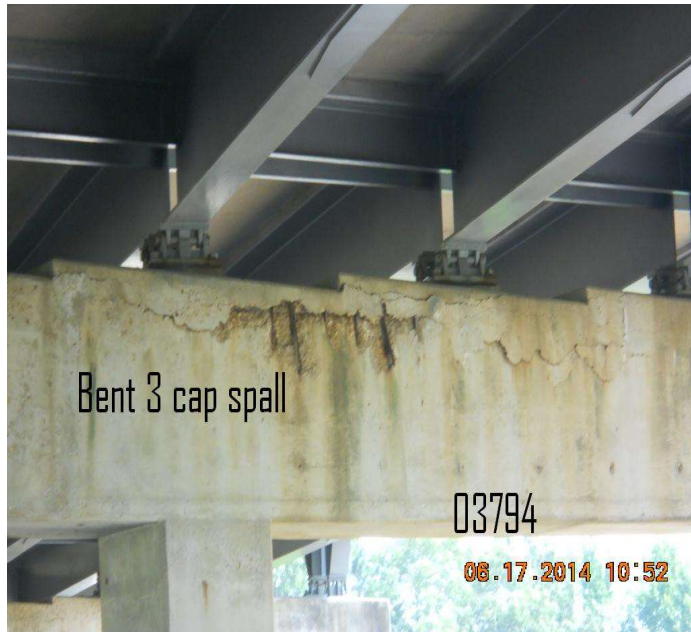
Large spall with exposed steel. 06/28/2017 JPR -- Spall @ Bt. 3 cap back has gotten larger since 2014 inspection. The exposed steel has pack rust with some significant section loss to reinforcing steel.

PHOTO 1 Description 2014 inspection photo. 03794 Bt 3 cap spalls with exposed steel.

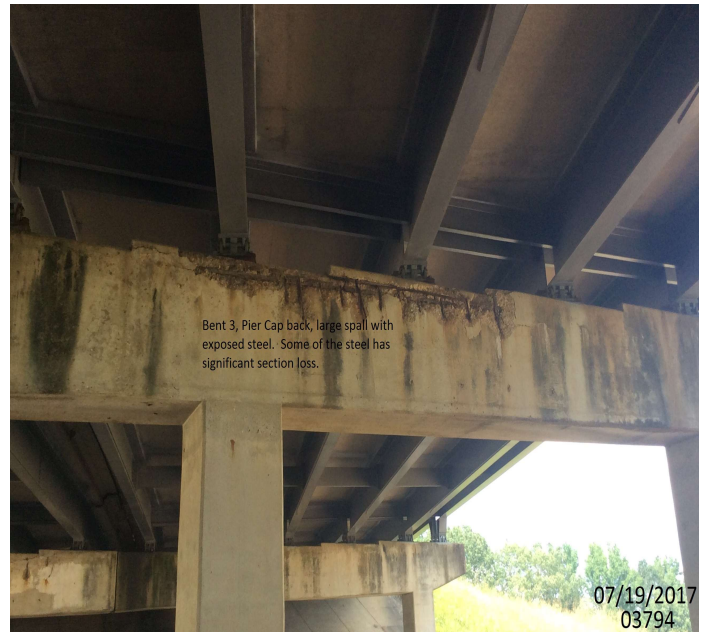
PHOTO 2 Description Spall @ Bt. 3 cap, back.

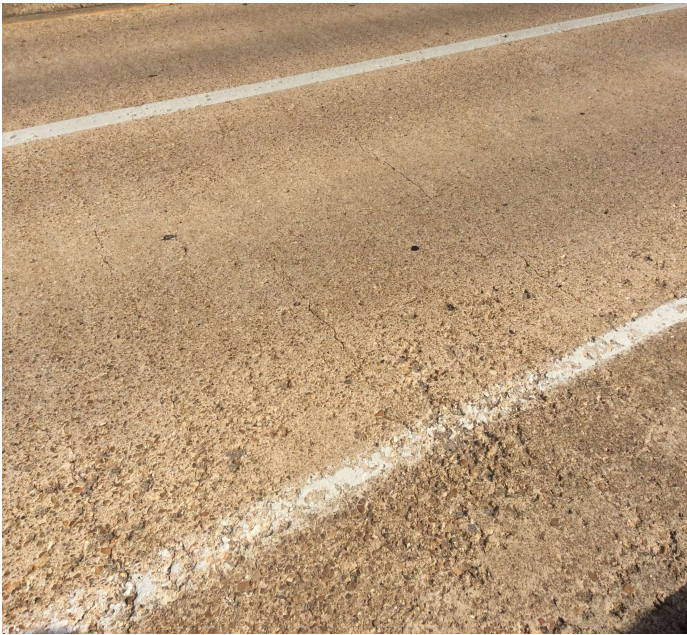
Sealable deck cracks all spans, bent 2 right has several small potholes, no exposed steel. Both approach spans have cracks.

PHOTO 1 Description 03794 deck cracks span 1 rt.

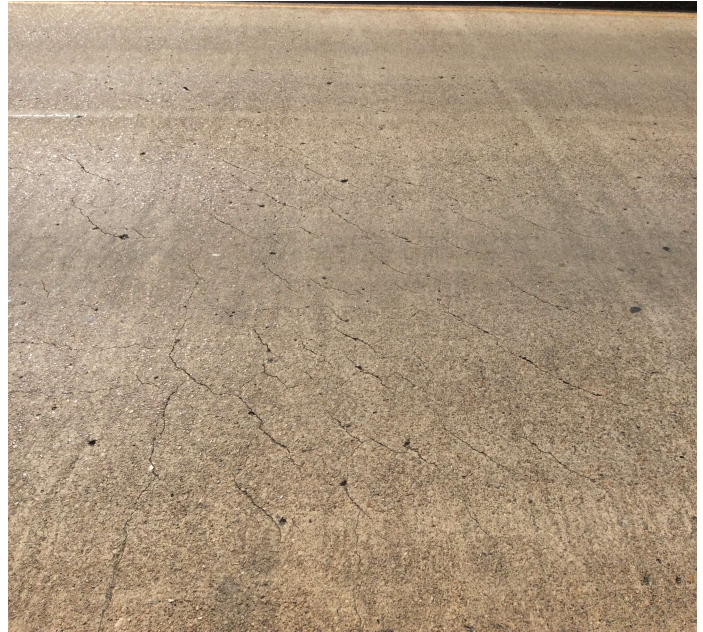
PHOTO 5 Description 03794 span 4 lt. Cracks

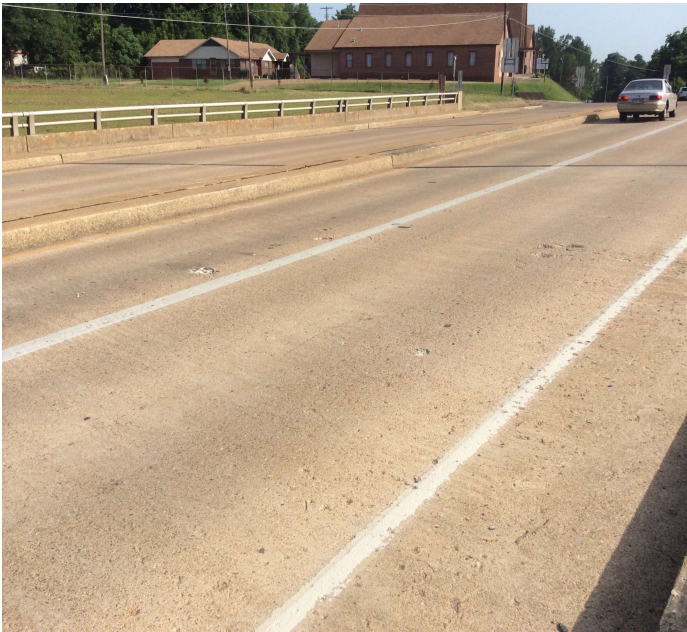
PHOTO 4 Description 03794 span 2 right deck cracks and potholes.
