# Bridge Inspection Report

**A5901**  
**SH 7SB S-3 LM9.72**  
**over**  
**MILL CREEK, UPRR**

Structure Number: A5901

Facility Carried: SH 7SB S-3 LM9.72

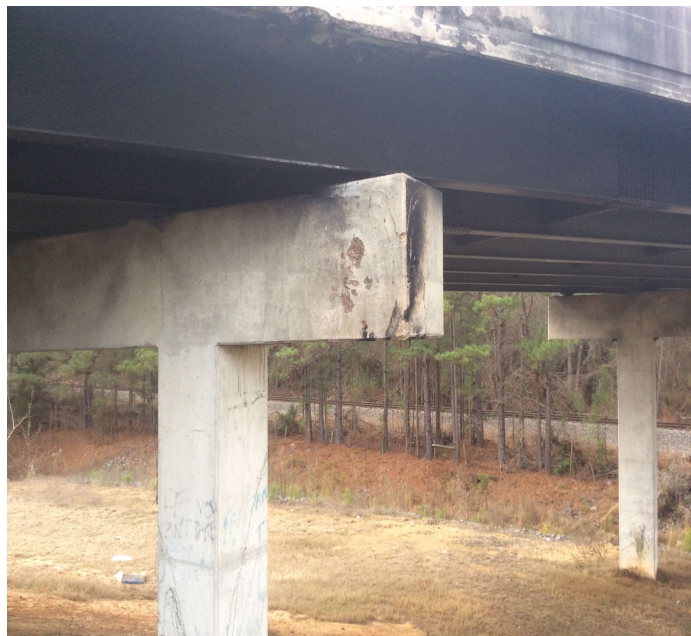
06-26-2017 structure was struck by an 18 wheeler that burned outside the parapet @ Bent 2 right side. Bent 2 bearing 6 is charred. Bent 2 right end of cap is cracked and delaminated. Protective coating (paint system) of the right outside girder is charred, bubbled and cracked.

PHOTO 1      Description      Bent 2 cap right side
