Bridge Inspection Report

A5936
SH7 SB S-3 LM 1.34
over
UNION PACIFIC RR

Structure Number: A5936

Facility Carried: SH7 SB S-3 LM 1.34

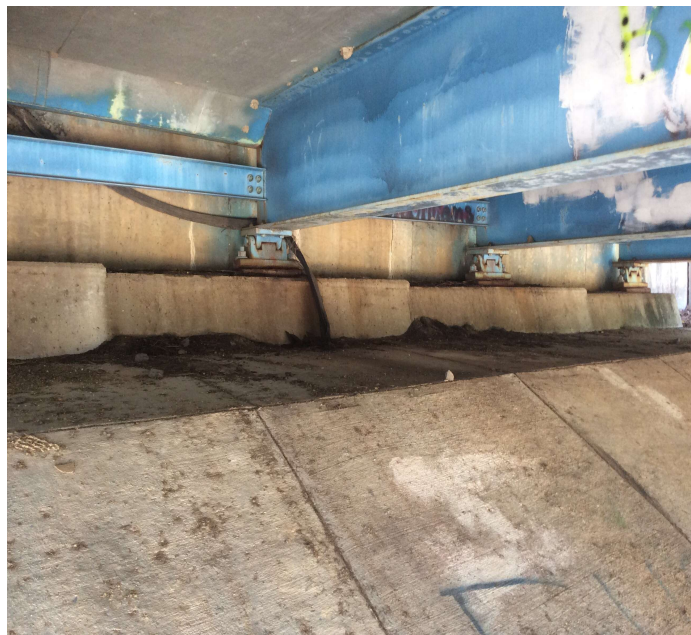
Expansion Joint Seal is missing from rt. of C/L Lt., @ Abutment 1, over bearings 1 - 3, thus allowing dirt, debris, and road salts to reach the girder ends and bearings.

PHOTO 1 Description Abutment 1, joint material is hanging down on top of the cap and there is dirt and debris on the cap.

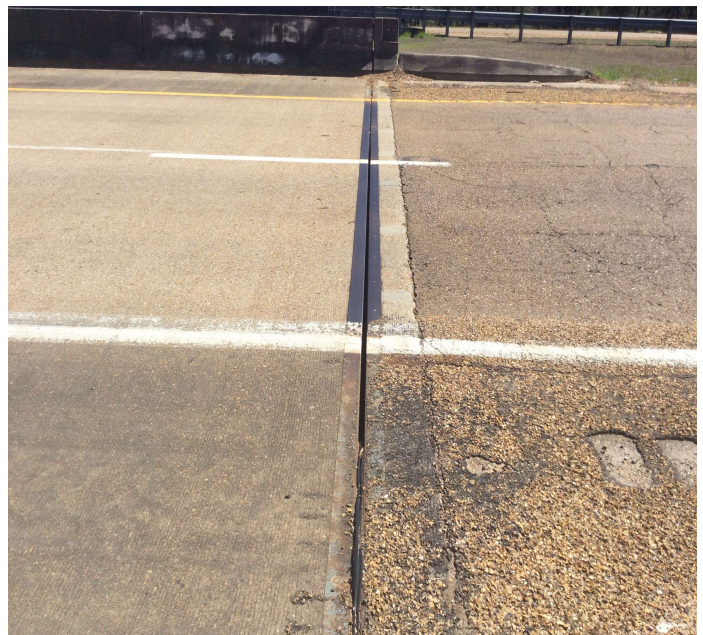
PHOTO 2 Description Joint material missing abutment 1, from 2' past the outside white line to 1' past C/L, over bearings 1 - 3.

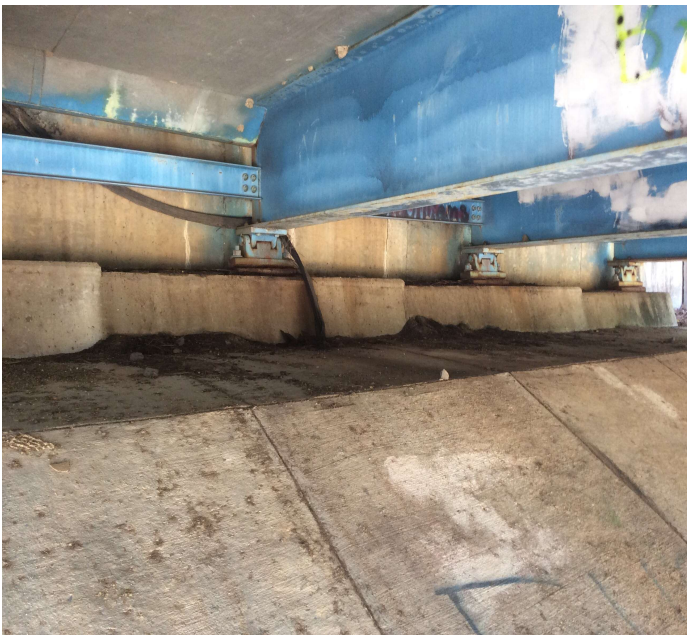
Abutment 1 bearings 1, 2, & 3 have pack rust to masonry plates, with bearing #3 being the worst.

PHOTO 1 Description Bearings 1 - 3 at abutment 1, pack rust to masonry plates.

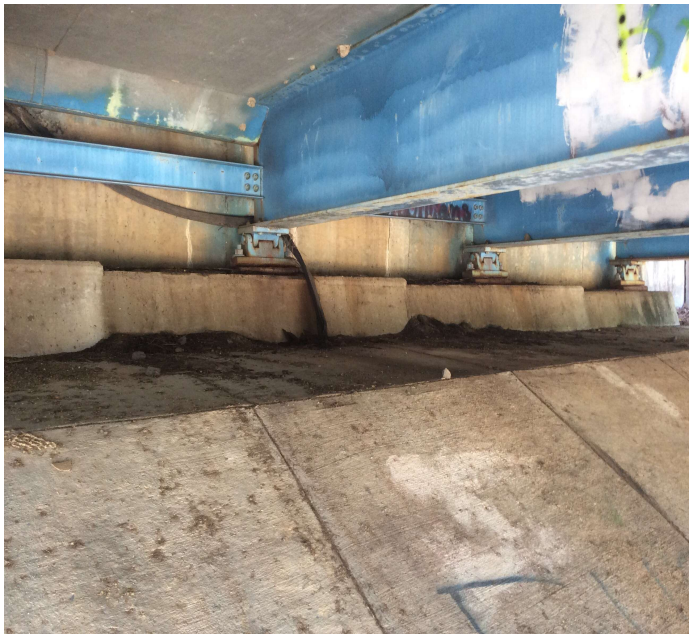
Paint system is chalky. 03/12/2018 JPR -- All girders, paint is chalky with some light rust to bottom & top flanges with little or no section loss. Abutment 1 bearings, 1 & 2 have light rust to masonry plates and rocker bearings. Bearings 3 - 6 have moderate to heavy pack rust to masonry plates and the rocker bearings have light to moderate rust.

PHOTO 1 Description Bearings at abutment 1 pack rust

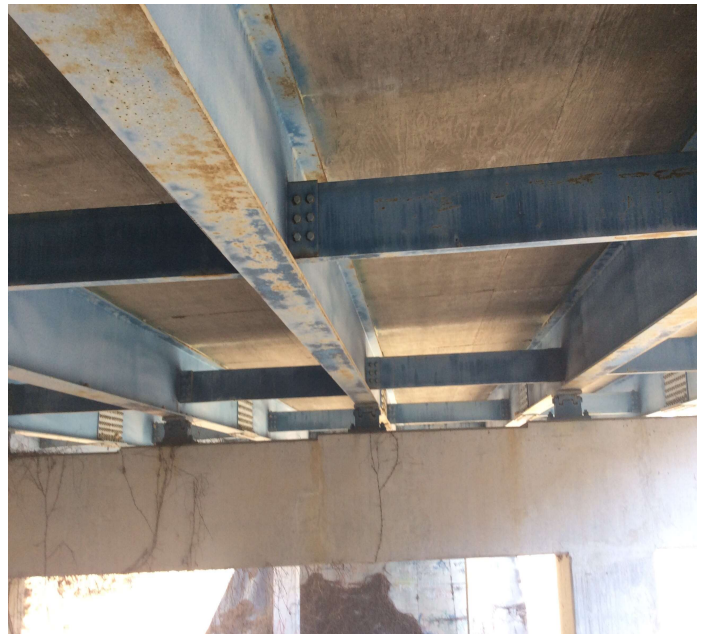
PHOTO 2 Description All girders have paint is chalky and they have some light rust to bottom and top flanges.
