# Bridge Inspection Report

**B5936**  
**SH7 NB S-3 LM 1.34**  
**over**  
**UPRR**

Structure Number: B5936

Facility Carried: SH7 NB S-3 LM 1.34

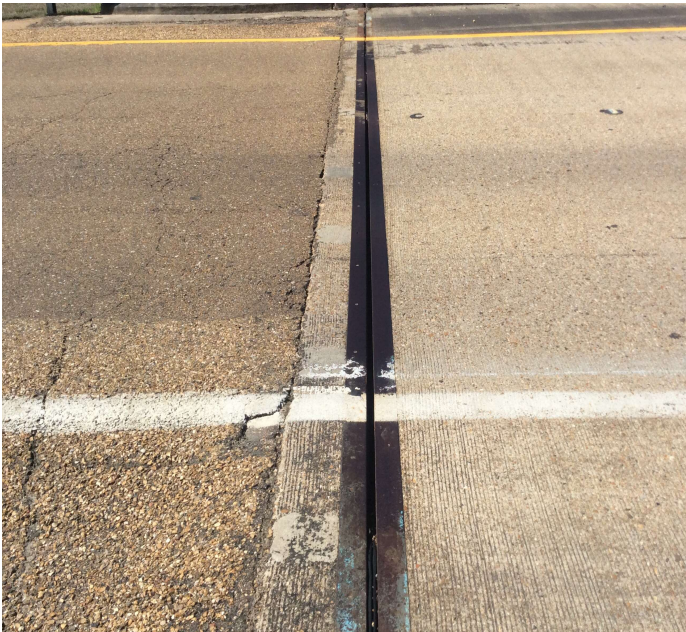
Expansion Joint Seal is missing from Lt. of C/L right @ Abutment 1 , over bearings 3 - 5, thus allowing dirt , debris and road salts to reach the girder ends and bearings.

PHOTO 1      Description      Joint material missing abutment 1
