Bridge 00899 Inspection Report

Asset #00899(Routine, Underwater type 2)

US 67 S-6 LM 3.73 over CADDO RIVER

Team Lead: Rickie Bratton Inspection Date: 08/21/2024

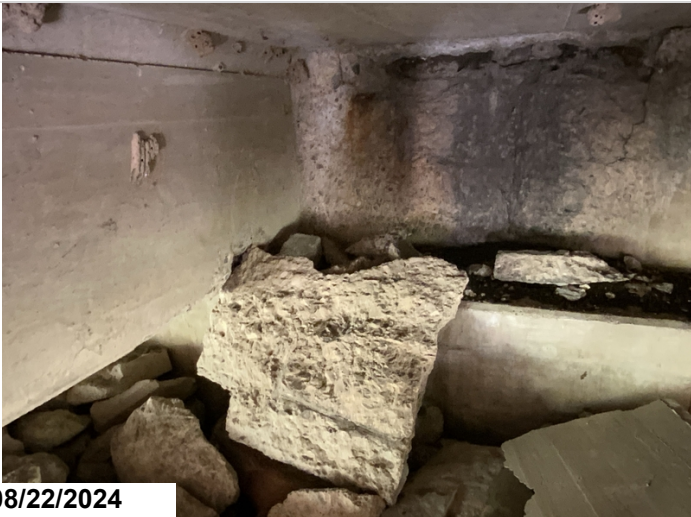
Span 1 @ abut 1 girder 1 has 1' exposed rebar CS3

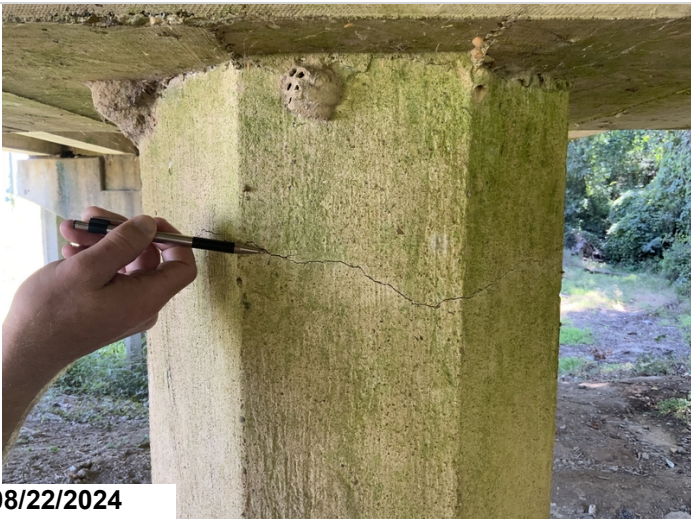
Bent 4 pile 3 cracked CS2

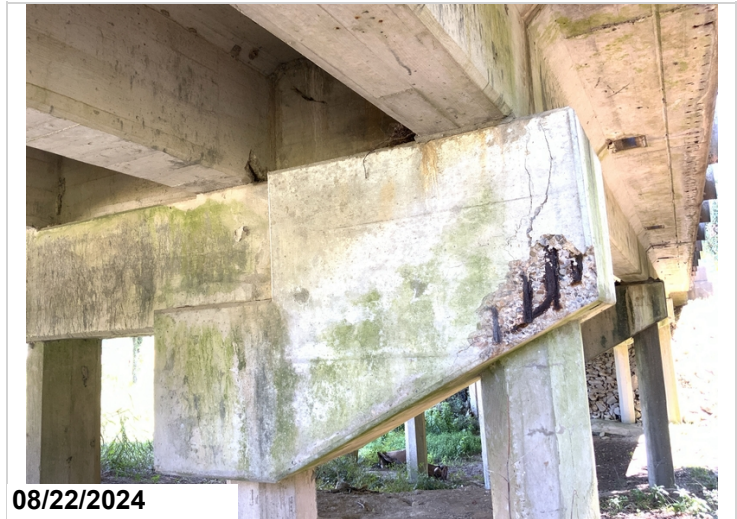
Bent 4 cap ahead left side 1' exposed rebar CS3

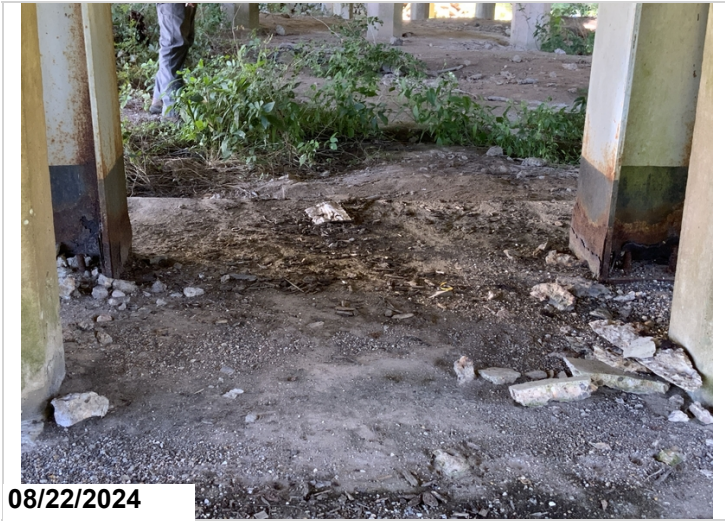
Bent 5 all steel helper piles have flaking rust 6' CS2

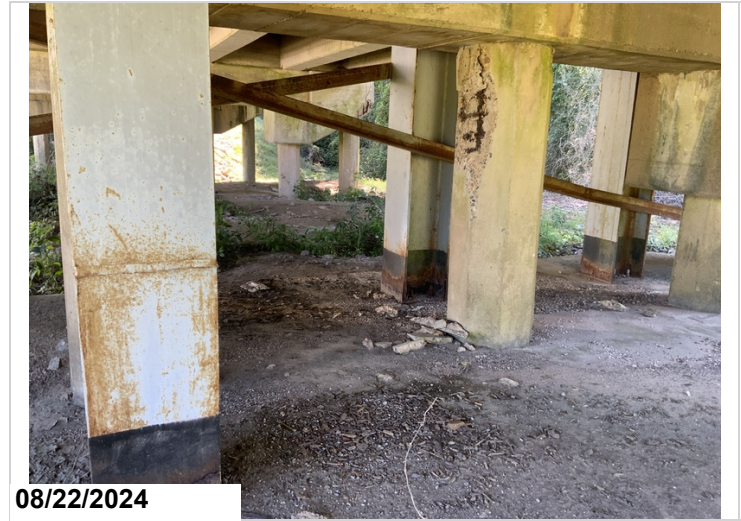
Bent 5 pile 3 exposed rebar CS3

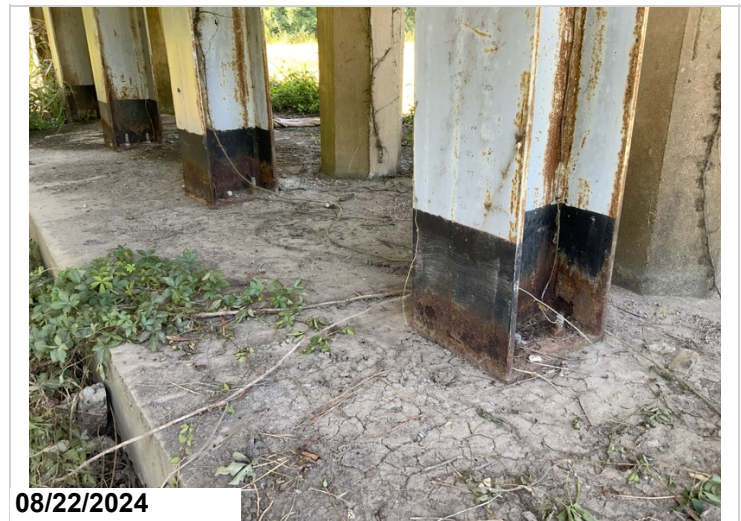
Bent 7 all 6 steel piles have flaking rust 6' CS2

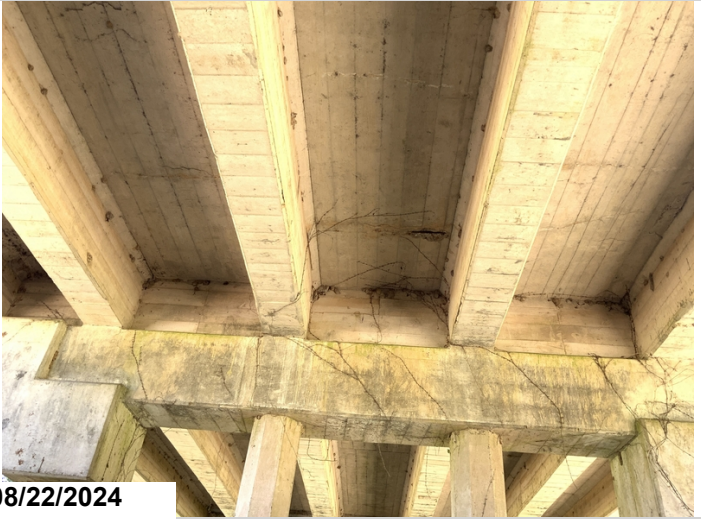
Span 8 all bays have cracks with efflorescence 20' CS2

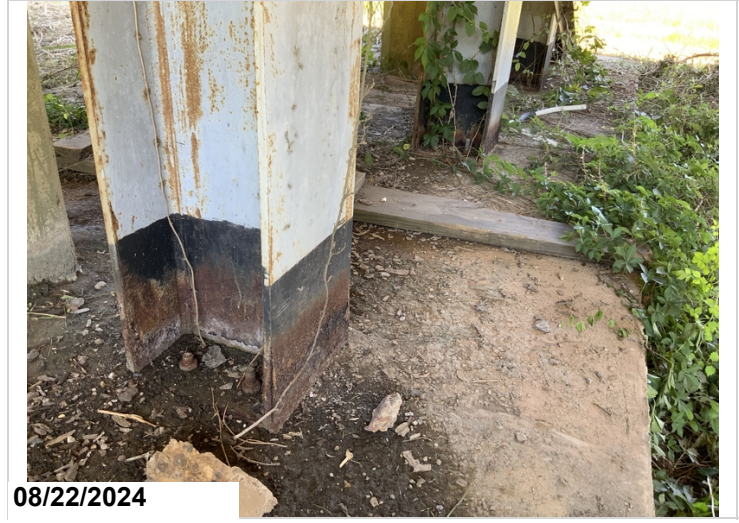
Bent 11 all steel piles have flaking rust 6' CS2

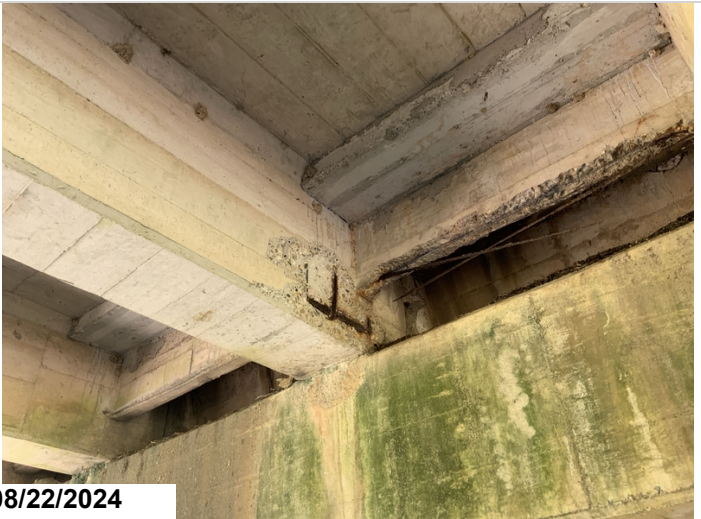
Span 12 bent 13 girder 3, exposed rebar 1' CS3

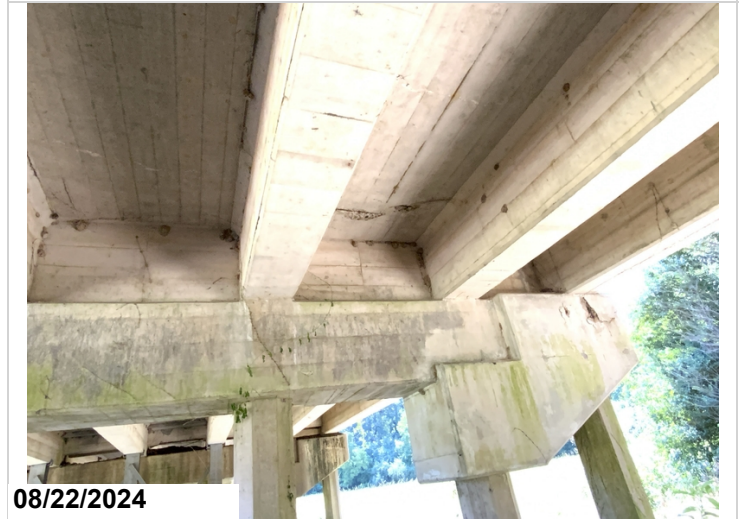
Bent 14 cap ahead left side 1' exposed rebar CS3

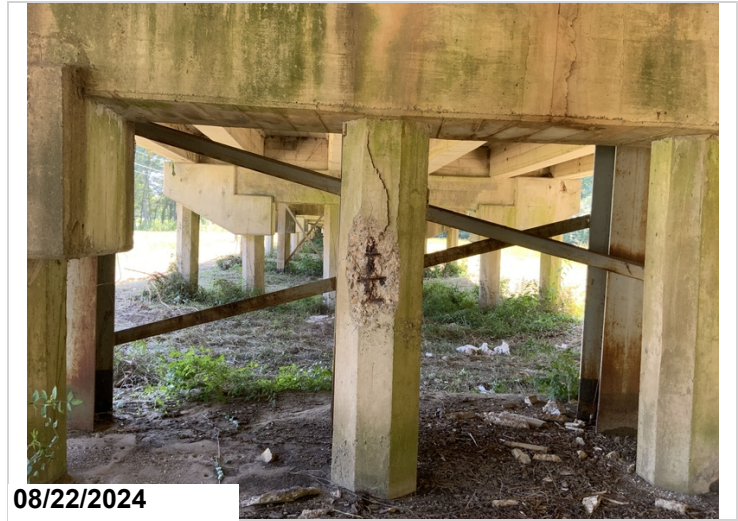
Bent 15 pile 4 exposed rebar 1' CS3

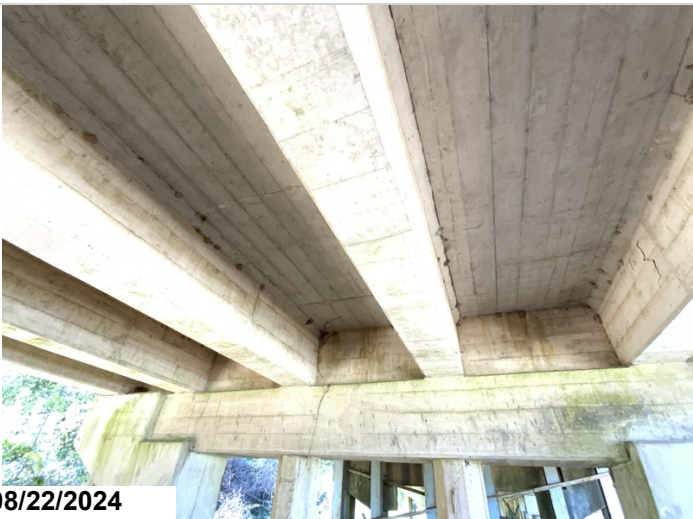
Span 15 all bays have cracks with efflorescence 23' CS2.

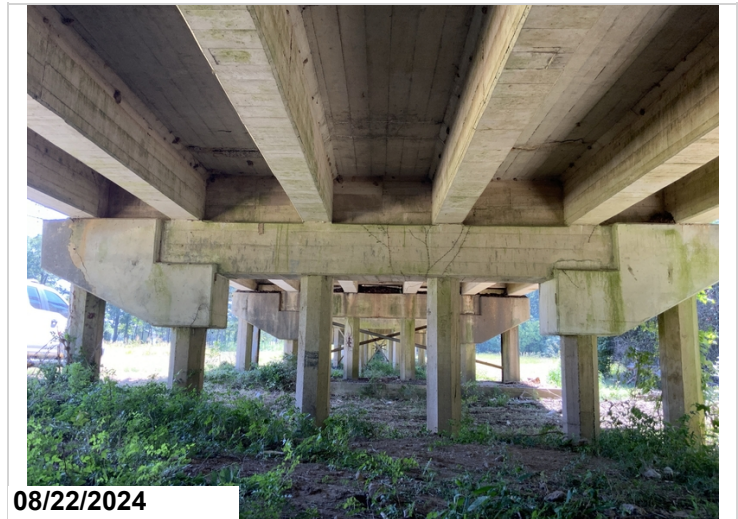
Span 16 bays 1-4 have exposed rebar, 5' CS3

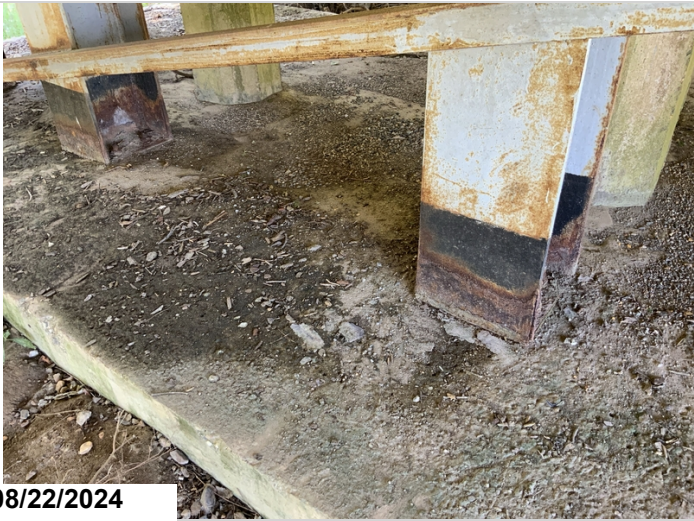
Bent 17, all 6 steel helper piles have flaking rust. 6' CS2.

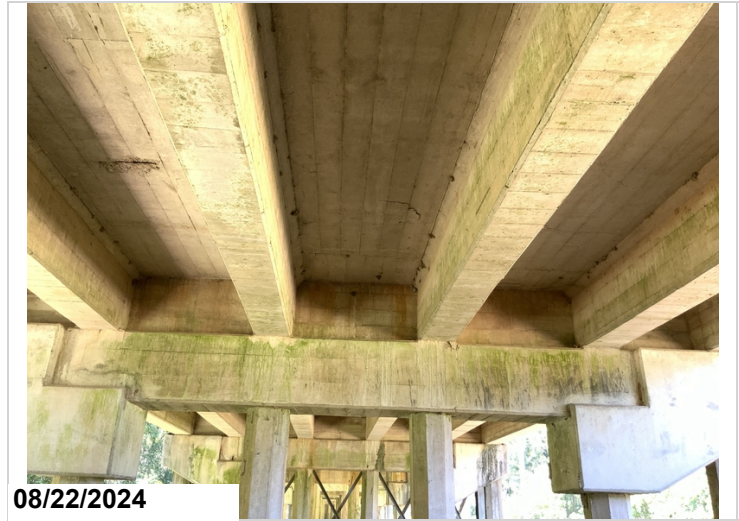
Span 17 bay 2 exposed rebar 3' CS3

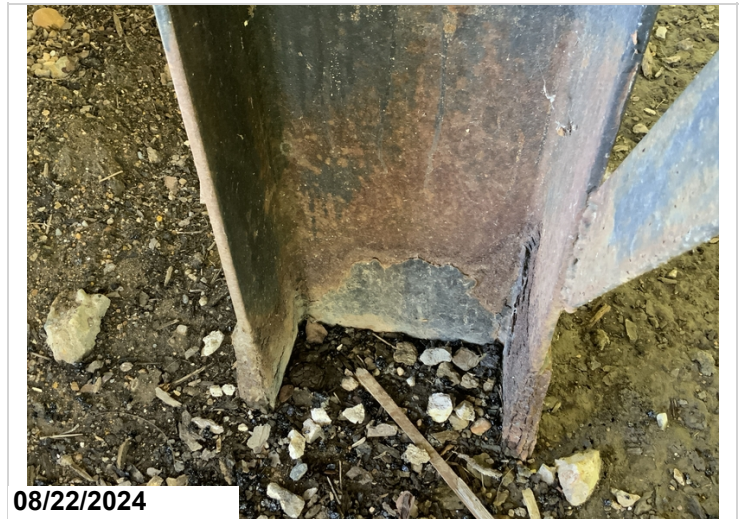
Bent 18 pile 10 flaking rust, all piles in this bent has flaking rust 1' CS2

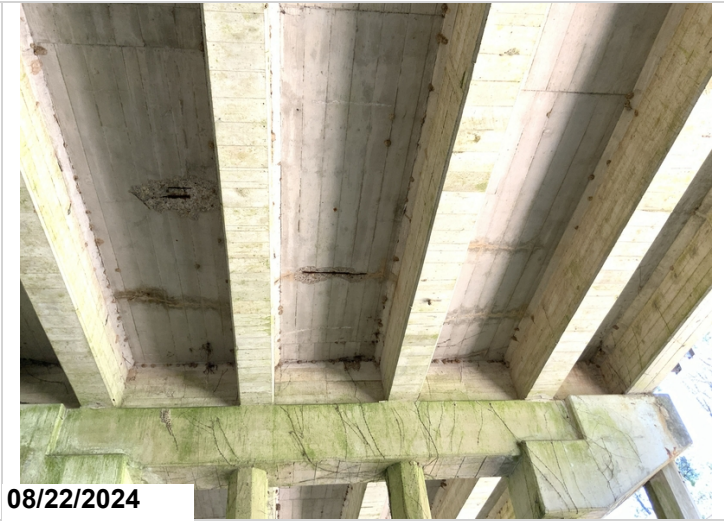
Span 22 bays 1-5 efflorescence 36sq' cs2
Bays 2 and 3 exposed rebar 4 sq' cs3

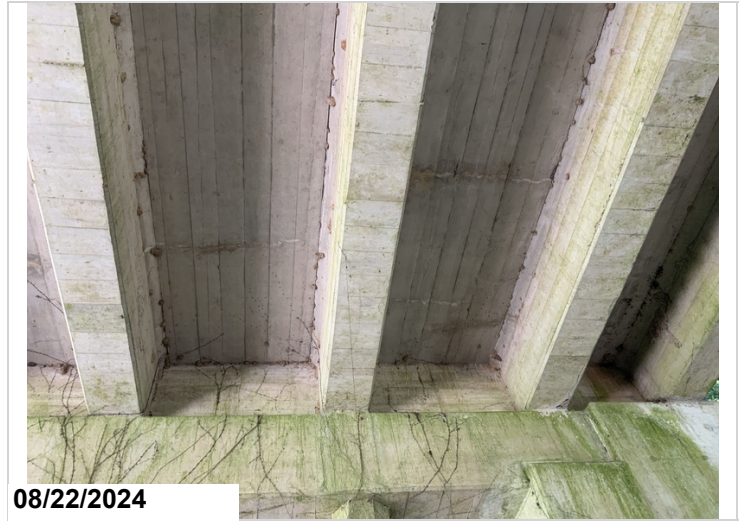
Span 23 bays 1 and 2 efflorescence 25' CS2.

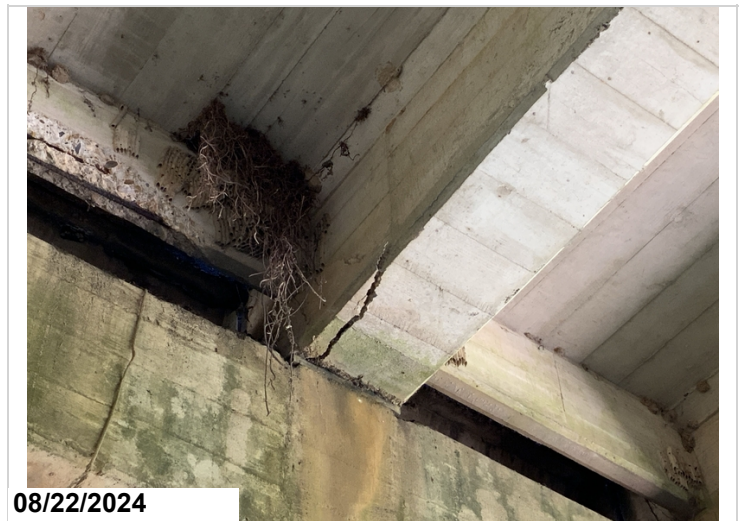
Span 23 bent 24 girder 4, delam 1'CS2

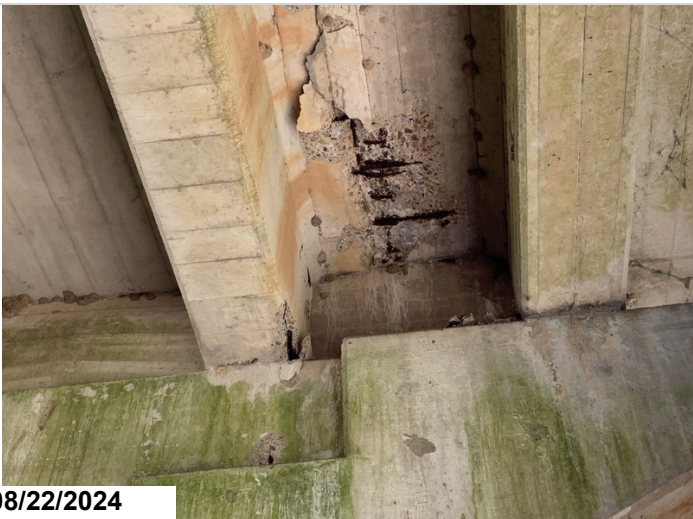
Span 25 girder 2, spall with exposed rebar cs 3

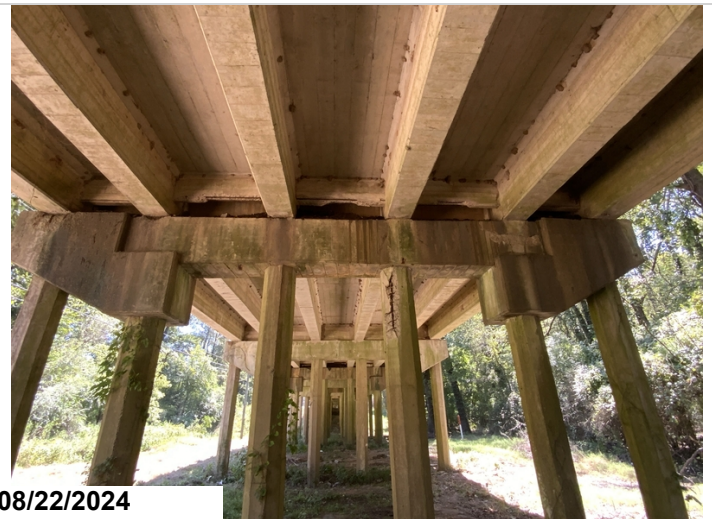
Bent 26 pile 3 exposed rebar CS3

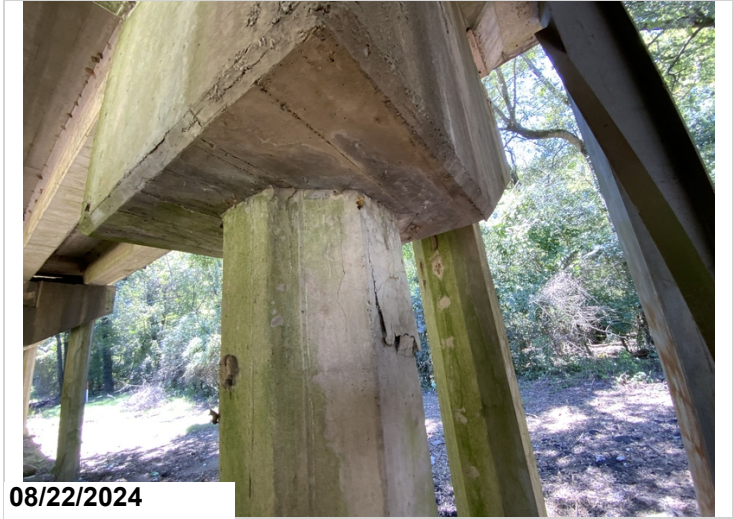
Bent 27 pile 2 has crack and delam CS2

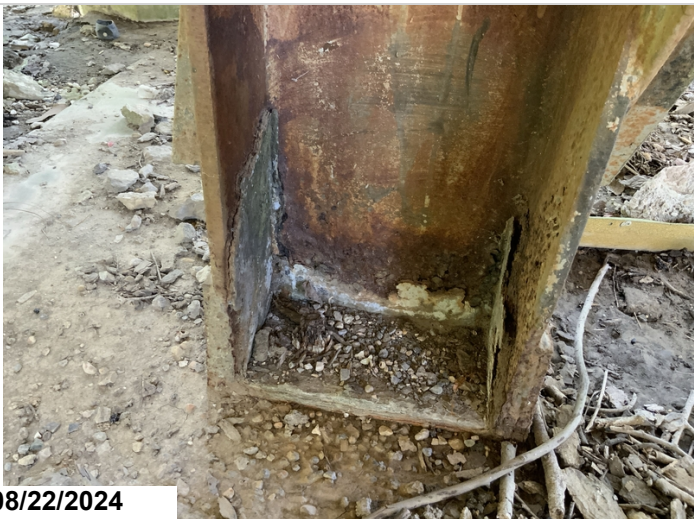
Bent 27 pile 9 1' corrosion CS3

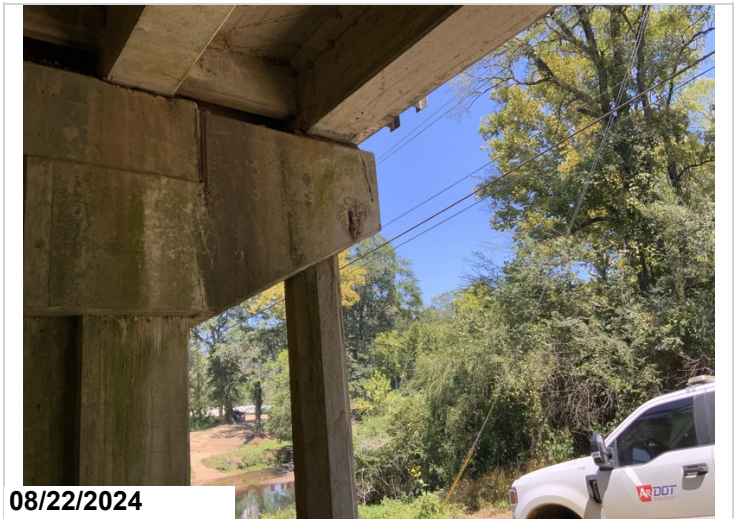
Bent 28 cap back right side exposed rebar CS3 1'

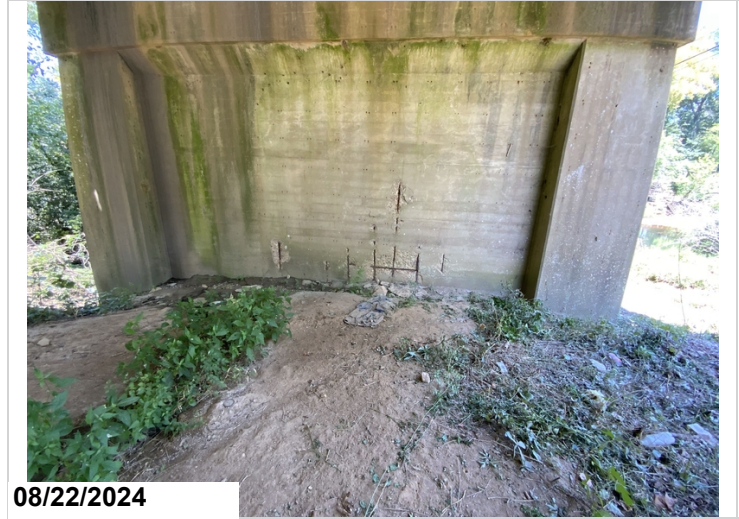
Bent 29 back pier wall 7' exposed rebar CS3

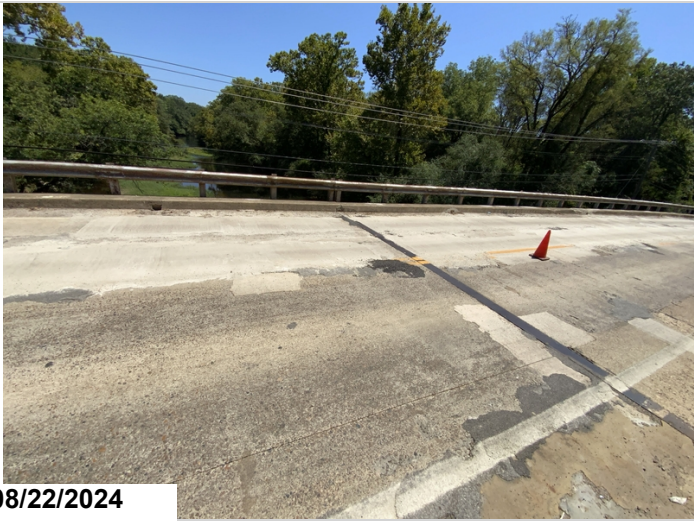
Spans 29 & 30 right lane has patched deck repairs.

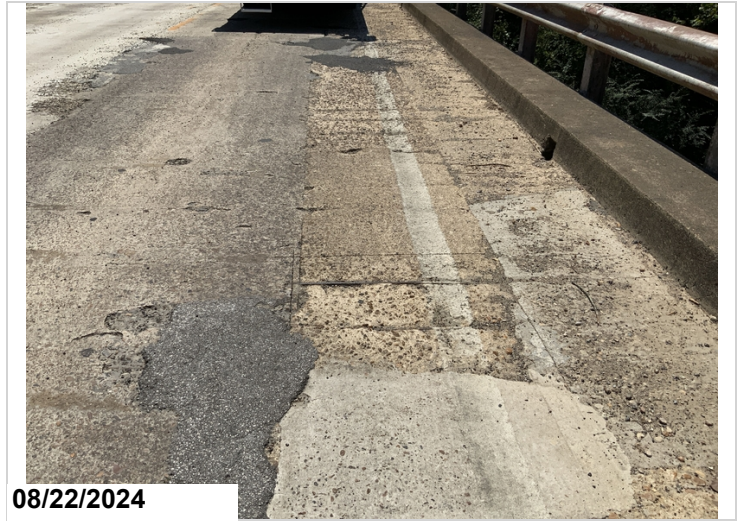
Deck Span 29 near bent 30 right lane: spalls with exposed rebar 20' CS2

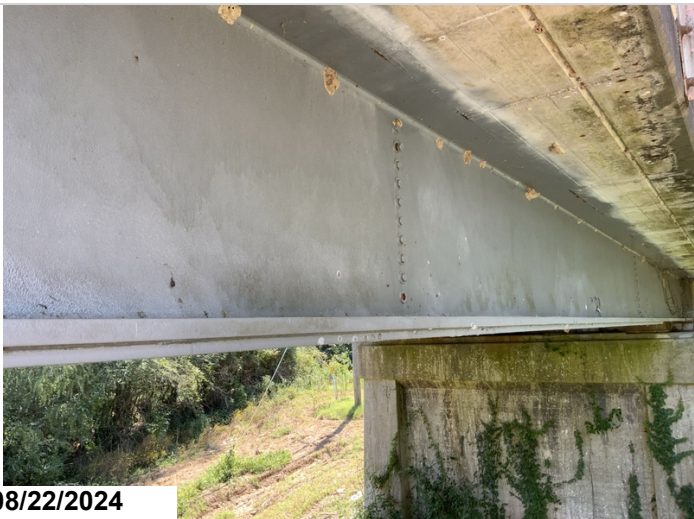
Span 29 girder 1 at second diaphragm ahead of bent 29: missing and broke bolts.

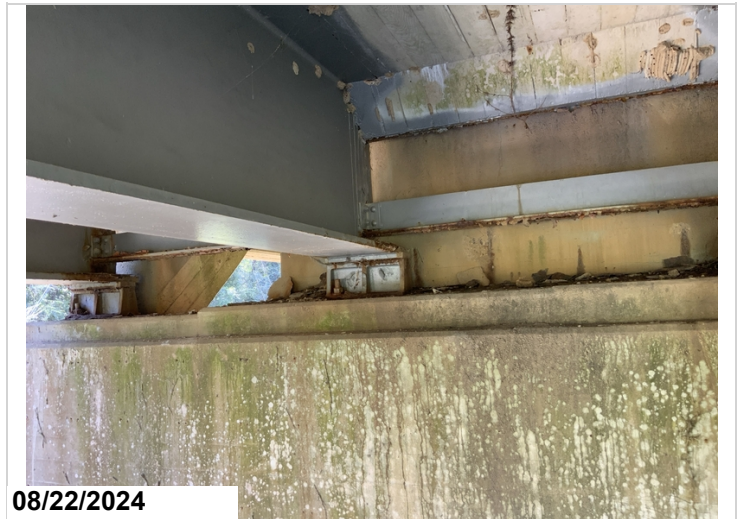
Overview of bent 29 ahead: rust to lower web/ flanges, bearings and diaphragms. 6' CS2

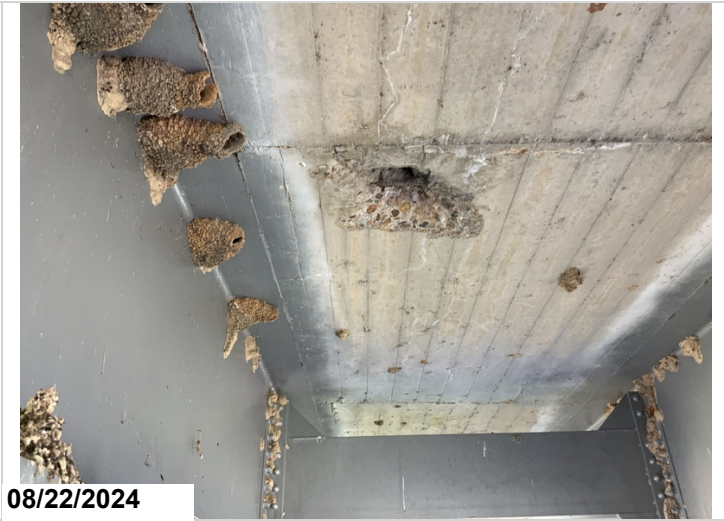
Span 29 bay 1 exposed rebar 1' CS2

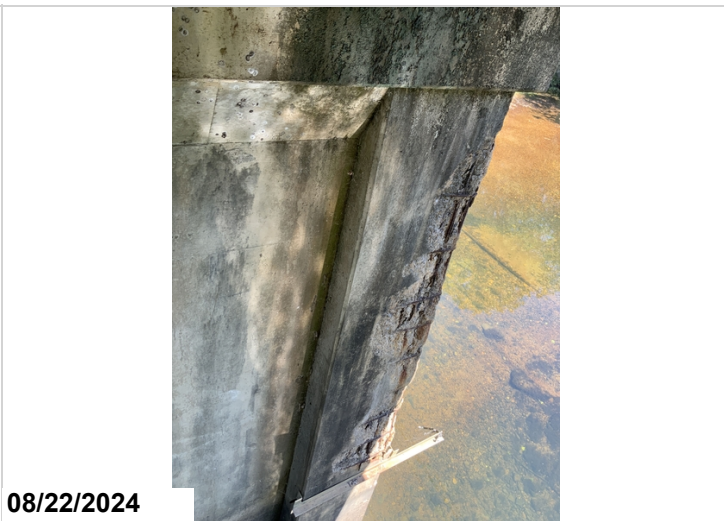
(205) Bent 30 Pier column #2 has large spall on back face of the column. (1080-205) Bent 30 ahead face column 2 : large delaminating near cap CS3 (1090-205) Bent 30 column 2 back: large spall with exposed rebar. CS3 Bt. 30, column 2, spall with exposed rebar							
210	Reinforced Concrete Pier Wall	LF	125	88	30	7	0
1080	Delamination/Spall/Patched Area	LF	5	0	5	0	0
1090	Exposed Rebar	LF	7	0	0	7	0
1190	Abrasion/Wear (PSC/RC)	LF	25	0	25	0	0
(1090-210) Bent 29 back pier wall 7' exposed rebar CS3							
215	Reinforced Concrete Abutment	LF	63	19	31	13	0
1080	Delamination/Spall/Patched Area	LF	12	0	0	12	0
1090	Exposed Rebar	LF	1	0	0	1	0
1130	Cracking (RC and Other)	LF	31	0	31	0	0

Bent 30 column 2 back: large spall with exposed rebar. CS3

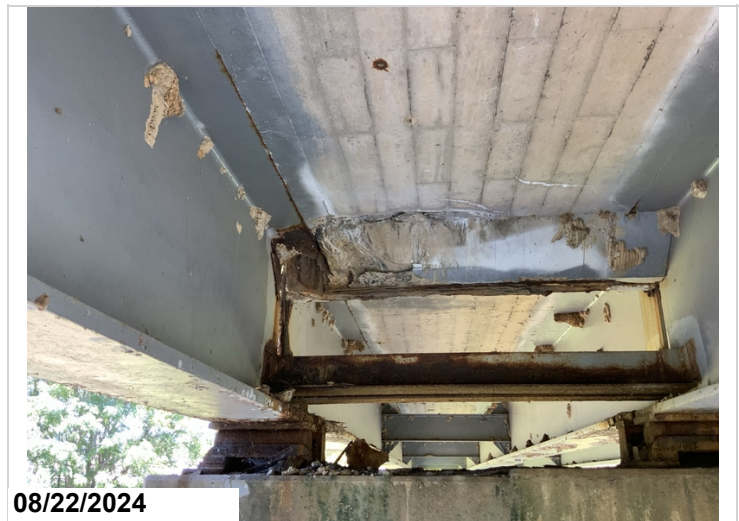
Span 29 bent 30 girder 1 right: heavy flaking rust at haunch
CS3

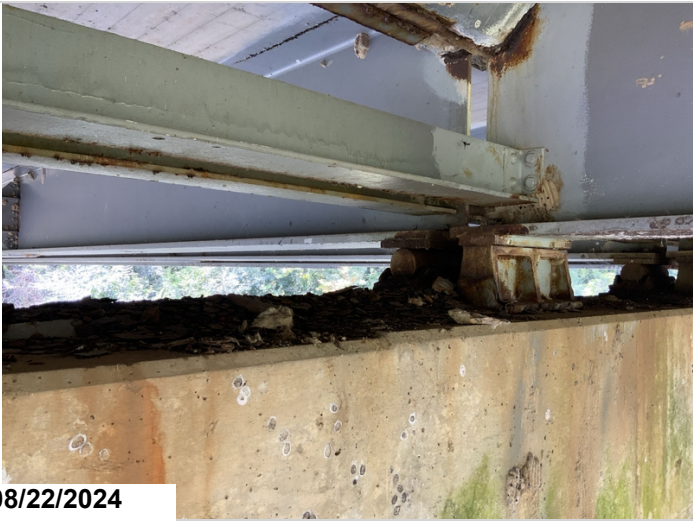
Bent 30 bearings have heavy flaking rust with some debris buildup up CS3

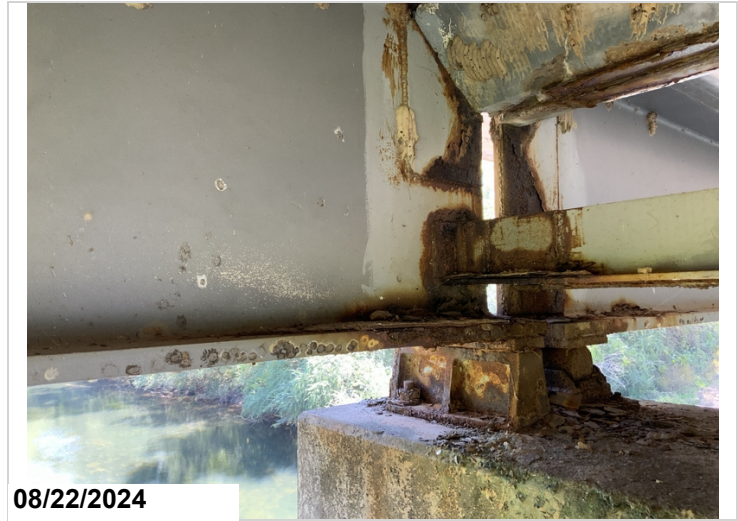
Bent 30 ahead, girder 5: heavy flaking rust with section loss near bearing area and haunch. 4LF CS3 Corrosion.

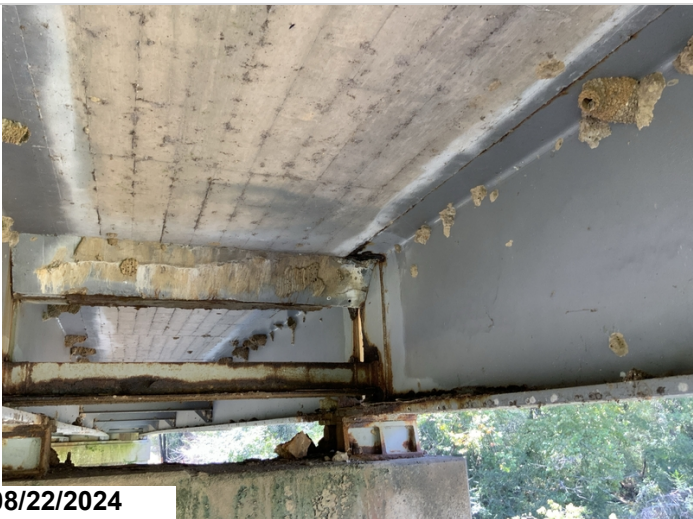
Bent 30 ahead girder 1: heavy flaking rust with section loss near bearing area and haunch. 4LF CS3 Corrosion.
Common all girders this location.

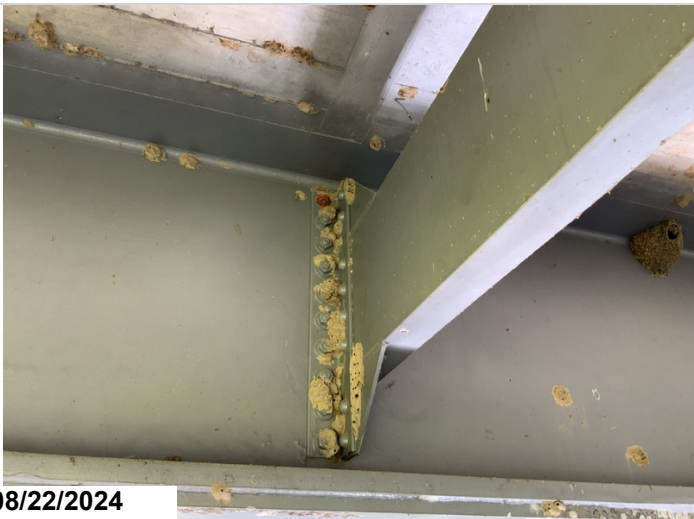
Span 30 girder 5 left at first diaphragm ahead of bent 30:
missing nut.

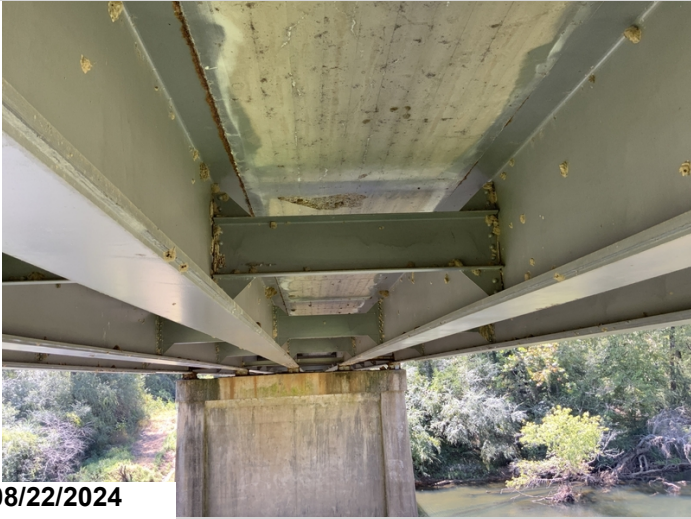
Span 30 bay 2 spall 2' CS3

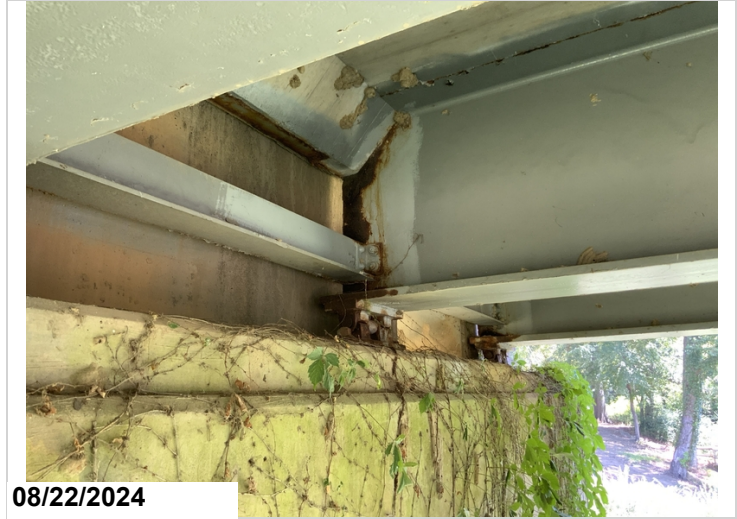
Span 30 bent 31 bearing 4 & 5: flaking and tilted CS2

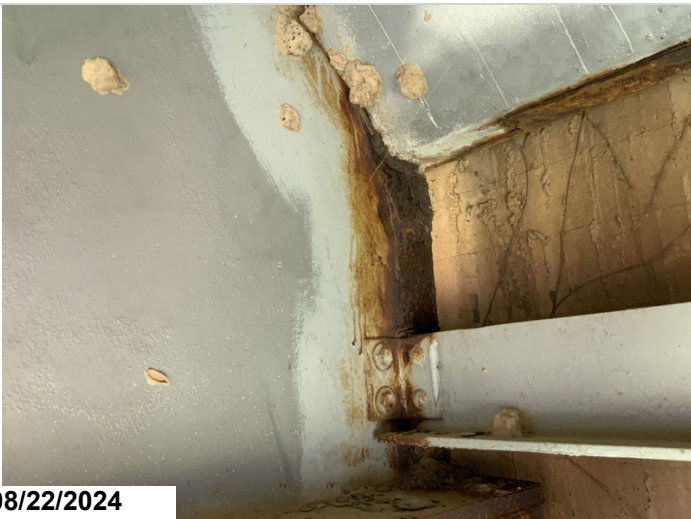
Span 30 bent 31 back girder 2: heavy flaking rust at haunch
CS3

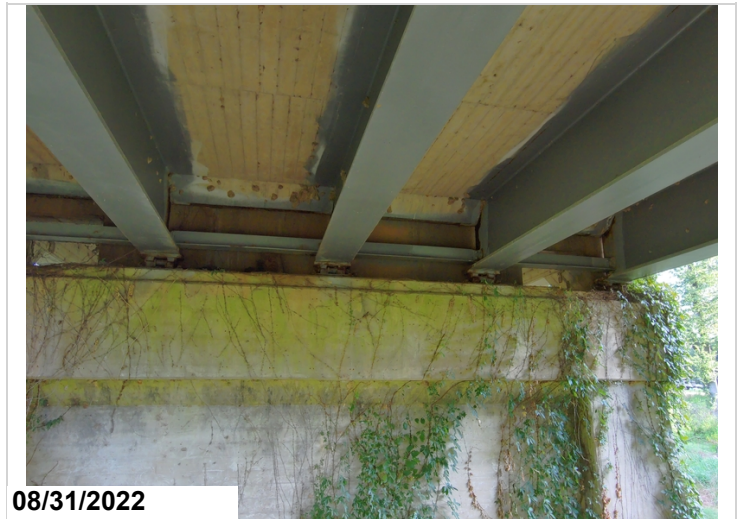
Span 30 at Bt. 29, beam ends have corrosion

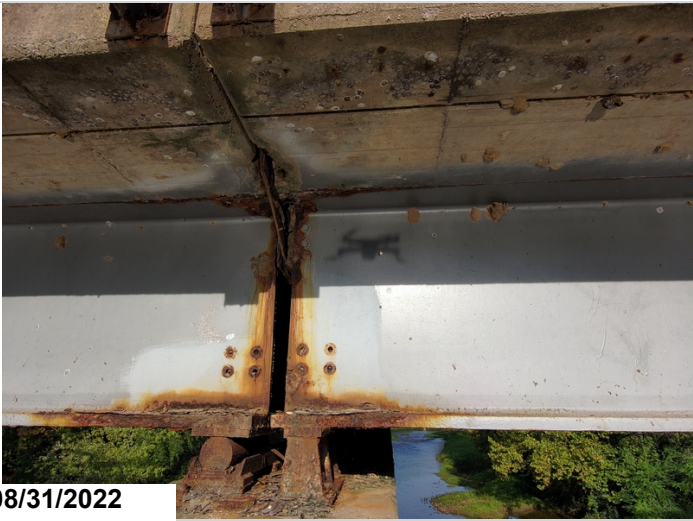
Span 29 and 30 at Bt. 30, Beam 5, beam end has active corrosion.

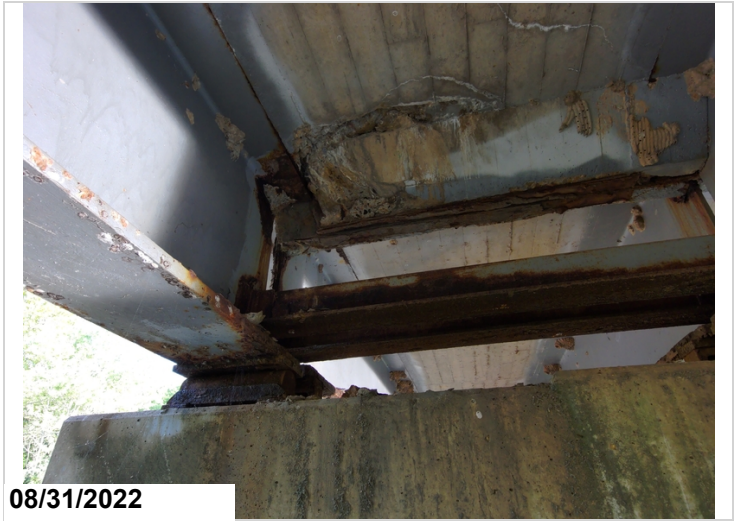
Span 29 at Bt. 30, Beam 1, beam end has active corrosion.

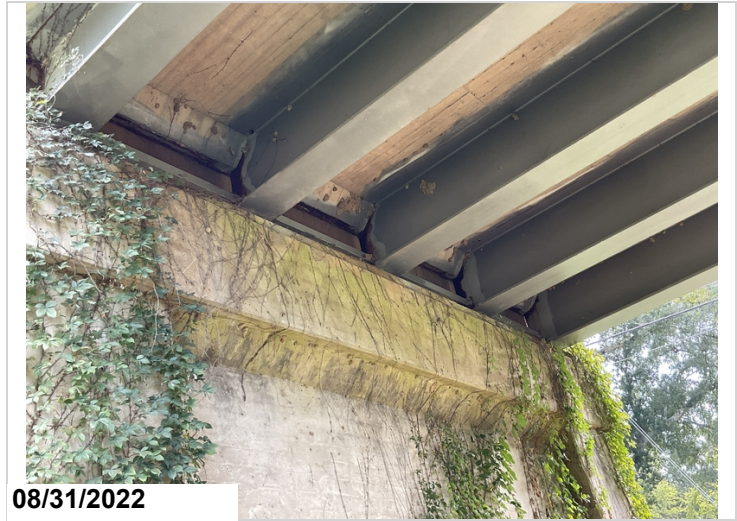
Span 30 at Bt. 31, all beam ends have active corrosion.

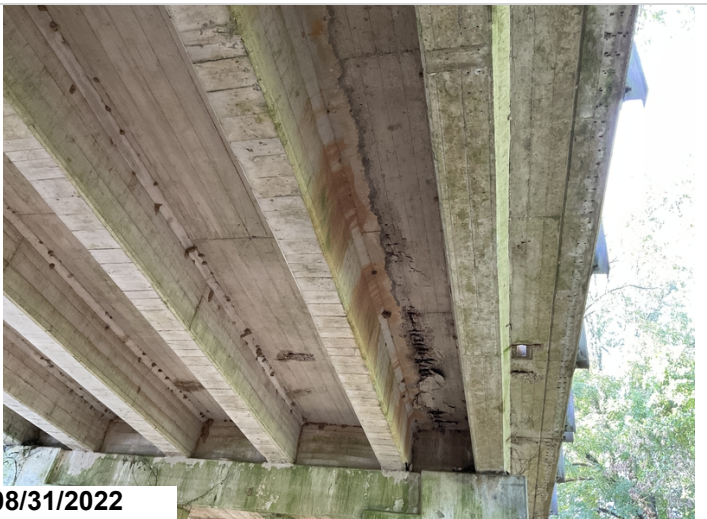
Span 25, bottom side of top flange, spalls with exposed rebar between girders 1 & 2.

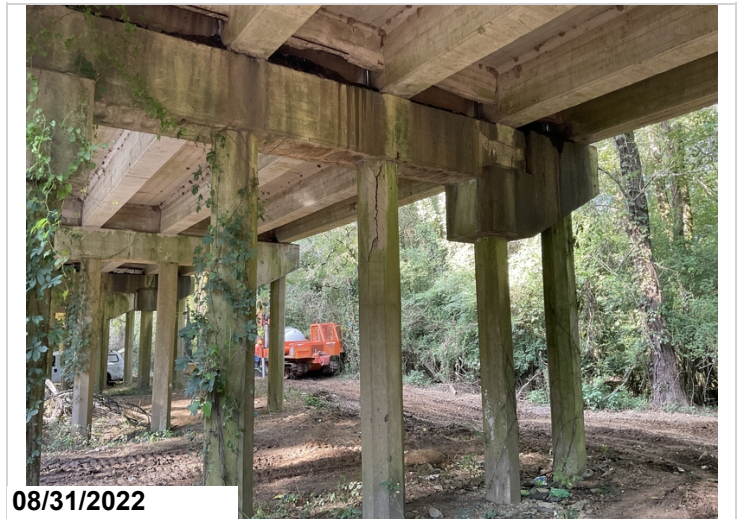
Bt. 26, pile 3 has large crack, cap has spall below girder 2.

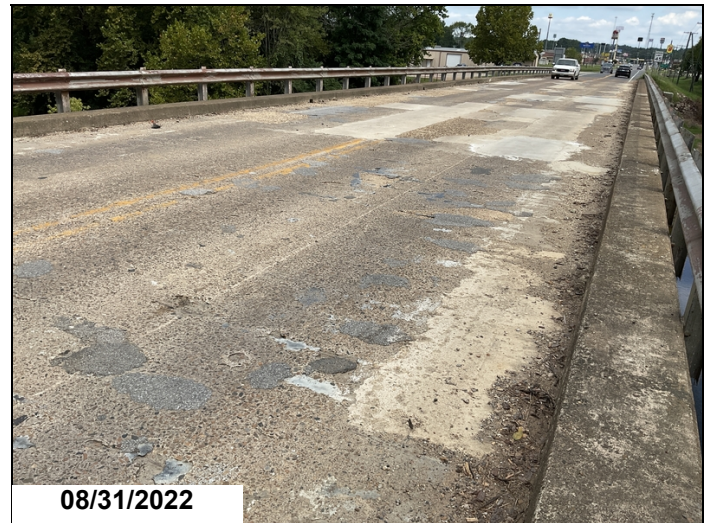
Scattered spalls with exposed rebar in most spans throughout the entire bridge.

Span 29 & 30, spalls with exposed rebar.

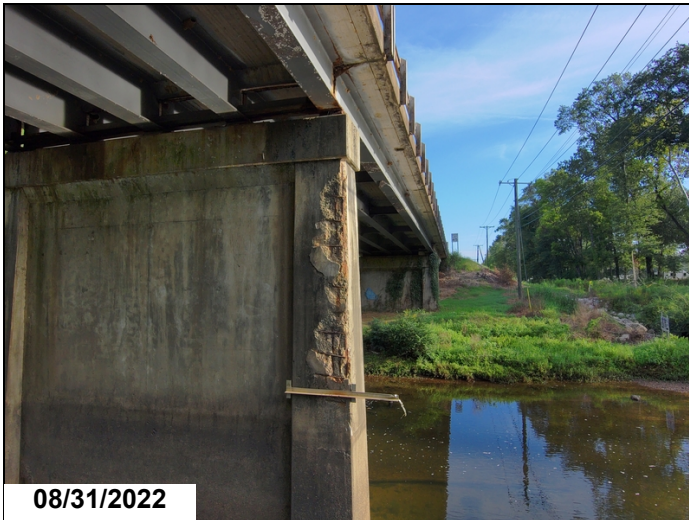
Bt. 30 Pier Column #2 Bk, there is 10 ft of spall with exposed steel, the spall is just below the bottom of the pier cap. The spall is approx. 3" deep and 1 1/2 ft wide and continues down to the original spall.

Bt. 30, column 2, spall with exposed rebar

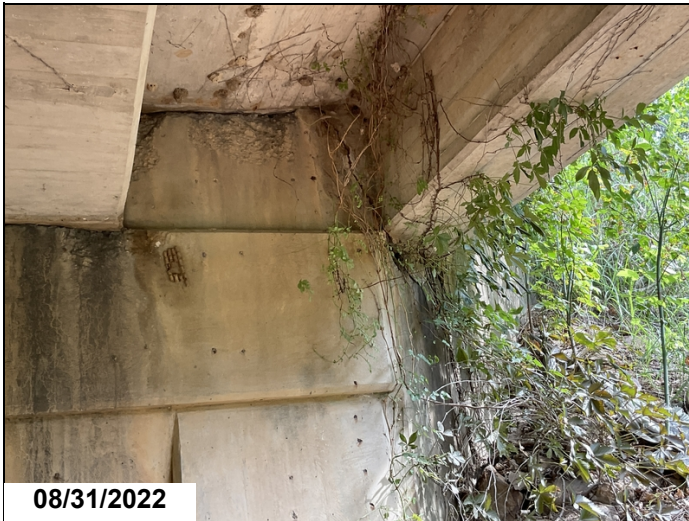
Bt. 33, the abutment @ Girder #5 there is a large crack coming down the inside of the backwall and continues across the bottom of the girder and then back out to the edge of the wingwall.

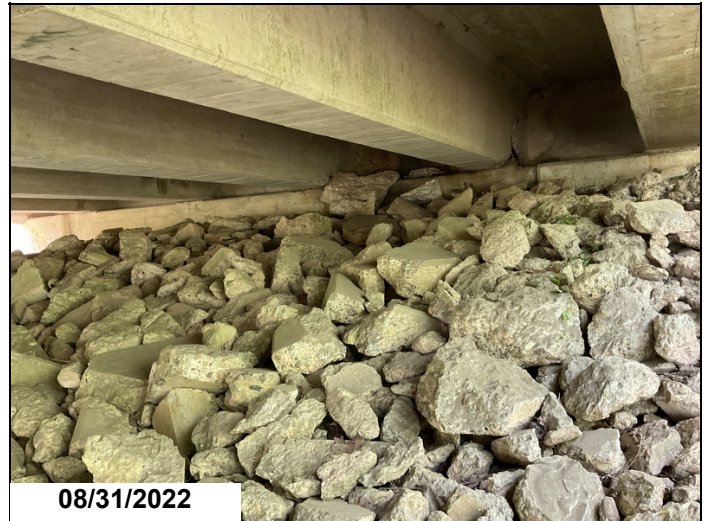
Span 1 at Bt. 1, girders 2 & 3, spall with exposed rebar at the end of the girder.

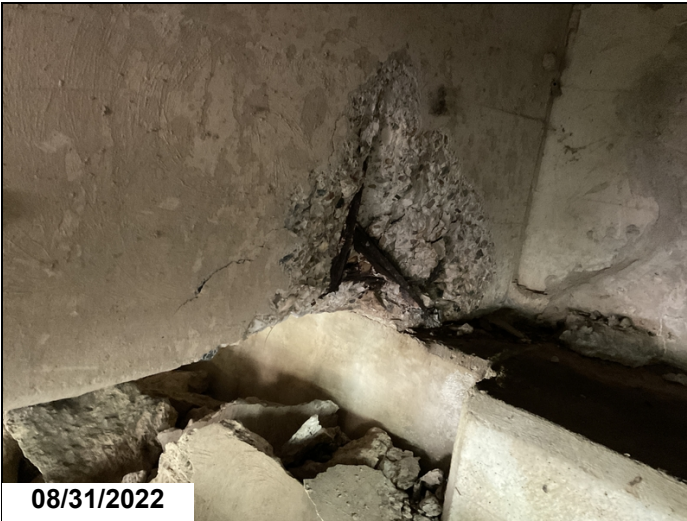
Span 1 at Bt. 1, girder 2, spall with exposed rebar at the end of the girder.

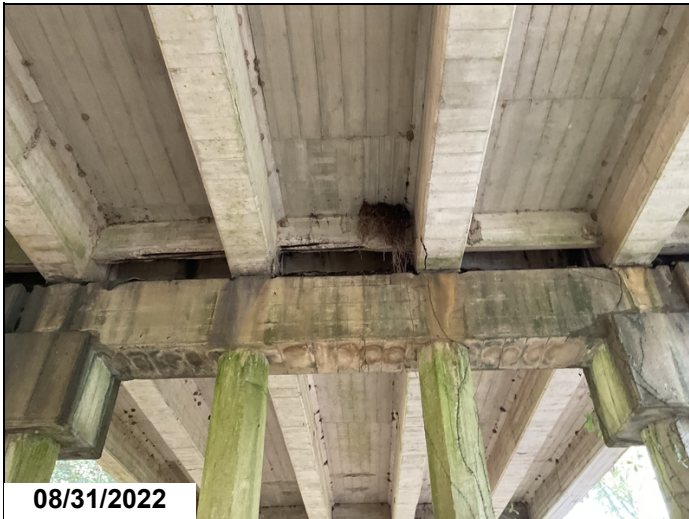
Span 23 at Bt. 24, girders 3 & 4 have spalls.

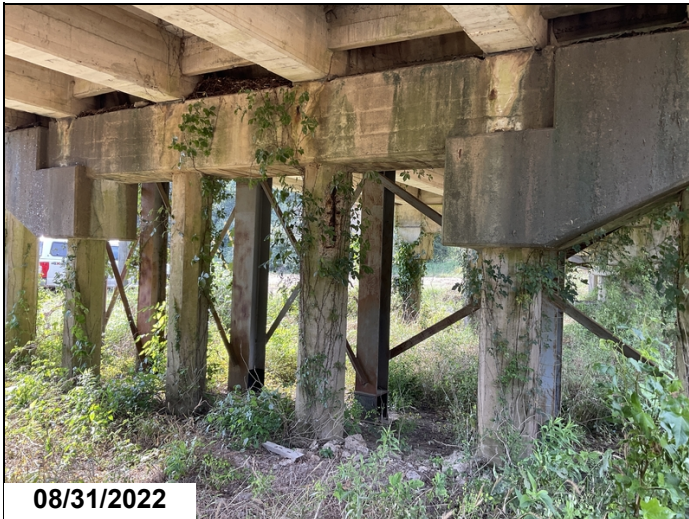
Bent 10, pile 3, spall with exposed rebar.

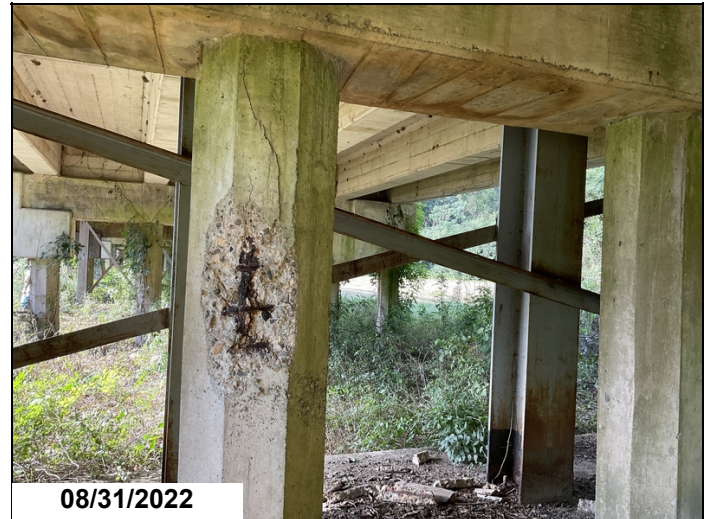
Bt. 15, pile 4, spall with exposed rebar.

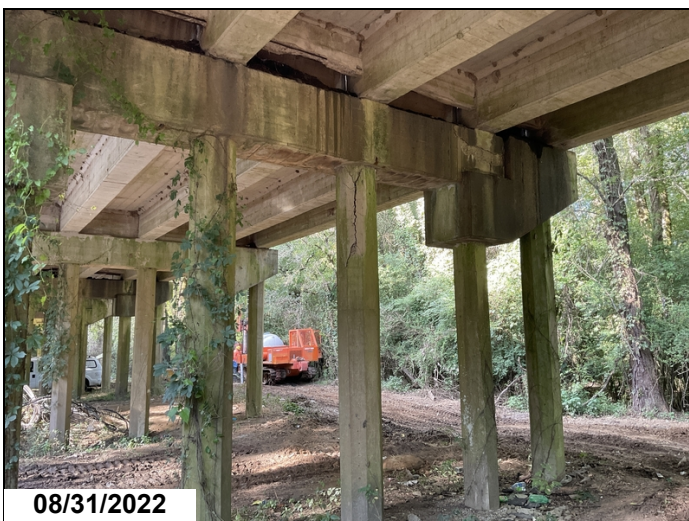
Bt. 26, pile 3 has large crack, cap has spall below girder 2.

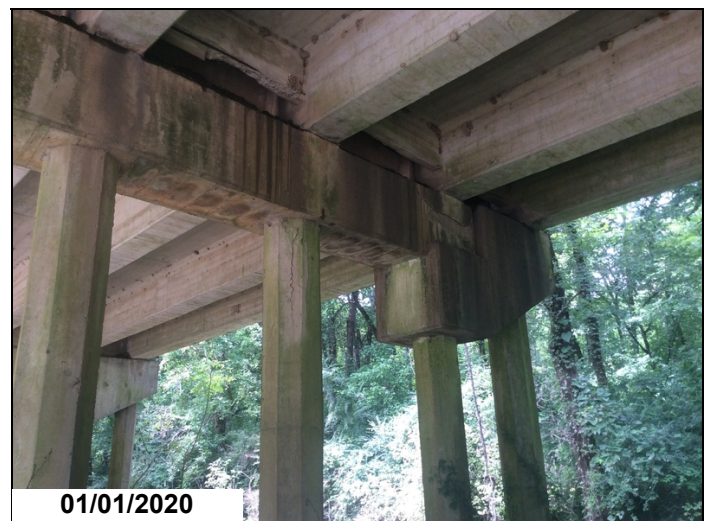
Bent 26 ahead, Pile 3 has a 3' crack that starts @ bottom of the cap & goes down.

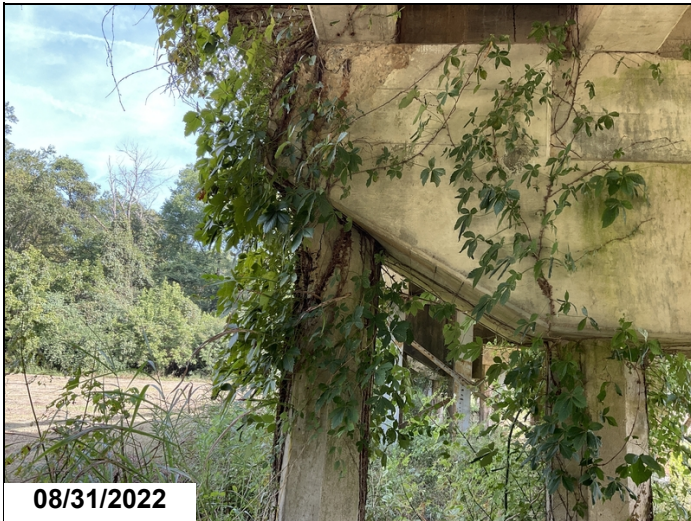
Bt. 8 pile # 1 is cracked and starting to delamn. The crack starts @ the bottom of the cap.

Bt. 8, pile 1, cap & pile have spall with exposed rebar.
