Bridge 00900 Inspection Report

Asset #00900(Routine, Underwater type 2)

US 67 S-6 LM3.36 over CADDO RIVER RELIEF

Team Lead: John Parks Inspection Date: 03/05/2025

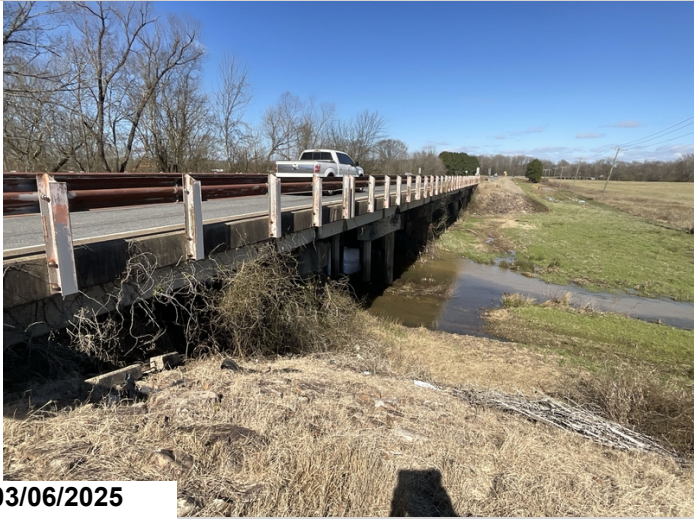
Elevation

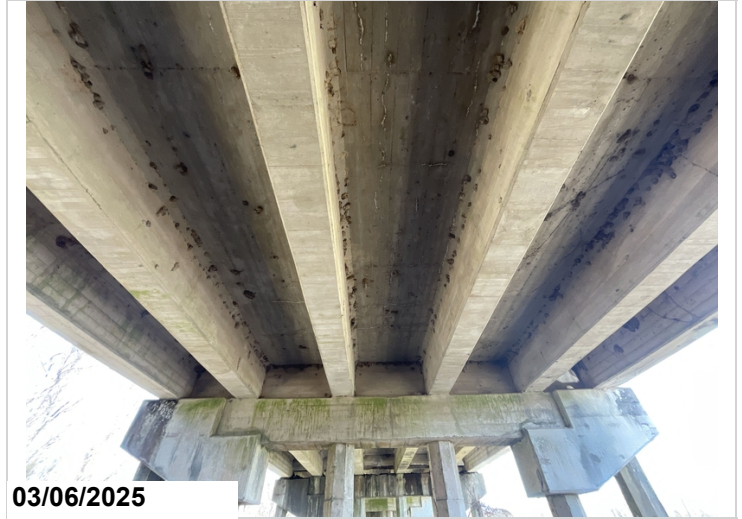
Deck is rated 6 due to the top flange under surface having scattered cracks with efflorescence, some are moderate. The top surface is covered with an asphalt wearing surface, That has scattered cracking and minor potholes.

Under surface of top flange

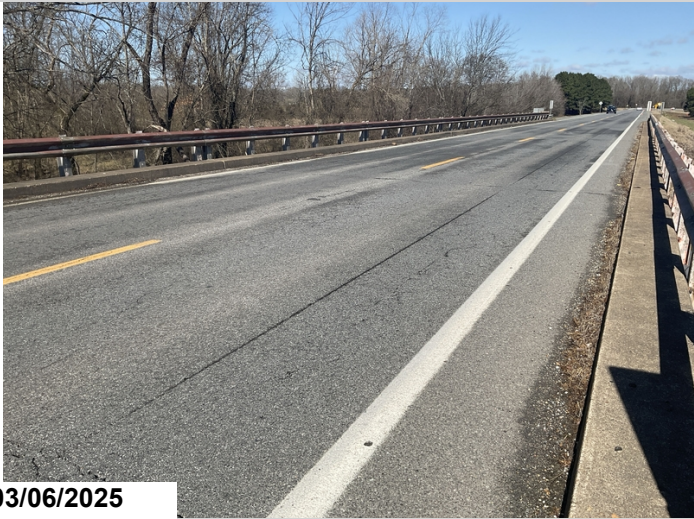
Deck overview

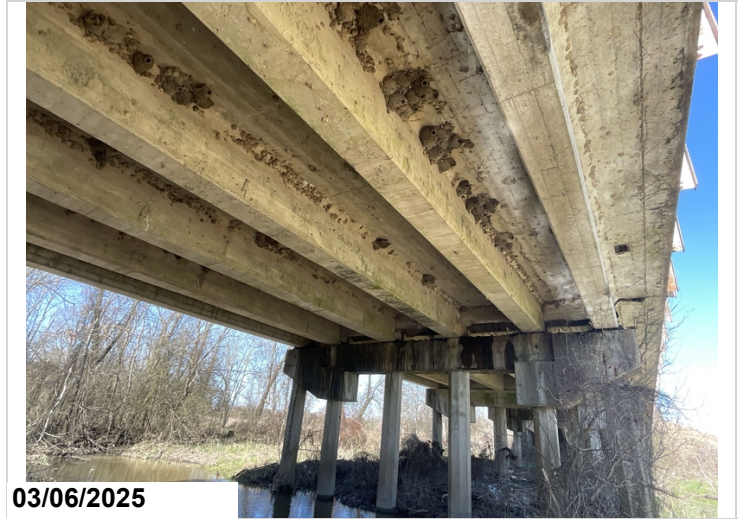
The superstructure is rated 6 due to girders having scattered moderate spalls with exposed rebar, minor spalls, and efflorescence.

Typical superstructure

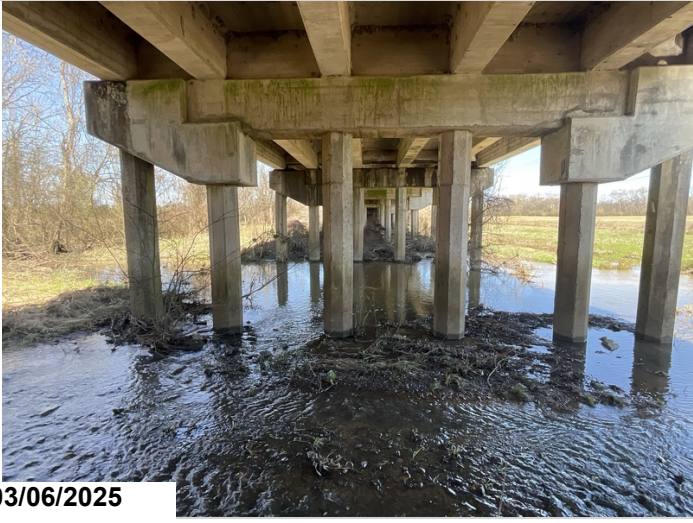
Substructure is rated 6 due to caps having scattered moderate spalls, minor exposed rebar, and cracks with efflorescence.

Typical substructure

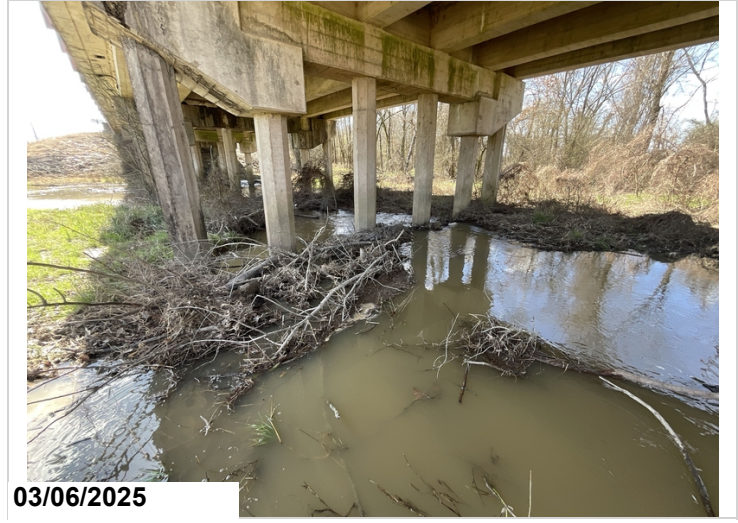
Channel is rated 7 due to banks of the stream being vegetated and stable. There is minor drift debris built up on the piles.

Debris in the channel

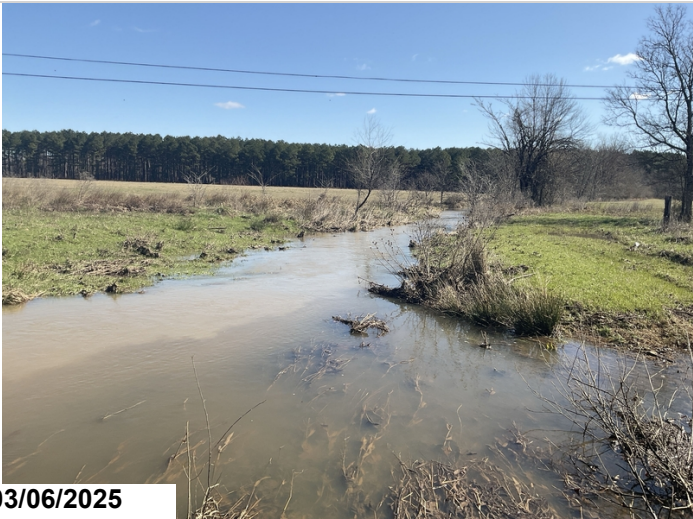
Channel right side downstream

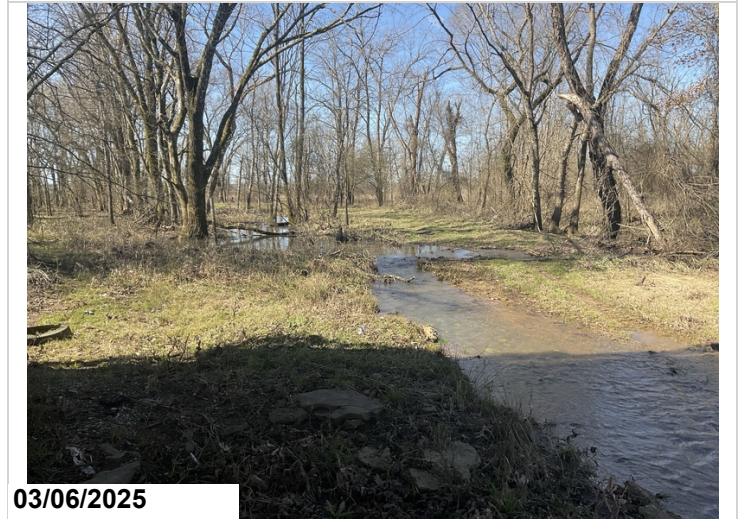
Channel left side upstream

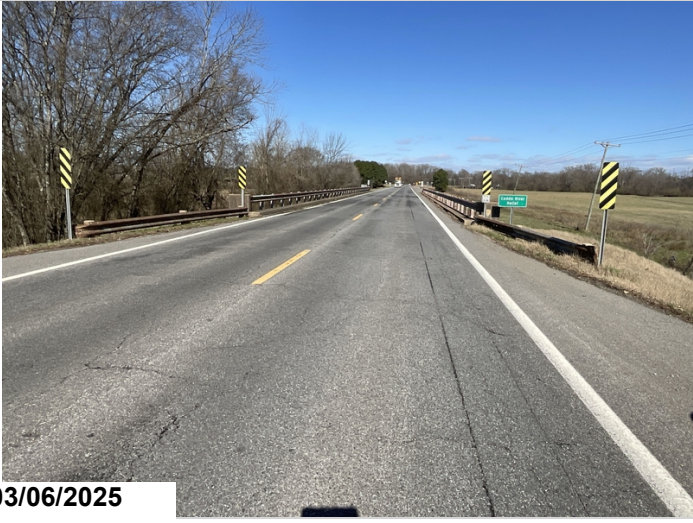
Approach

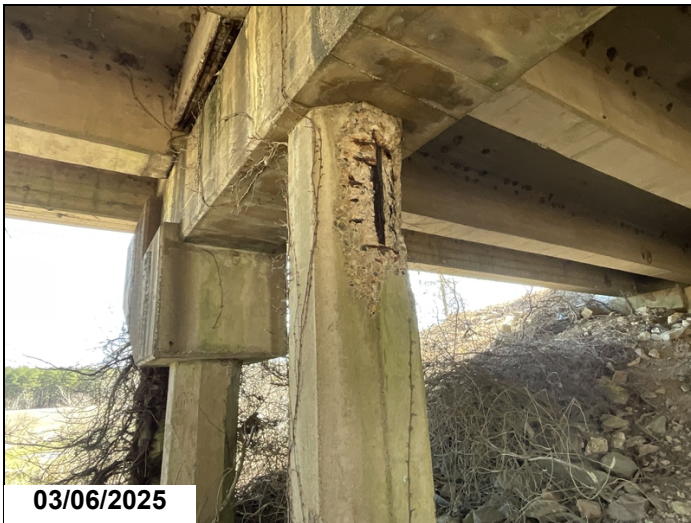
Bent 2, Pile 3, has 2' of spall with exposed steel with section loss to steel.

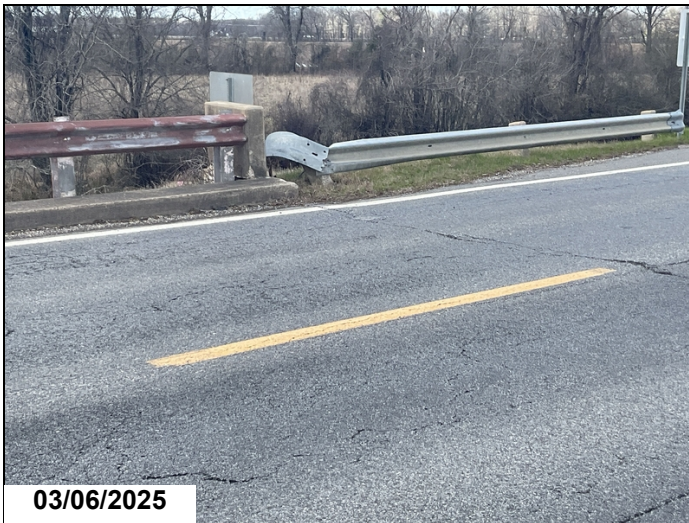
03/06/2025

Guardrail rail left side Bent 8 end of bridge has impact damage.

Type of Work: Repair (General)

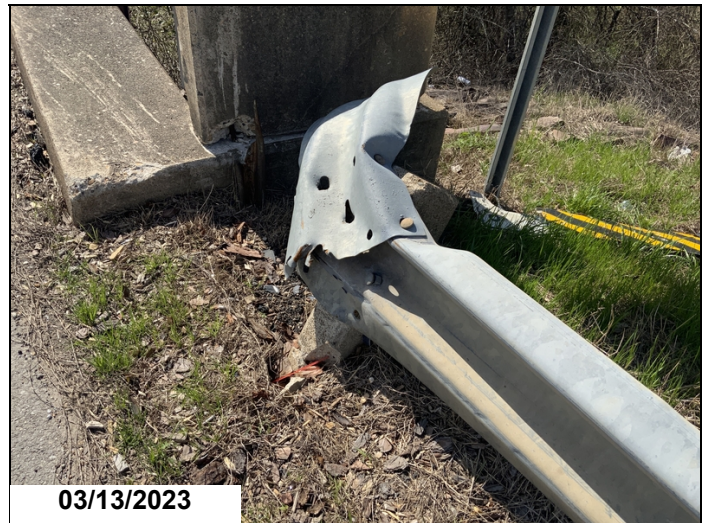
03/13/2023

Guardrail rail left side north end of bridge has impact damage.

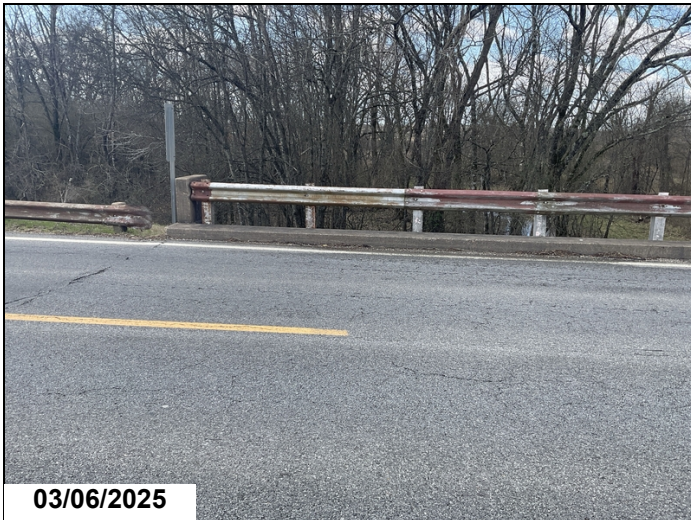
Bridge rail abutment 1 left has collision damage. First post is missing and rail end is detached from endpost. Span 3 right side rail damage and post bent.

Rail has been repaired Span 1, left

Bridge rail has been repaired.

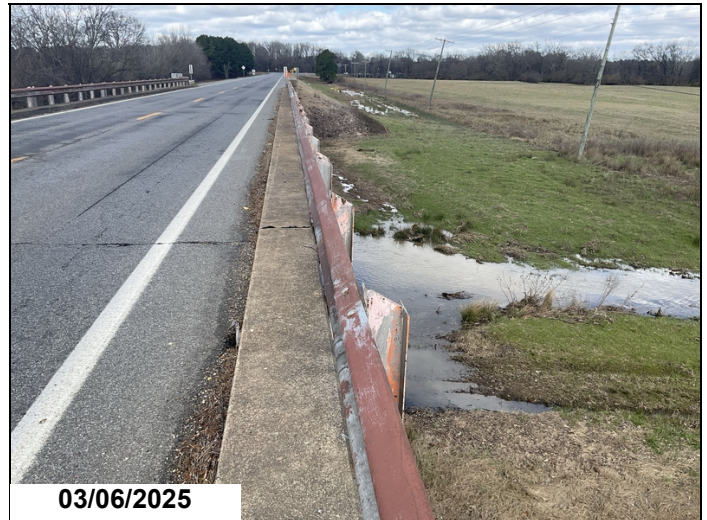
Rail has been repaired Span 3, right
