**Bridge #03873(Other Special Recurring)**  
**SH 51 S-1 LM 2.17 over I-30-SEC 14 LOG 53.67**

**Location: .6 MI NE NEVADA CO LINE**

**Team Lead: John Parks Inspection Date: September 06, 2022**

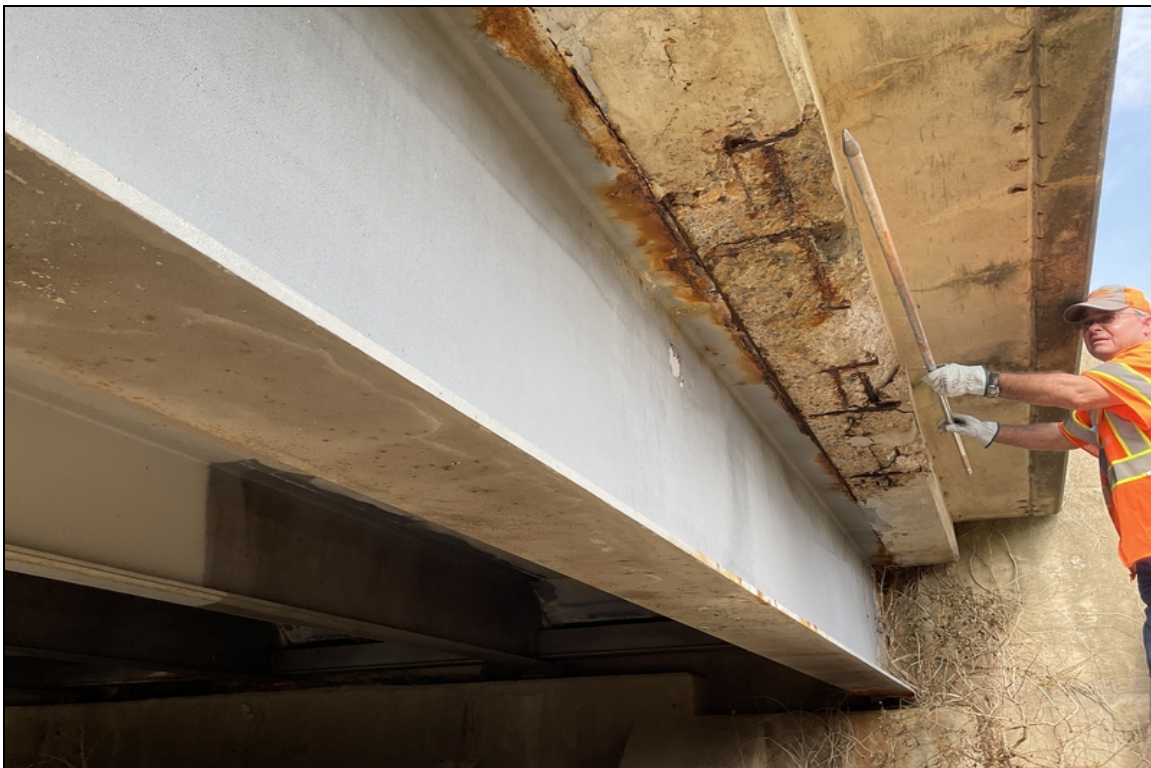
Spall in curb right side span 4

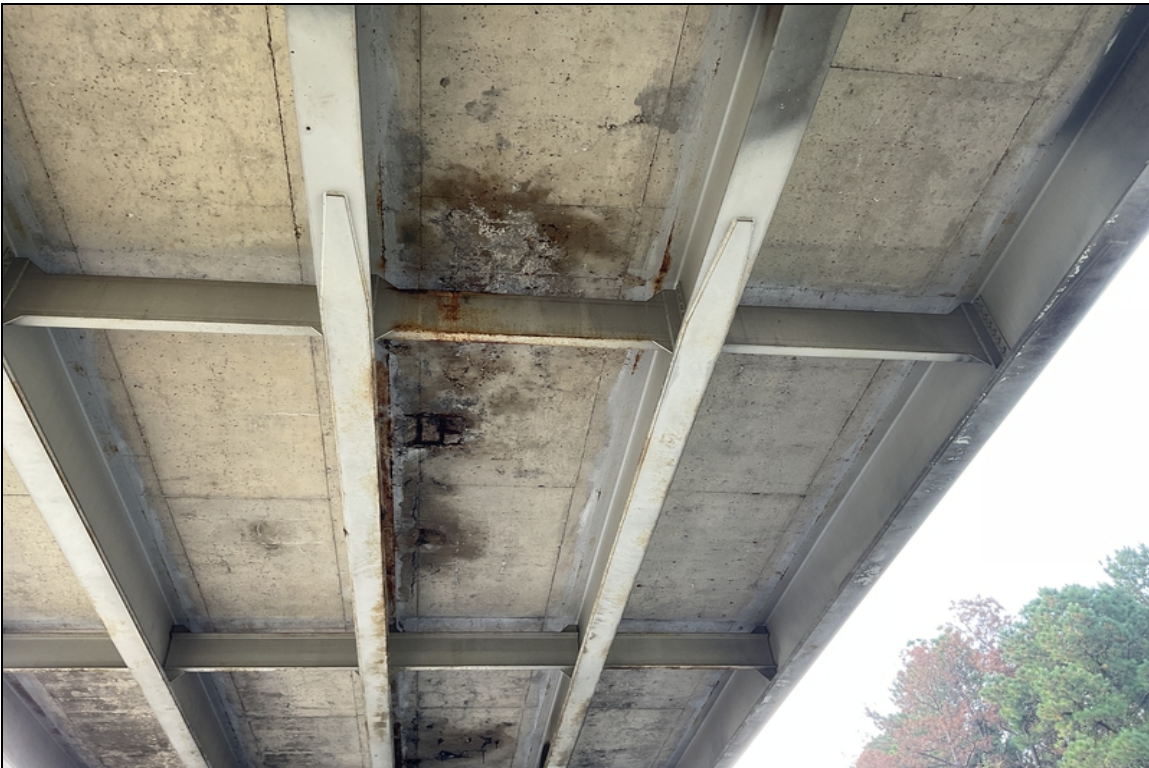
Soffit span 2 spalls cracks

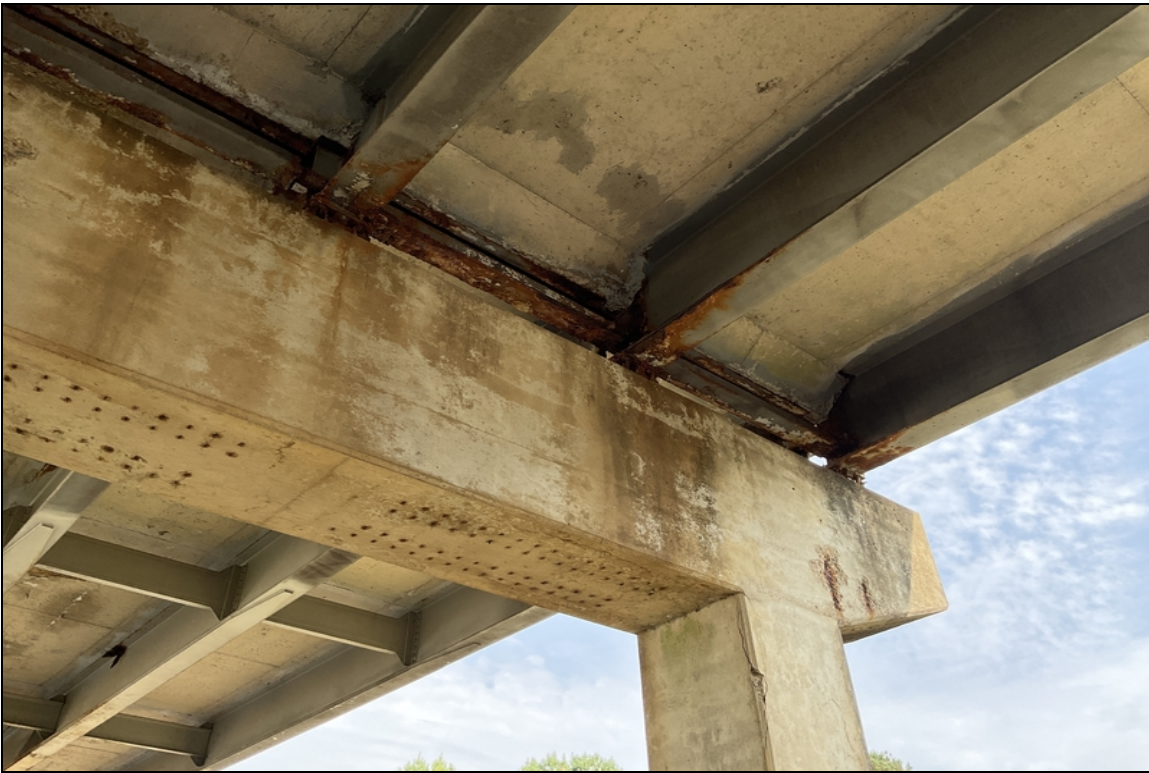
(107)							
<p>Girder ends are rusty at bearing areas. In addition the outside top flanges have heavy pack rust @ the areas exposed to drainage near the weep holes. The pr has caused the outer soffit to break off in these areas.</p>							
205	Reinforced Concrete Column	EA	6	3	1	2	0
1080	Delamination/Spall/Patched Area	EA	2	0	0	2	0
1130	Cracking (RC and Other)	EA	1	0	1	0	0

Span 2 girder ends pack rust

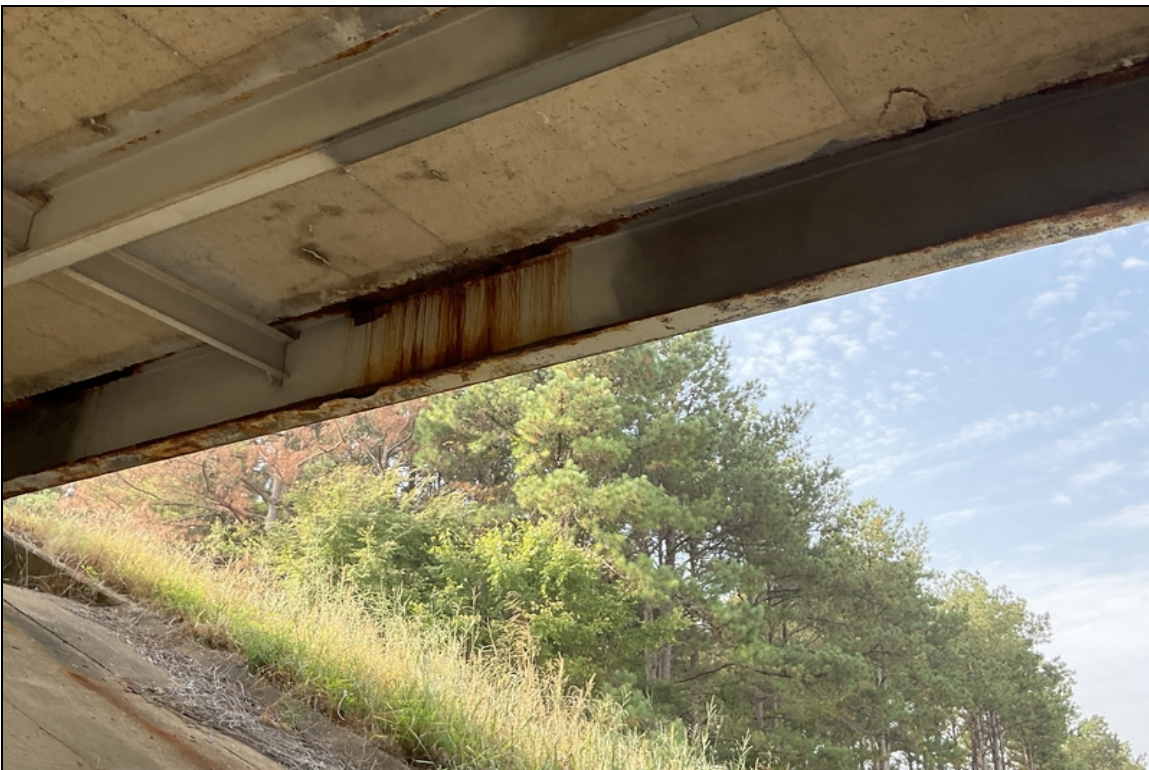
Span 1 girder 1 pack rust with section loss

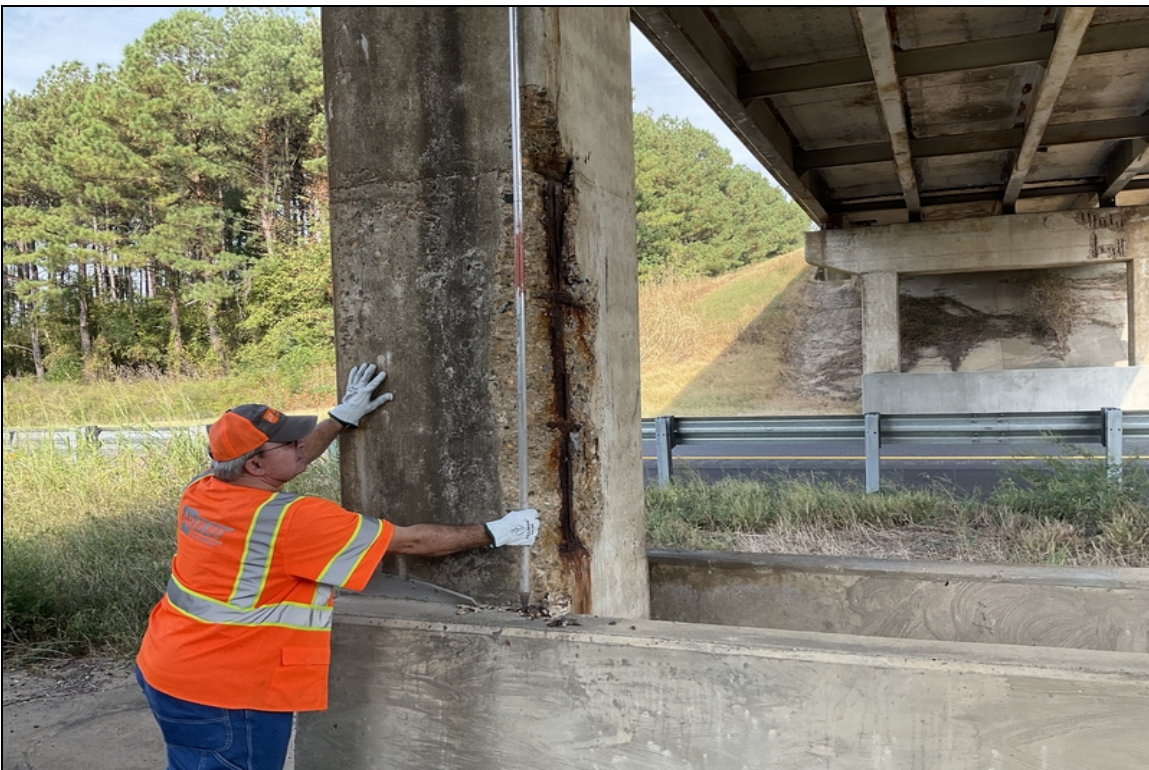
(205)							
<p>Bt 2 columns have cracks and delamination. 03/06/2018 JPR --- Bt. 2 Column 1 also has some spalls with exposed steel. 08/12/2021 Reinforced Concrete Columns = (2 columns per bent x 3 interior bents) = 6 columns total.</p>							
215	Reinforced Concrete Abutment	LF	75	58	2	15	0
1080	Delamination/Spall/Patched Area	LF	15	0	0	15	0
1090	Exposed Rebar	LF	2	0	2	0	0

Spall bent 3 column 1

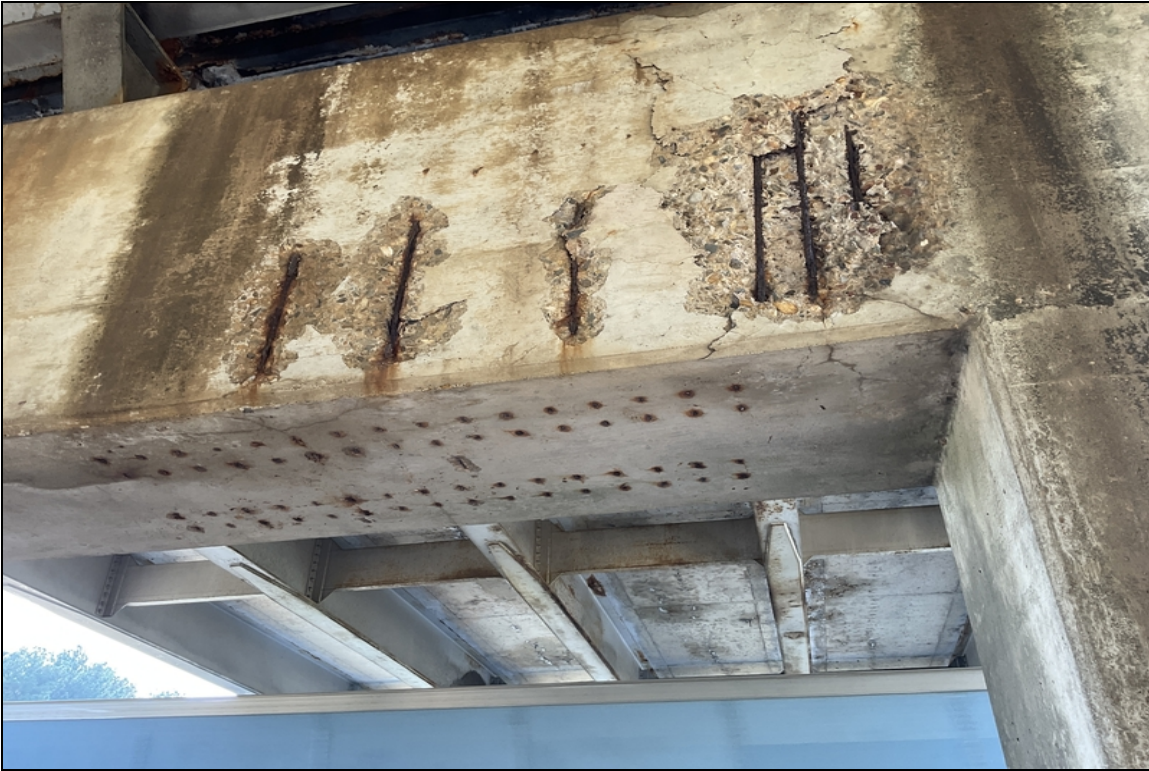
(234)	Spalls with exposed steel pier cap 2 ahead side. 03/06/2018 JPR -- Bt. 3 backside, has spalls with exposed steel. 8/02/2021 JPR -- Reinforce Concrete Pier Caps = $((18.75' - 5.0') \times 5) = 137.5'$ or 138', per plans.						
304	Open Expansion Joint	LF	140	140	0	0	0

Spall cap bent 4 back

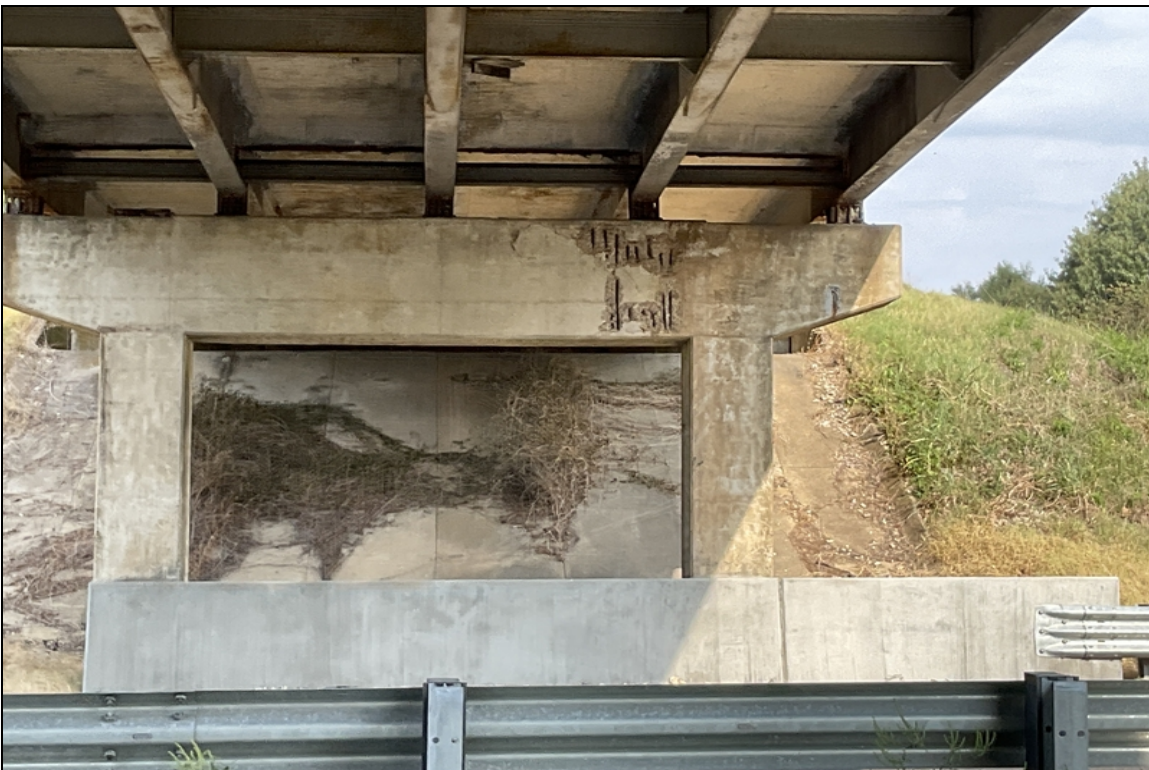
Spall bent 4 cap ahead side

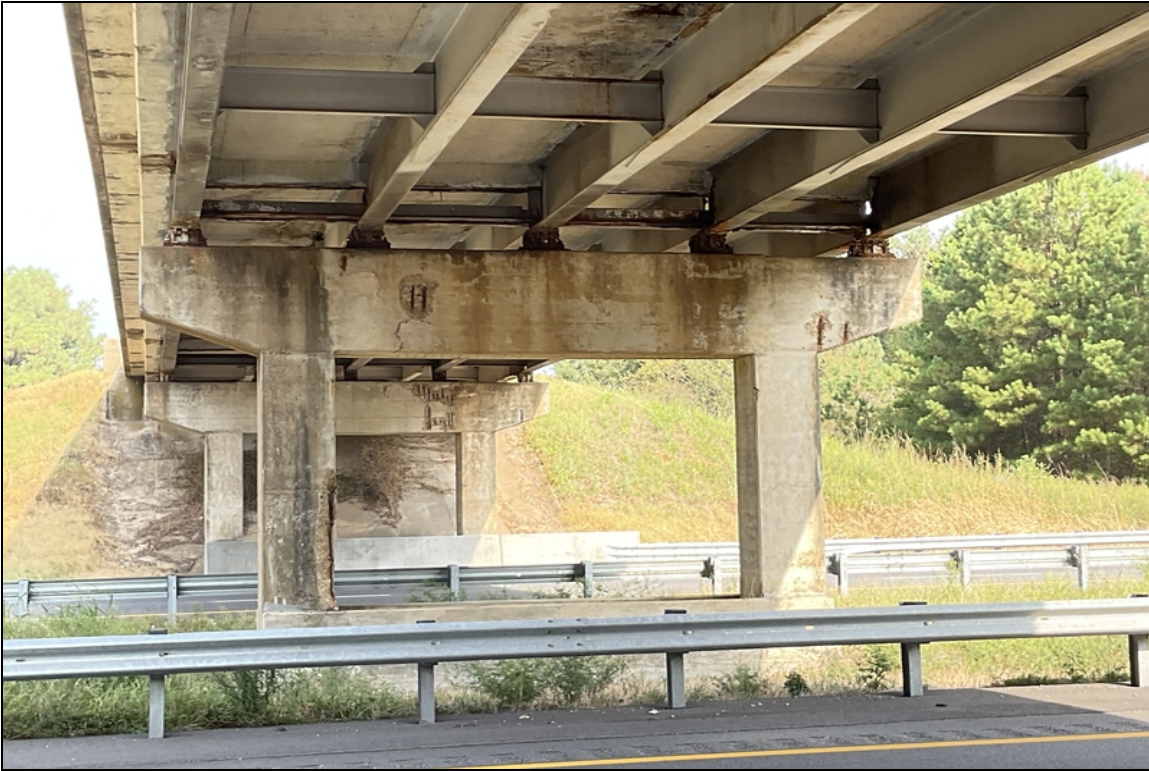
Bent 3 cap spalled and bearings have pack rust

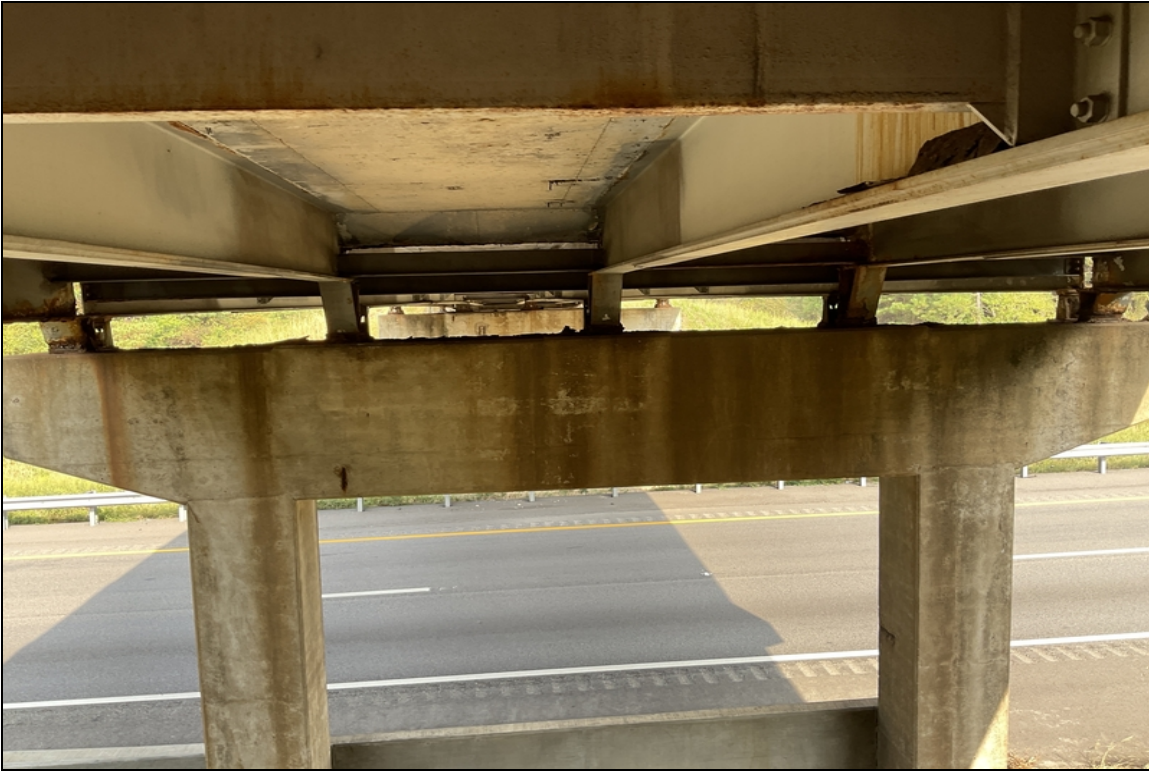
(311)	Rusty Moveable Bearings = (Bent 2 - 5 bearings, Bt. 3 - 10 bearings, Bent 4 - 5 bearings) for a total of 20 moveable bearings.						
313	Fixed Bearing	EA	20	0	15	5	0
1000	Corrosion	EA	20	0	15	5	0

Bent 2 bearings pack rust

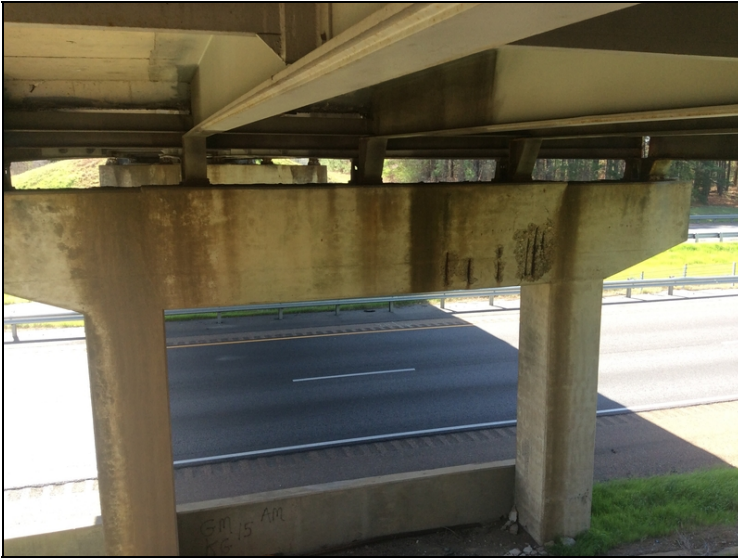
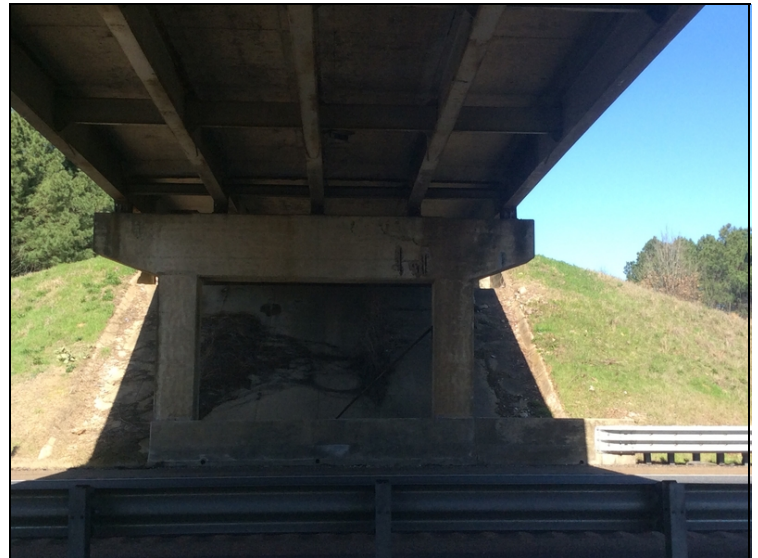
Caps on Bents 2, 3, & 4 have minor spalls, cracks, and delams to the sides of the caps with some exposed steel.

Bent 3 cap spalled

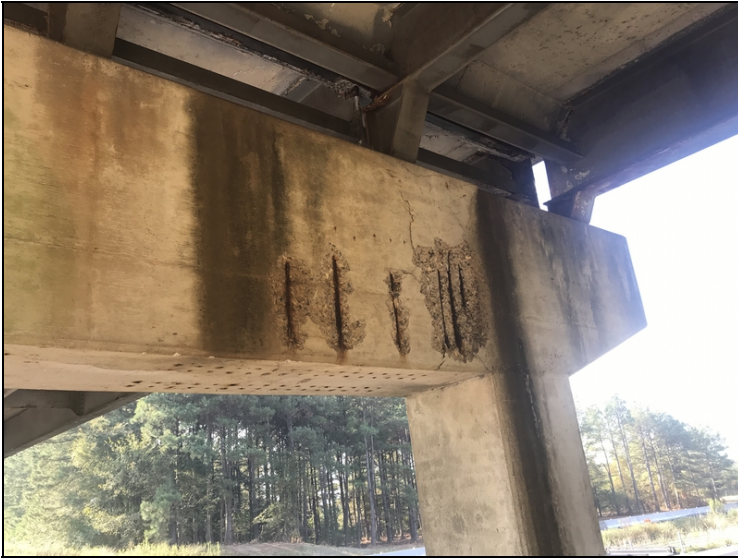
Bent 4, ahead side spall with exposed rebar.

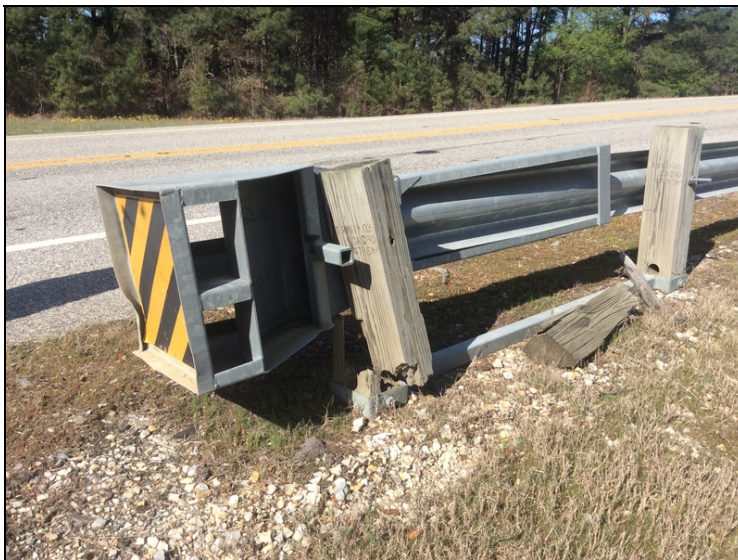
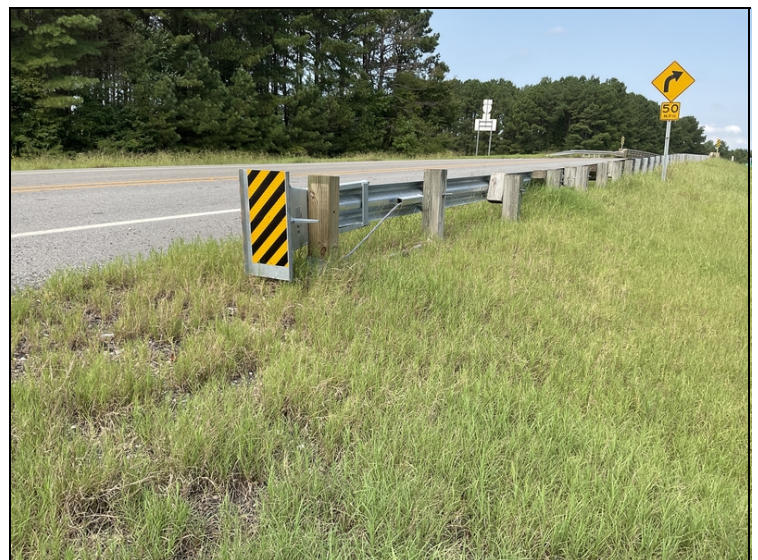
Right approach extruder end has a broken support post.

Post has been replaced. 09/07/2022

Post has been replaced.

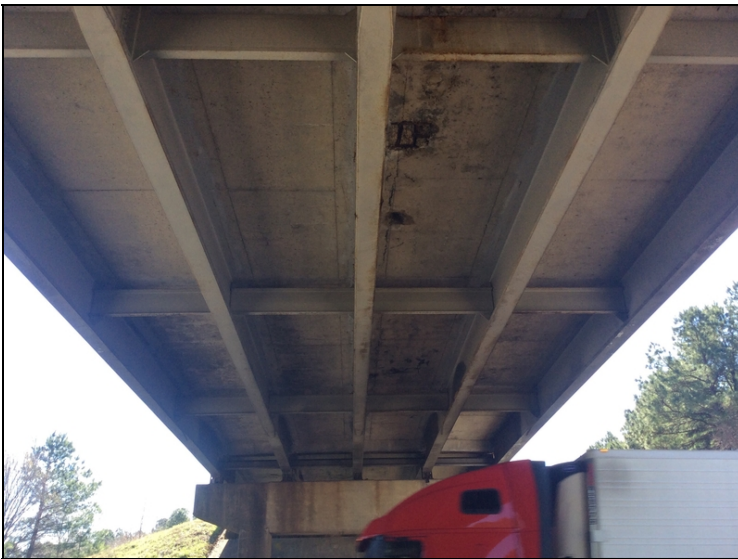
Soffit span 2, looking back between girders 2 & 3 @ spall and delamn.

Repaired by State Forces. 08/21/2021 JPR -- the repairs that were made and completed were deck spalls, on spans 1 & 2. There are still some spalls on both spans that have been patched with cold mix.

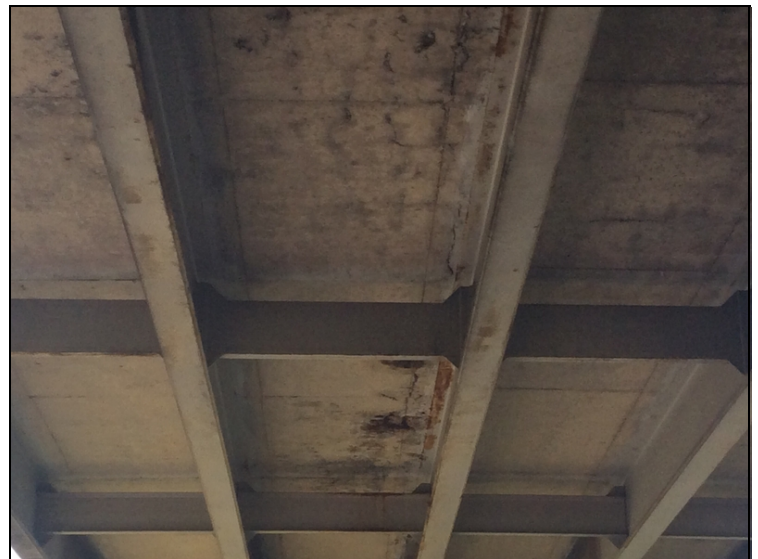
Deck Soffit, Span 2 over EB travel lanes, between girders 2 & 3, has numerous cracks with efflorescence & some spalls with exposed steel.

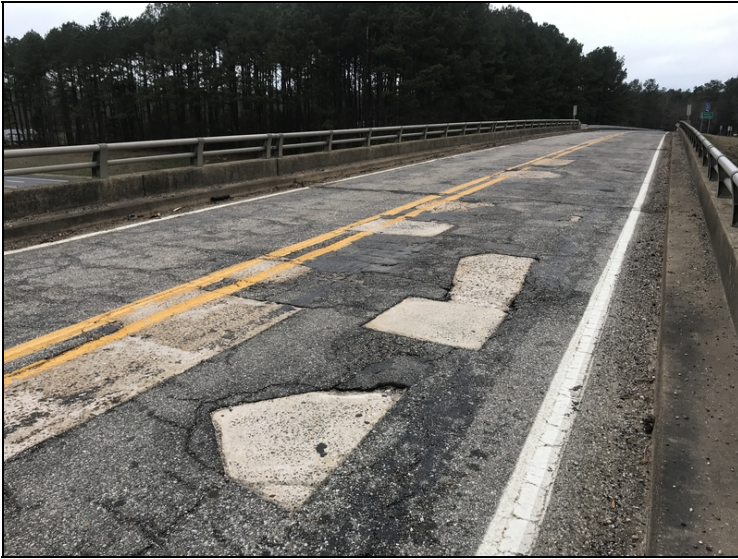
Deck spalls spans 1 and 2

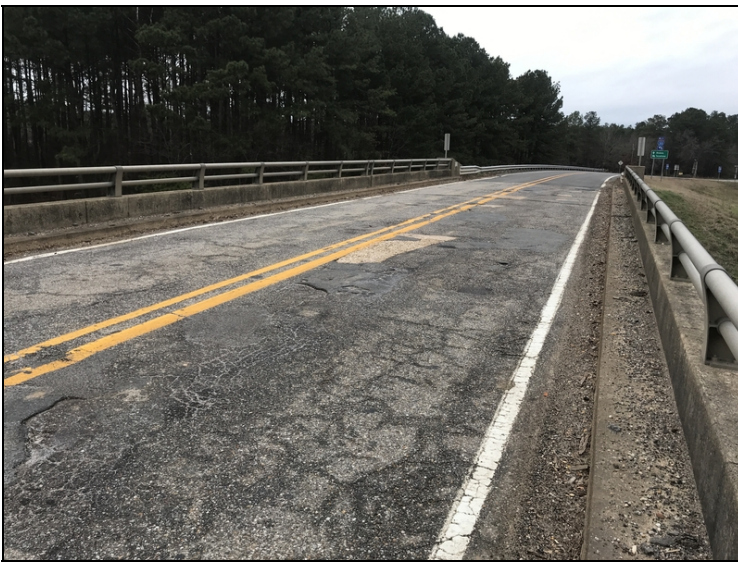
Deck spalls spans 3 and 4. There are several spall on both spans that have been patched with cold mix.

Deck spalls spans 3 and 4

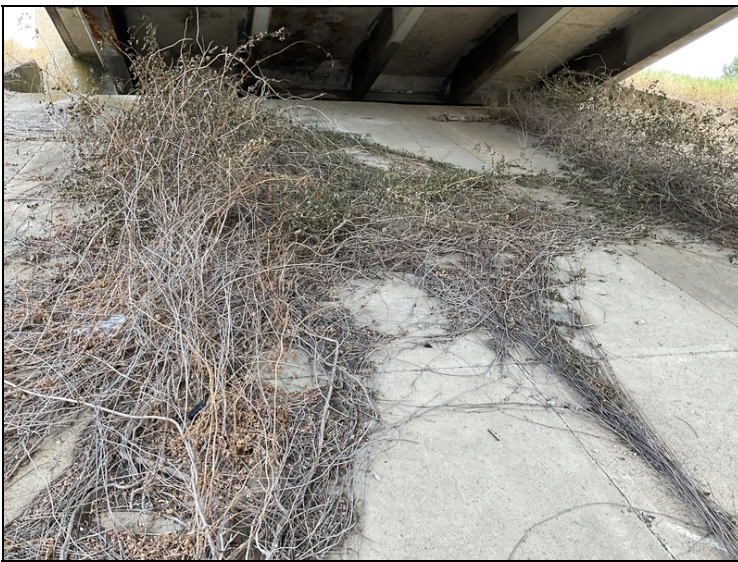
Vegetation abutment 2 slope
