Asset #06072(Routine)

SH 114 S-0 LM 3.12 over BRUSHY CREEK

Location: 3.13 MI E JCT SH 35

Team Lead: Rickie Bratton, Inspection Date: 09/12/2023

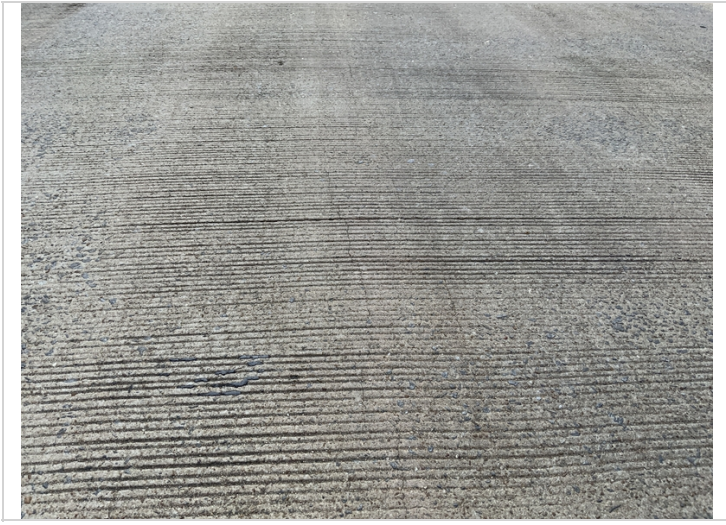
Span 1 longitudinal cracks up to 0.020". Common all spans.

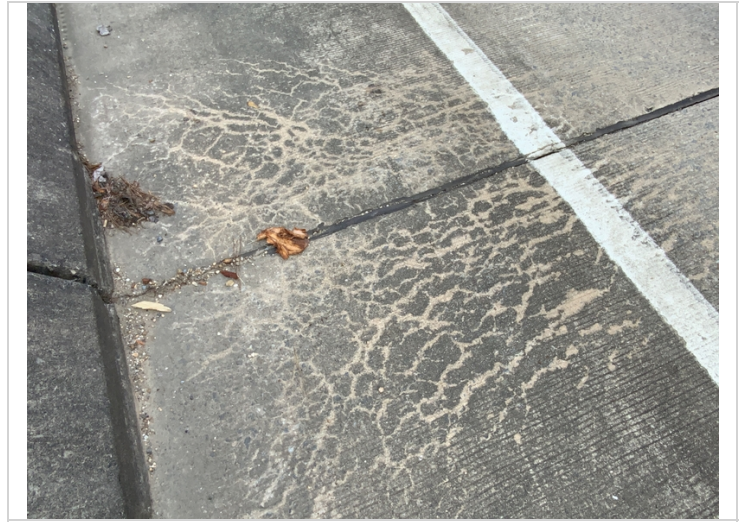
| ELEMENTS | DESCRIPTION | UNITS | TOTAL | | | | |
|---|---|---|---|---|---|---|---|
| (38) Slab edges have efflorescent cracks under the parapets. | | | | | | | |

All corners of slabs over bents have map cracking.

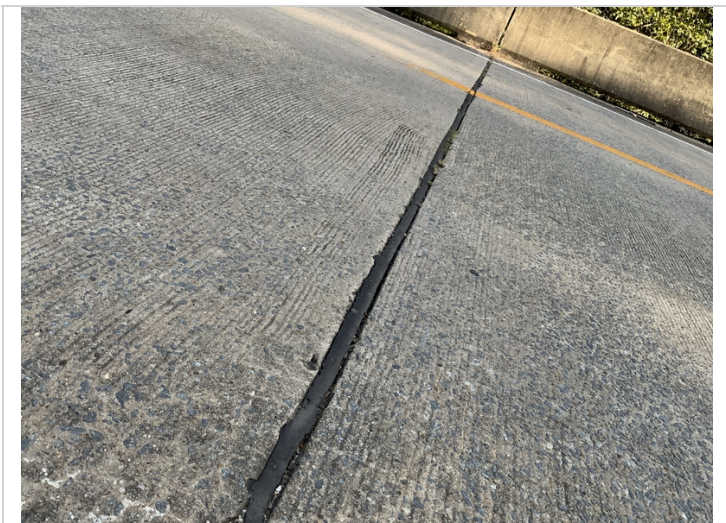
| ELEMENTS | DESCRIPTION | UNITS | TOTAL | CS1 | CS2 | CS3 | CS4 |
|---|---|---|---|---|---|---|---|
| (301) Tattered and losing bond. Leaking. | | | | | | | |

Bent 3 joint seal loss of bond.

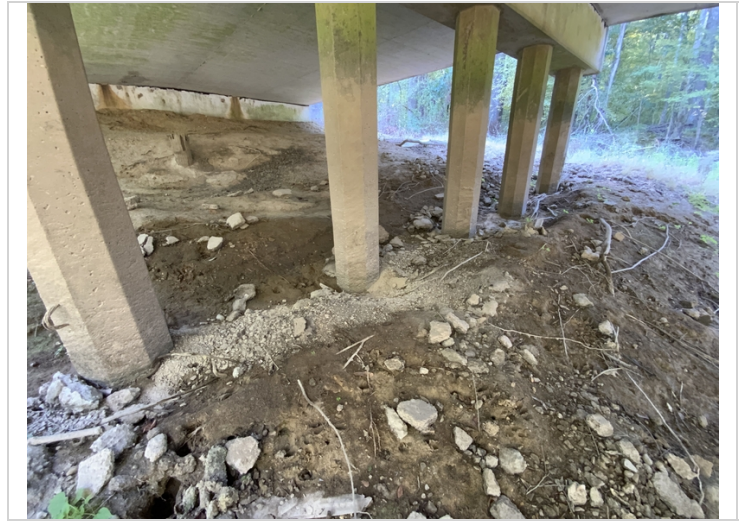
Bent 4, minor erosion around all piles. 1ft deep

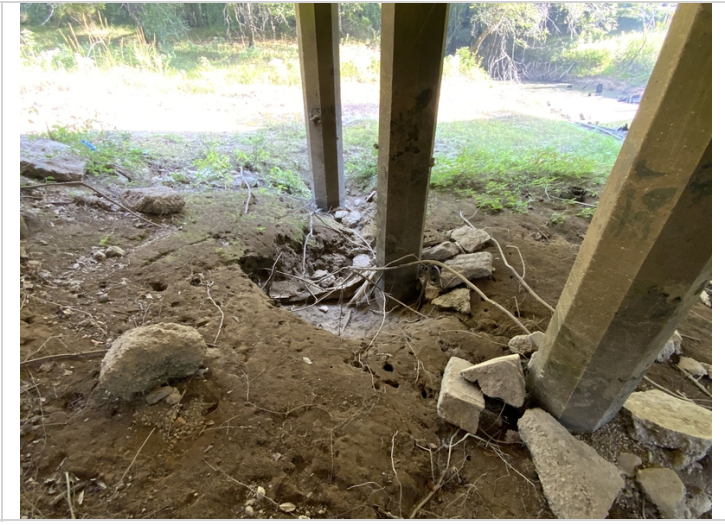
Scour hole around pile 2 Bt 2, 3ft deep, 5ft diameter

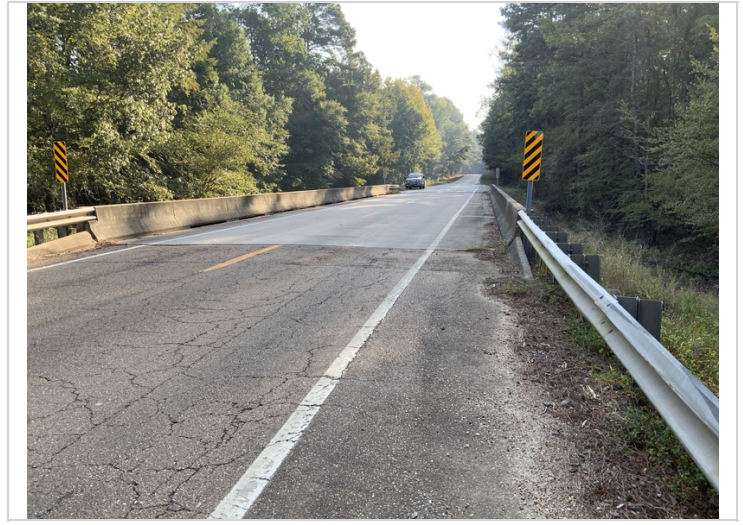
Both ends of structure missing log mile signs.

Missing log mile

| Type of Maintenance | Is recommended? |
|---|---|
| A-63 Missing/Incorrect Log Mile Signage | Yes |

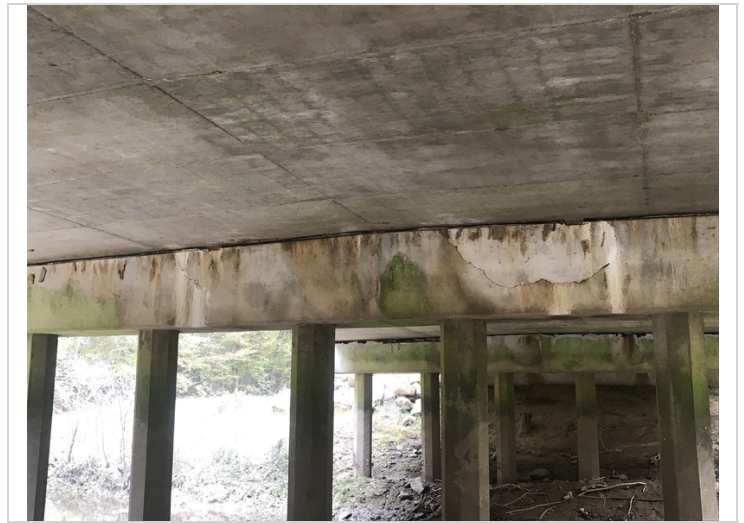
| ELEMENTS | DESCRIPTION | UNITS | TOTAL | CS1 | CS2 | CS3 | CS4 |
|---|---|---|---|---|---|---|---|
| (1080-234) Bent 3, back, delam over piles 2 and 4. | | | | | | | |

Delam, bent 3, back face.

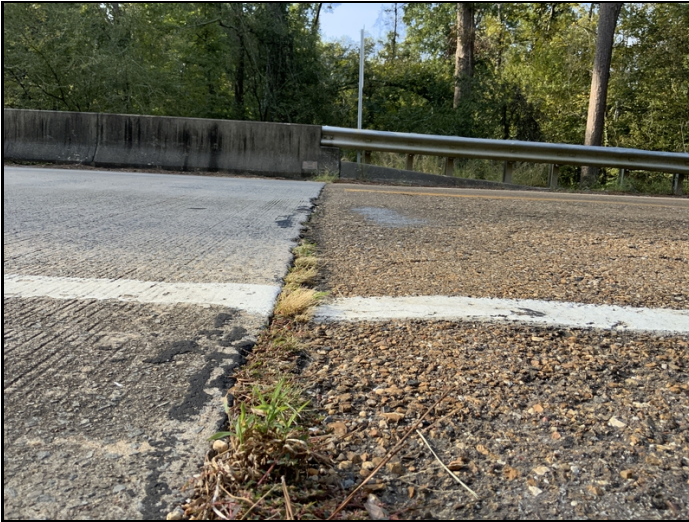
West end of westbound lane has 1" of roadway settlement

Type of Work: Approach Leveling/Maintenance

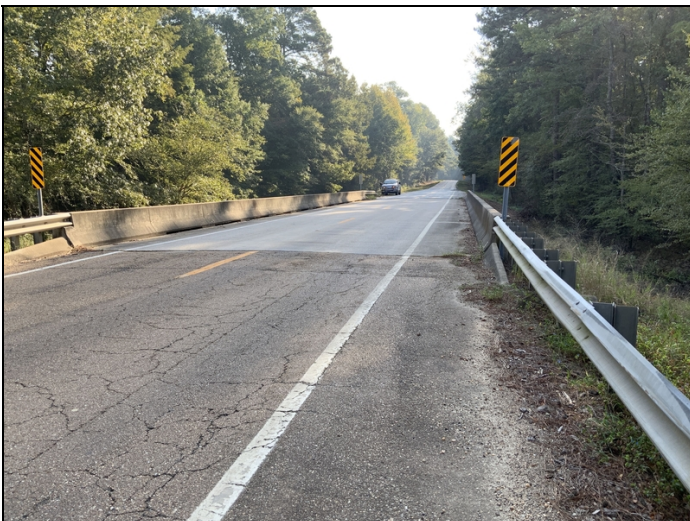
Both ends of structure missing log mile signs.

Missing log mile

A-63 - Missing/Incorrect Log Mile Signage (Yes)
