**Asset #M4070**(Routine, Underwater type 2)

**SH 114 S-O LM 6.30 over KESSEE CREEK**

**Location: 2.32 MI W JCT SH 15**

**Team Lead: Rickie Bratton, Inspection Date: 09/06/2023**

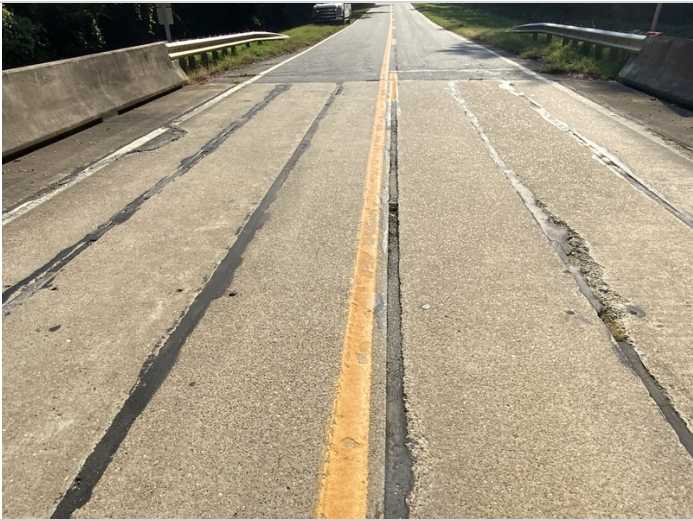
Span 2, unit 2 6 and 7, spalls

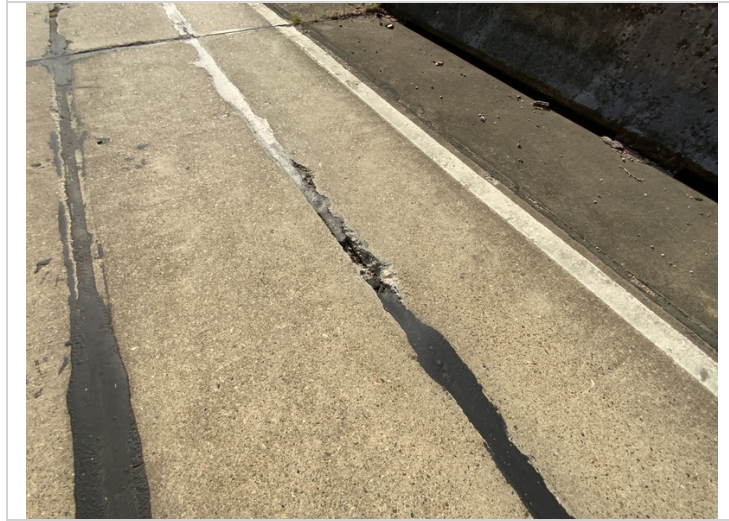
span 1, Joint between units 6 and 7, missing grout.

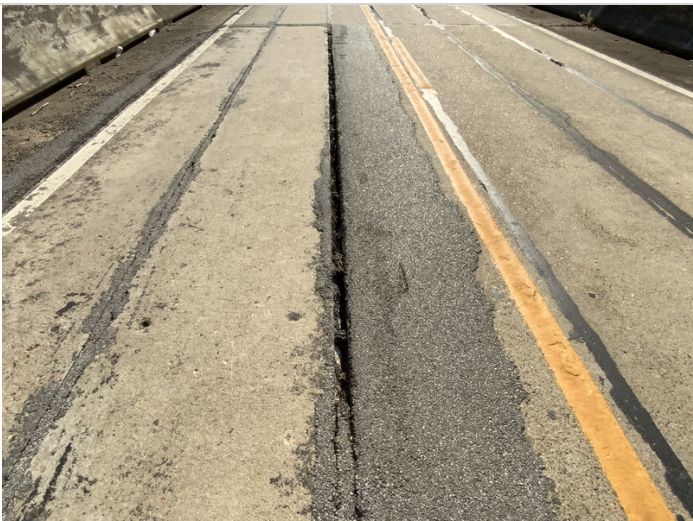
Span 1 missing grout between units 3 and 4.

span 1, Joint between units 3 and 4 missing grout.

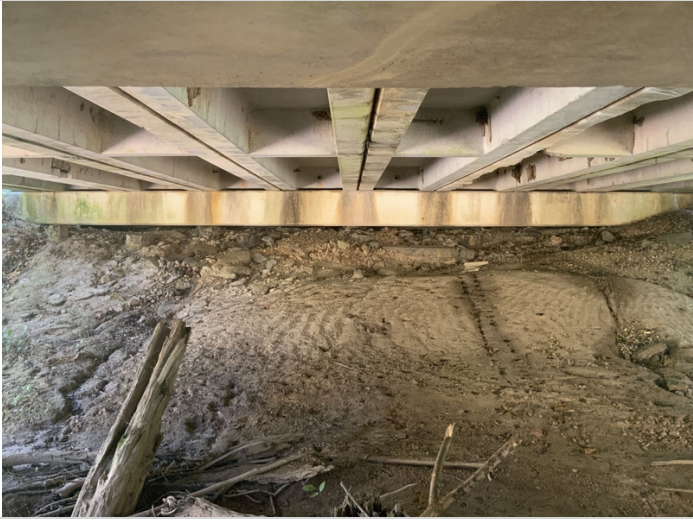
(215) 06/13/2018 JPR -- Both Abutments have scour that goes back under the abutment caps, but at this time there is very little roadway settlement @ either abutment.							
228	Timber Pile	EA	6	2	4	0	0
1150	Check/Shake	EA	1	1	0	0	0
1160	Crack (Timber)	EA	4	0	4	0	0
234	Reinforced Concrete Pier Cap	LF	31	21	6	4	0
1080	Delamination/Spall/Patched Area	LF	4	0	0	4	0
1090	Exposed Rebar	LF	6	0	6	0	0
304	Open Expansion Joint	LF	31	31	0	0	0
331	Reinforced Concrete Bridge Railing	LF	126	126	0	0	0

Abutment 2 (bent 3) settlement

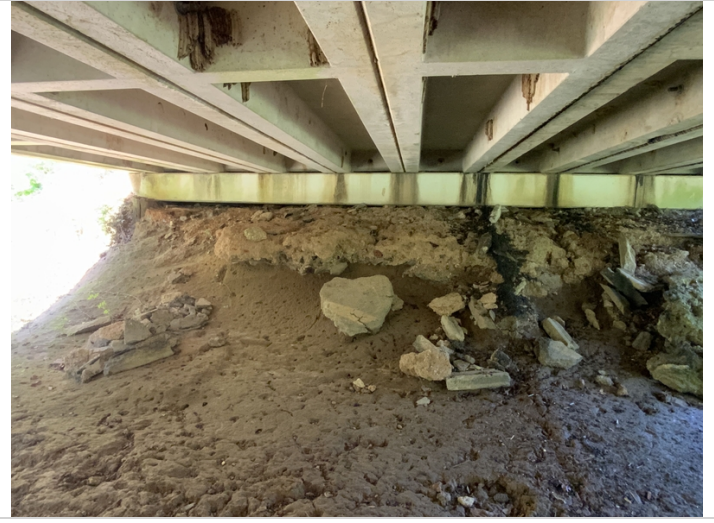
Abutment 1, settlement

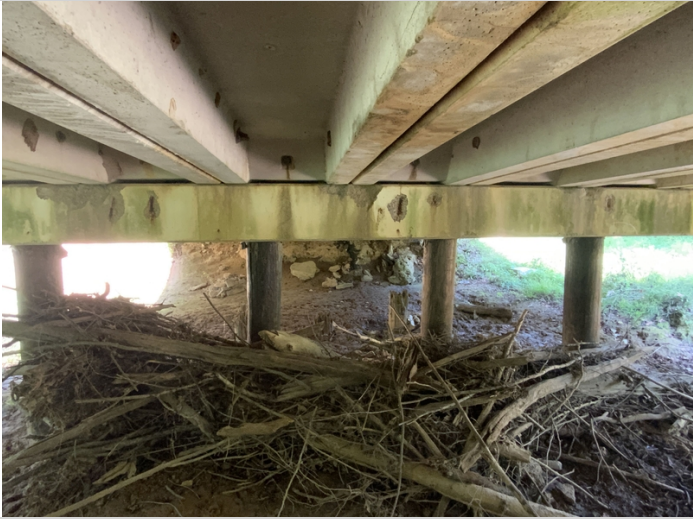
bent 2 ahead, spalled under units 2-8. Also has exposed rebar.

Bent 2 cap ahead exposed rebar

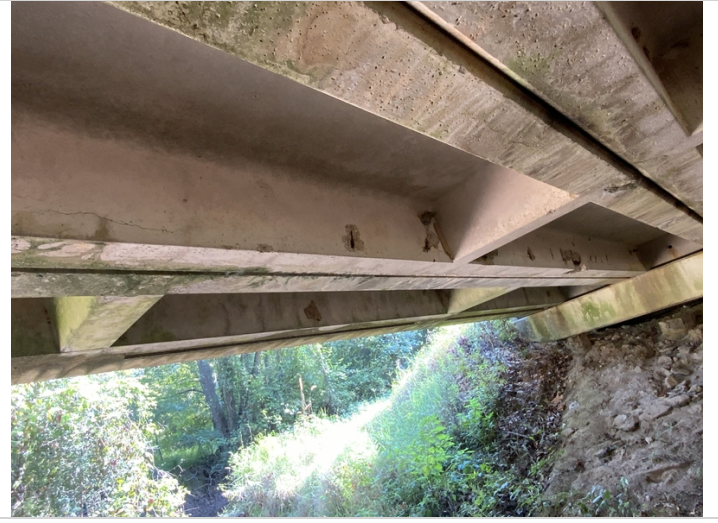
Span 2 unit 2, cracks, and exposed rebar

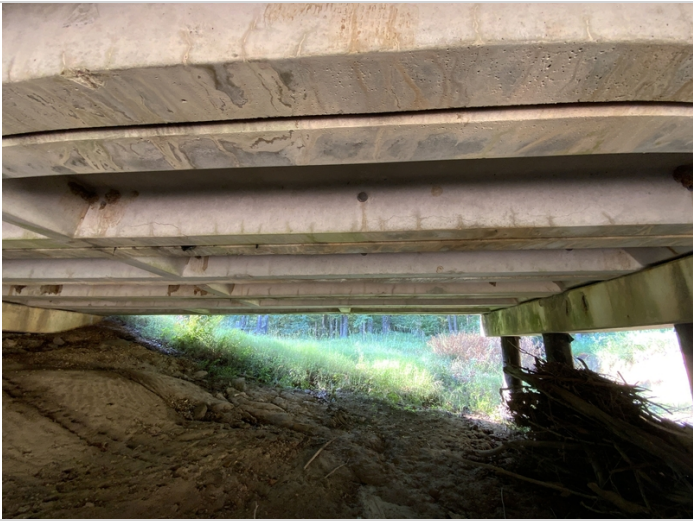
Span 2 unit 4, cracks

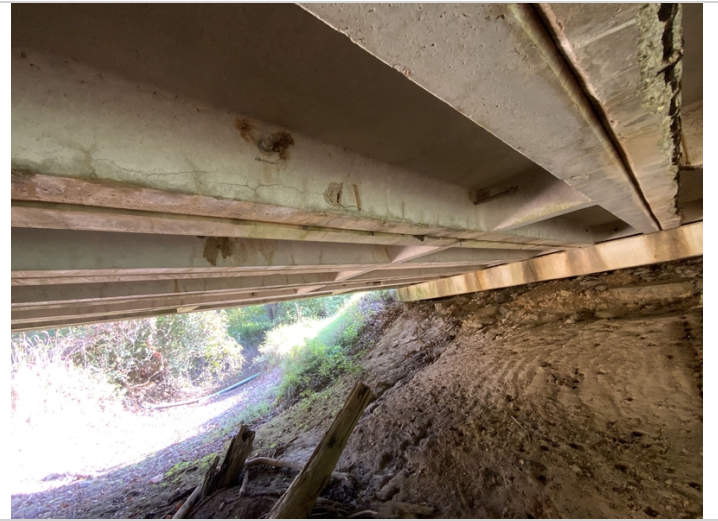
Span 2 unit 5, cracks

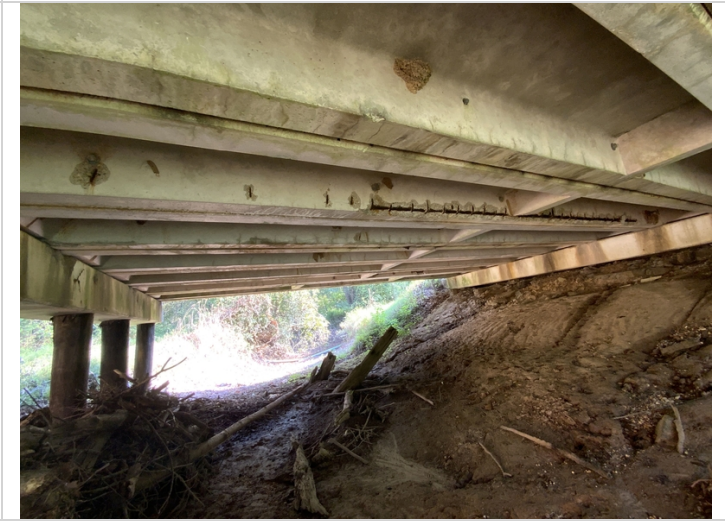
Span 2 unit 6, exposed rebar

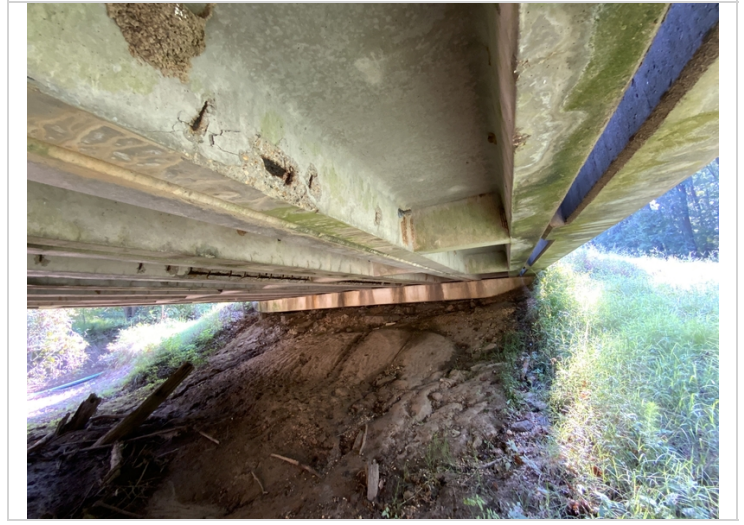
Span 2 unit 8, exposed rebar

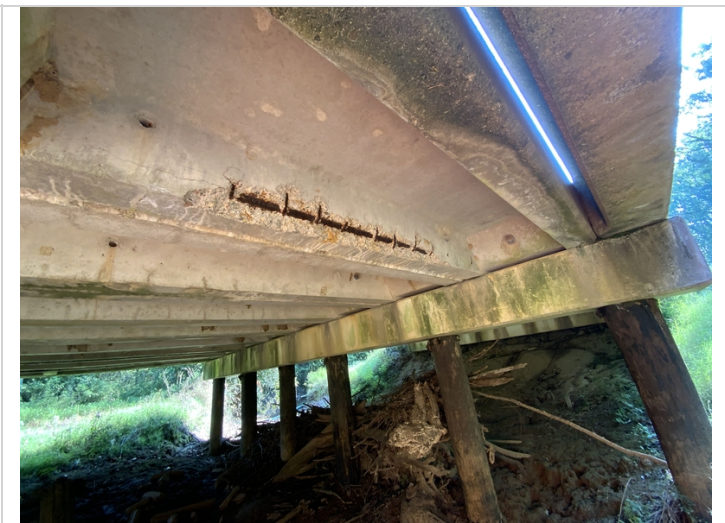
Span 1 unit 8, exposed rebar

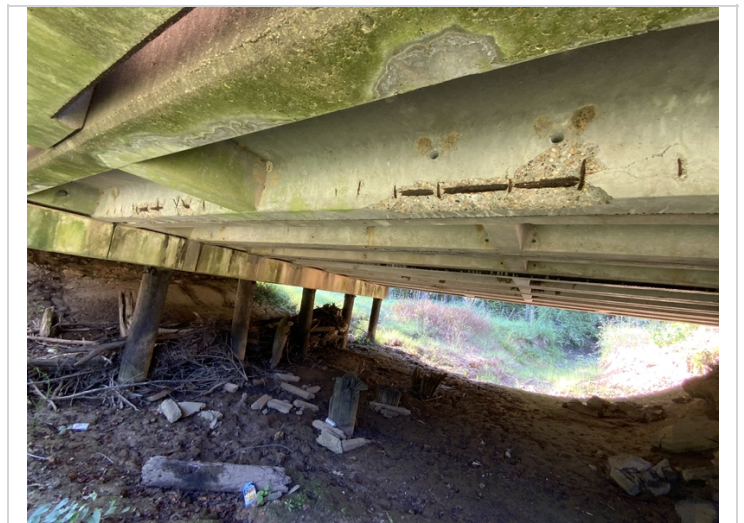
Span 1 unit 1, exposed rebar

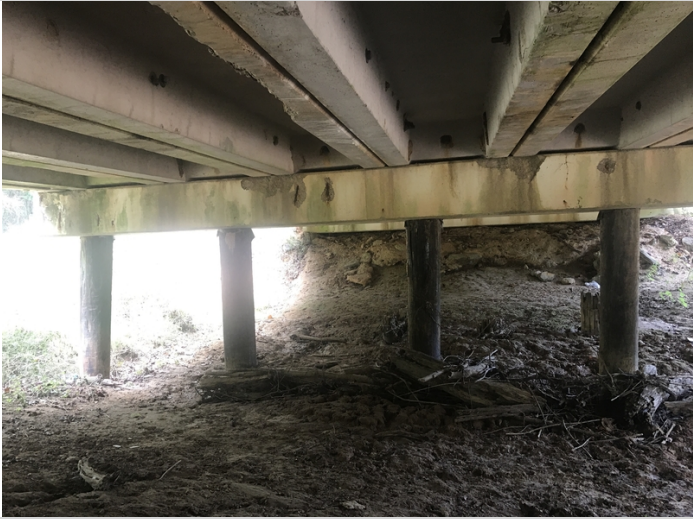
Bent 2 cap ahead face spalled delam and exposed rebar.

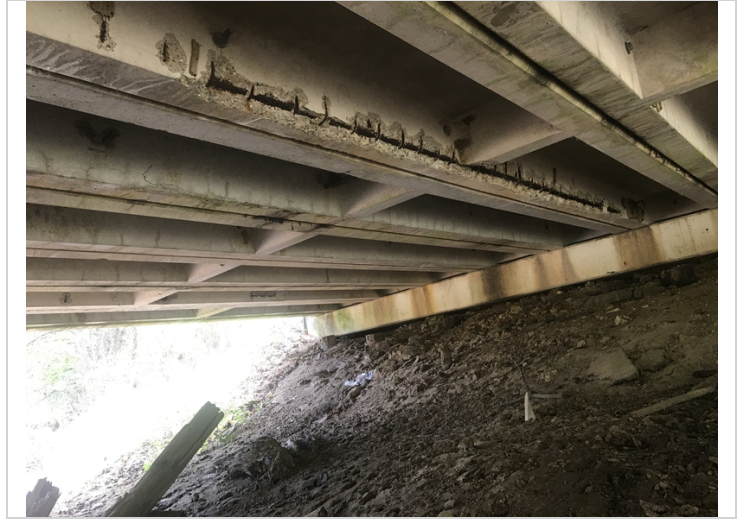
Span 2 unit 6, spall with exposed rebar.

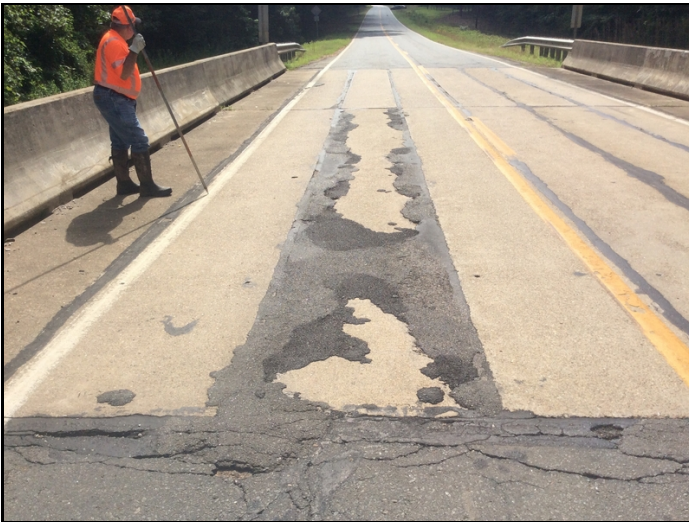
Span 1 unit 3, heavy surface spalling, filled with asphalt.

Span 1 unit 3 has numerous large spalls for entire length of the PC Unit.

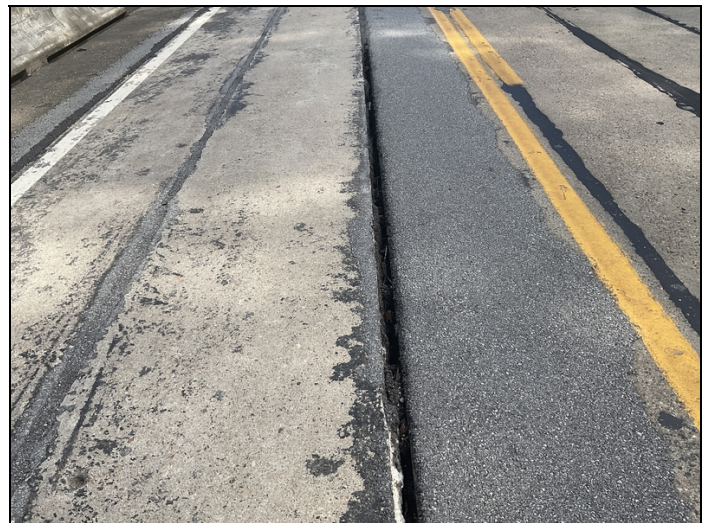
Grout missing between units 3 and 4 span 1

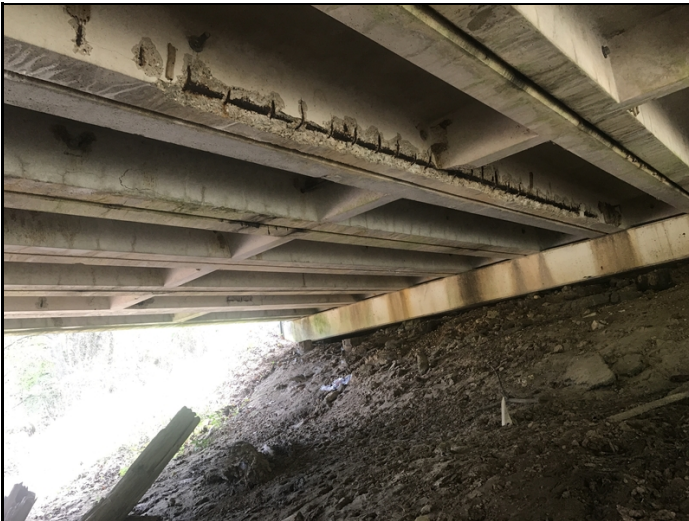
Span 2 unit 6 has 18' of spall on the girders, with exposed steel. 10/18/2021 JPR -- The exposed steel on span 2 PC Unit 6 has increased to 25' of total exposed reinforcing steel, this structure was built in 1975 so we are not sure if it has any shear reinforcing steel at the ends.

Span 2 unit 6, spall with exposed rebar.

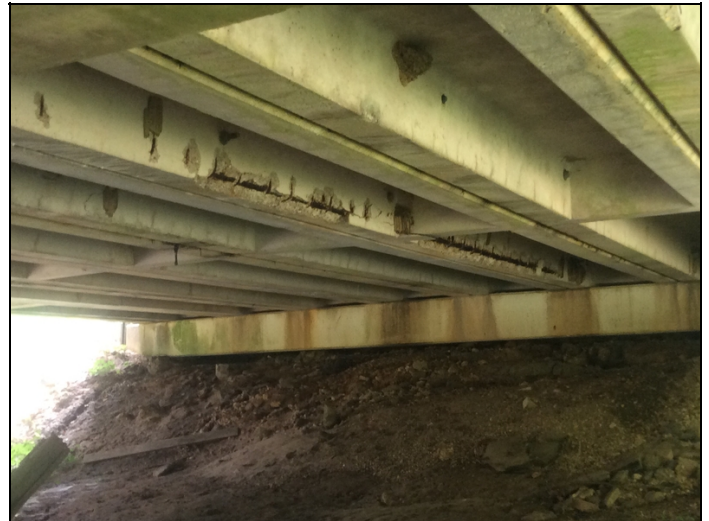
Span 2 unit 6 spalled with exposed rebar

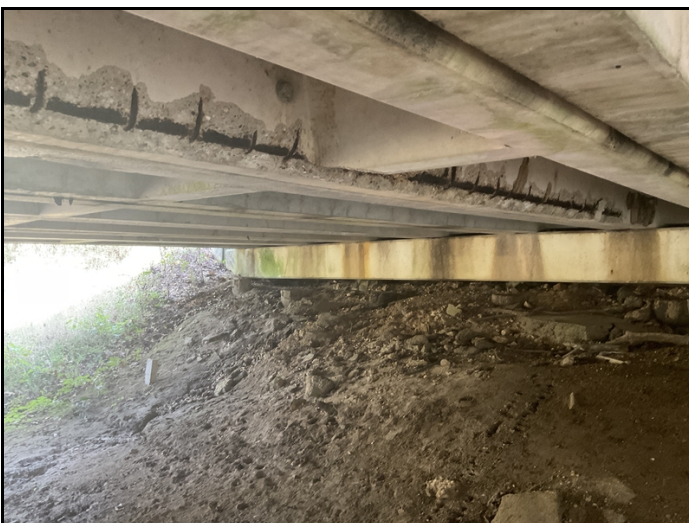
Span 2 unit 6 spalled

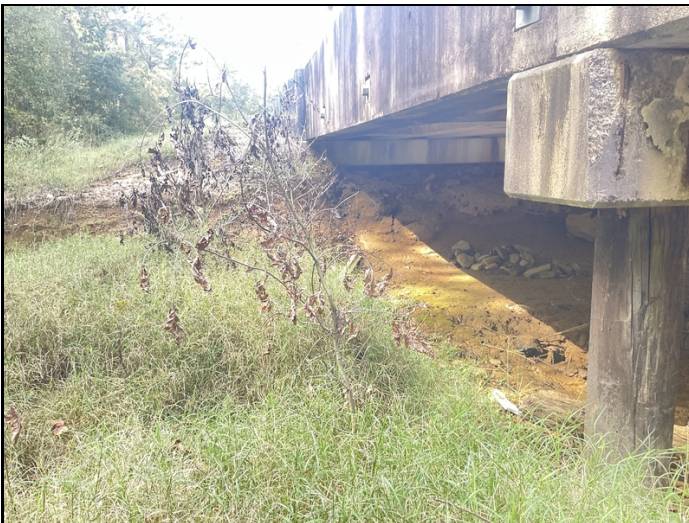
Abutment 1, span 1 slope has scoured out back towards the abutment and back under Rt. side of the abutment cap. There is scouring on the down stream side and channel is migrating towards abutment 1, there is also a deep hole just outside the Rt. side of the bridge. There is also silt and sediment built up on the Lt. side, down stream side just outside the Rt. side of the bridge and is blocking about 2/3 of the drainage area and thus causing the scouring on abutment 1.

Scour under cap abutment 1

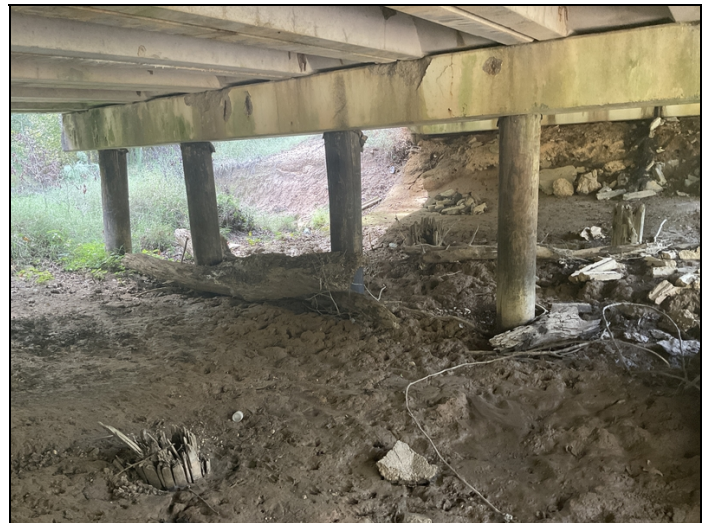
Scour abutment 1

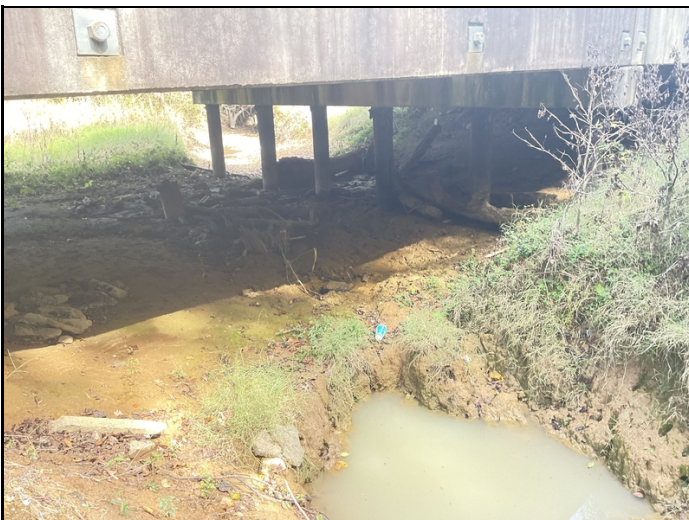
Span 1 scour Rt. side with silt and sediment built up in the stream bed

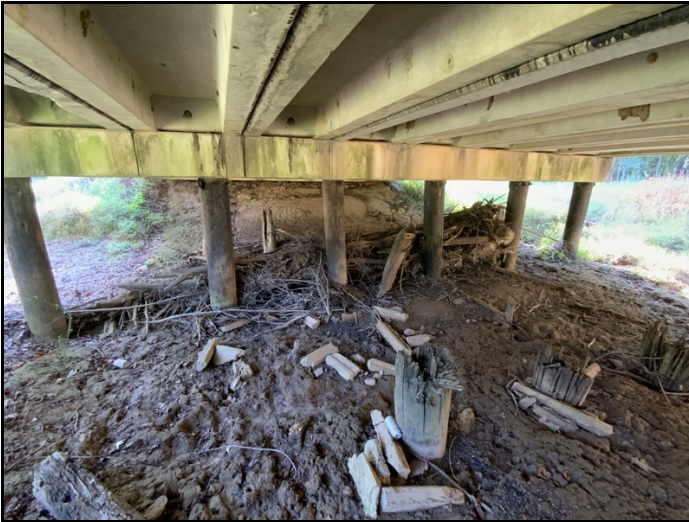
Drift bent 2

Bent 2 drift.

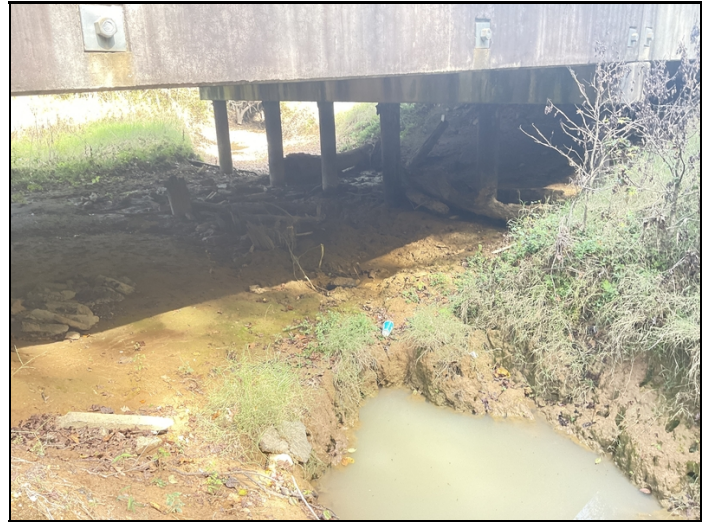
Drift bent 2
