Bridge #06962(Routine)

SH51Sec1KingOP over I 30 Sec. 14 log 72.86

Location: 2.25 Mi. W Jct US 67

Team Lead: Rickie Bratton Inspection Date: June 17, 2020

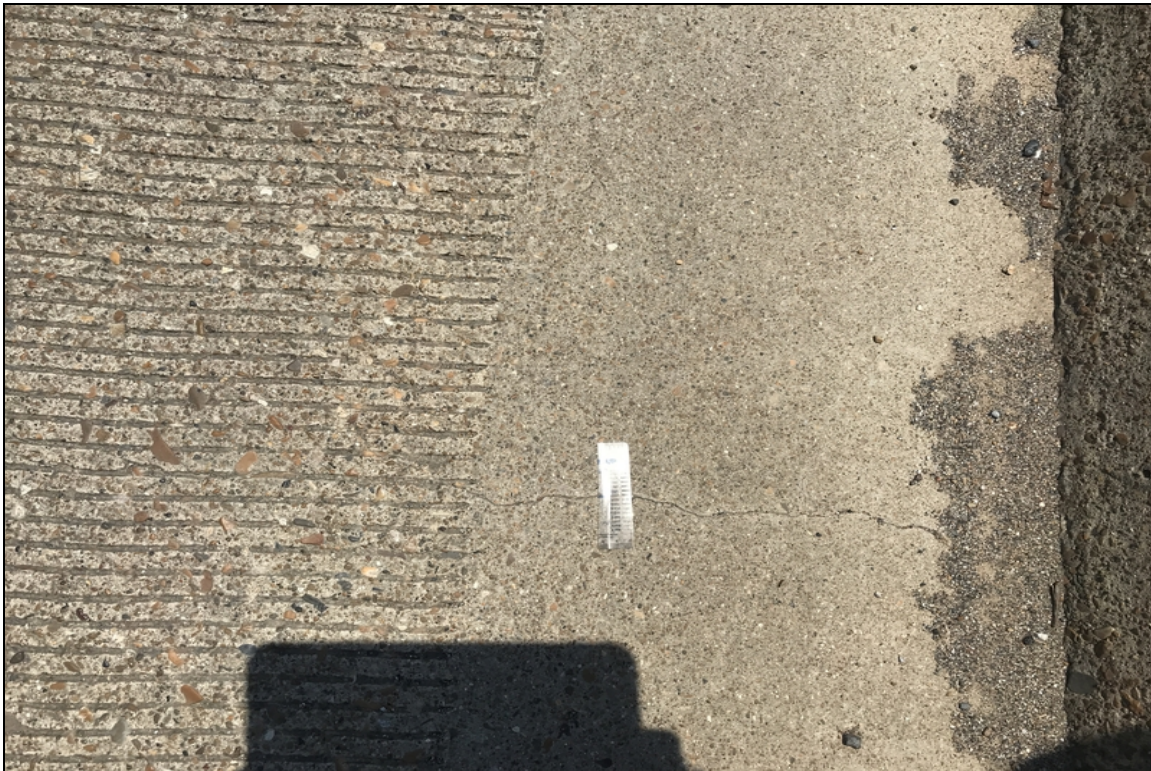
Deck crack

Very minor cracking. Seals are adhering and working.
