Bridge #A3706(Routine)
I-30 S4 WB LM76.81 over CADDO RIVER

Location: .14 MI SW JCT SH 7

Team Lead: Rickie Bratton Inspection Date: July 29, 2019

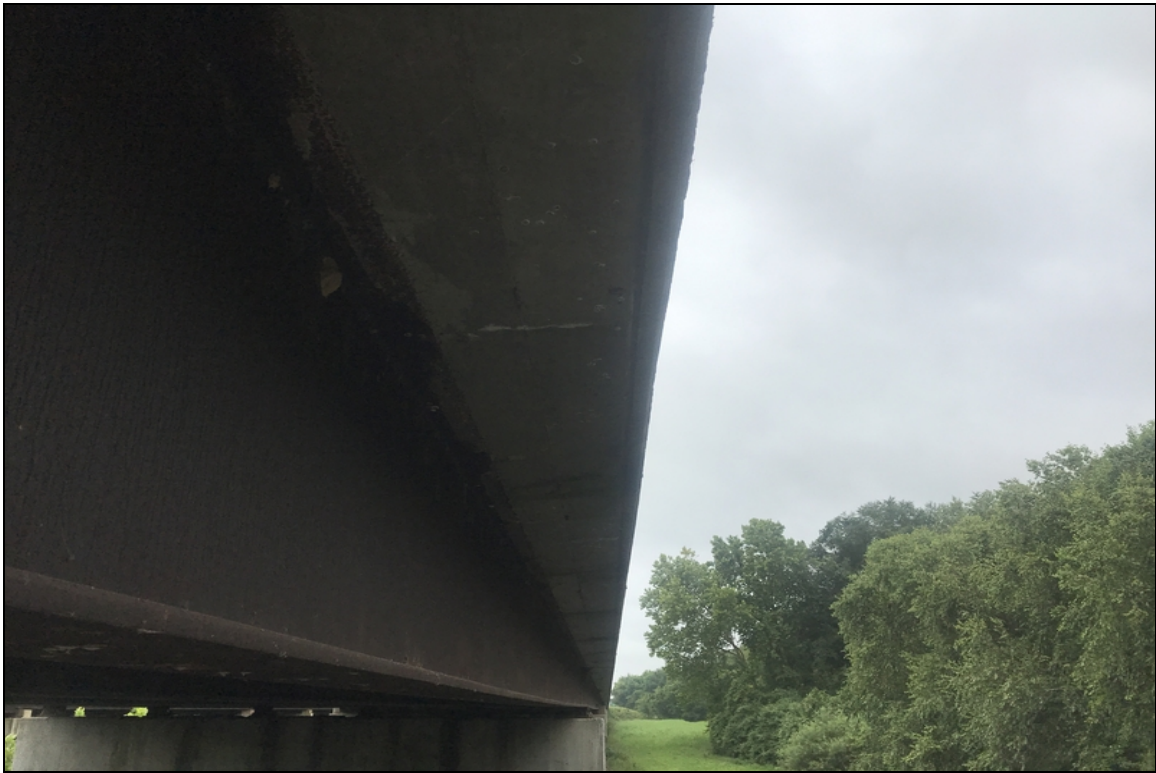
Crack in overhang span 18

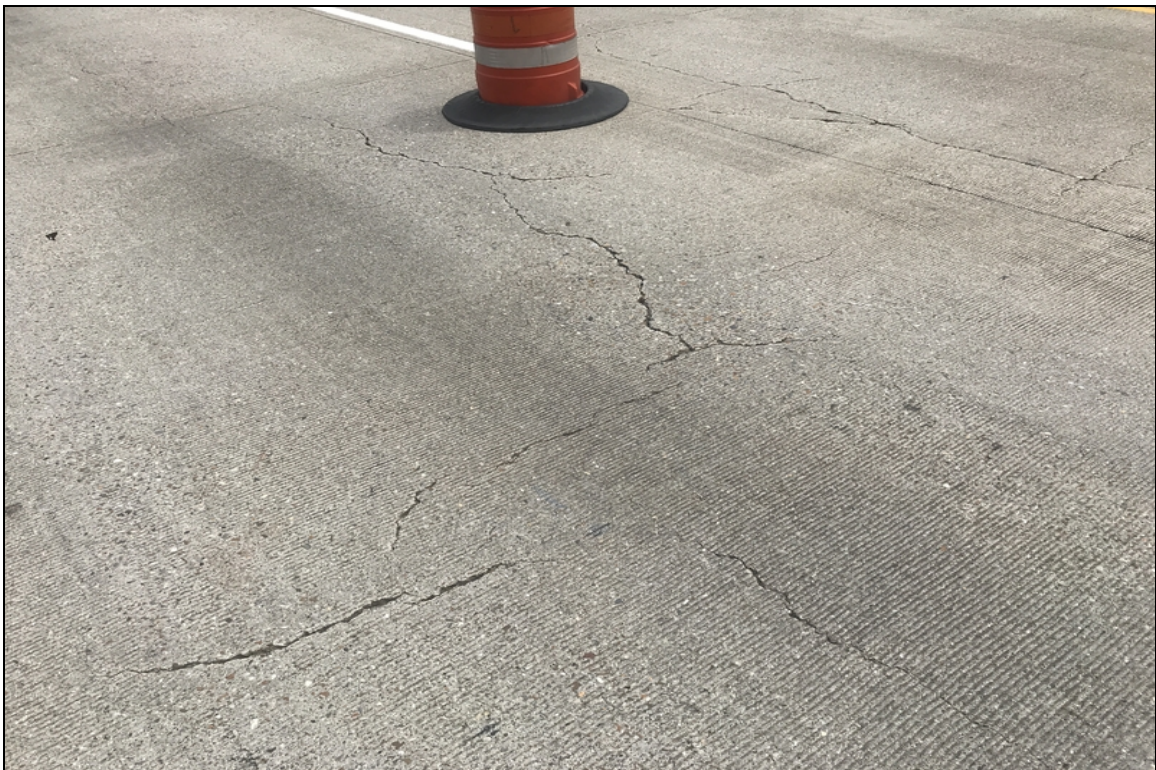
Approach slab cracks

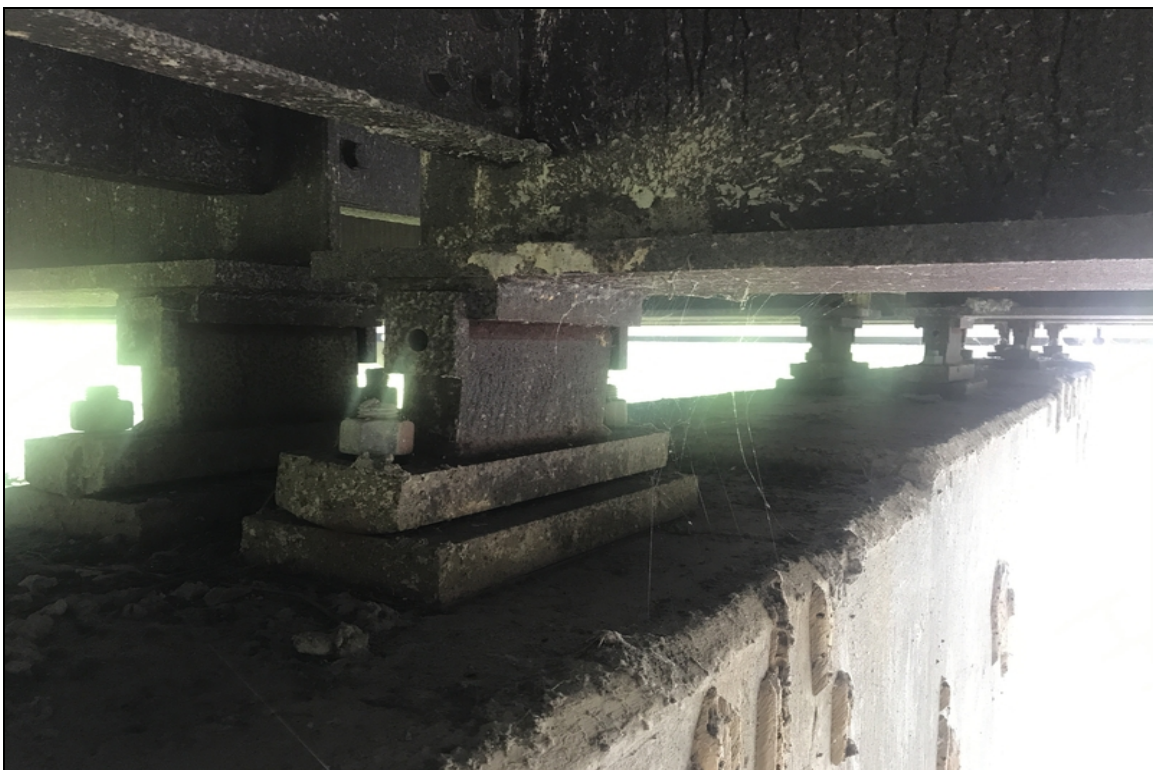
ELEM	DESCRIPTION	UNITS	TOTAL	CS1	CS2	CS3	CS4
1020	Connection	EA	5	0	0	0	5
2220	Alignment	EA	4	0	4	0	0
(311)							
Pier 1 back, bearings have rocked							
Bent 18 sp 17, bearings 1 and 4, missing top bolt at bearing and beam connection.							
Bent 19 sp 18 bearings 3-5 missing top bolt at beam connection.							
313	Fixed Bearing	EA	37	28	9	0	0
1000	Corrosion	EA	9	0	9	0	0
321	Reinforced Concrete Approach Slab	SF	2957	2757	100	100	0
1130	Cracking (RC and Other)	SF	200	0	100	100	0
(321)							
Both ends have numerous cracks							
331	Reinforced Concrete Bridge Railing	LF	1142	892	250	0	0
1130	Cracking (RC and Other)	LF	100	0	100	0	0

Span 18 bent 19 bearing 3, 4 and 5 missing top bolts on left side

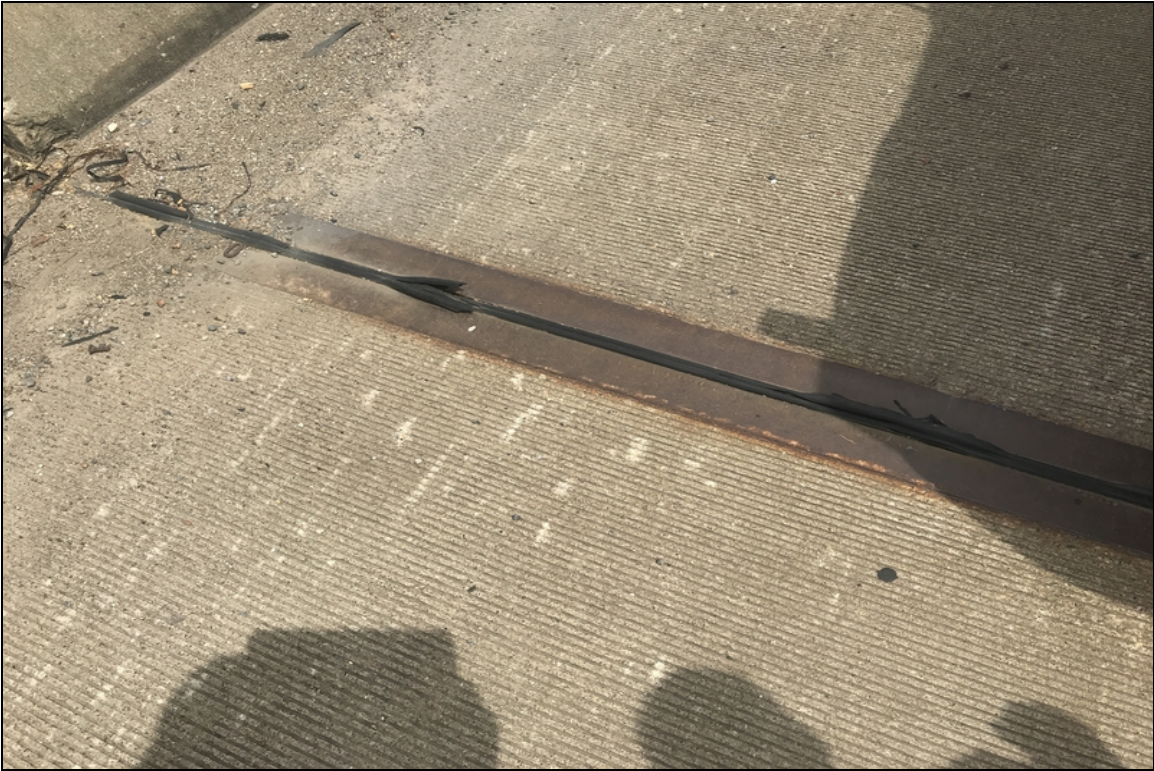
Bent 5 joint seal tore

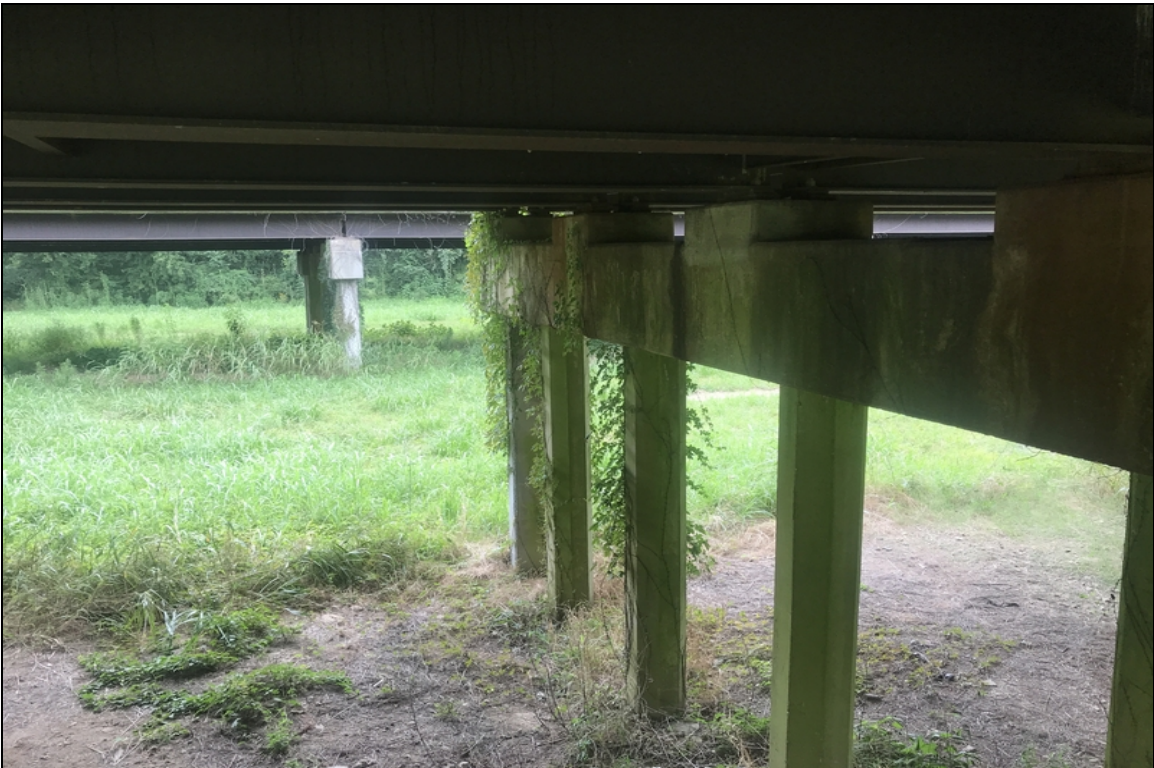
Bents 1-5 typical of all with vegetation

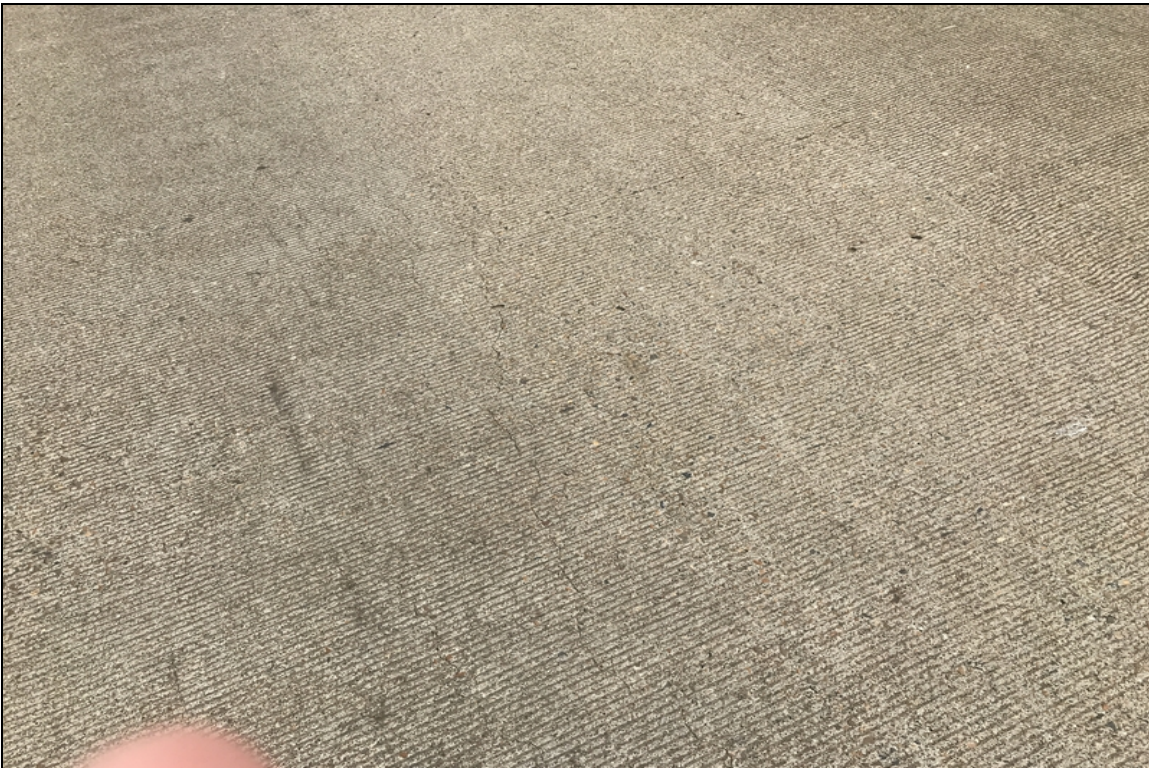
(12)							
All spans have longitudinal cracks and numerous transverse cracks. Spans 19 & 20 @ Bent 19 joint there are 2 small spalls, these spalls have been patched with cold mix.							
107	Steel Open Girder/Beam	LF	6840	6840	0	0	0
515	Steel Protective Coating	SF	50760	50755	5	0	0

Span 1 deck cracks

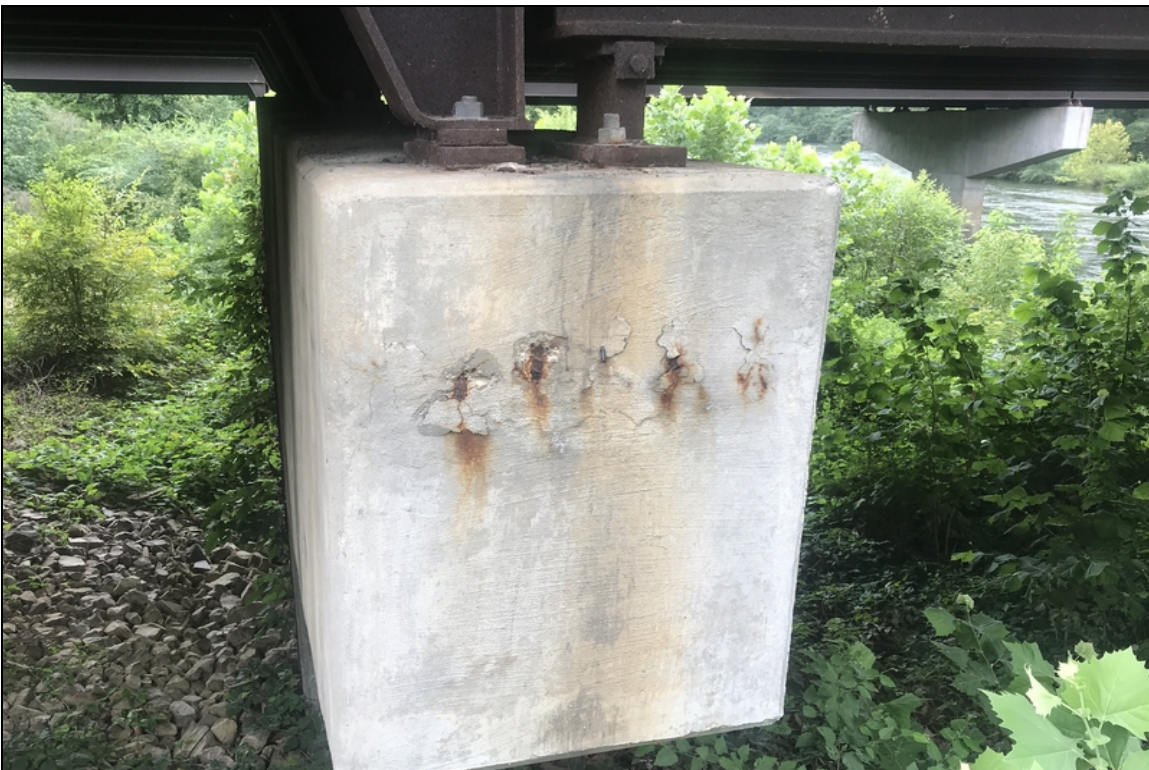
Left end of cap at bent 20, spall with exposed rebar.

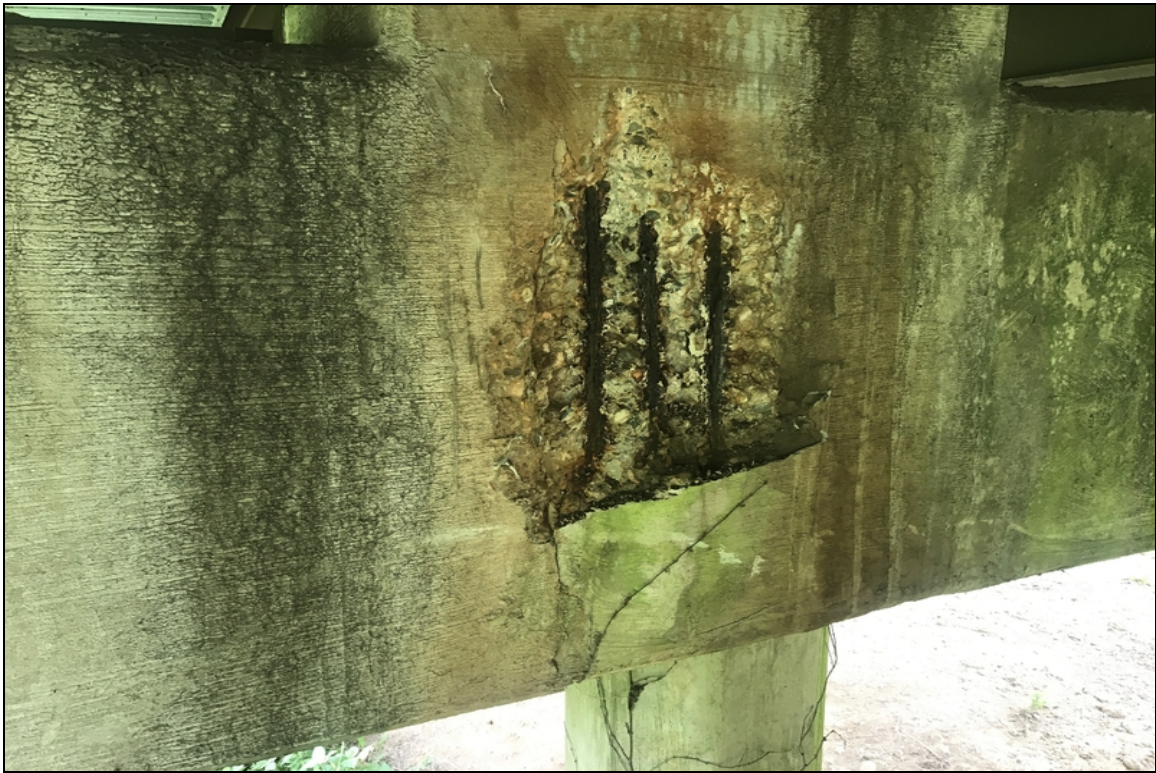
Bent 4

Several spalls, delams, etc. Bent #'s 4-5 are the worst. 07/31/2017 JPR -- Pier 1 looking back @ rocker bearing are rocked ahead.

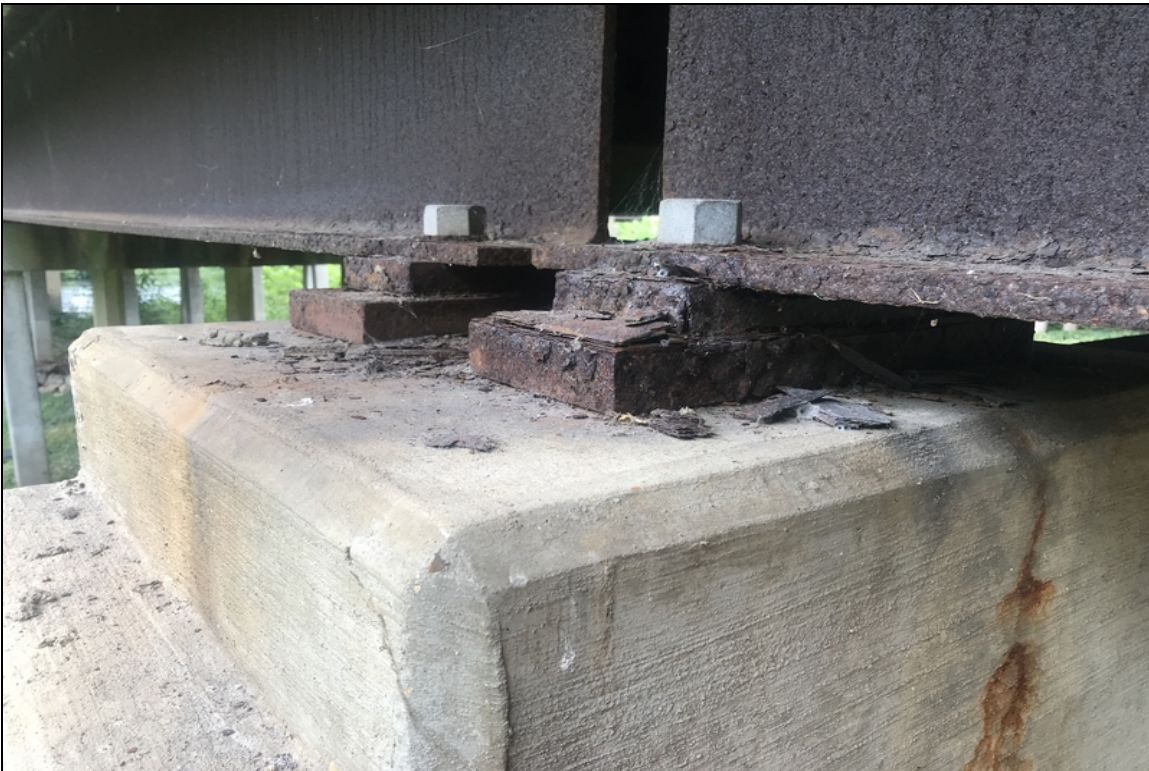
Bent 15 bearing 1 flaking rust

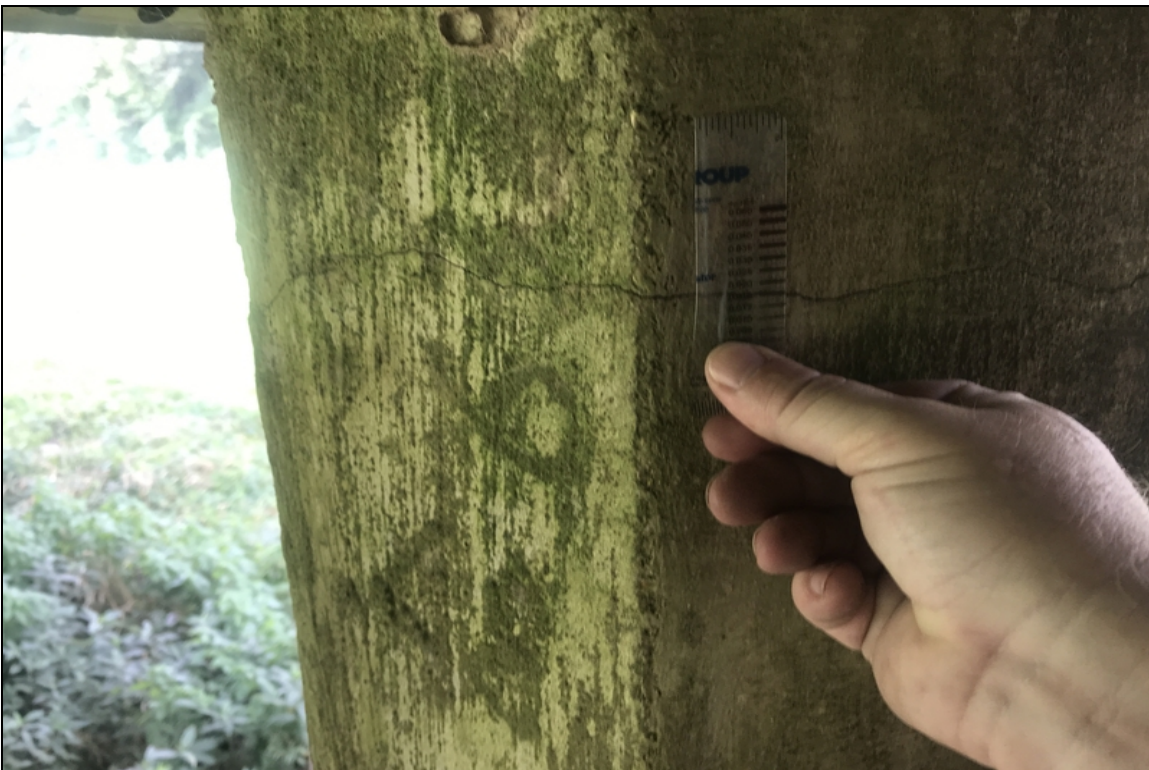
Crack pile 3 bent 14

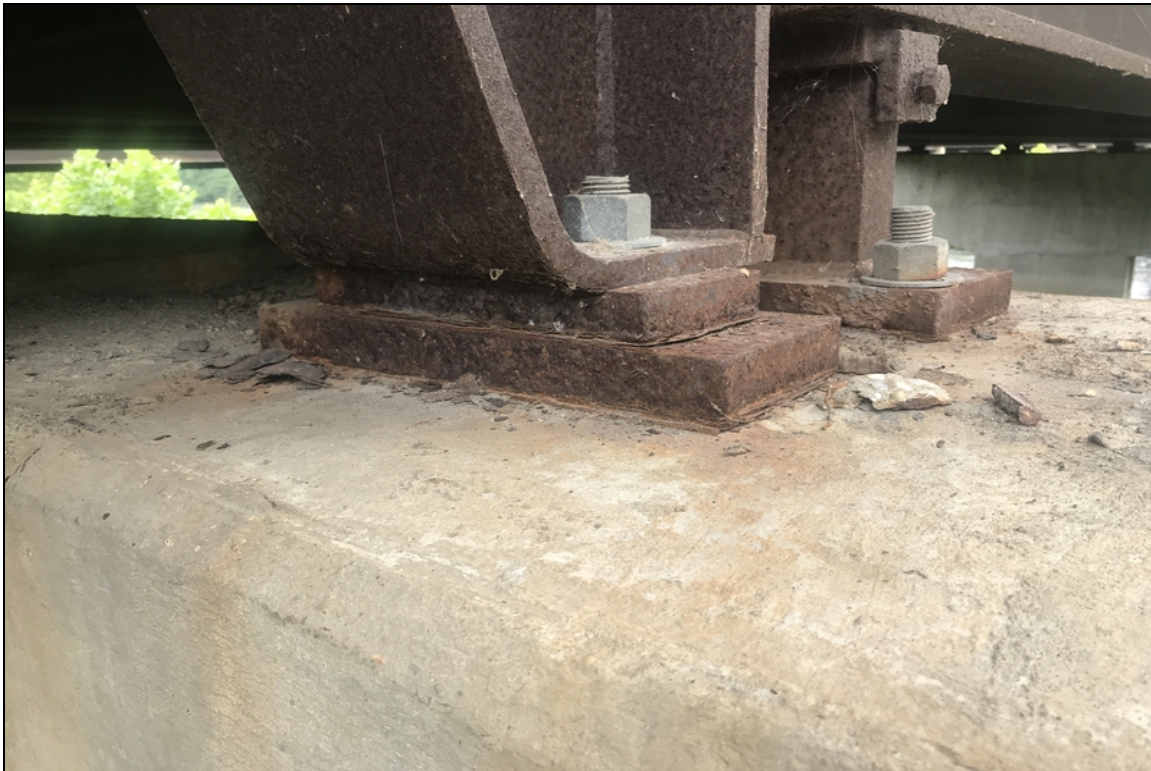
Bent 20, beam 1, light flaking rust on bearings.

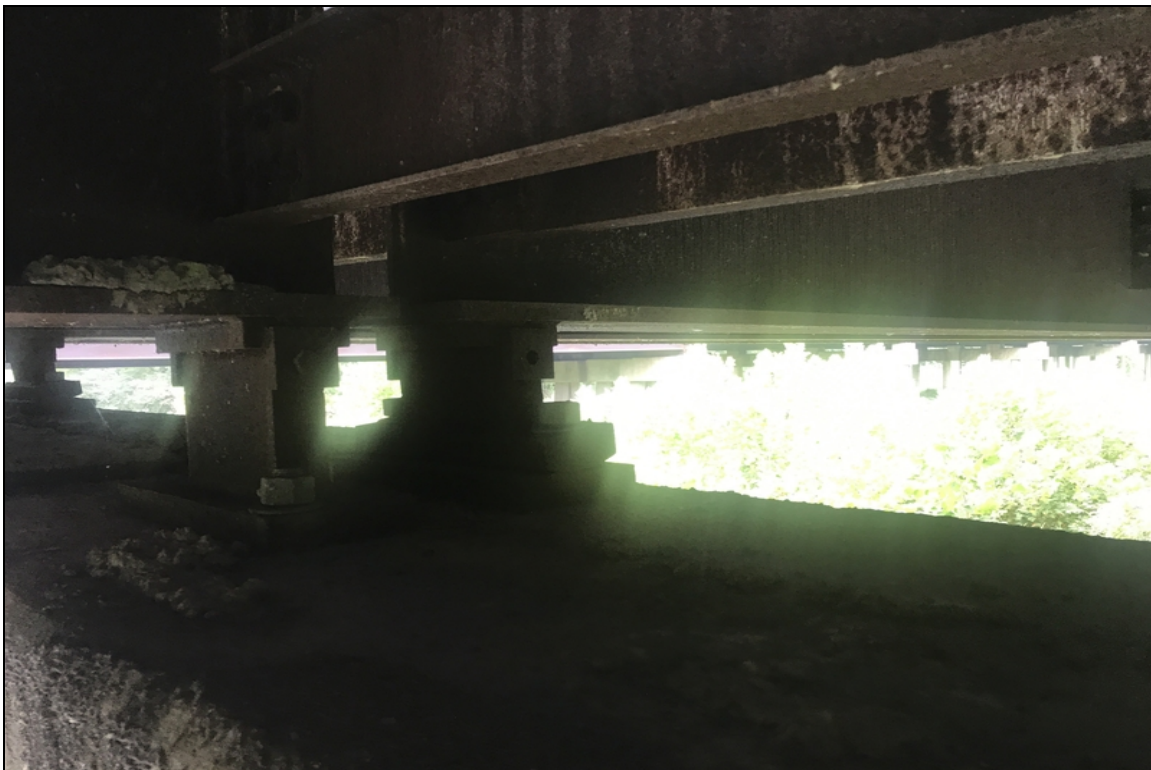
Missing bolt span 17 bent 18 bearing 4 also not pictured also bearing 1
