Bridge #B3706(Routine)

I- 30 SEC 14, EB L over CADDO RIVER

Location: .74 MI SW JCT SH 7

Team Lead: Rickie Bratton Inspection Date: June 15, 2020

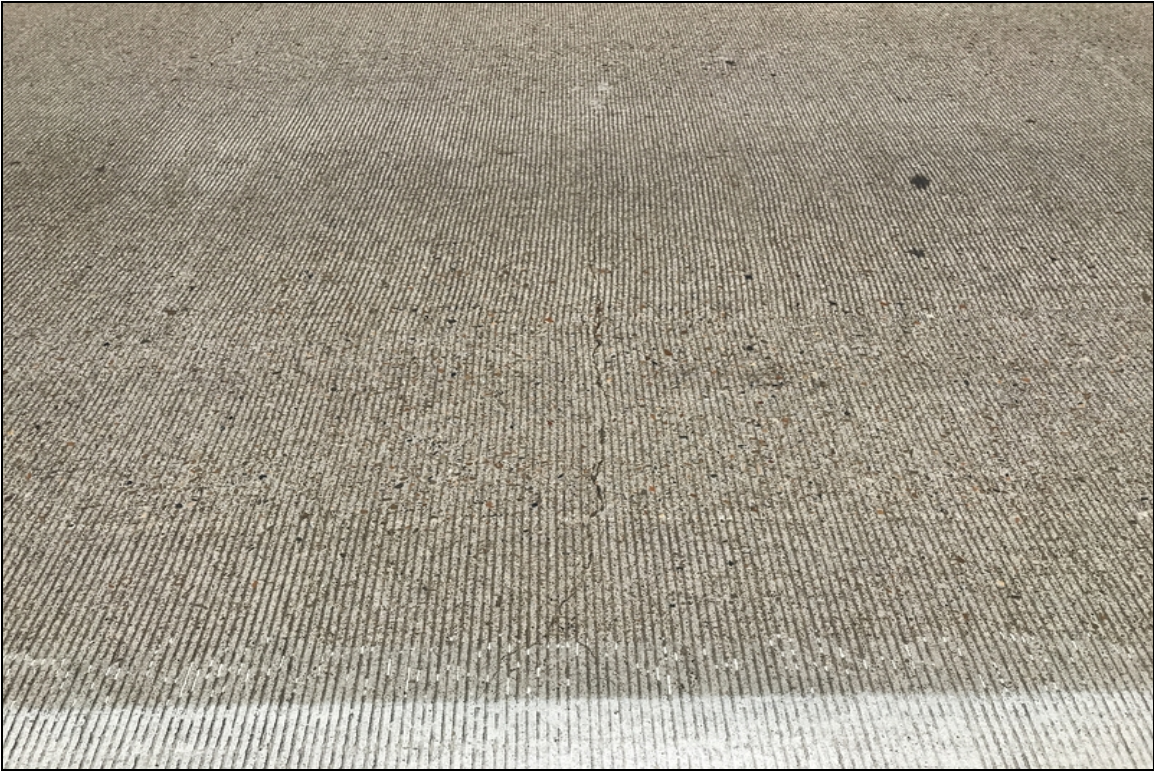
Typical transverse cracks, span 16

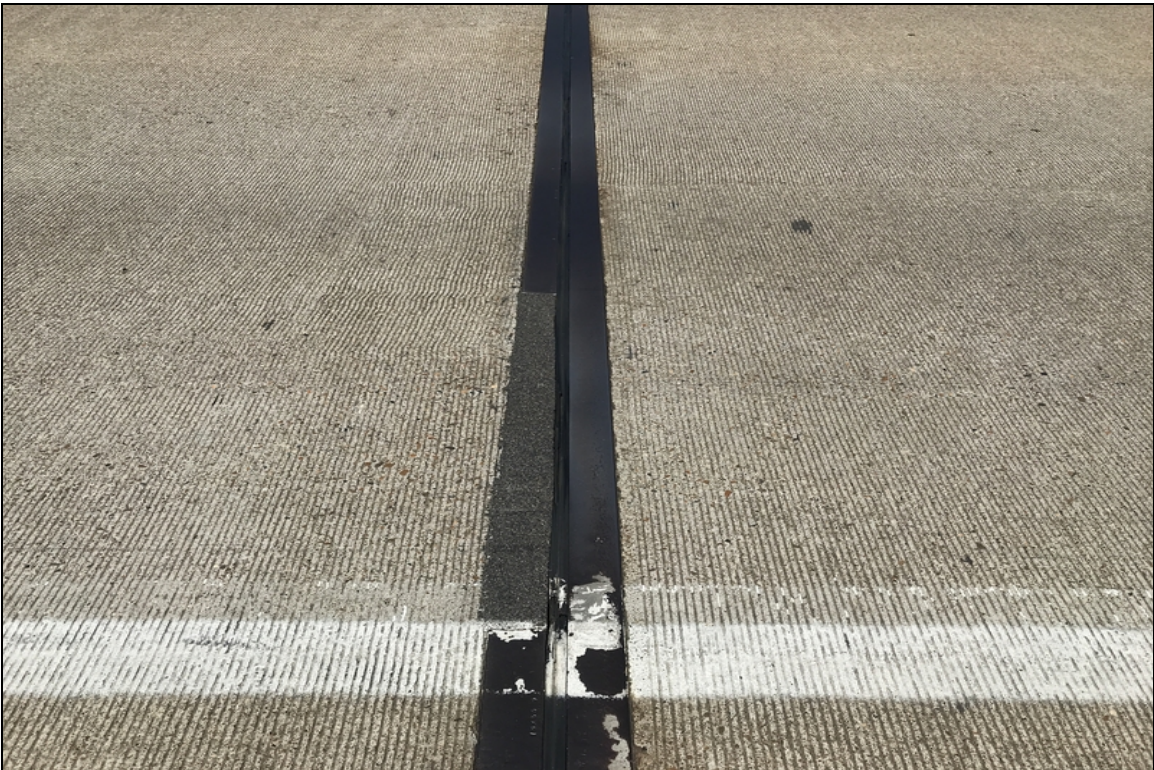
Joint 17, torn

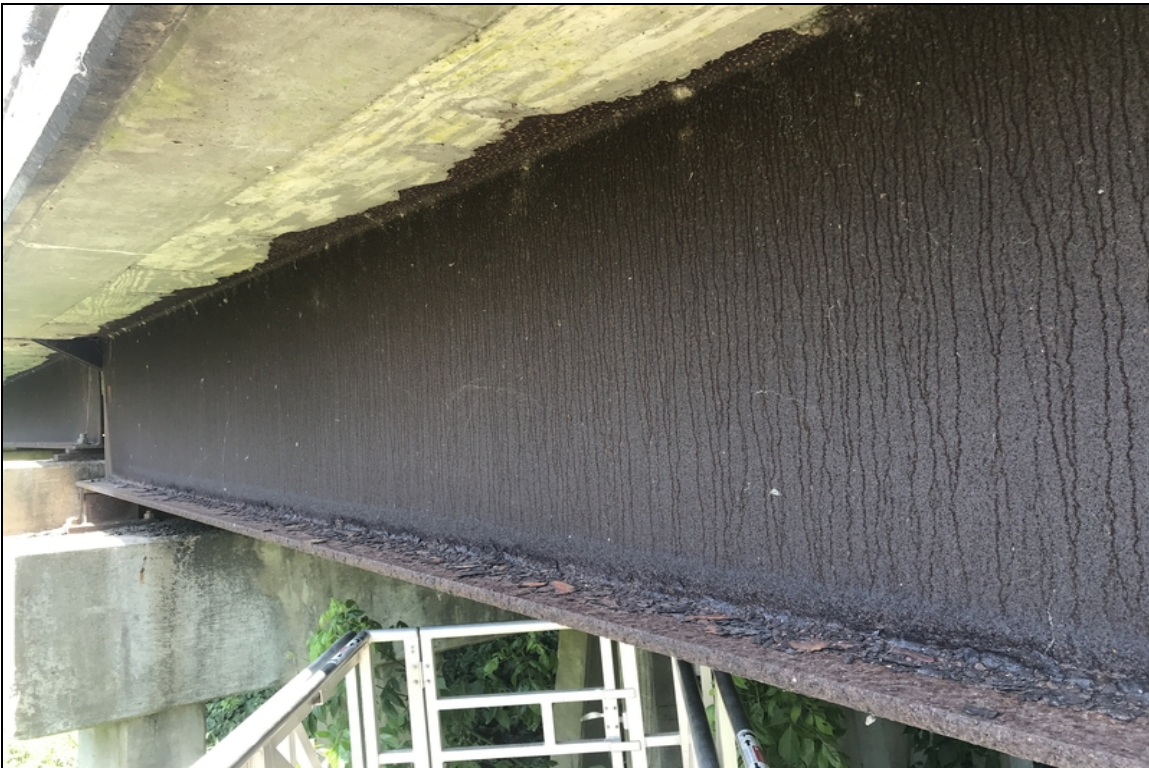
Span 18, beam 6, flaking rust, 20'

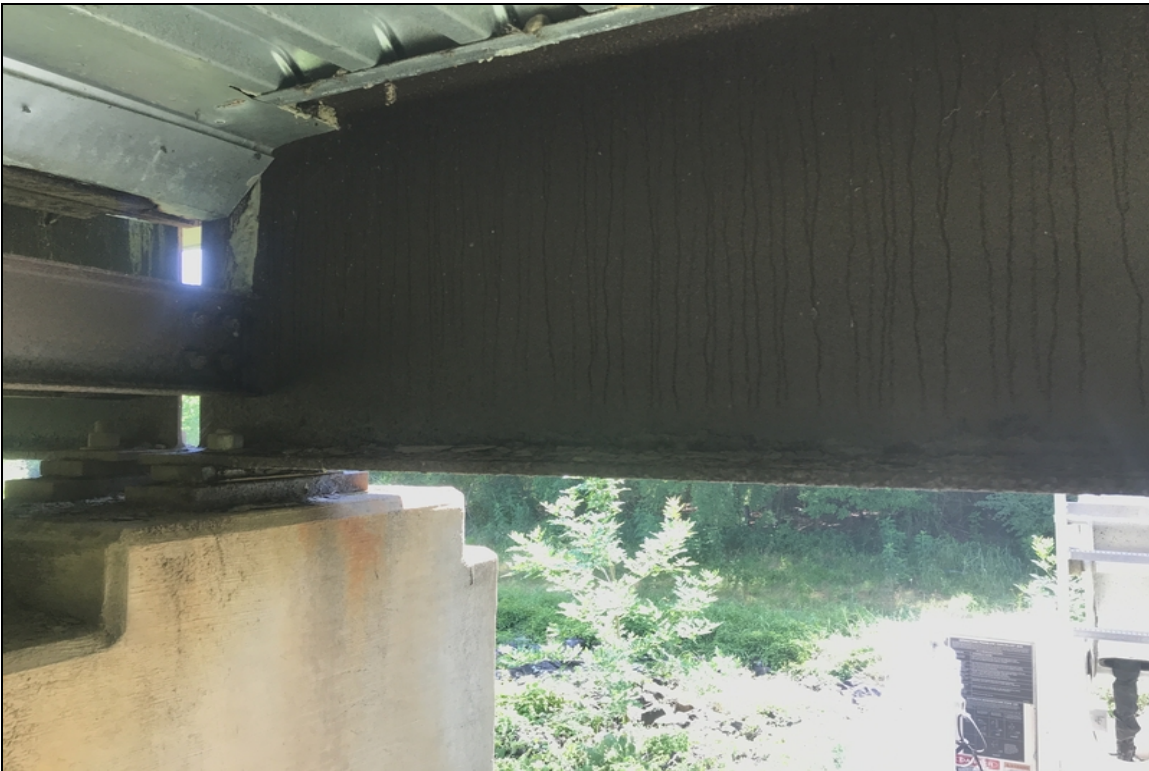
Span 15, bent 16, bottom flange and web flaking rust, 8'

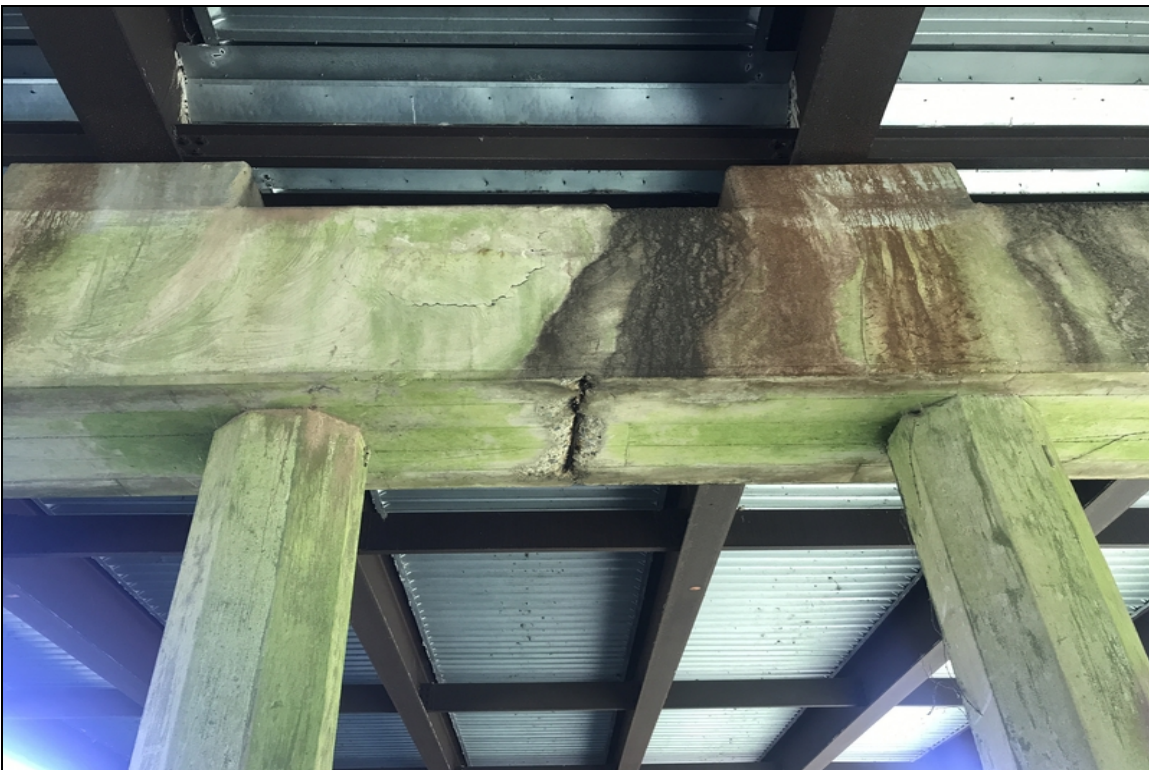
Bent 14 exposed rebar and delam, between piles 4 & 5

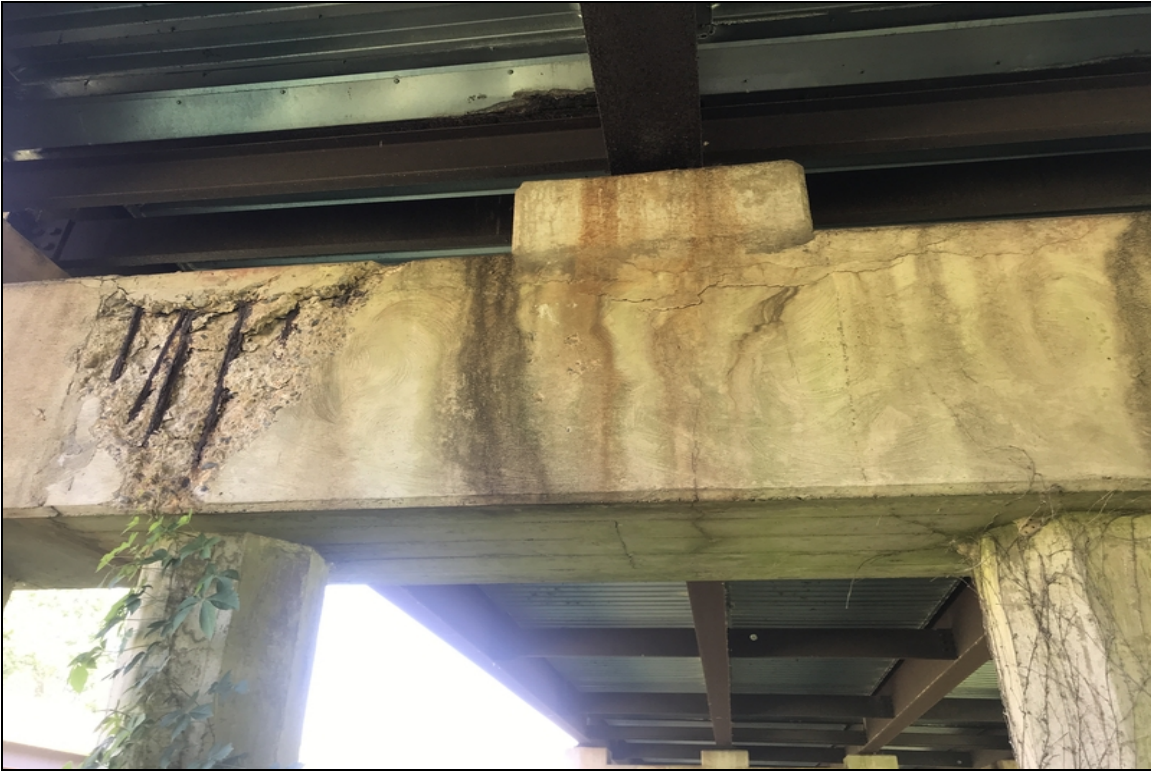
Bent 10, exposed rebar and crack 5' long

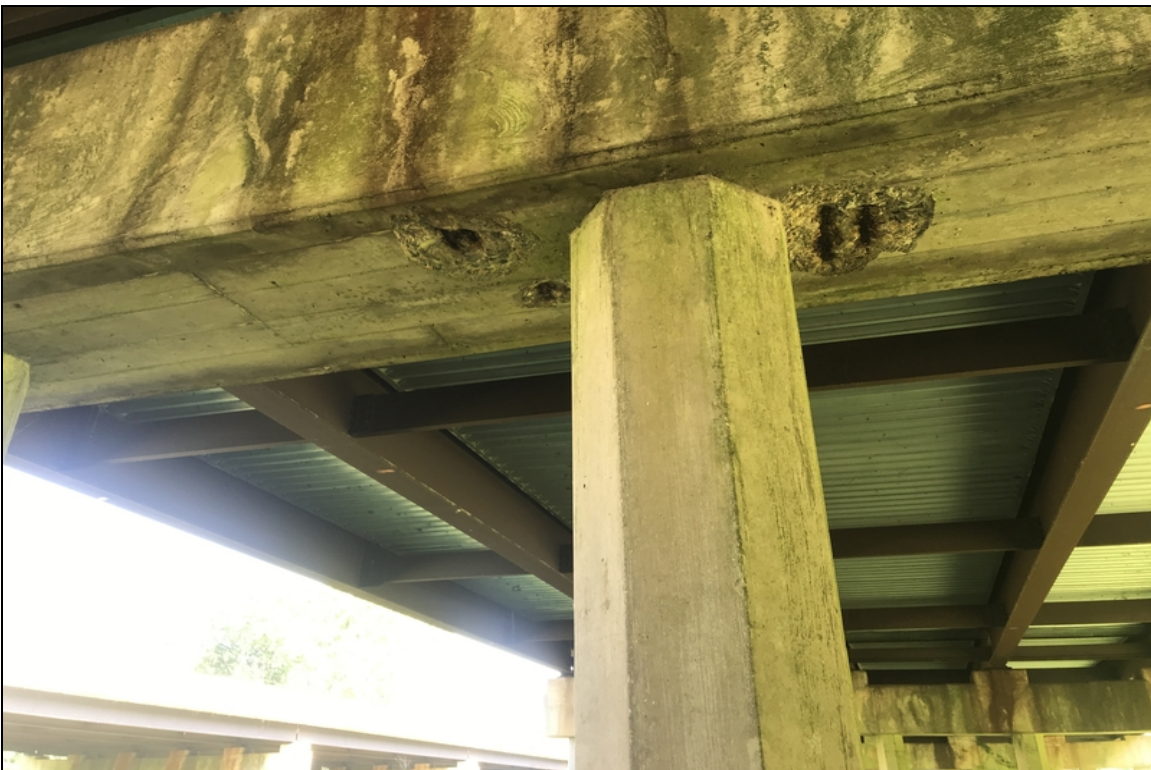
Bent 9 bottom of cap, exposed rebar

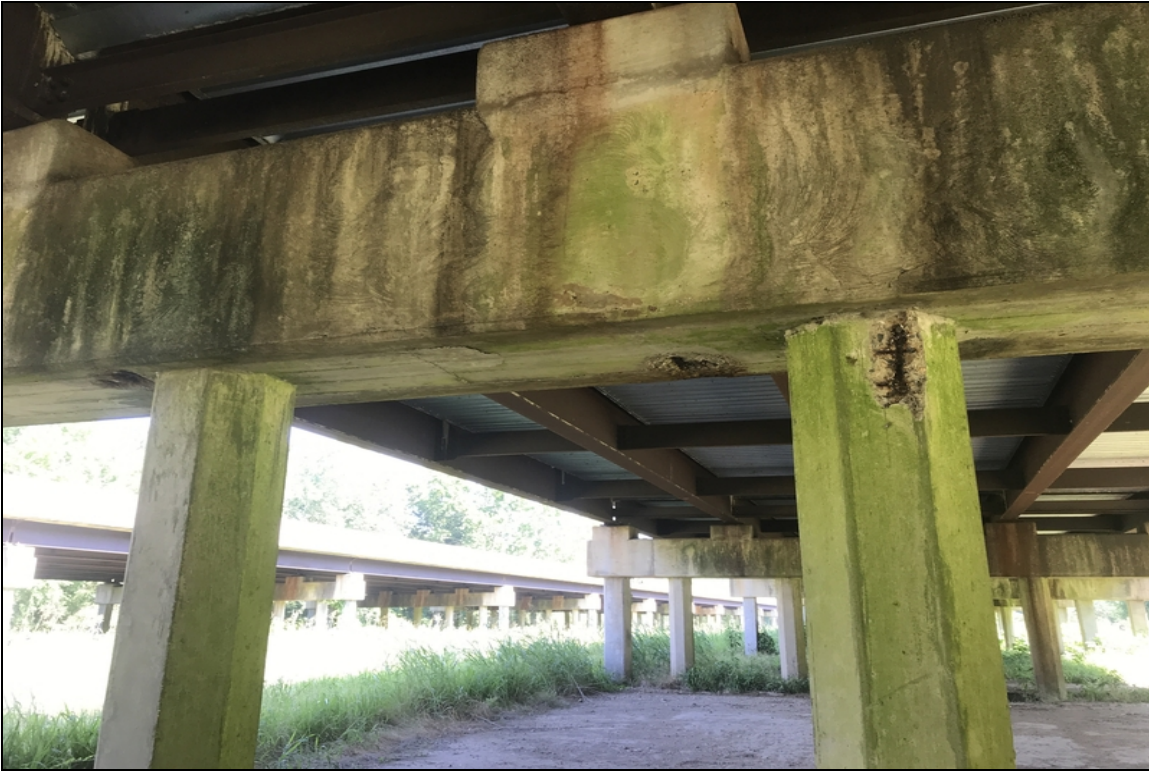
(227)	Bent 7 pile 4, exposed rebar.						
234	Reinforced Concrete Pier Cap	LF	836	781	5	50	0
1080	Delamination/Spall/Patched Area	LF	25	0	0	25	0
1090	Exposed Rebar	LF	25	0	0	25	0
1130	Cracking (RC and Other)	LF	5	0	5	0	0

Bent 7 pile 4 spall with exposed rebar. And 4 spall with exposed rebar on bottom of cap.

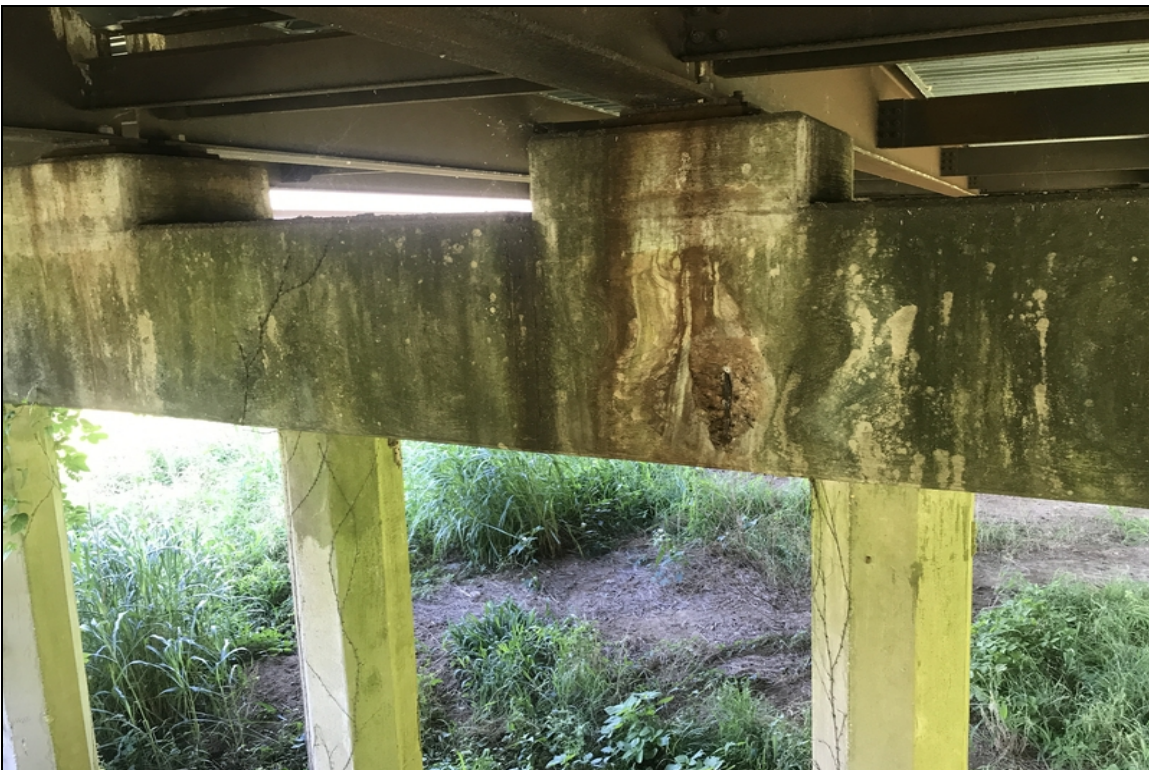
Bent 5, spall with exposed rebar between piles 3&4, backface.

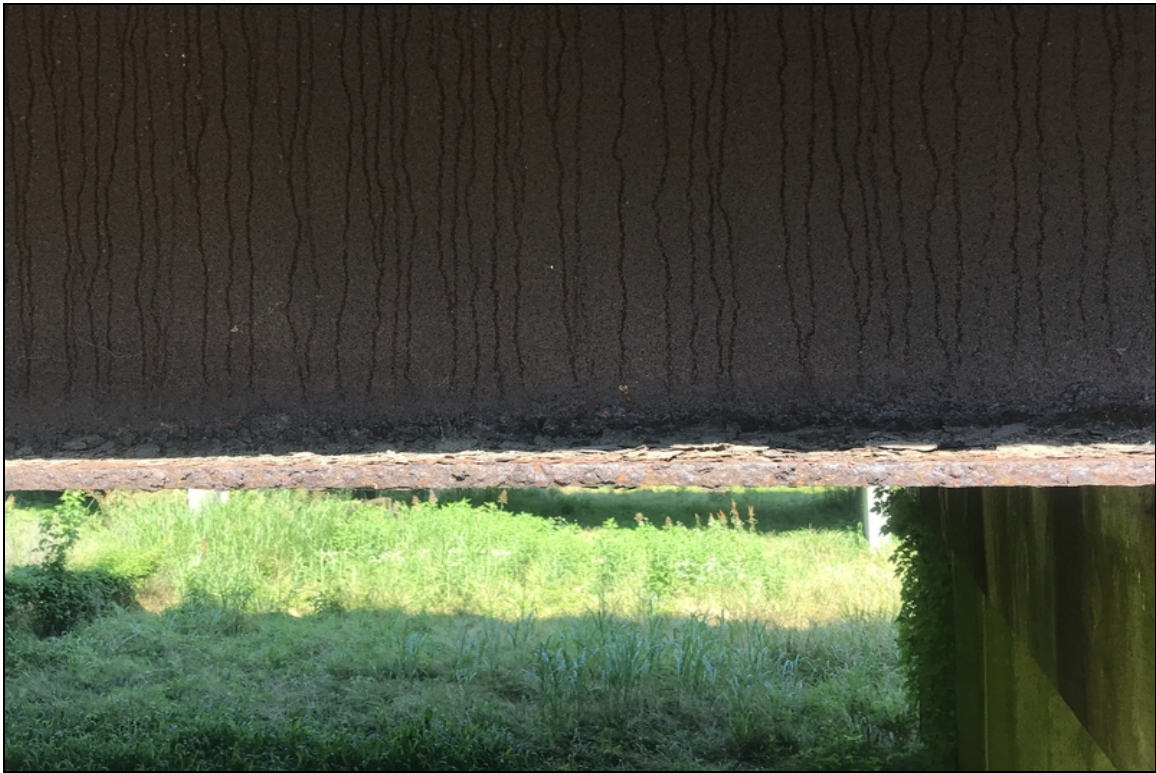
Span 2 beam 6, flaking rust

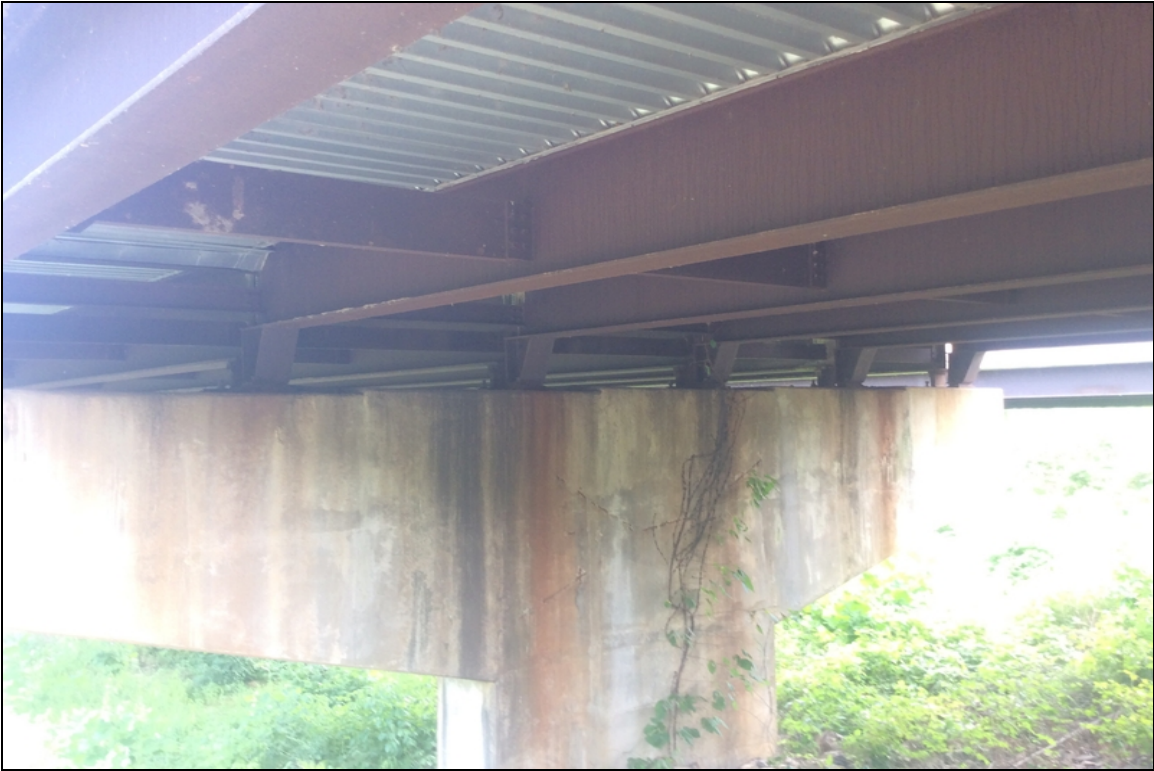
Bent 21 ahead, looking at the bearings.

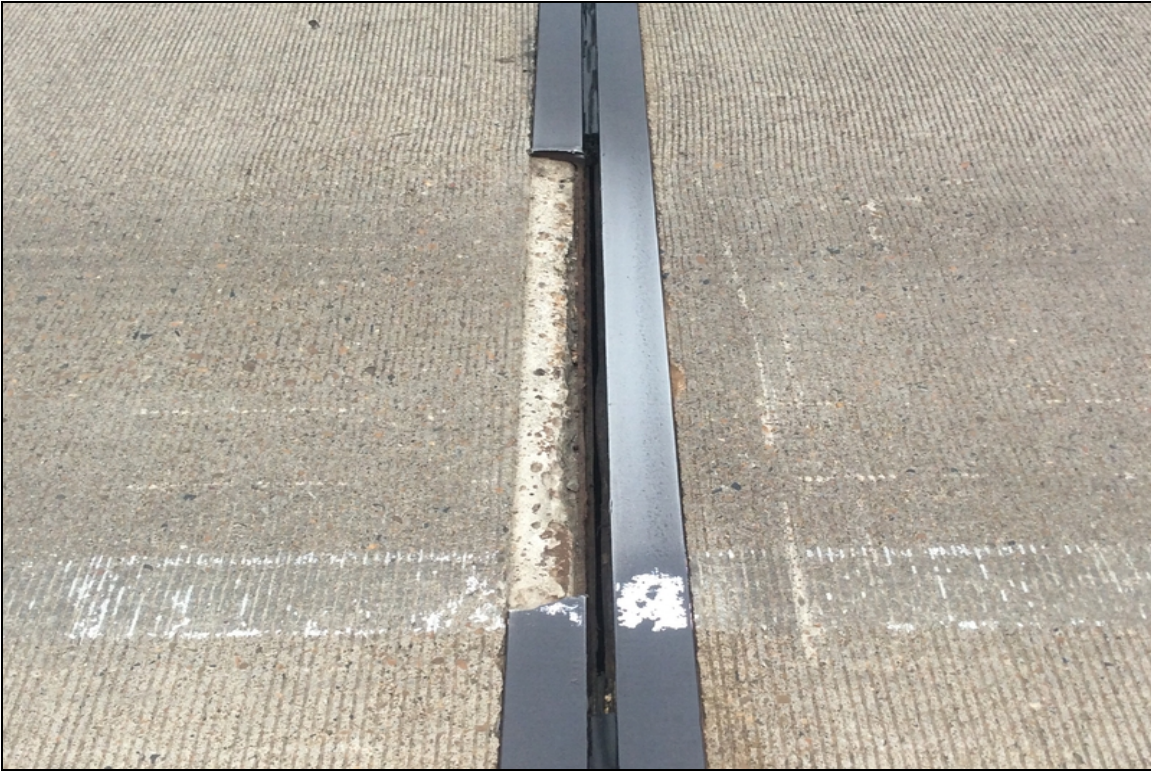
Bent 15, Rt. Mainlane 3' section of road iron is missing.

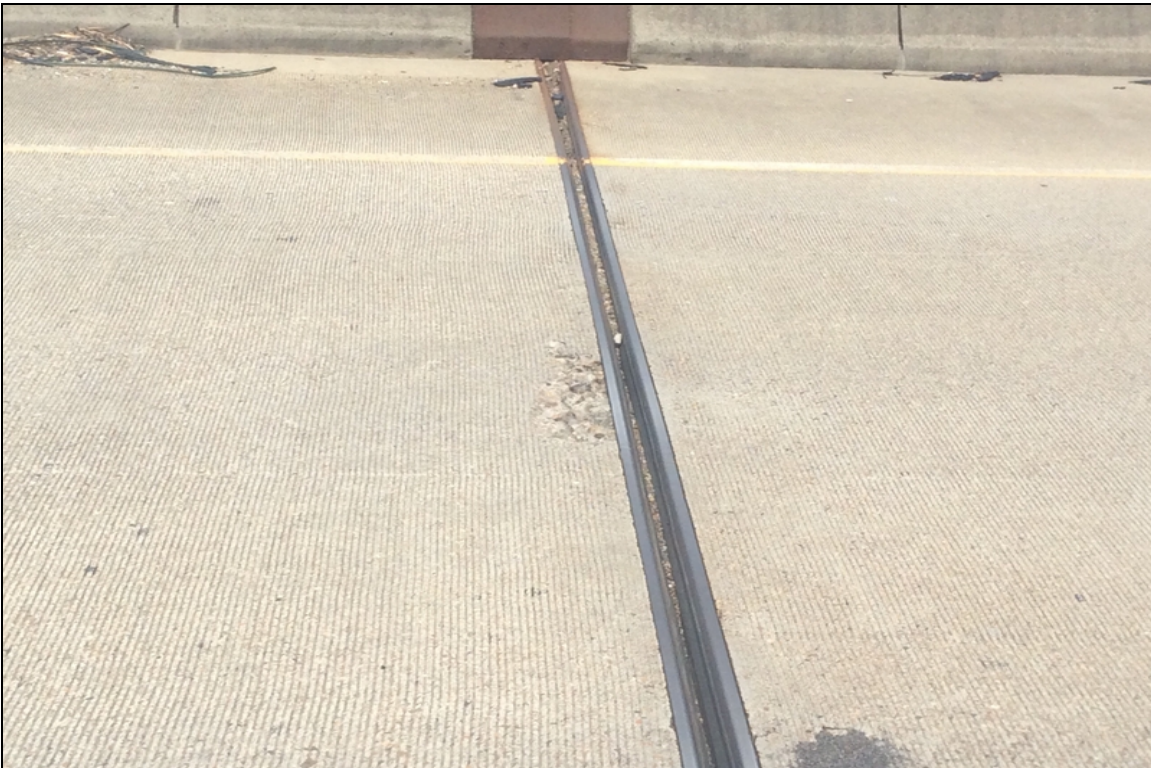
Span 19 @ bent 20 Rt. wheel path of Lt. Main lane has a (6" x 2') spall behind road iron.

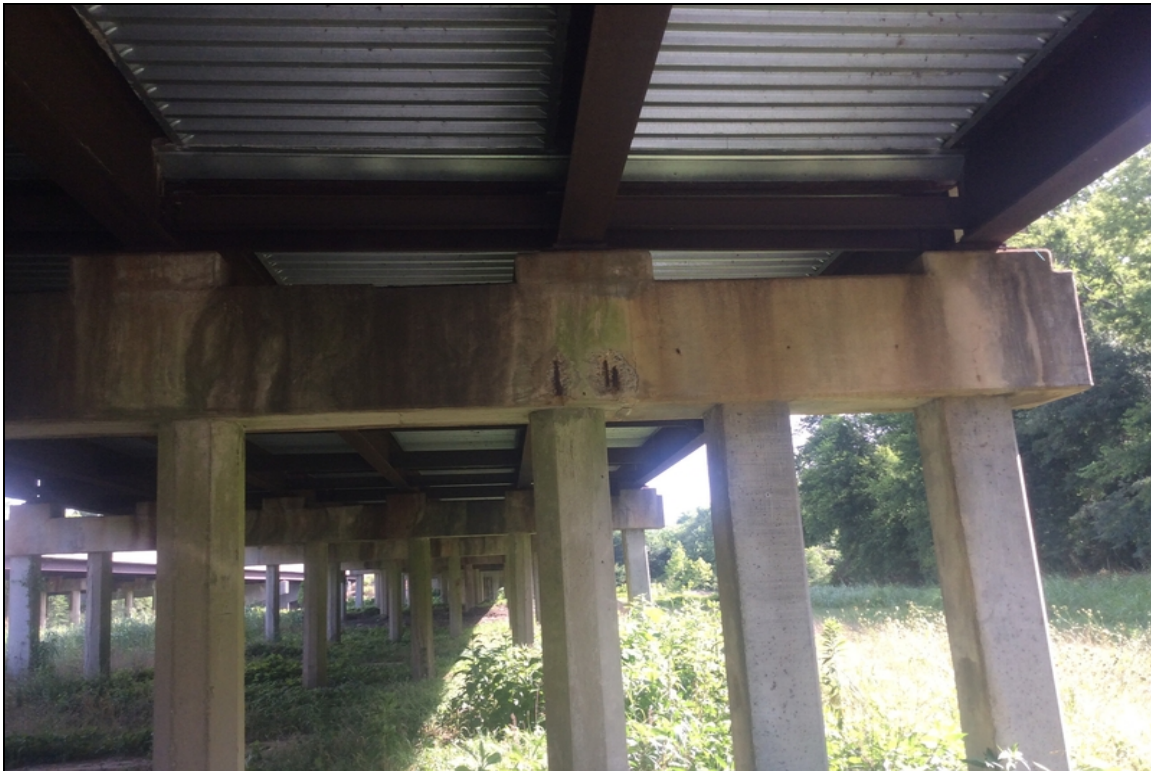
Bent 12 back, spall with exposed rebar

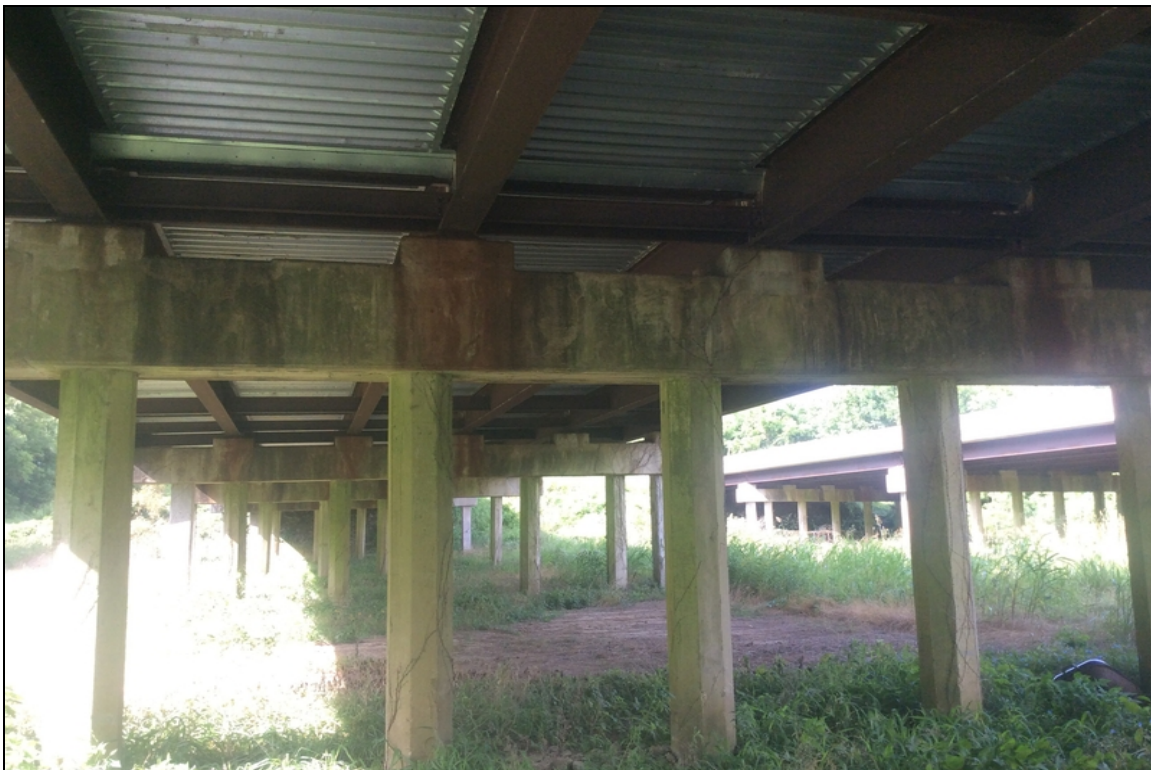
Bent 5 ahead, rust staining on caps below bearings, this is typical of several of the interior bearings on all caps.

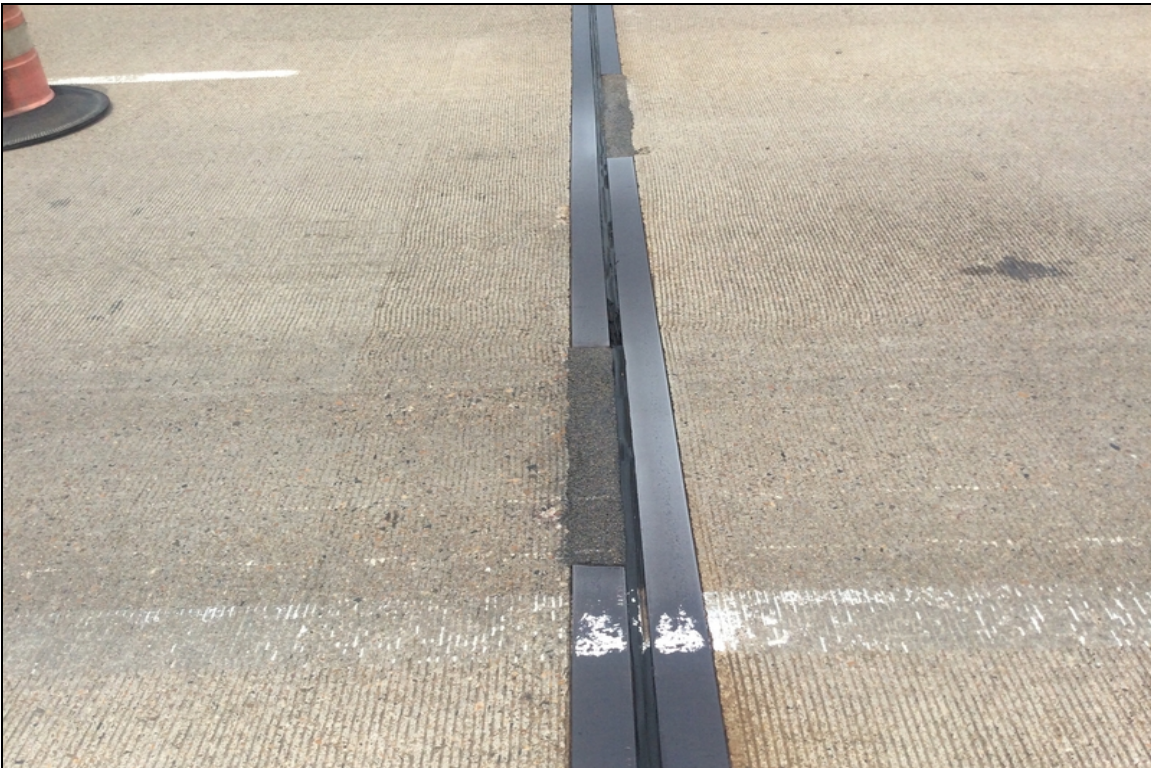
Bent 16 repair to missing sections of road iron.

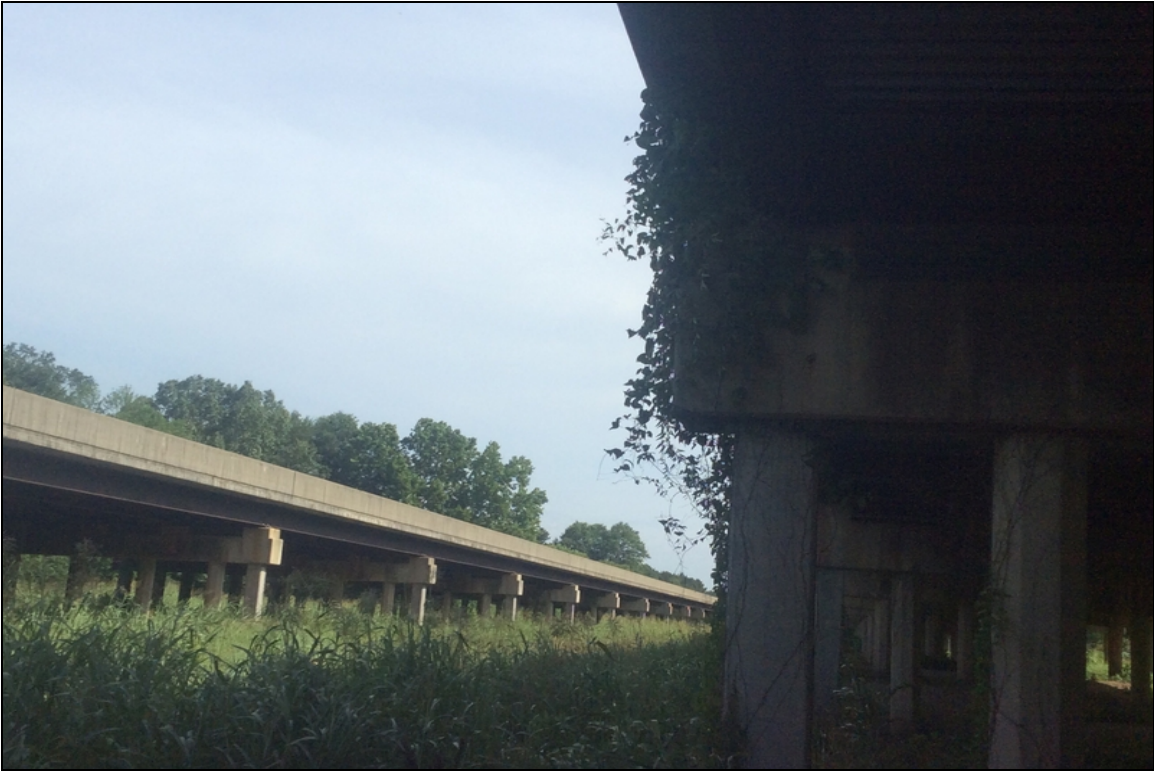
Bent 5 back, Lt. side has vegetation growing up on the cap & parapet rail.a

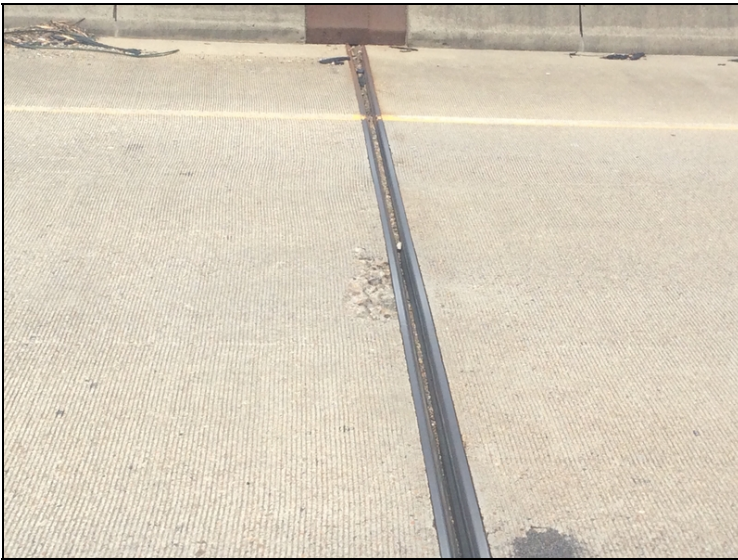
Span 19 @ bent 20 Rt. wheel path of Lt. Main lane has a (6" x 2') spall behind road iron.

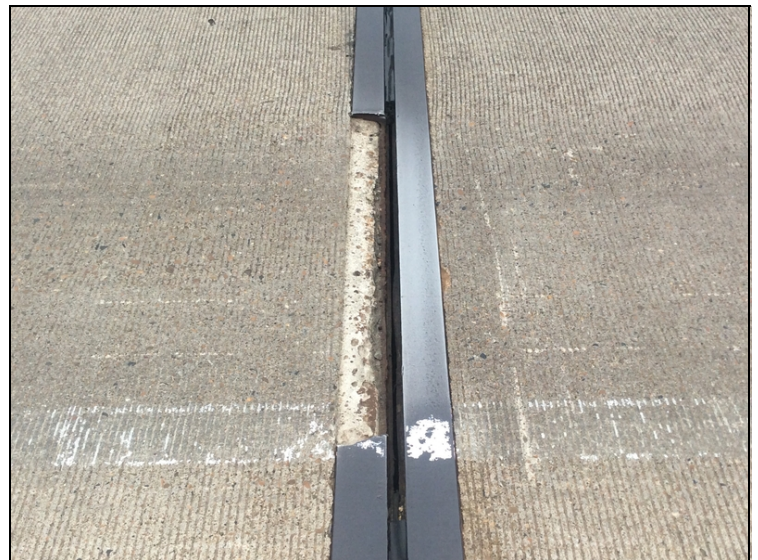
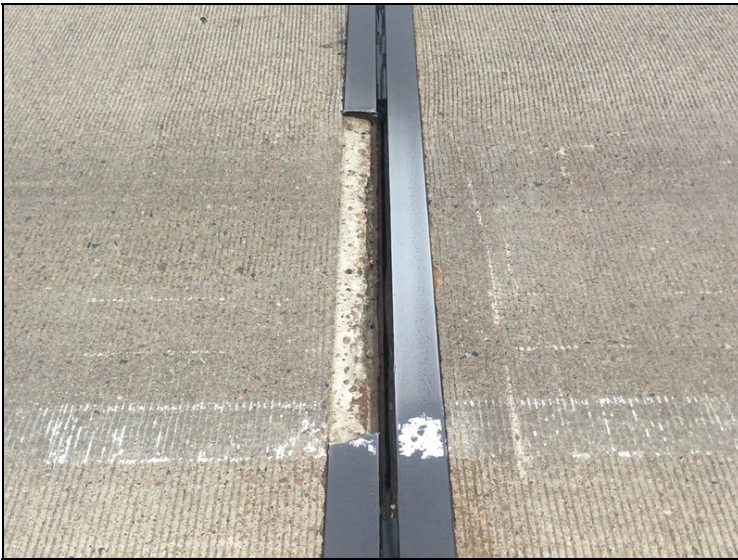
Bent 15, Rt. Mainlane 3' section of road iron is missing.

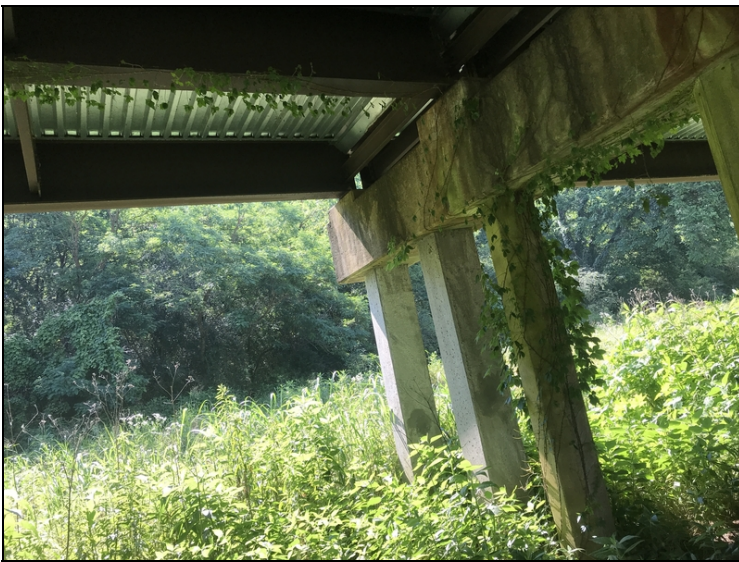
Vines are growing up pile and on to beams, several bents.

Vegetation on bent 11, typical of most bents

Date Reported: 06/16/2020
Priority: D- Routine
Type of Work: Clean
Status: Open
Component:

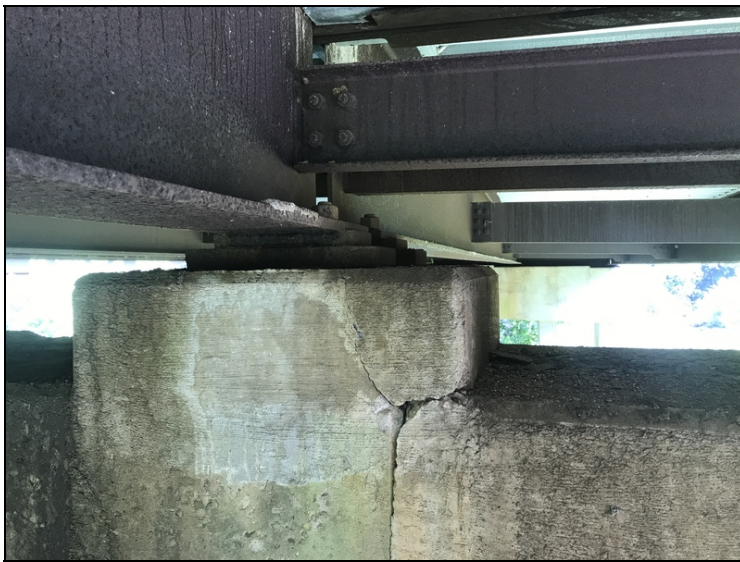
Span 16 bent 17, riser 5 has cracked extending to anchor bolt.
Span 17 bent 17, riser 3 has cracked extending to anchor bolt.

Span 16, bent 17, riser 5, crack in concrete, extending to anchor bolt

Date Reported: 06/16/2020
Priority: C - Important
Type of Work: Repair
Status: Open
Component:

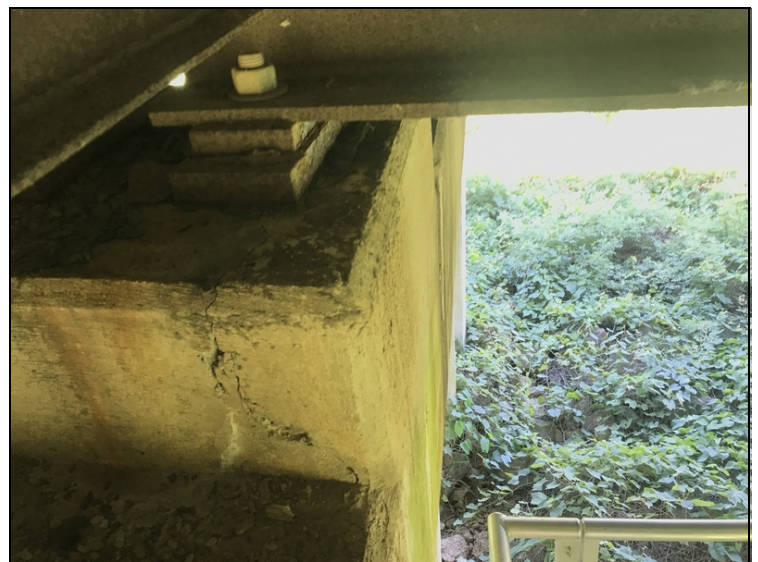
Bent 17, riser 3 cracked on 3 sides, extends to bolts.

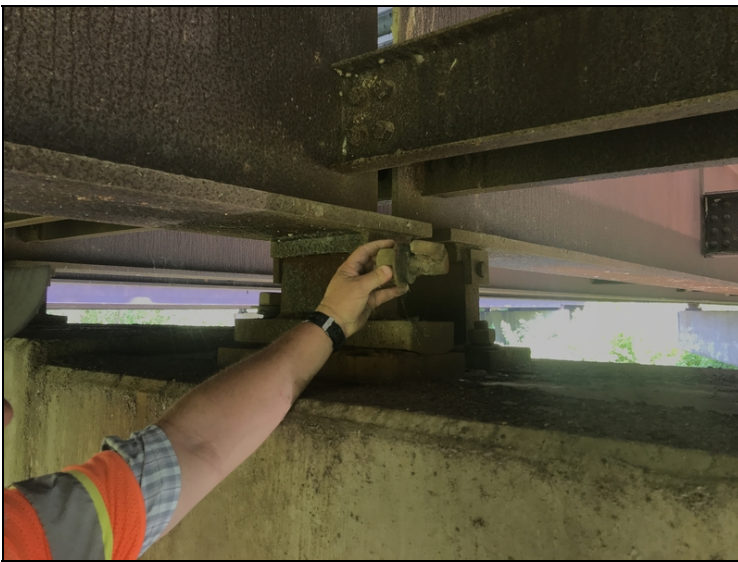
Bent 19 bearing 3, missing right anchor bolt
Bent 20 bearing 5, missing left bolt to top of bearing.

Bent 19, bearing 3, right bolt broke

Date Reported: 06/16/2020
Priority: C - Important
Type of Work: Replace
Status: Open
Component:

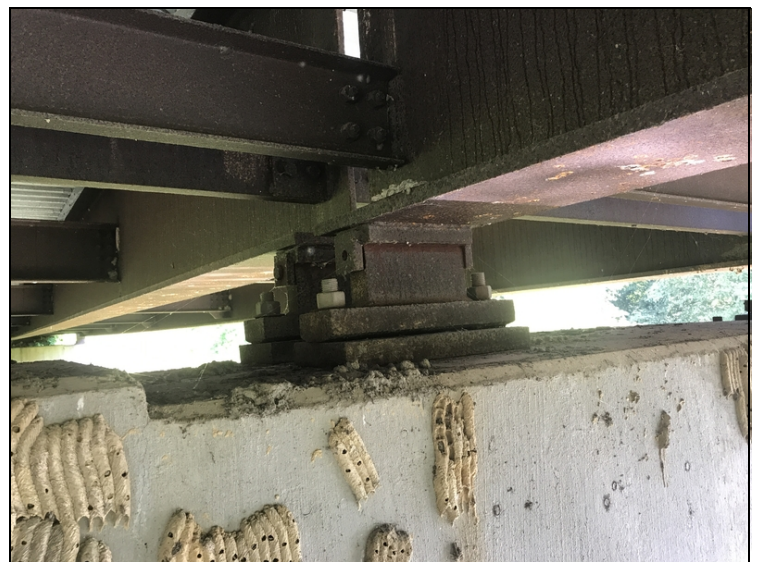
Bent 20, bearing 5 left side missing bearing bolt
