Bridge #A6515(Routine)

I-30WB S-14LM 77.5 over SH 7 SEC 7

Location: JCT I-30 & SH 7

Team Lead: Rickie Bratton Inspection Date: November 18, 2019

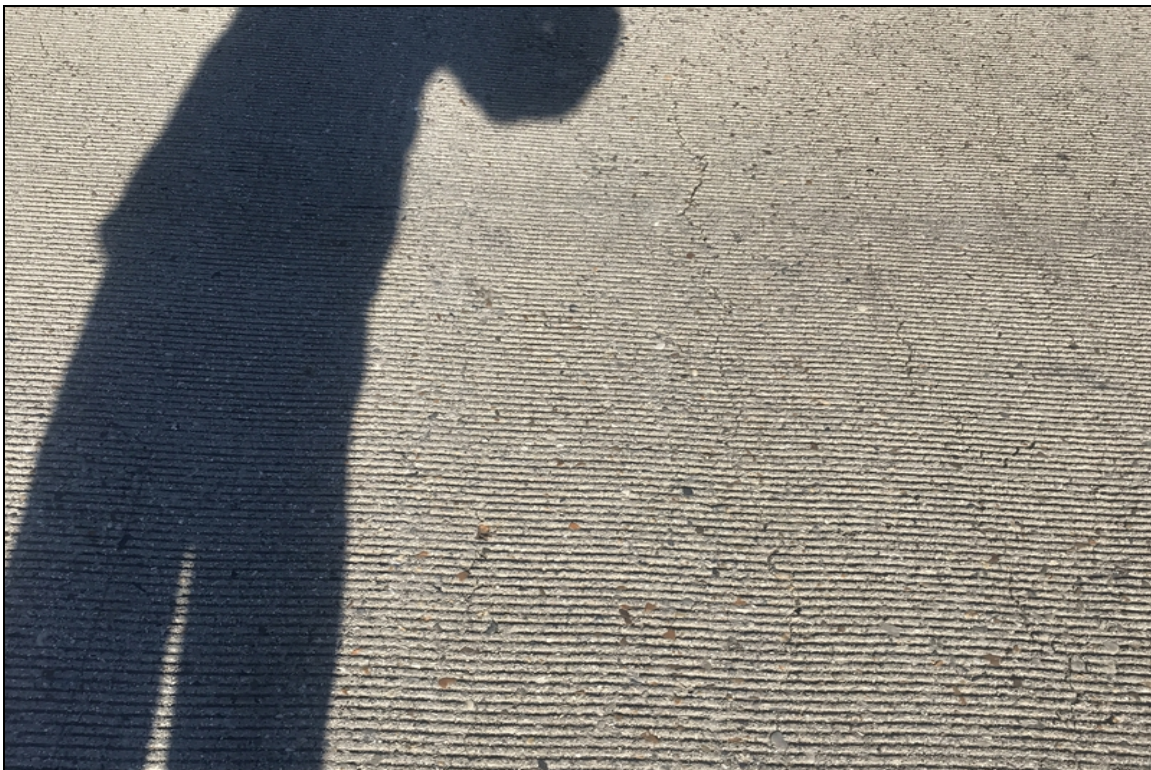
(12)	minor cracks, some efflorescent staining on SIP forms. 11/27/2017 JPR -- Rust on stay in place form 30' ahead of bent 2 close to girder 4						
107	Steel Open Girder/Beam	LF	1290	1290	0	0	0
515	Steel Protective Coating	SF	14800	14800	0	0	0

Span 2 deck cracks.

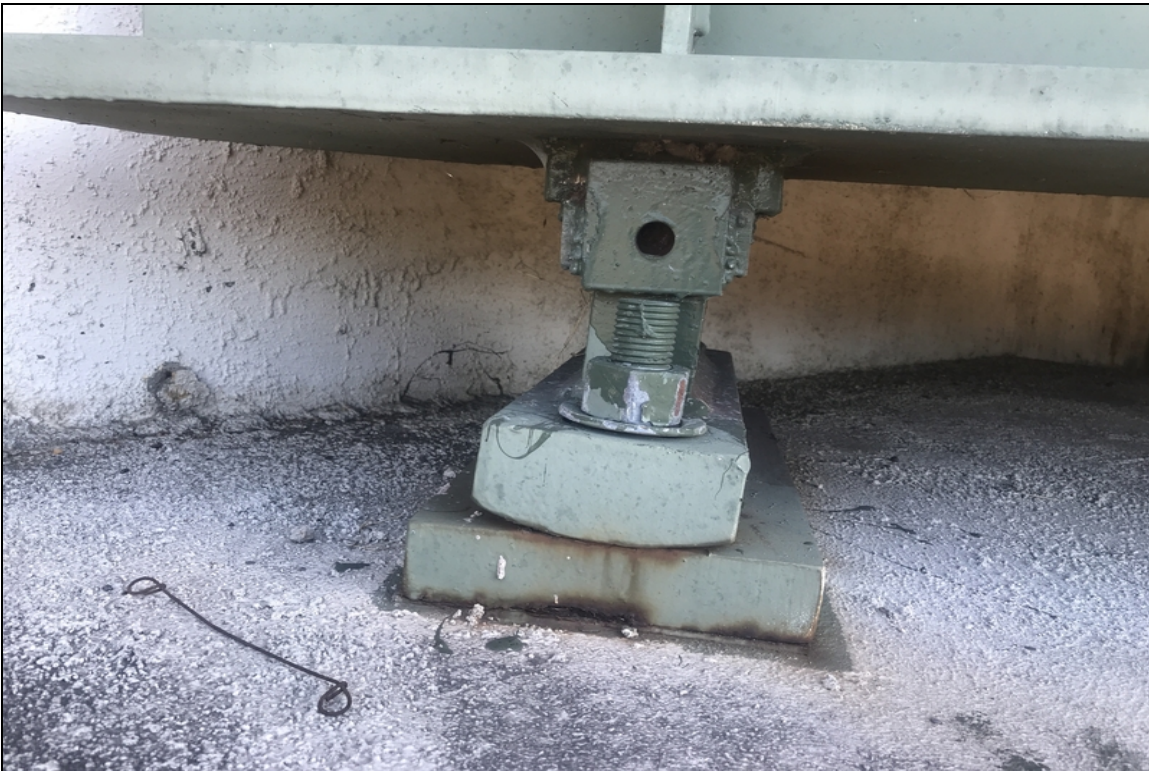
(311)	Bearings 1-2 abutment 1 as logged bolts have backed out of the bearing bracket. # 2 bolt has backed out enough to fall out or has sheared. 11/28/2017 JPR -- all bearings are rocked ahead.						
321	Reinforced Concrete Approach Slab	SF	2960	2379	290	291	0
1080	Delamination/Spall/Patched Area	SF	1	0	0	1	0
1130	Cracking (RC and Other)	SF	580	0	290	290	0

Bolts missing in bearings, abutment 4, 1 and 4. Abutment 1 girder 2 missing bolt also.

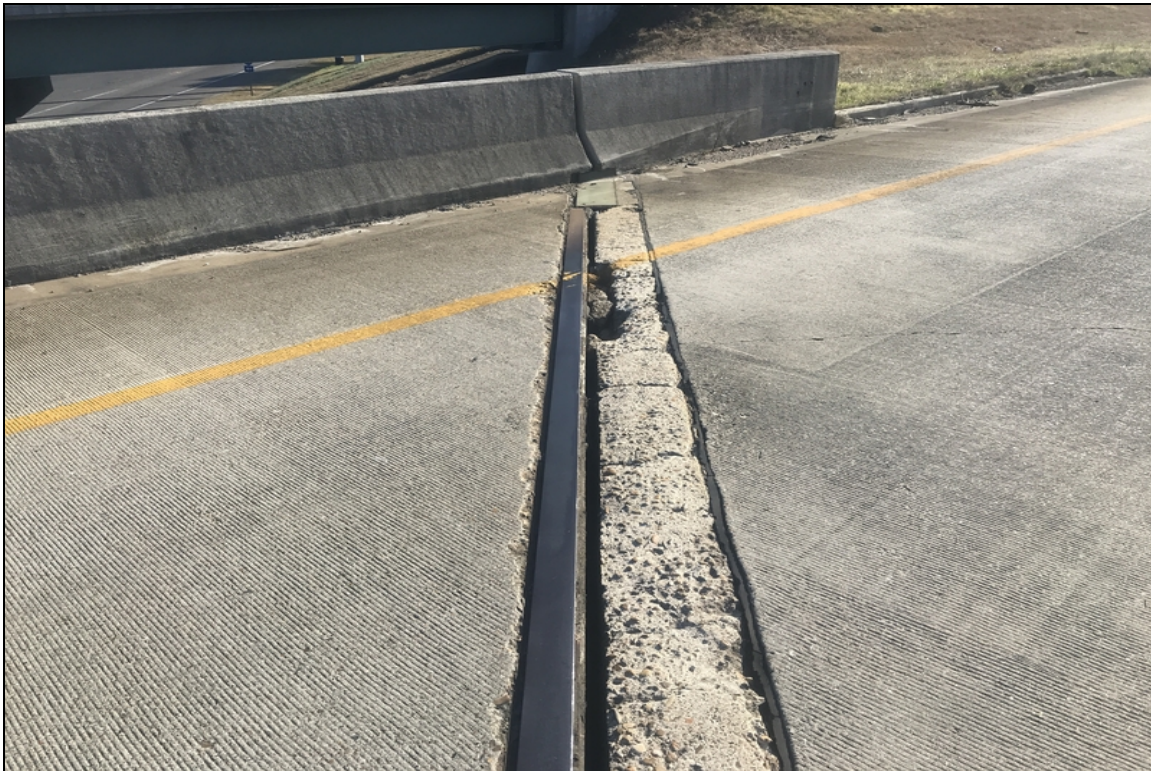
Spall at abutment 1, joint.

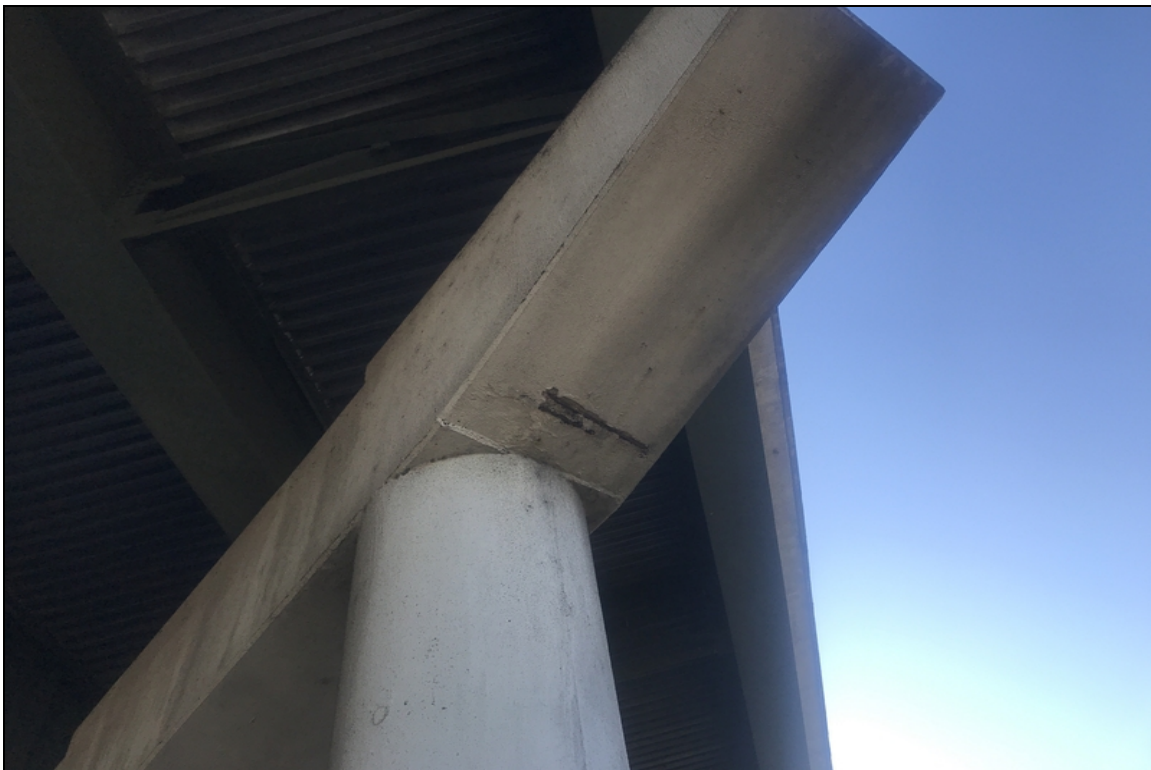
Bent 2 left spall with exposed rebar.
