Bridge #B6515(Routine)

I30 S-14 EBLM 77.5 over SH 7 SEC 7

Team Lead: Jimmy Reynolds Inspection Date: November 26, 2018

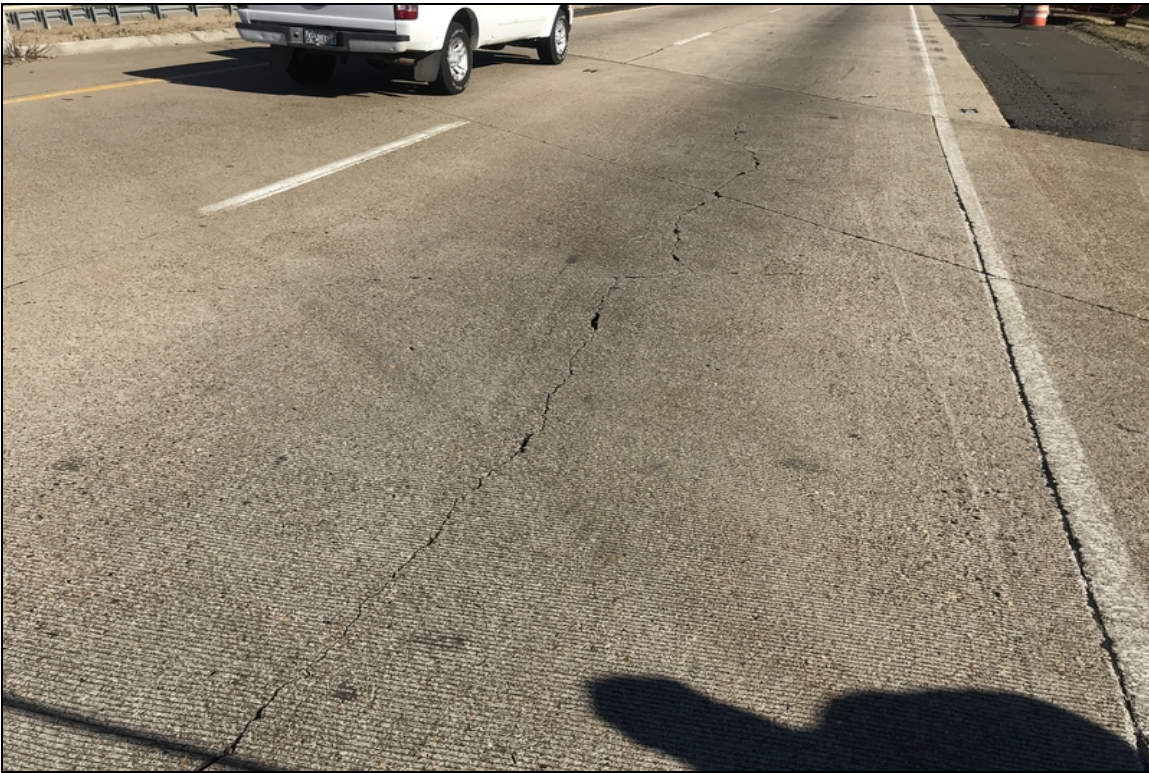
(321)							
Cracks and wear.							
331	Reinforced Concrete Bridge Railing	LF	516	258	258	0	0
1130	Cracking (RC and Other)	LF	258	0	258	0	0
(331)							
Normal wear with some cracks.

Crack in approach slab

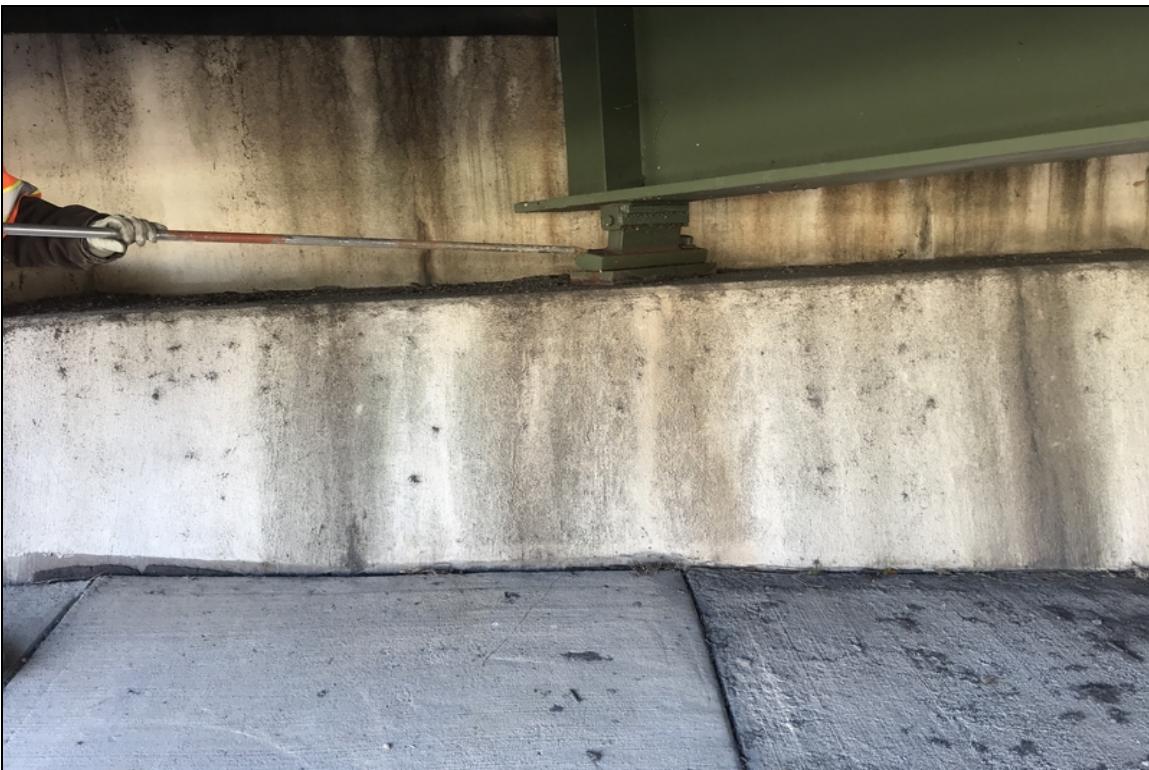
Abutment 2 bearing 2 anchor bolt, broke off and top 1/2 bolt and nut is missing.

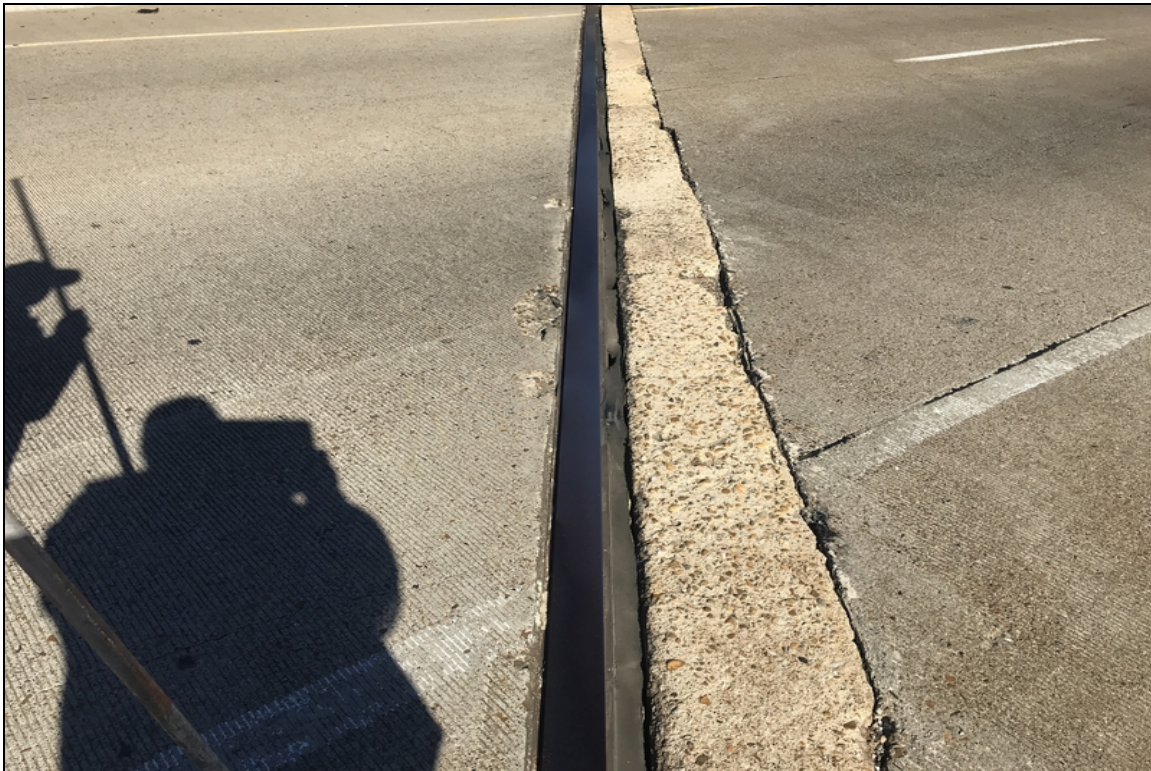
Abutment 2 joint material

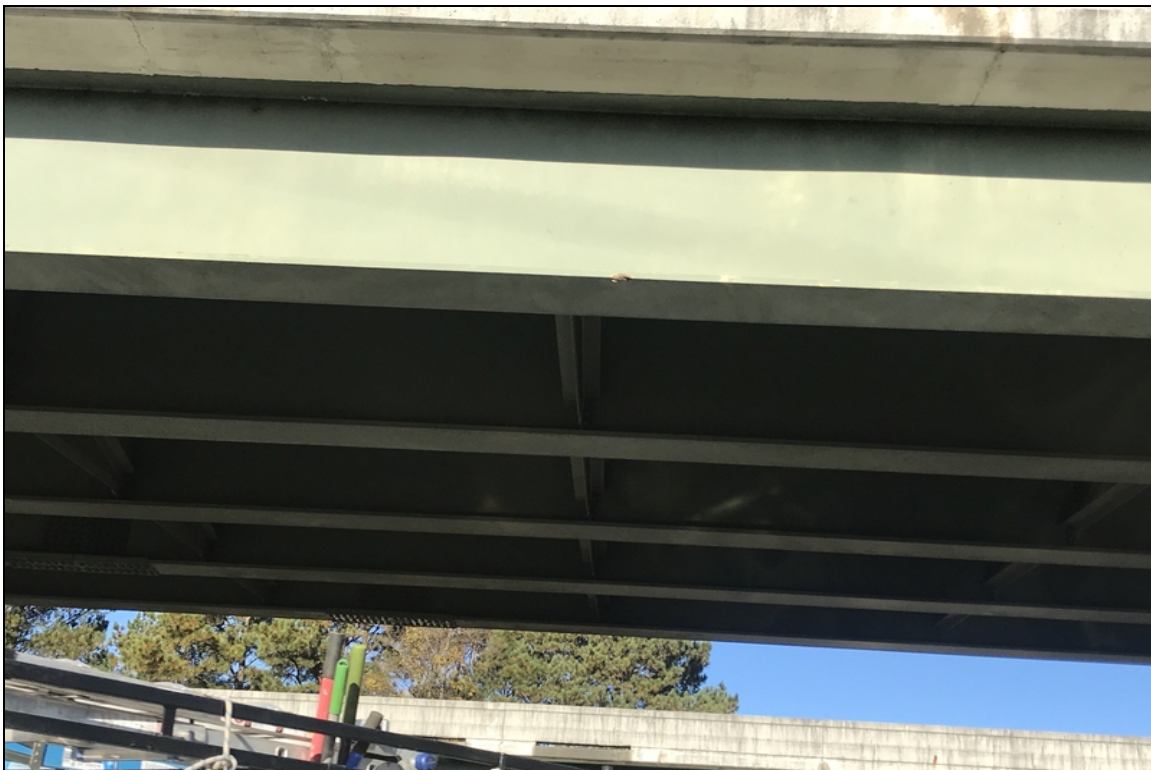
Girder 5 span 2 traffic impact to bottom flange

Protective system (paint) is in good shape and functioning well. 11/26/2018 JPR — while making a Routine Inspection noticed that on Span 2 Girder 5 has had collision damage to the bottom flange outside edge. Checked the height @ the collision damage was 16.06'. Damage appears to be minor, there appears to be no misalignment in the girder.

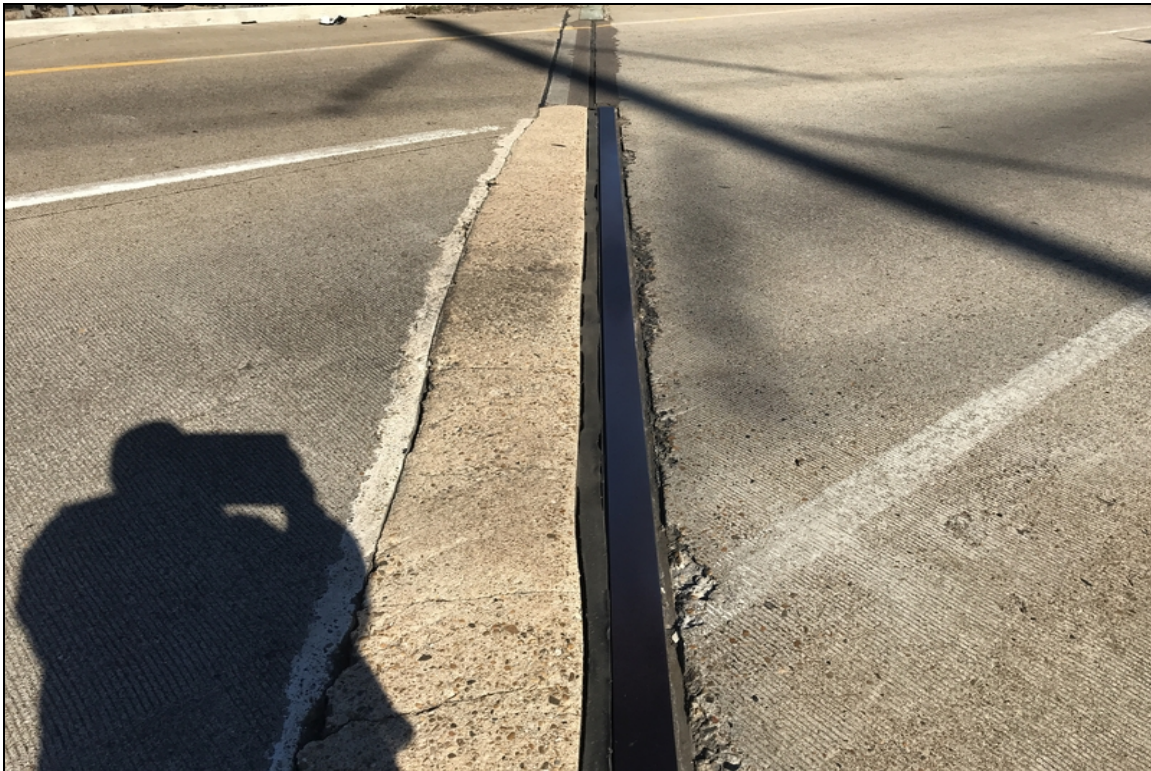
Abutment 1 joint material

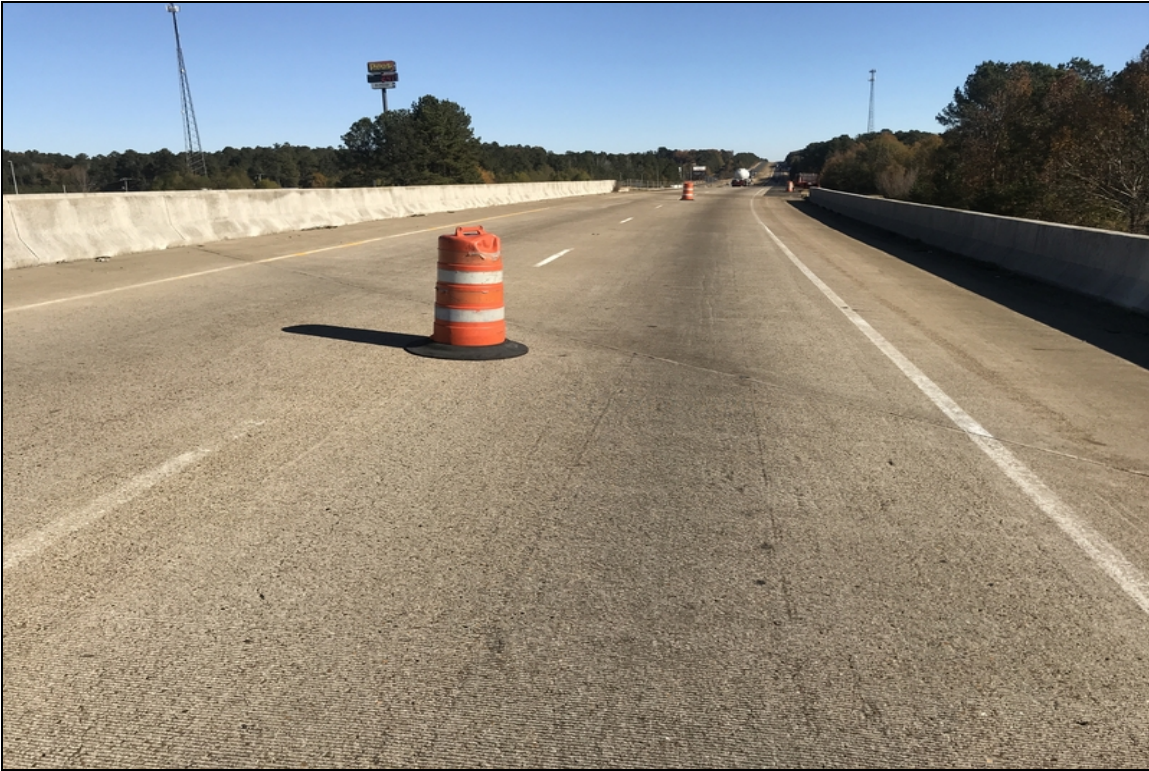
Deck

Longitudinal cracks, some wear and exposed aggregates. End joints leaking and adjacent deck is rough.

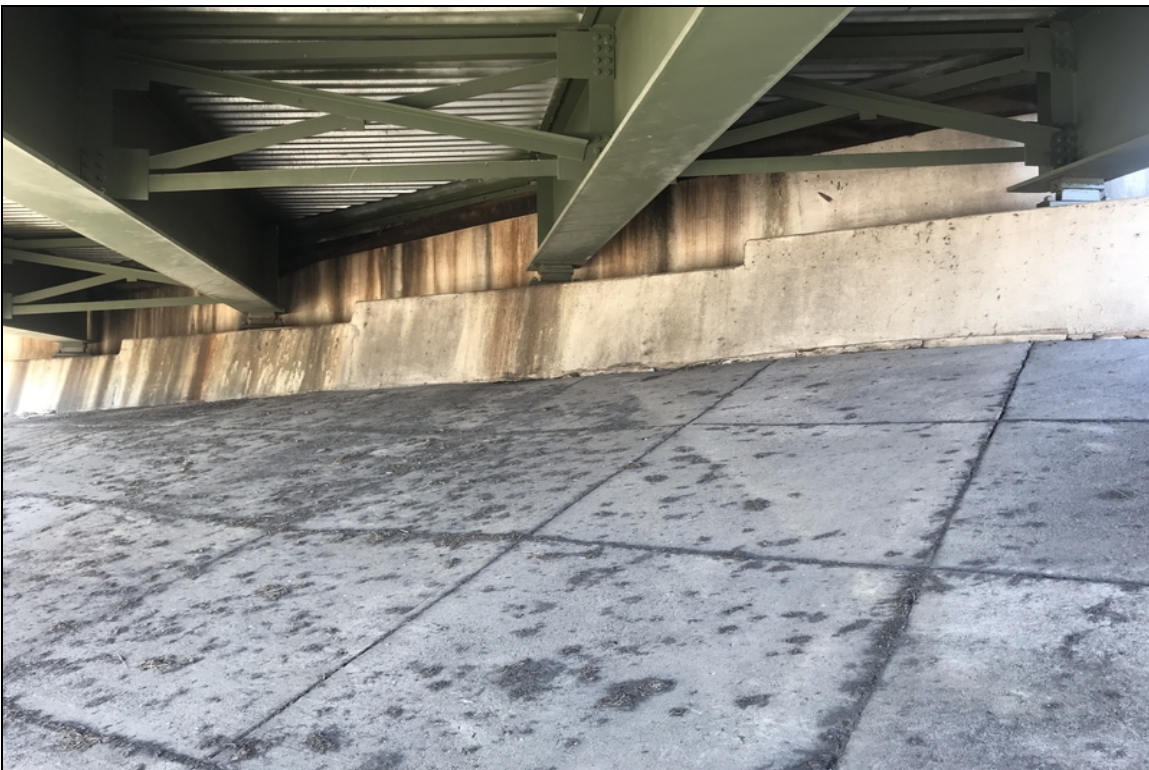
(303)							
End joints leaking and adjacent deck is rough.							
311	Movable Bearing	EA	20	20	0	0	0
321	Reinforced Concrete Approach Slab	SF	2800	2715	0	85	0
1130	Cracking (RC and Other)	SF	85	0	0	85	0

Abutment 1 cap joint leaking

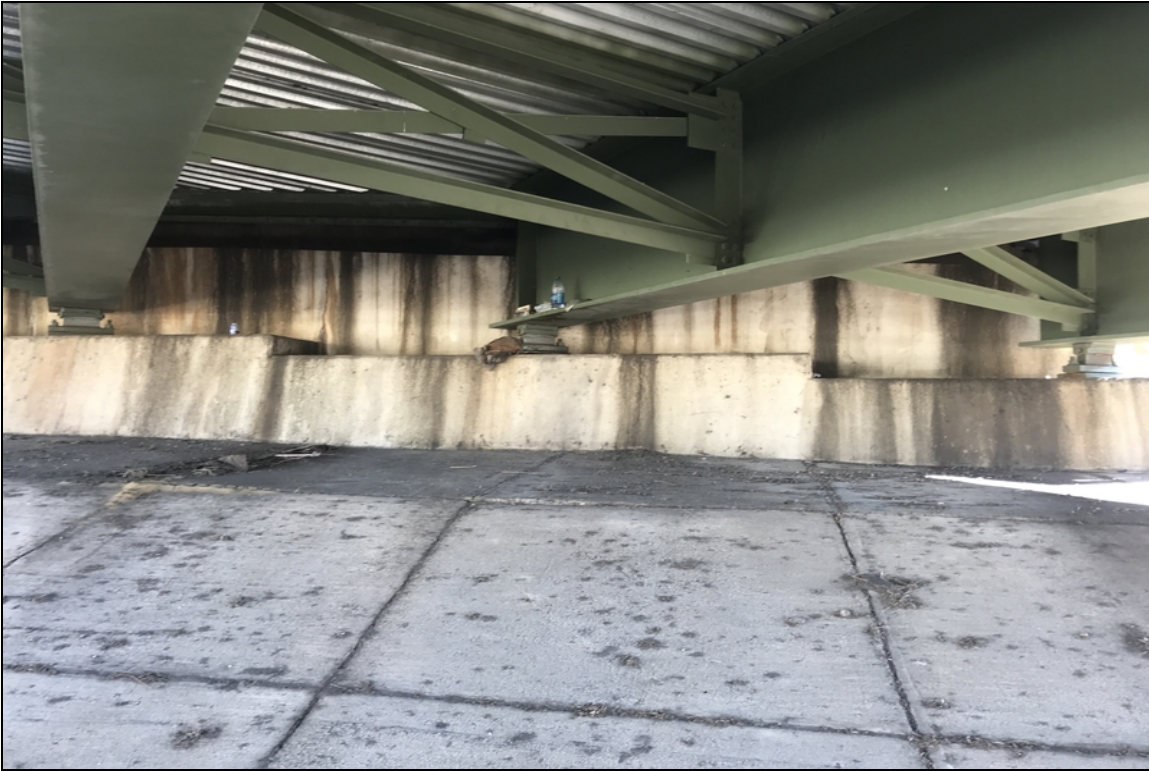
Joint leaking on to cap

Some water getting on to abutments.
