Bridge #03787(Routine)

SH 89 over I 40-SEC 32

Team Lead: William Wood Inspection Date: February 11, 2020

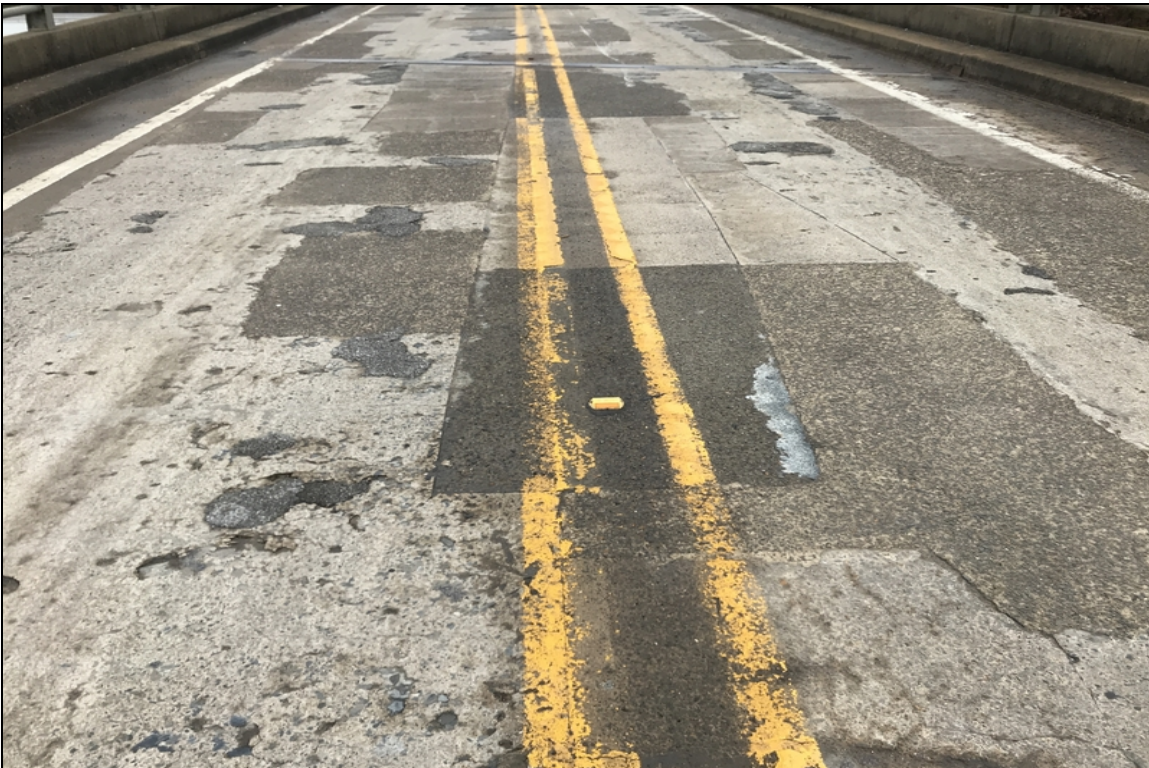
Typ. Condition of Deck.

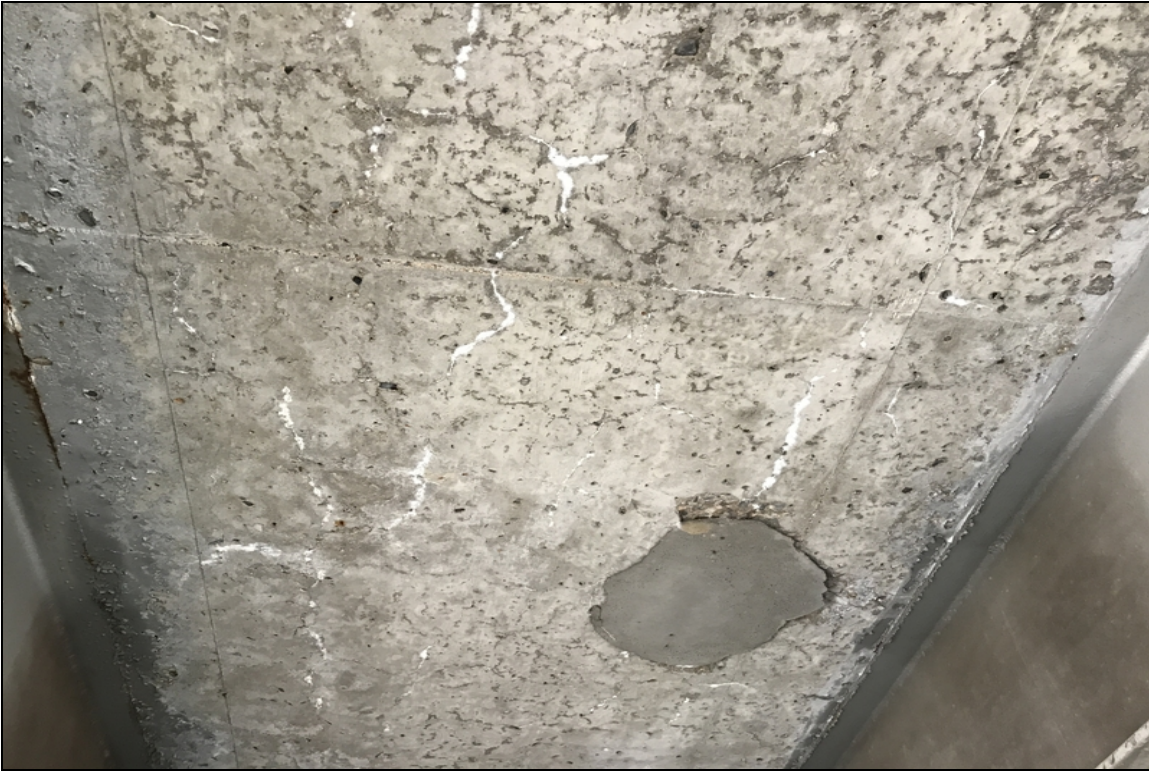
Typ. Condition of Soffit.

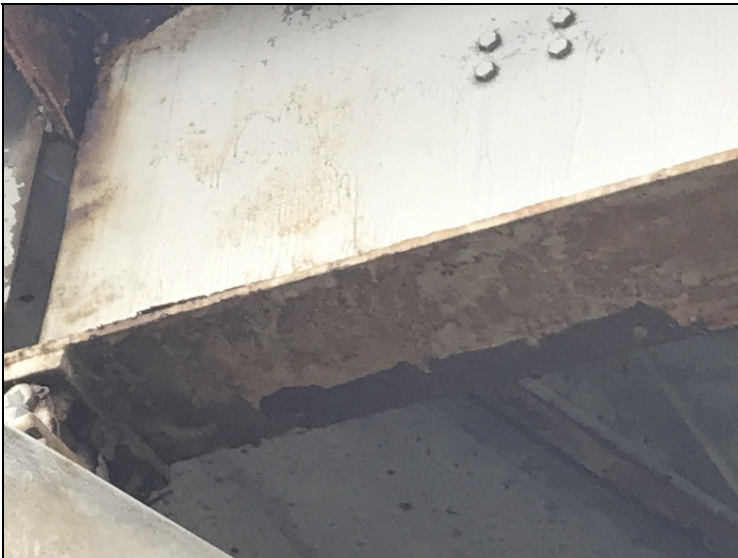
Typ. Rust on Ends of Beams.

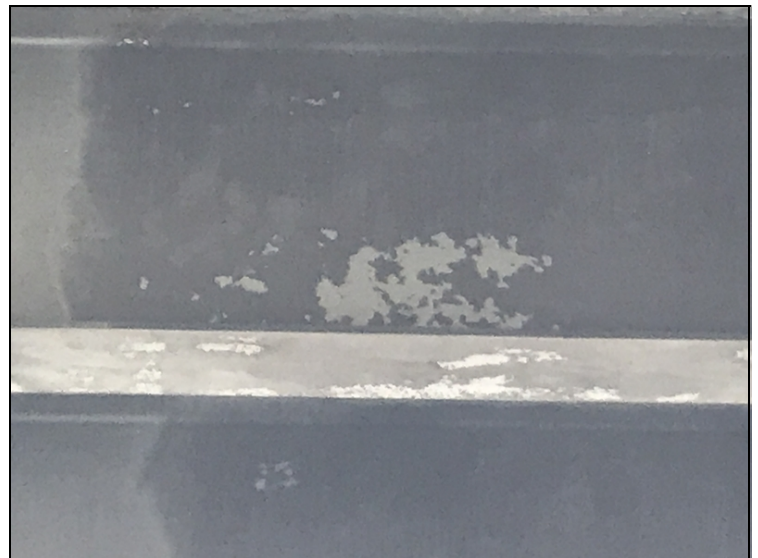
Typ. Chalking & Peeling of Paint on Beams.

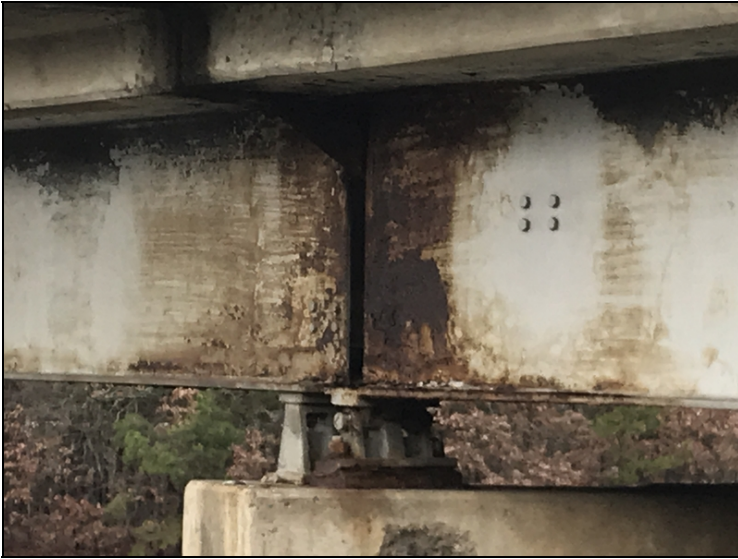
Typ. Rust on Ends of Beams.

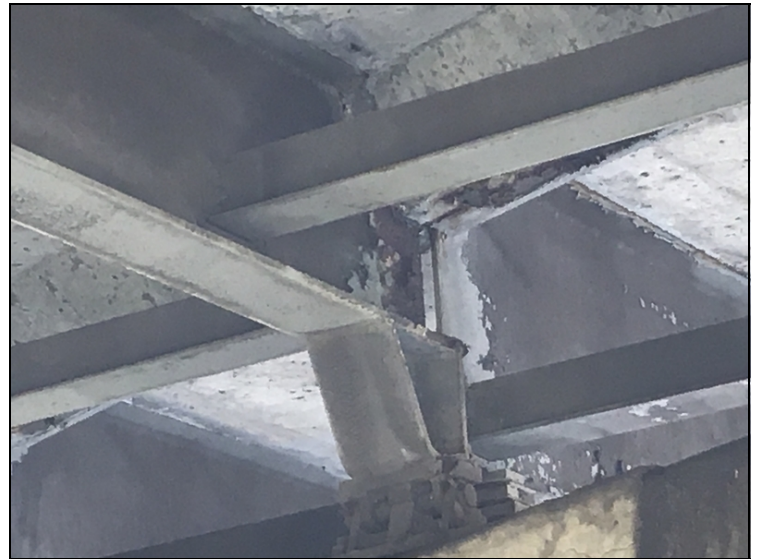
Pier #3 & #4, Beam #3, ahead side - Major section loss in the web below the concrete haunch.
Minor section loss in the web below the concrete haunch at various locations.

Photo Included - Beam #3, ahead side of Pier #4.

Typ. Rust & Section Loss on End of Beam 3.

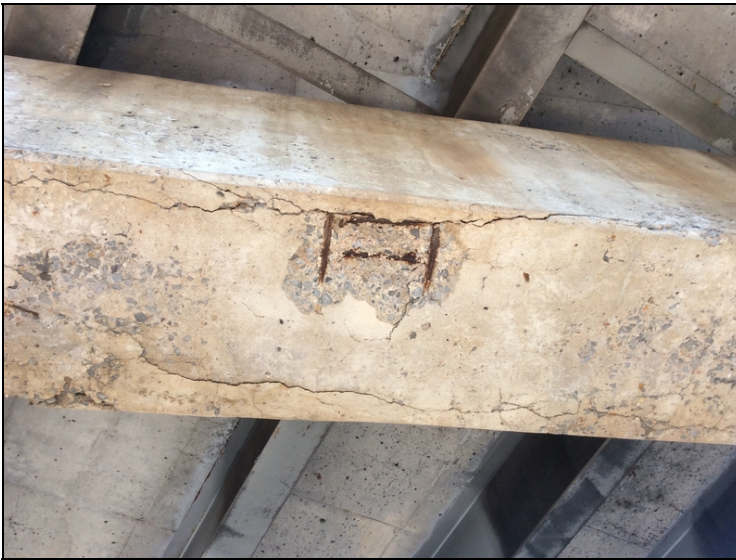
Delam, Cracking & Spalling W / Rebar Exposed in Faces of Caps. Bt Face of Cap 3 is the Worst

Dealm, Cracking & Spalling W / Rebar Exposed in
Bt. Face of Cap 3

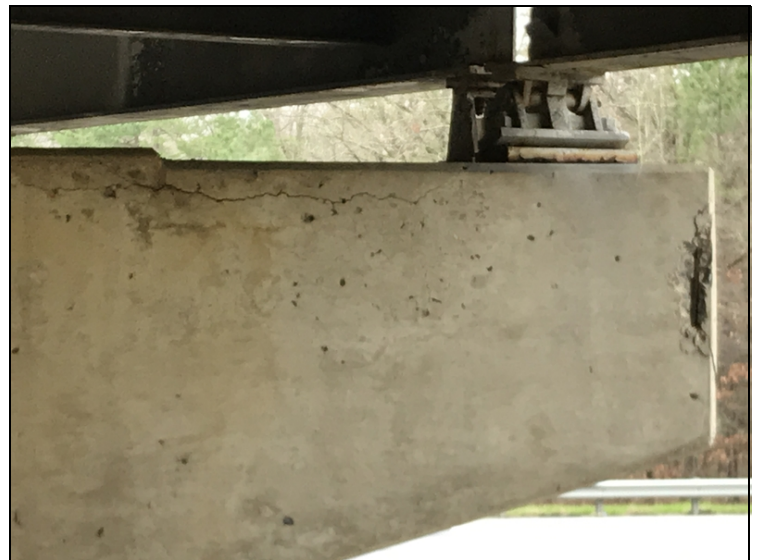
Typ. Cracking & Spalling in Faces of Caps.

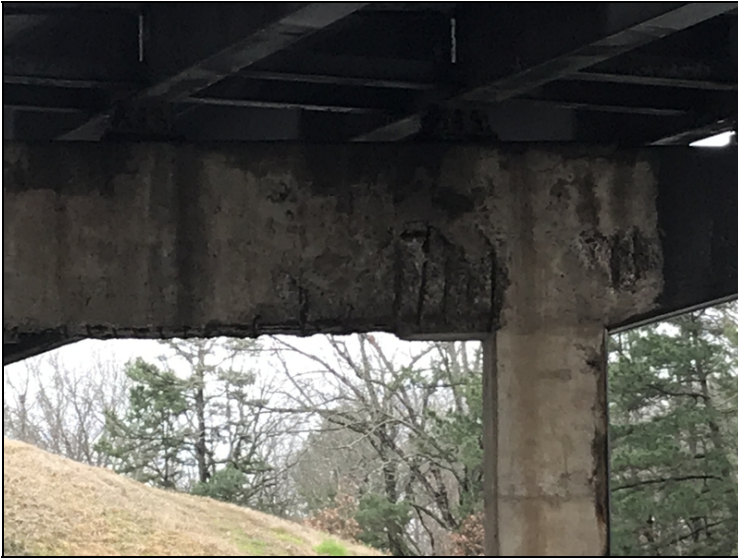
Delam, Cracking & Spalling W / Rebar Exposed in
Ahd. Face of Cap 3.

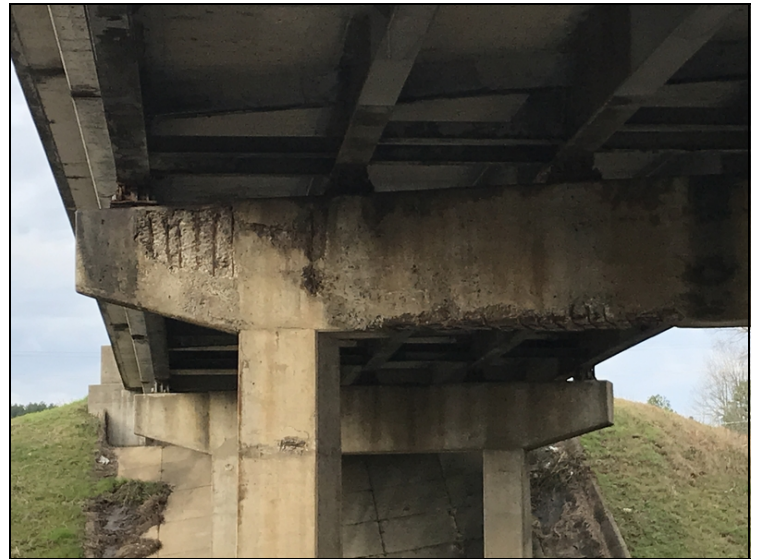
Typ. Condition of Bk. Face of Cap 3.

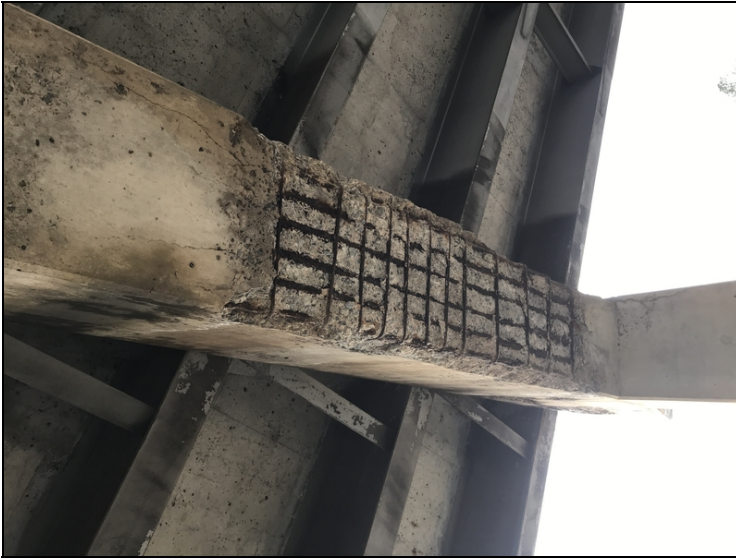
Dealn, Cracking & Spalling W / Rebar Exposed in
Bt. Face of Cap 3

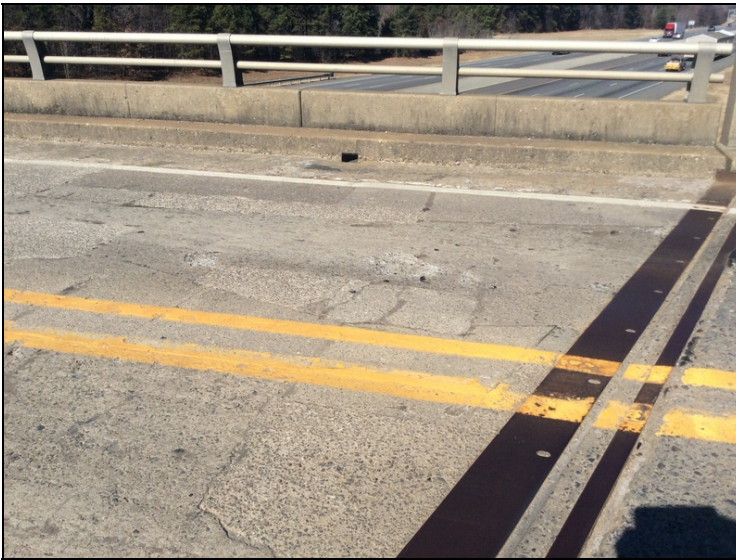
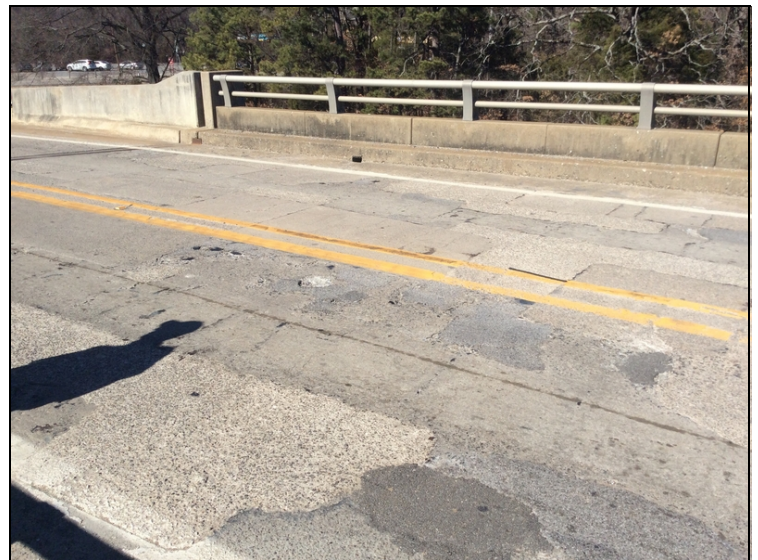
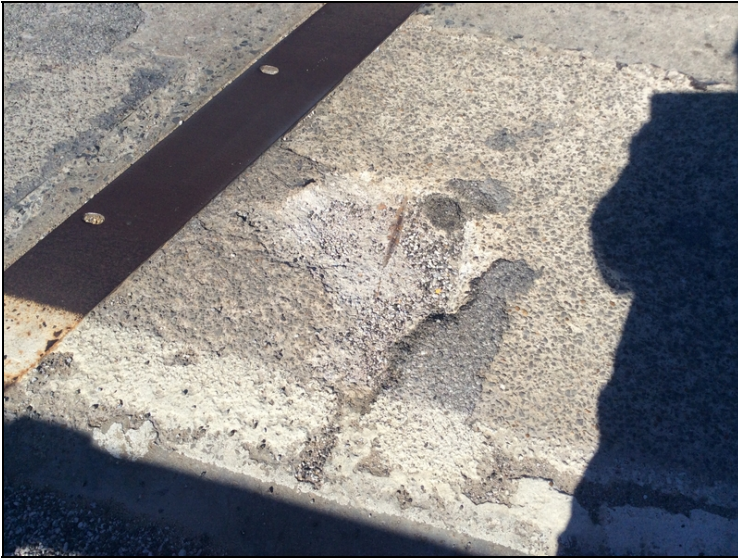
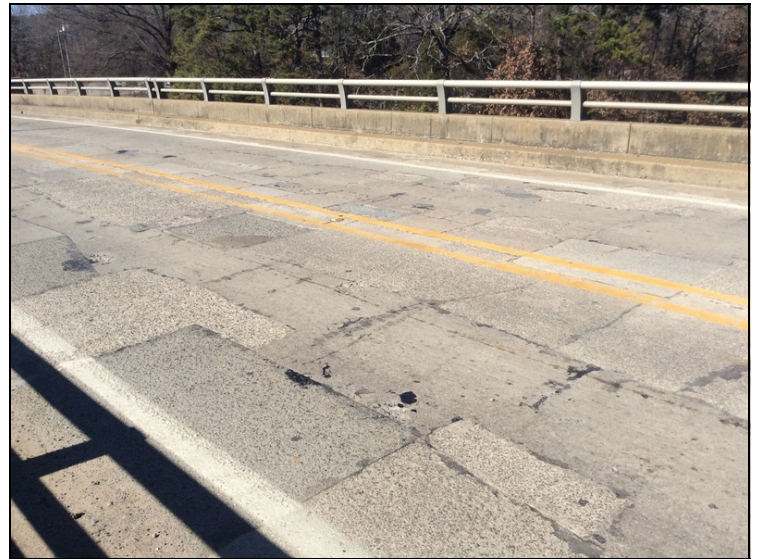
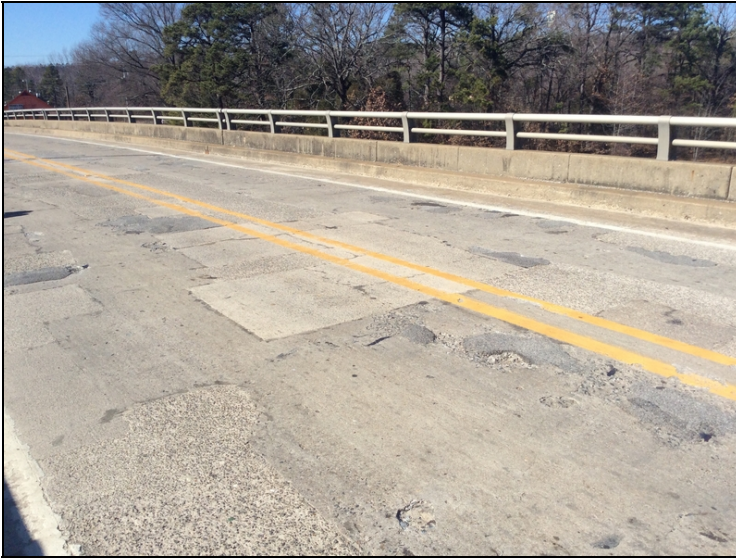
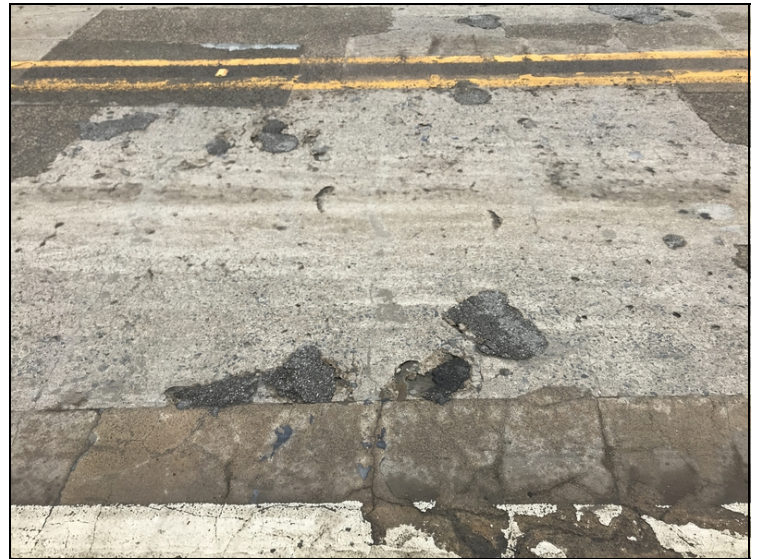
The deck has several minor to moderate spalls throughout all spans, some spalled areas have rebar exposed.

Typ. Delam, Cracking & Spalling in Deck.

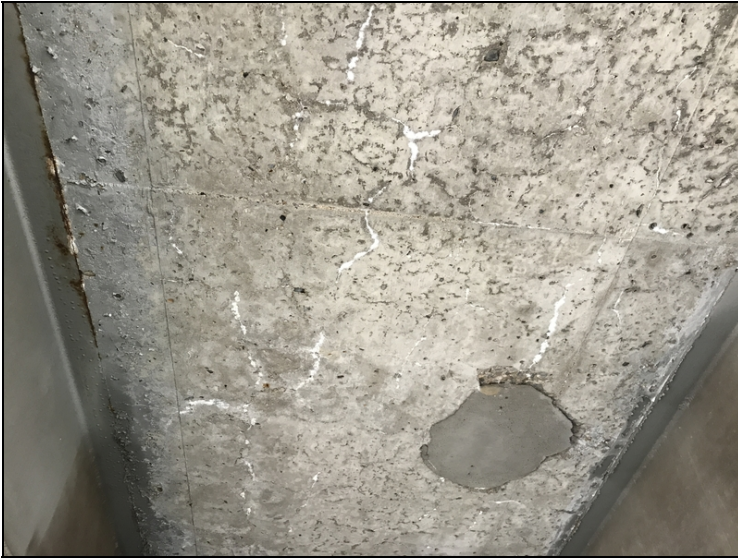
Typ. Condition of Soffit.

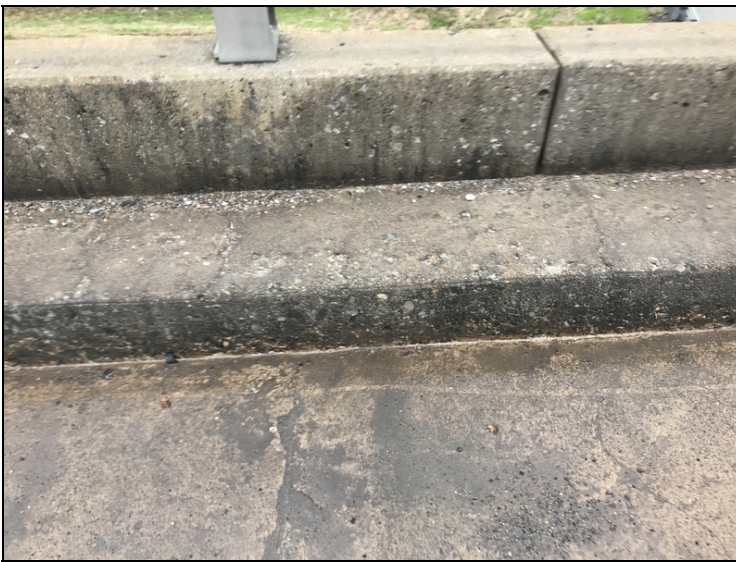
RAIL - MINOR TO MODERATE CRACKING & SCALE IN CONCRETE CURBS.

Typ. Cracking & Scale in Curbs under Rail.

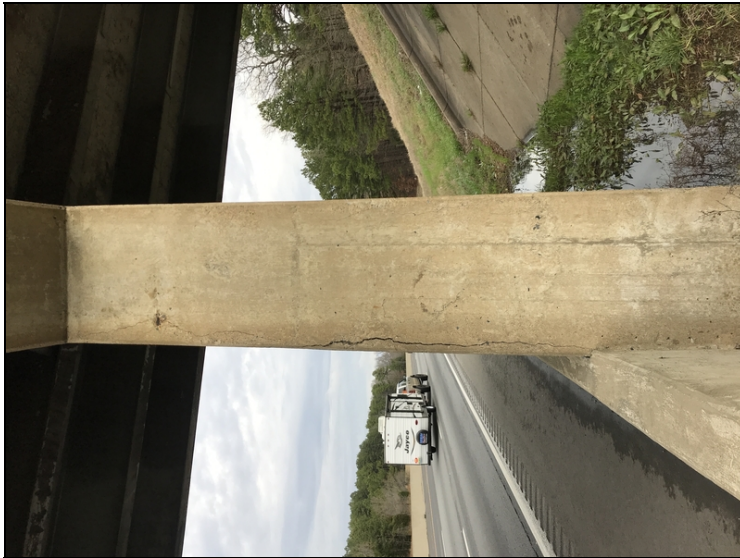
COLUMNS - MINOR TO MODERATE VERTICAL CRACKING IN COLUMN 1 AT PIER 2.
MINOR DELAM & SPALLING W / REBAR EXPOSED IN COLUMN 1 AT PIERS 3 & 4.
MINOR DELAM & SPALLING IN COLUMN 2 AT PIER 4.

Typ. Cracking in Columns.

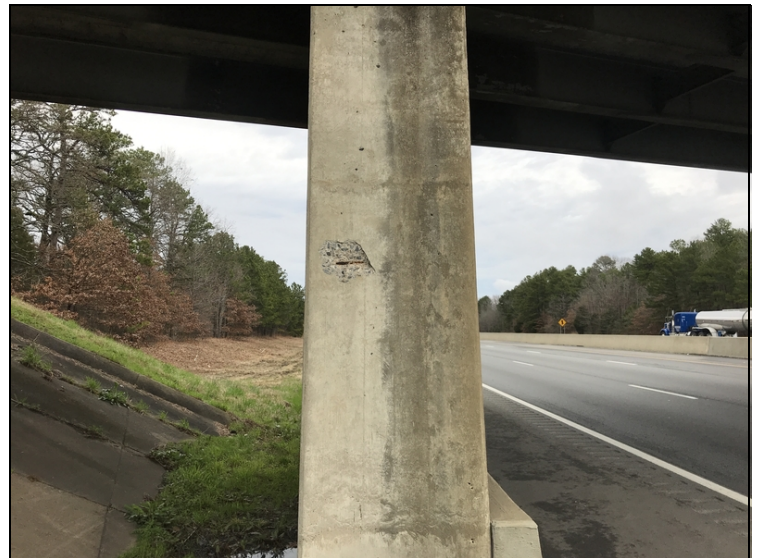
Typ. Delam & Spalling W / Rebar Exposed in Columns.

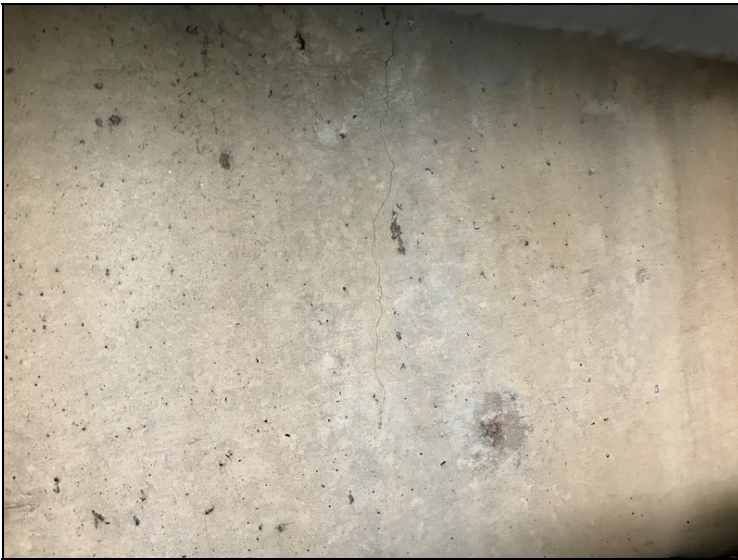
ABUTMENTS - MINOR VERTICAL CRACKING IN BACK WALLS.

Typ. Cracking in Back Walls.

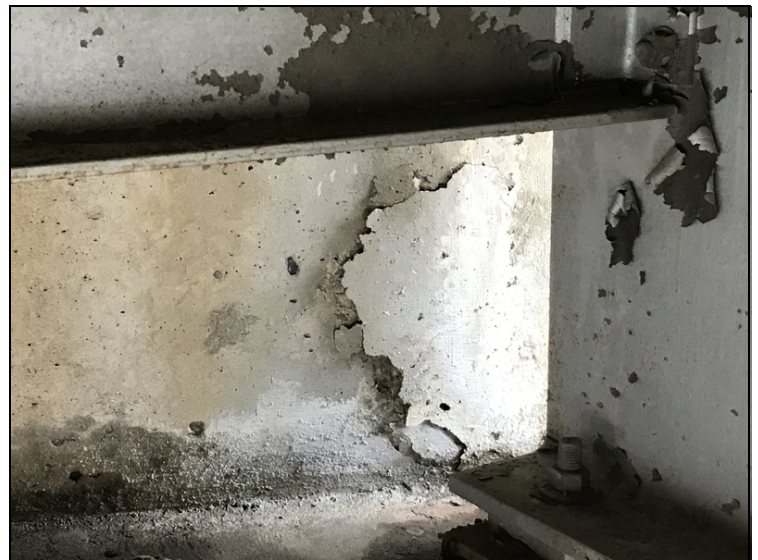
Typ. Cracking in Back Walls.

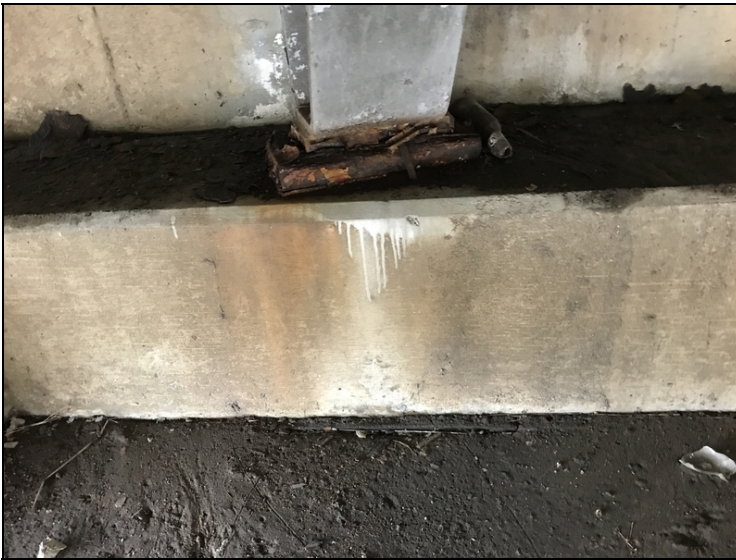
BEARINGS - MINOR TO MODERATE RUST & PACK RUST ON ALL BEARINGS.

Typ. Rust on Bearings.

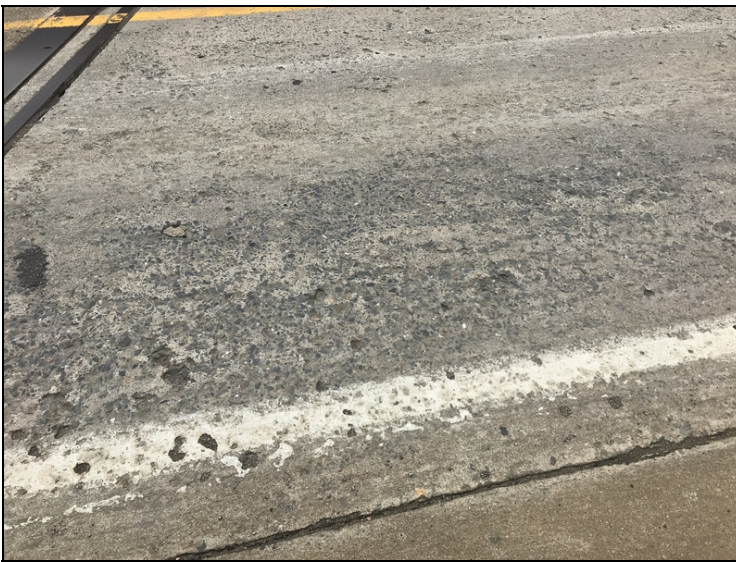
APPROACH SLABS - MINOR TO MODERATE CRACKING THROUGHOUT SLABS. MINOR SCALE.

Typ. Condition of Approach Slabs.

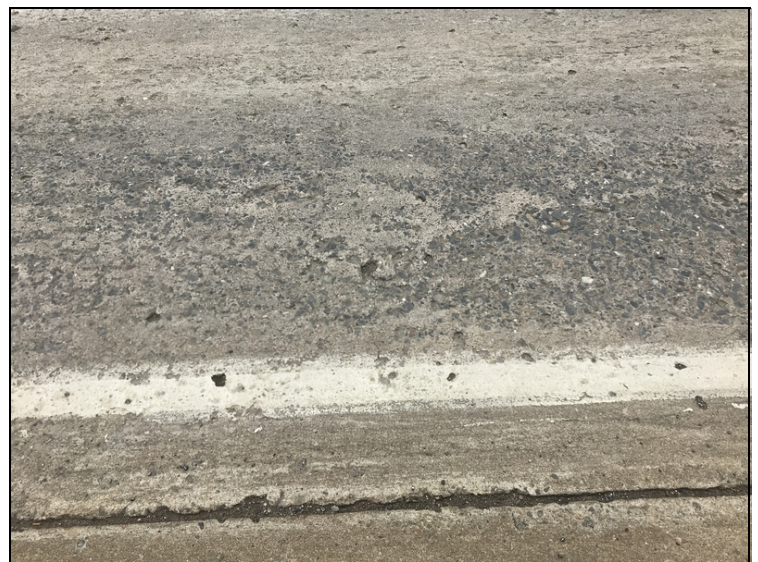
Typ. Condition of Approach Slabs.
