Bridge Inspection Report

00811
SH 105
over
Isabell Creek

Structure Number: 00811

Facility Carried: SH 105

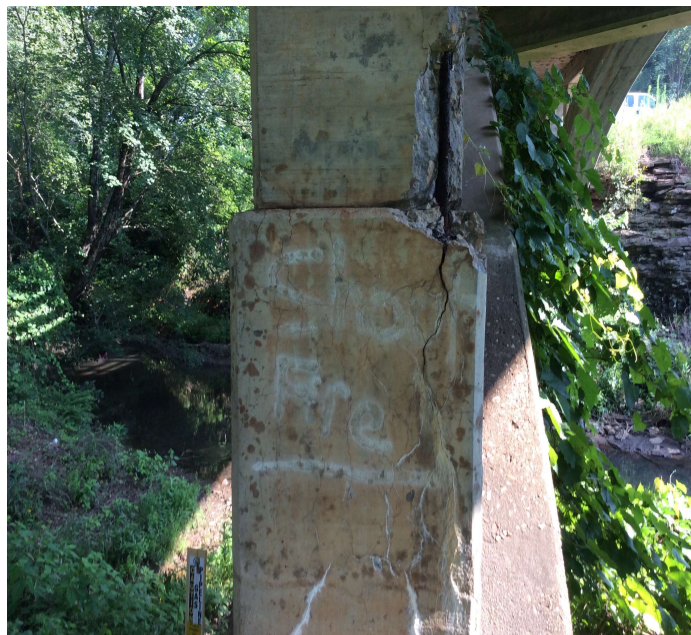
MODERATE DELAM, CRACKING & SPALLING W / REBAR EXPOSED IN COLUMN 6 & PEDESTAL ON RT. SIDE AT END OF ARCH AT PIER 3. MINOR SECTION LOSS ON REBAR.

PHOTO 1 Description DELAM CRACKING And SPALLING In COLUMN 7 And PEDESTAL AT PIER 3 ON RT SIDE.

item reviewed. Will continue to monitor.

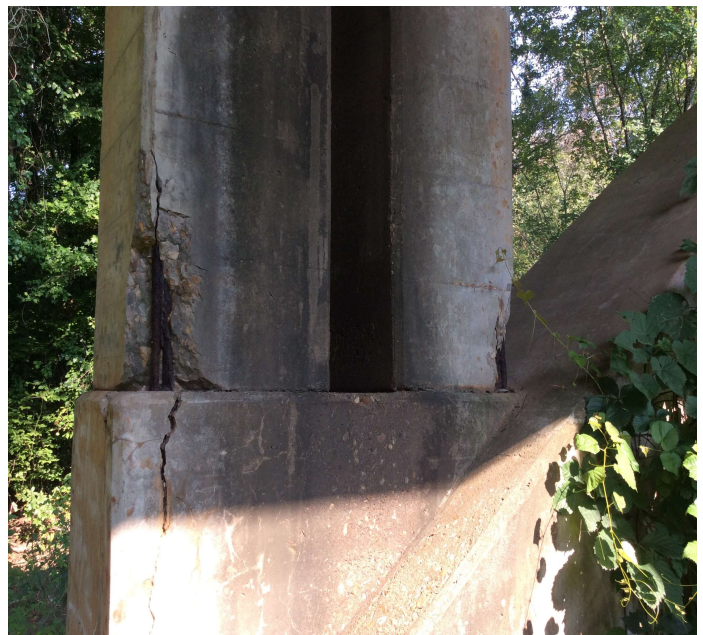
PHOTO 2 Description DELAM CRACKING And SPALLING In COLUMN 7 And PEDESTAL AT PIER 3 ON RT SIDE.

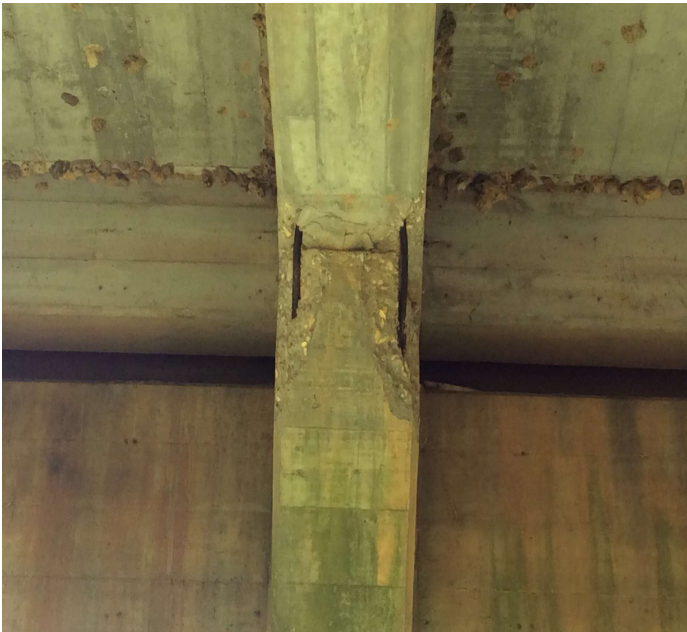
MINOR DELAM, CRACKING & SPALLING W / REBAR EXPOSED IN BEARING AREAS OF BEAMS 1 & 2 AT PIER 4 BK. SIDE & BEAM 2 AT PIER 5 BK. SIDE.

PHOTO 1 Description DELAM, CRACKING & SPALLING W /
REBAR EXPOSED IN BEARING
AREAS OF BEAMS.

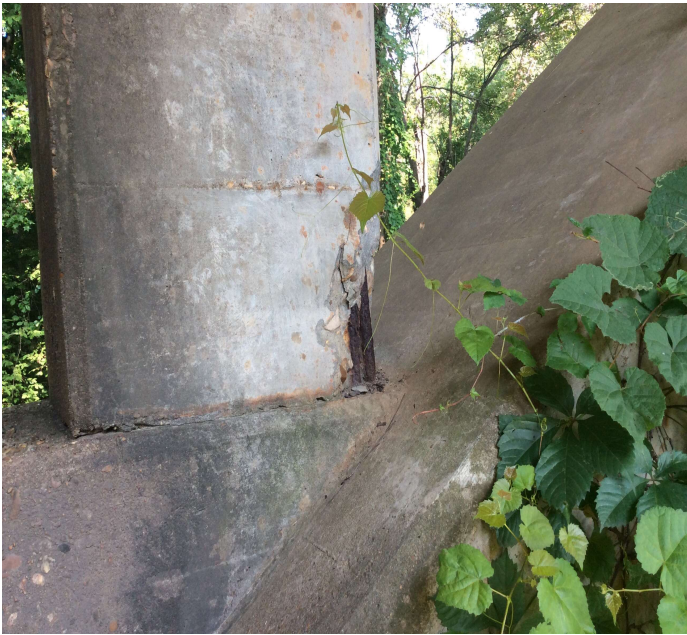
MINOR DELAM, CRACKING & SPALLING W / REBAR EXPOSED IN COLUMN 5 ON RT. SIDE AT END OF ARCH AT PIER 3. MINOR SECTION LOSS ON REBAR.

PHOTO 1 Description MINOR DELAM, CRACKING & SPALLING W / REBAR EXPOSED IN COLUMN 6 ON RT. SIDE AT END OF ARCH AT PIER 3. MINOR SECTION LOSS ON REBAR.
