Bridge Inspection Report

02822
SH 9
over
SLICK ROCK CREEK

Structure Number: 02822

Facility Carried: SH 9

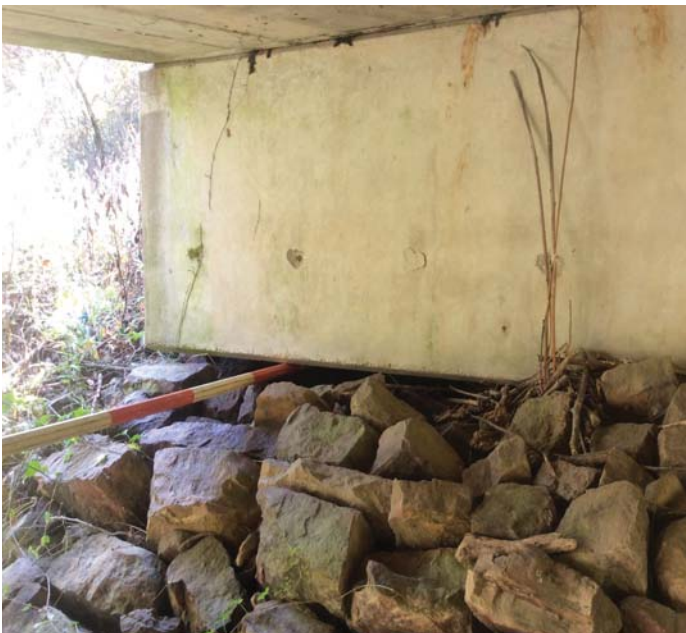
Erosion under cap for 2.5 ft back of face at all ends for 6.0 ft in length. Shoulders at back wall have settled 1/2 in.

PHOTO 1 Description Ends of abutment undermined 2.5 ft back of face at wings for 6 ft.

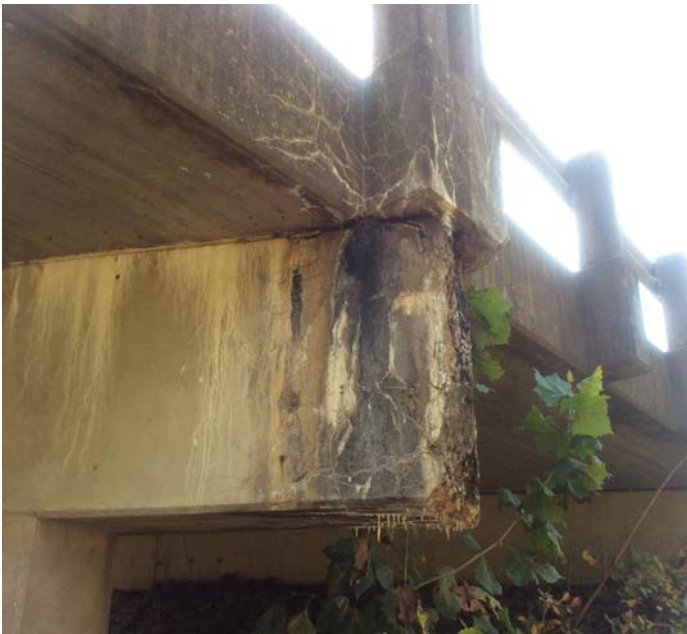
Pier # 2, each end of cap.

Minor spalling (no rebar exposed) and moderate delamination and cracking.

PHOTO 1 Description End of cap pier 2 upstream
