Bridge Inspection Report

02823
SH 9
over
DRY FORK CREEK

Structure Number: 02823

Facility Carried: SH 9

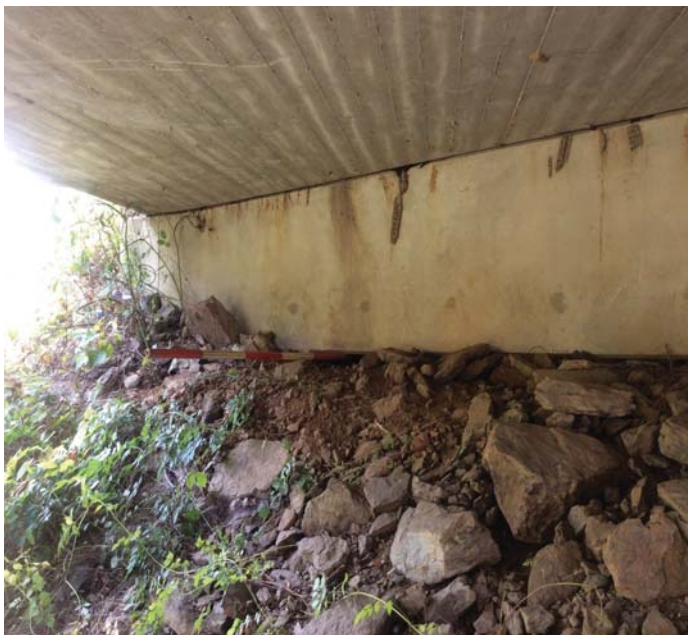
Undermining of cap at abutment 1 & 2 , settlement of approach pavement, scour to slopes. riprap ineffective over 50% of both abutments

PHOTO 1 Description Undermining of cap. 2' behind face

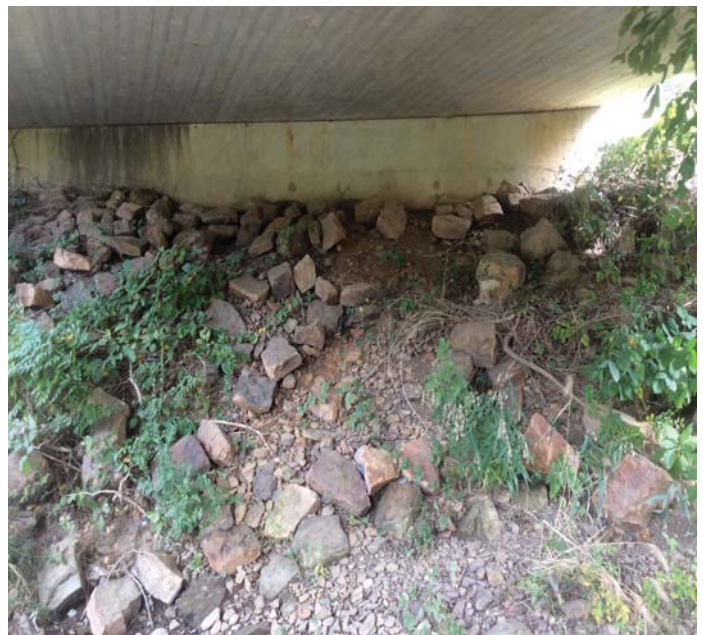
PHOTO 2 Description Riprap abutment 2

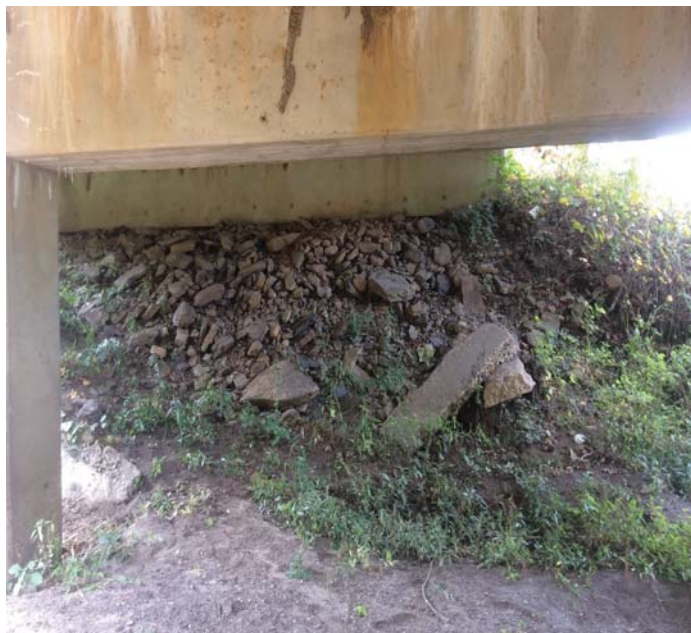
PHOTO 3 Description Riprap abutment 1

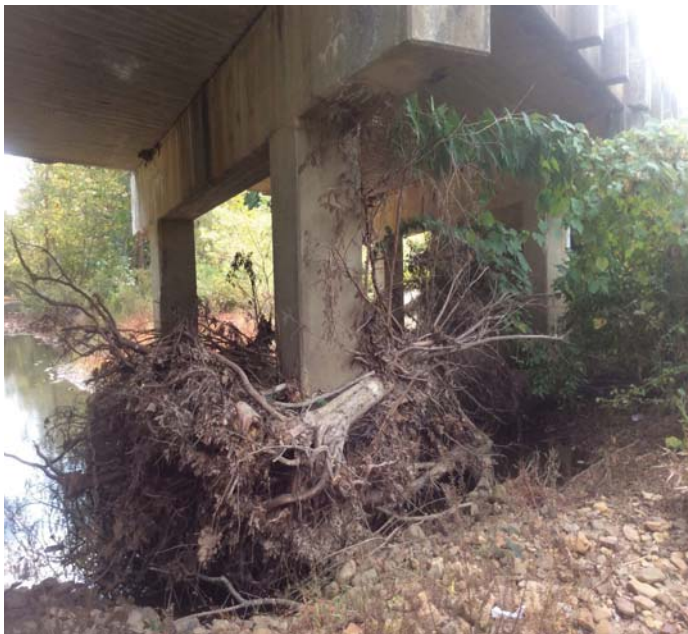
Channel, upstream side at pier # 2

Moderate drift is restricting flow.
4' scour hole in span 2

PHOTO 1 Description Drift on pier 2 upstream face

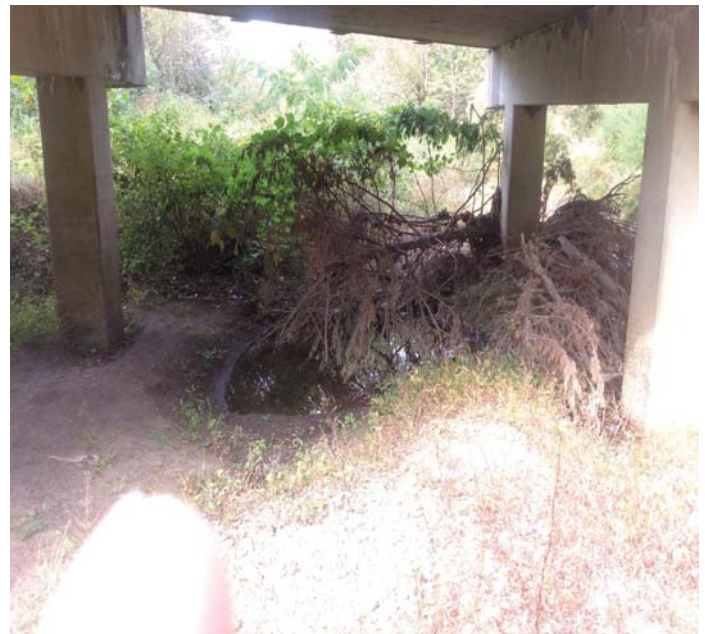
PHOTO 2 Description Scour span 2

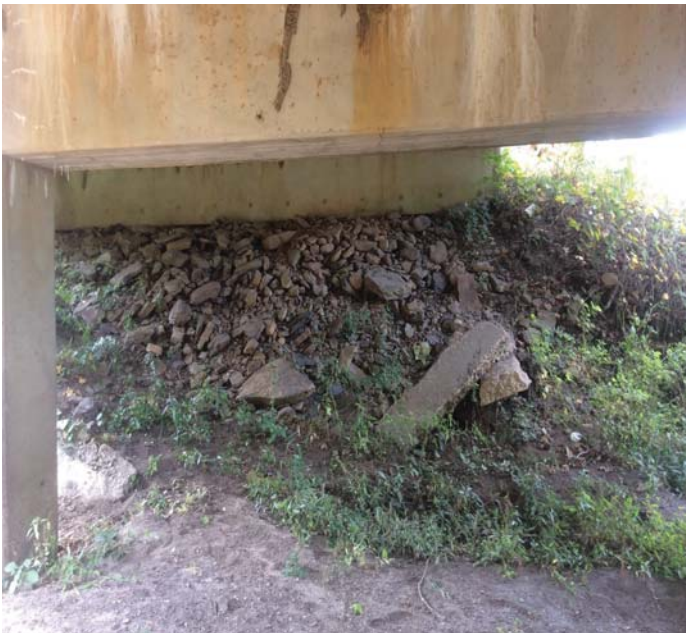
PHOTO 3 Description Riprap abutment 1

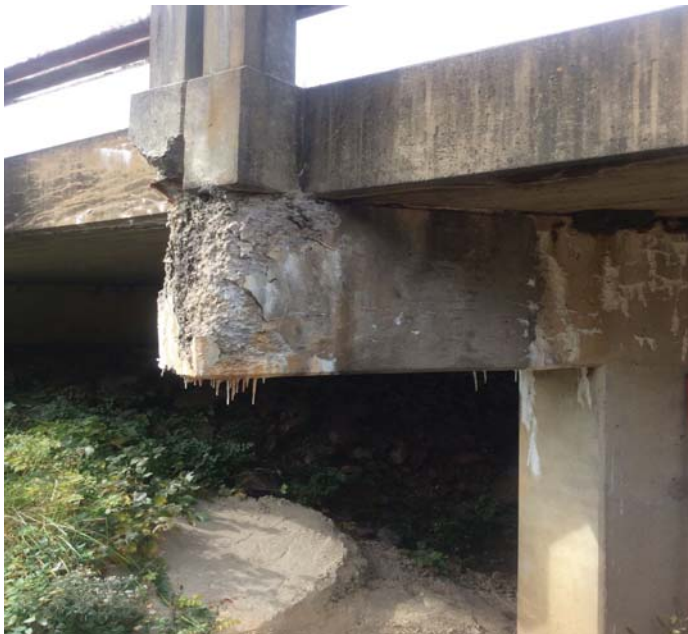
Right end of caps have minor spalling (no rebar exposed) and moderate delamination and cracking, also left end of caps have minor to moderate delamination and cracking.

PHOTO 1 Description Downstream end of cap pier 1

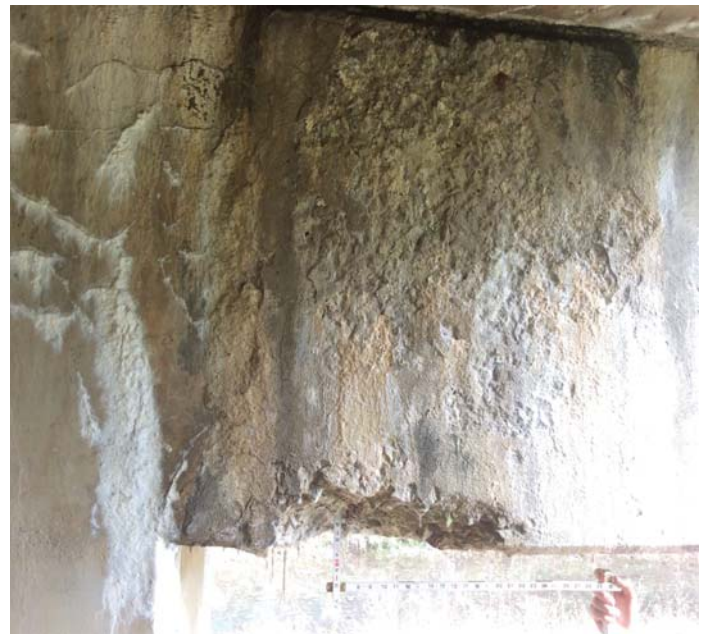
PHOTO 2 Description Spall pier 1 span 1 downstream

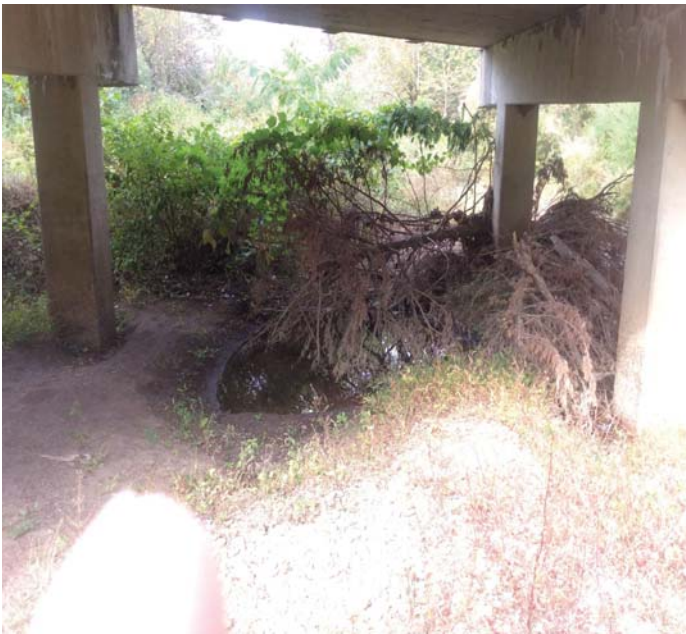
Channel at pier # 2 and in span # 2

Minor to moderate scour.

PHOTO 1 Description Scour span 2
