Bridge #B3947 (Routine)
I-40, EB LNS over Cabin Creek
Location: 0.73 M NW Of US 64

Team Lead: Kevin Milligan Inspection Date: March 09, 2020

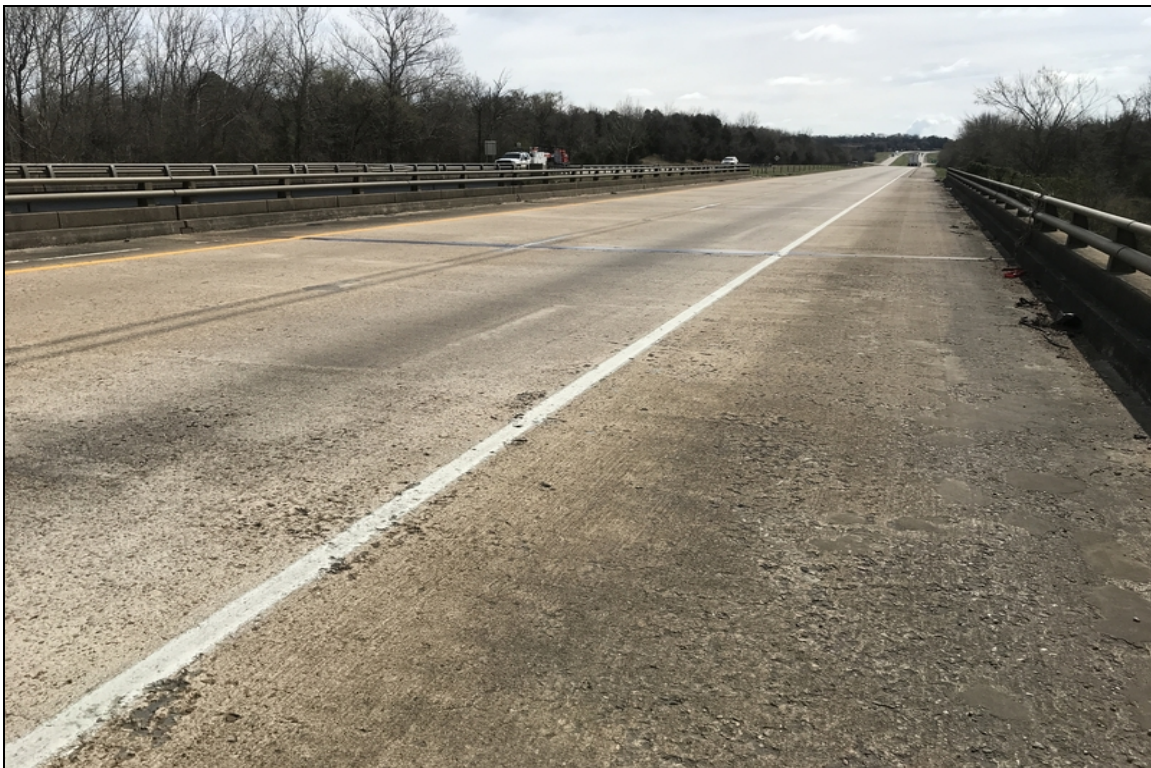
Typical deck.

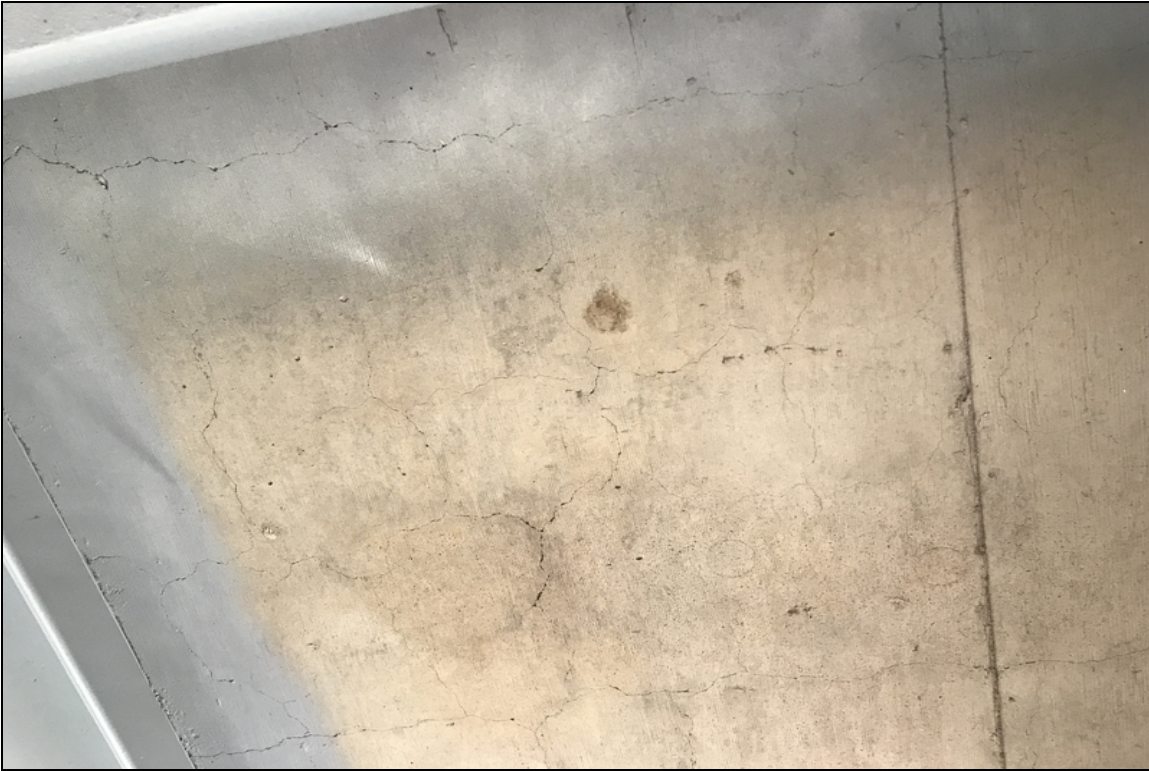
Span 1 bay 4, typical cracking of soffits.

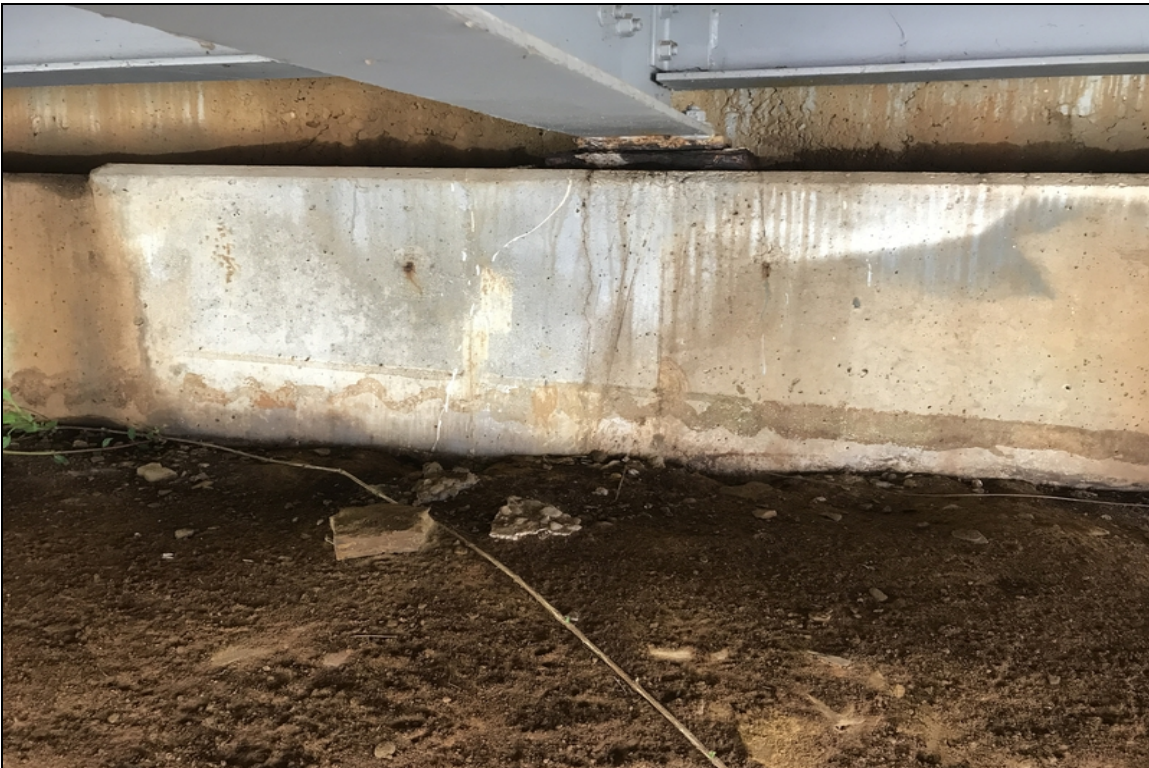
Bent 1 has a few vertical cracks.

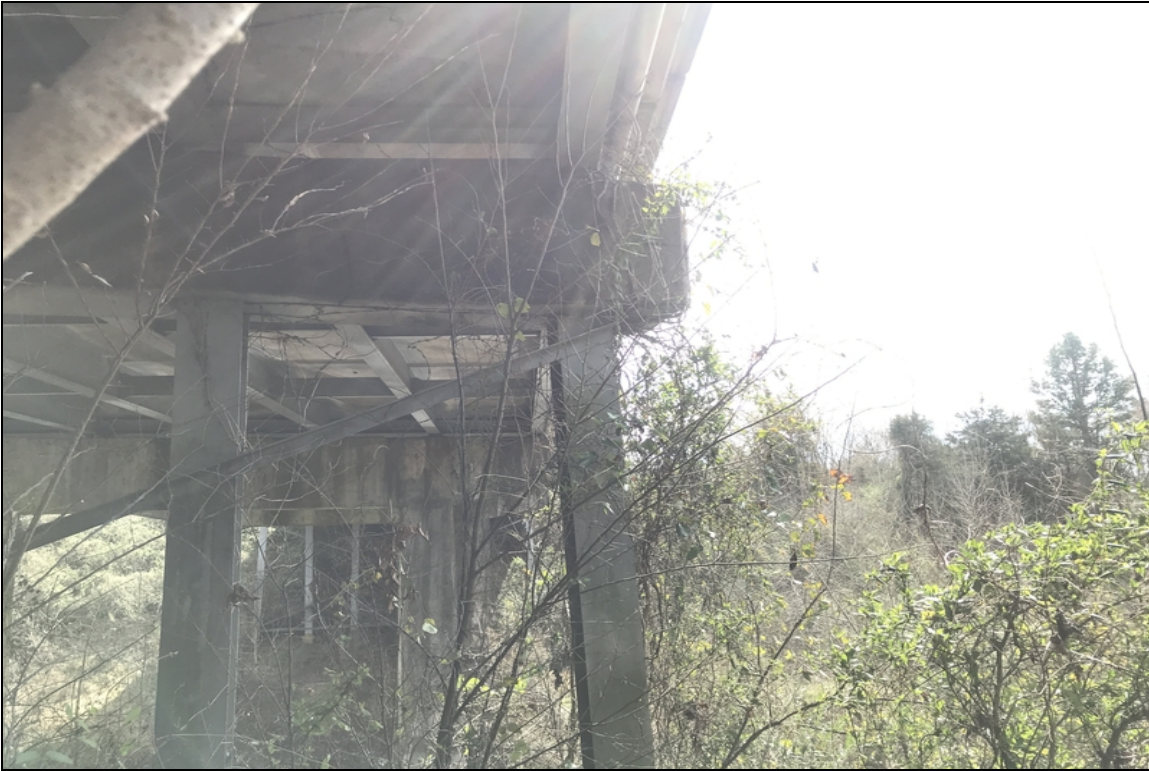
Vegetation at bent 2 right side.

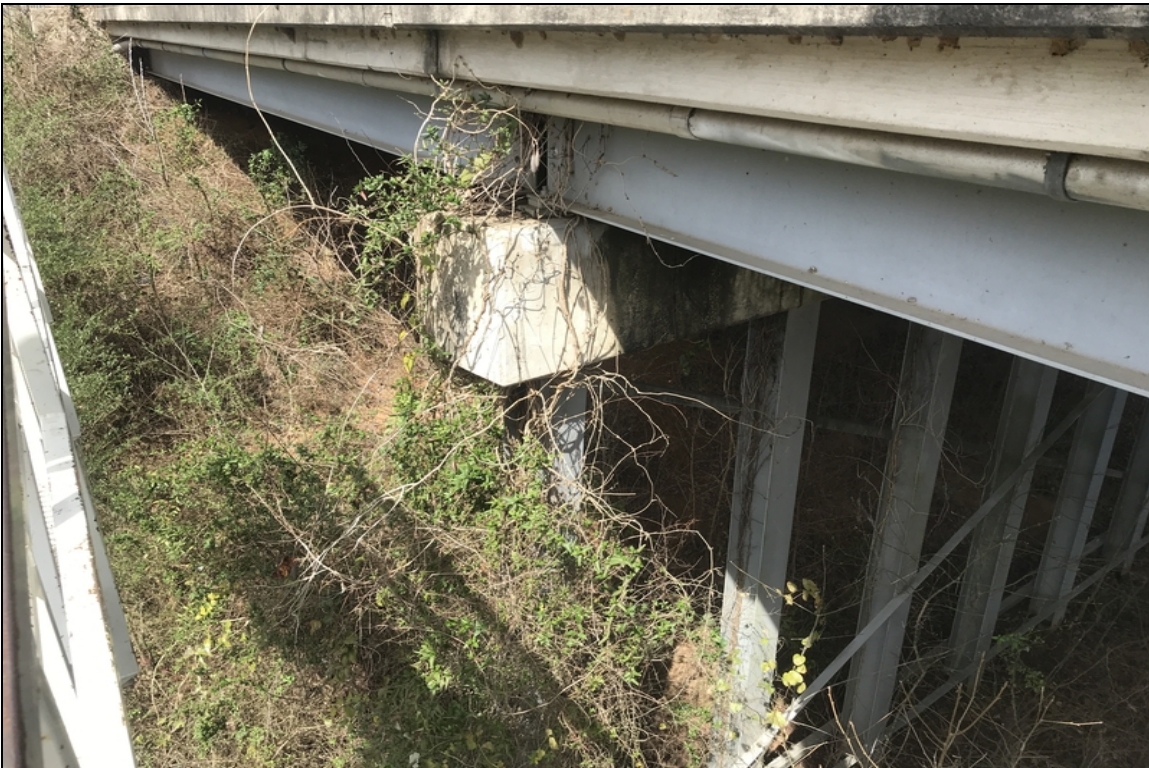
Bent 2 right vegetation up on cap and piles.

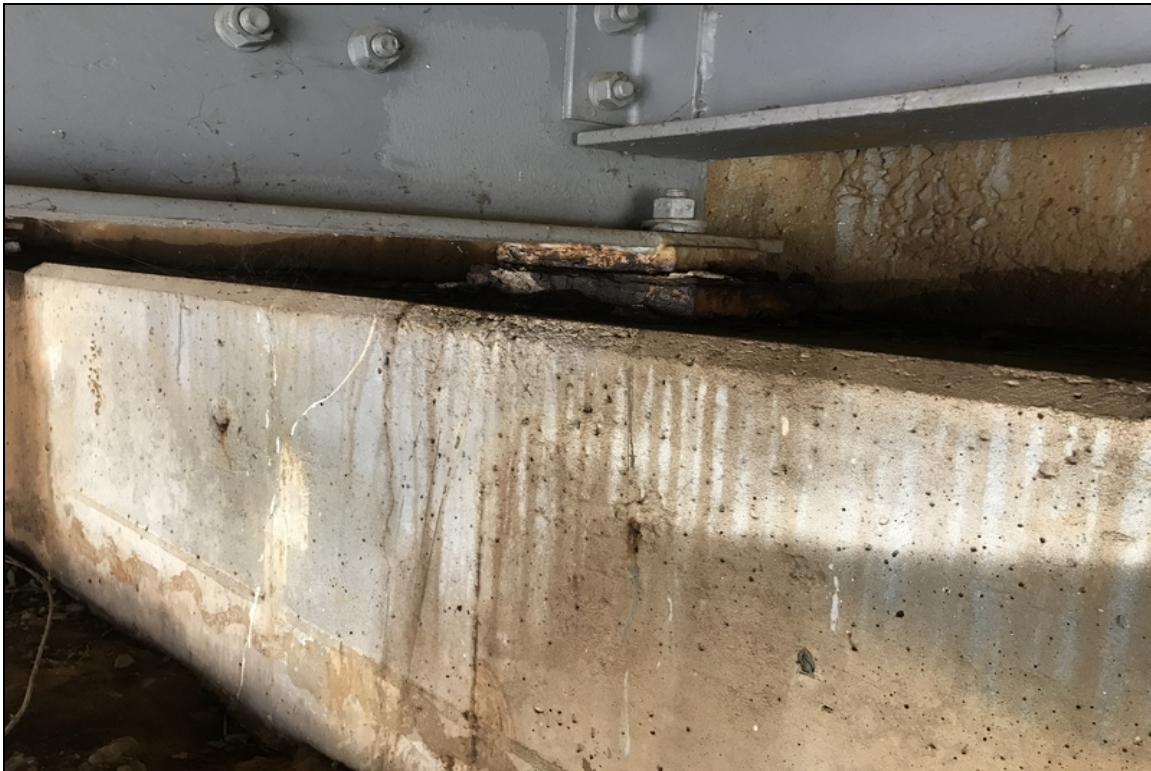
Bent 1 girder 4, bearing has corrosion with pack rust.

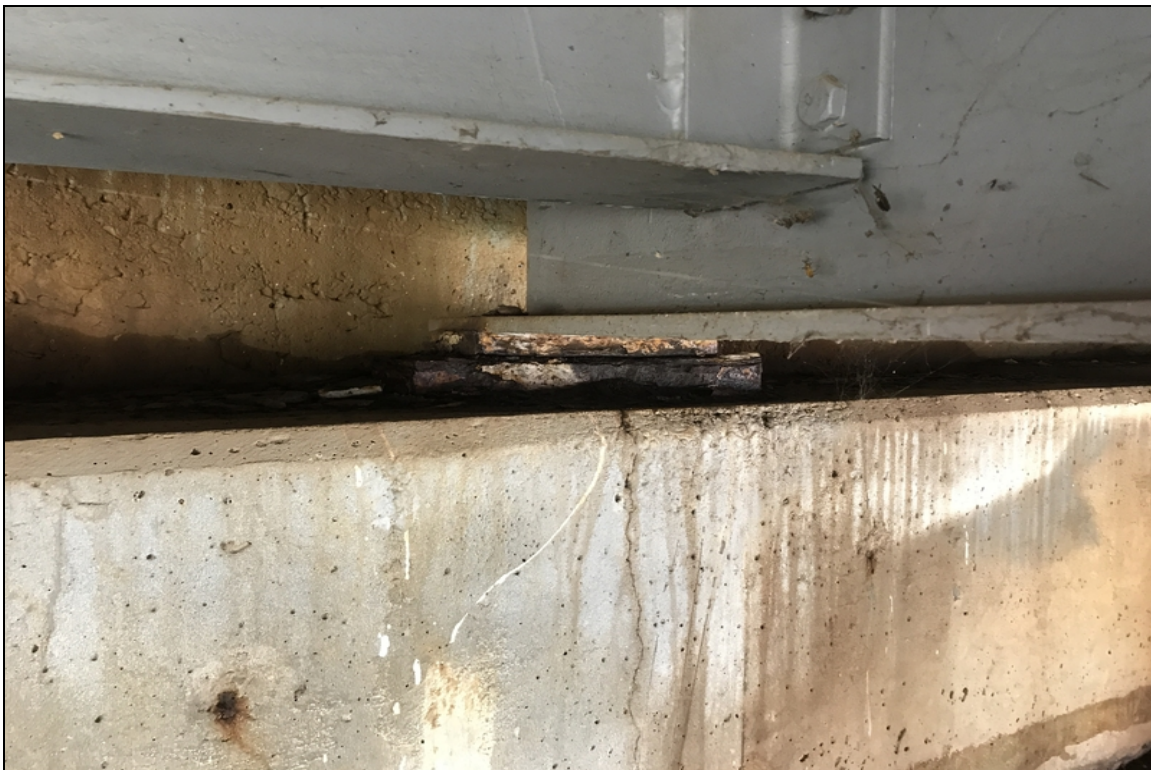
Bent 1 bearings 2 thru 4 are floating, making contact under load.

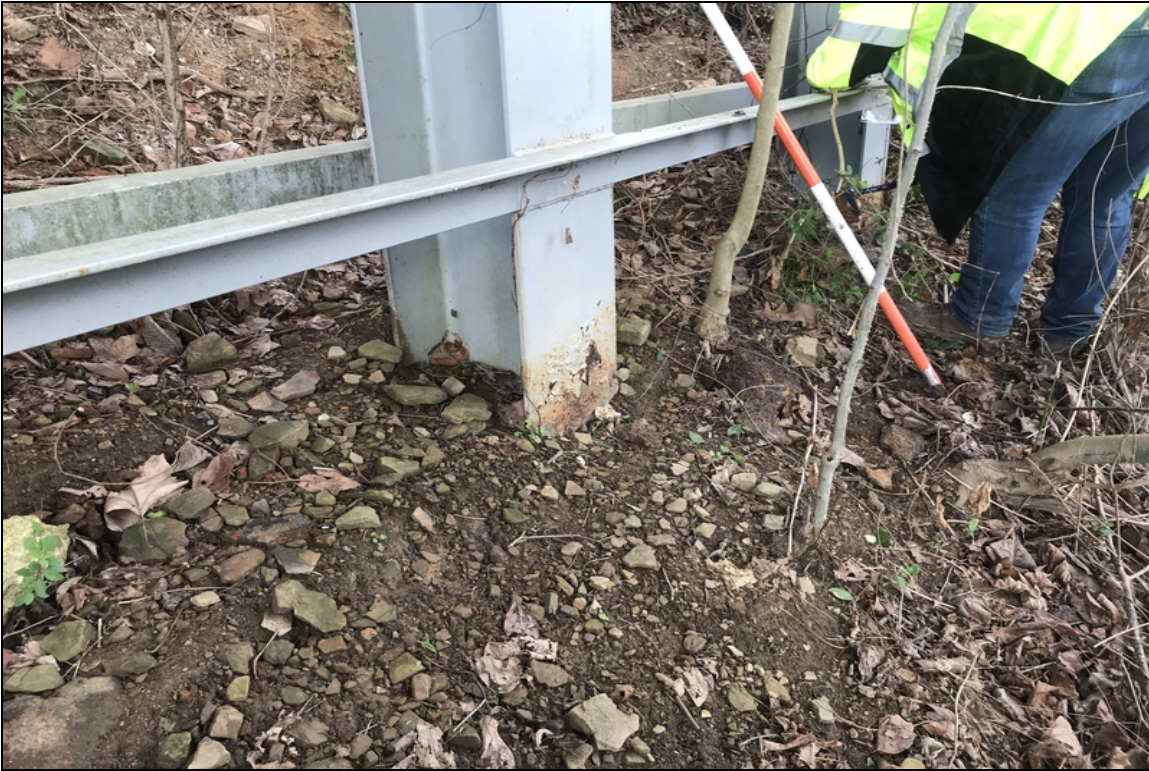
Bent 2 all steel piles have corrosion at ground level. Piles 2, 3, 5 and 7 have up to 1/8" section loss at ground level.

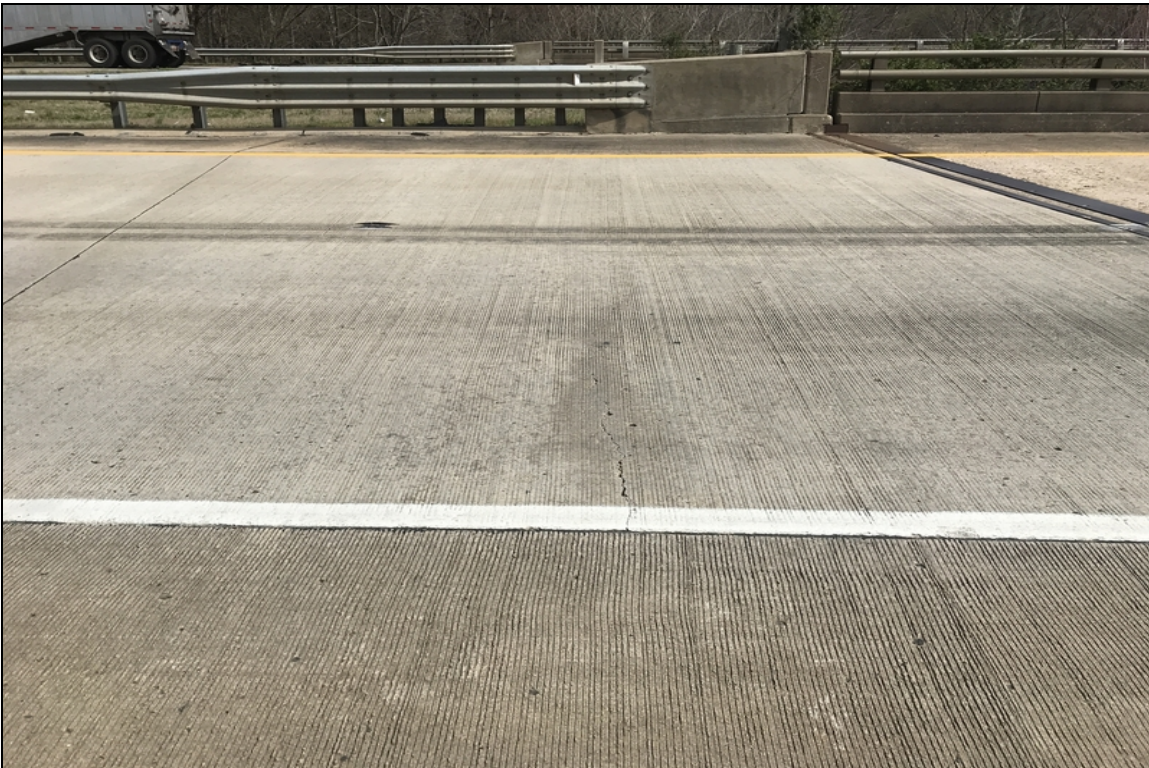
West approach right lane, large transverse crack.

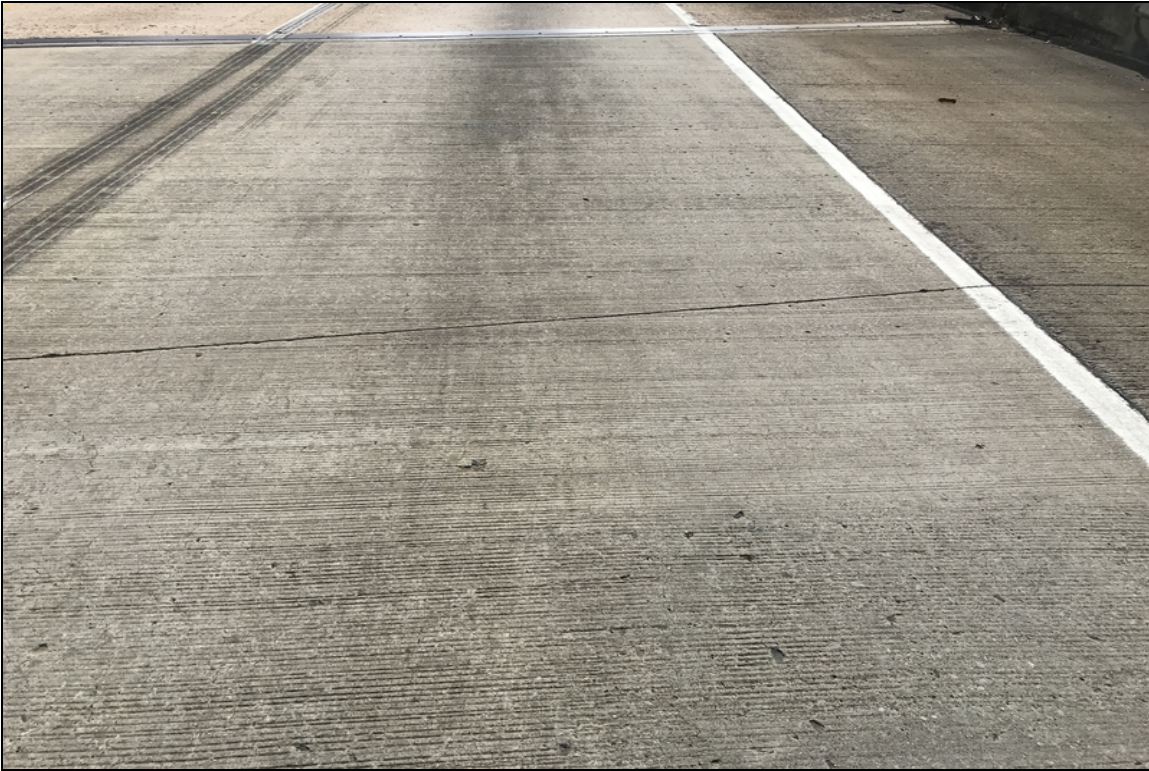
West approach has longitude cracking.

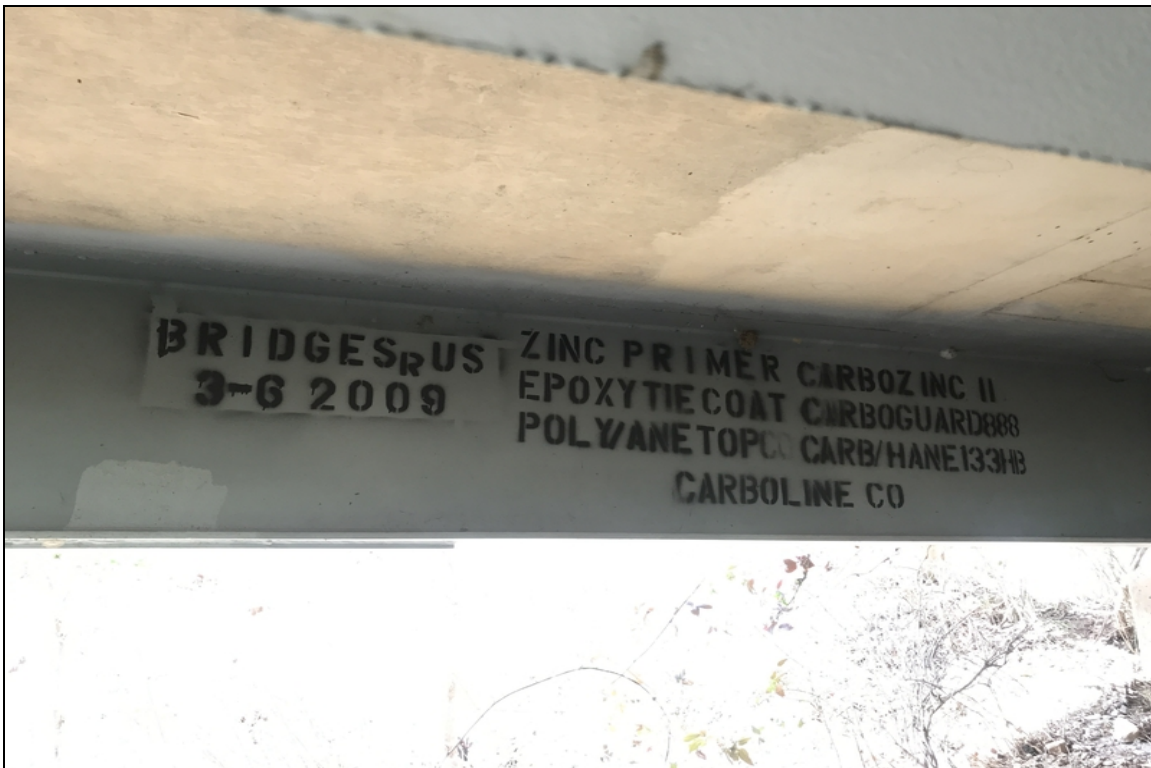
Bridge was painted 3/6/2009

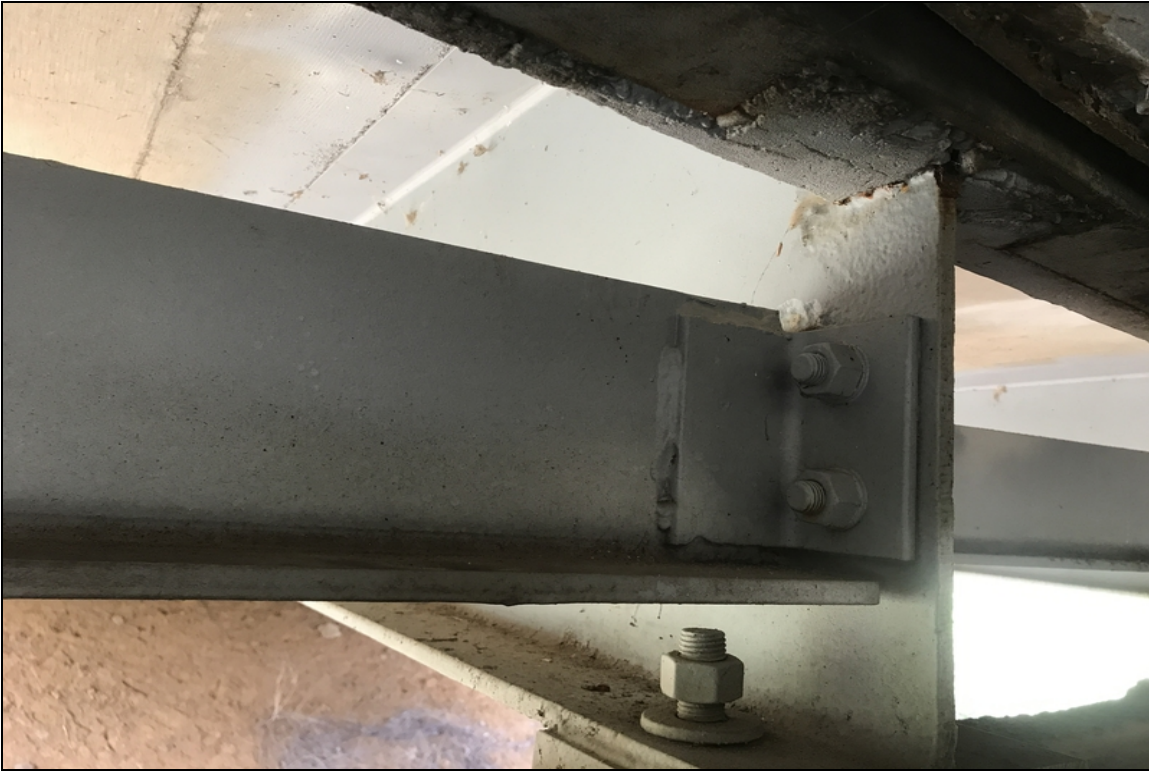
Bent 2 top of girders have section loss in the haunch area at the follow locations. Girders 2 thru 7 back side and girders 3 thru 5 on the head side.

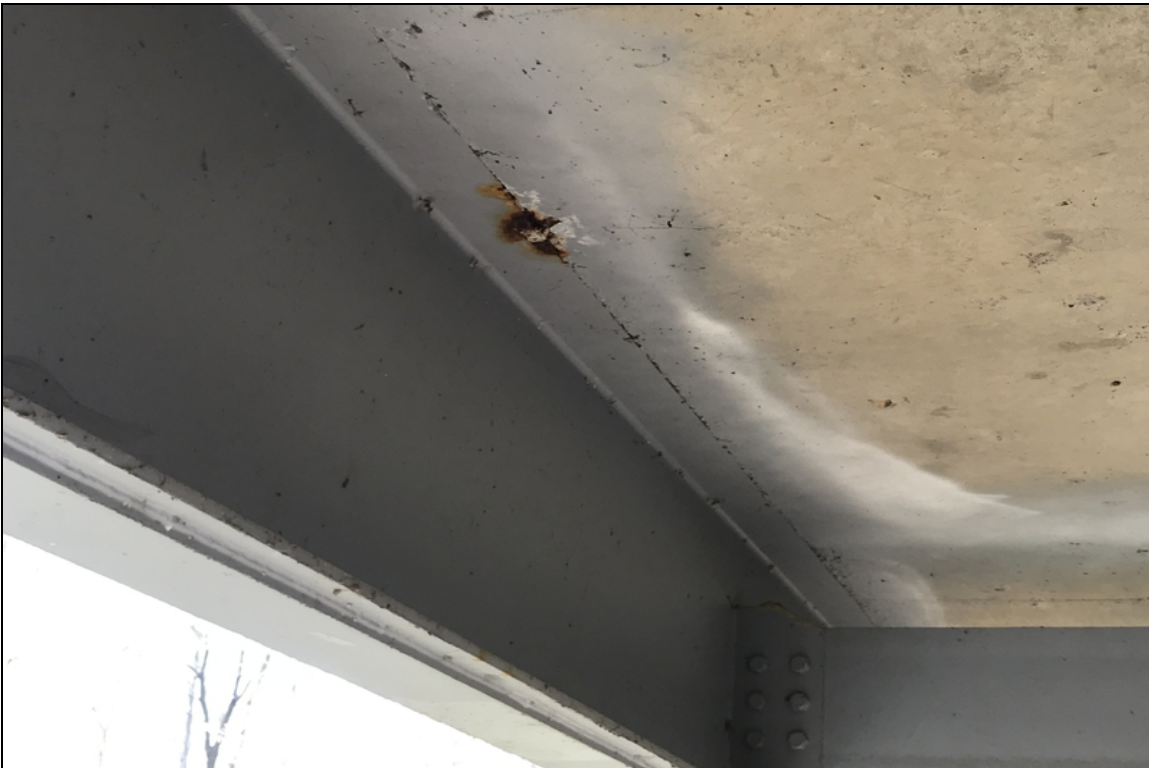
Span 2 girder 7 has corrosion on top flange between diaphragm 2 and 3.

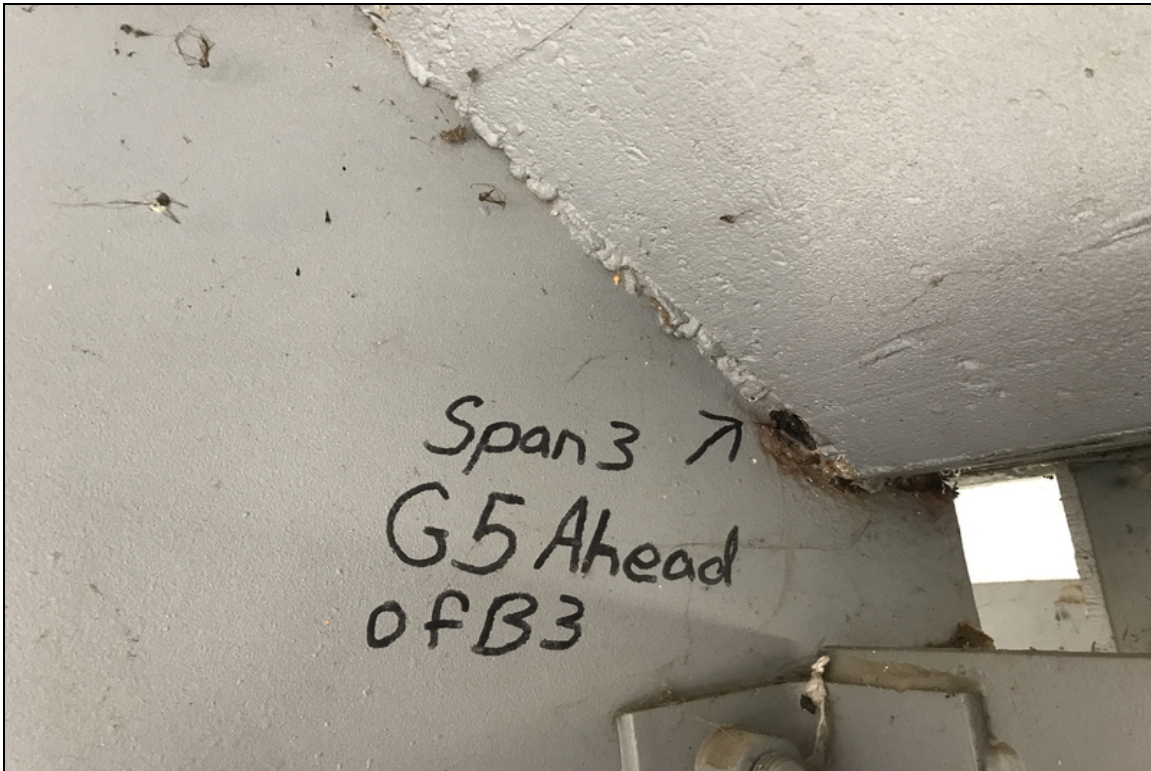
Span 3 Girder 5 ahead of bent 3 there is a crack in haunch area about an 1" long.

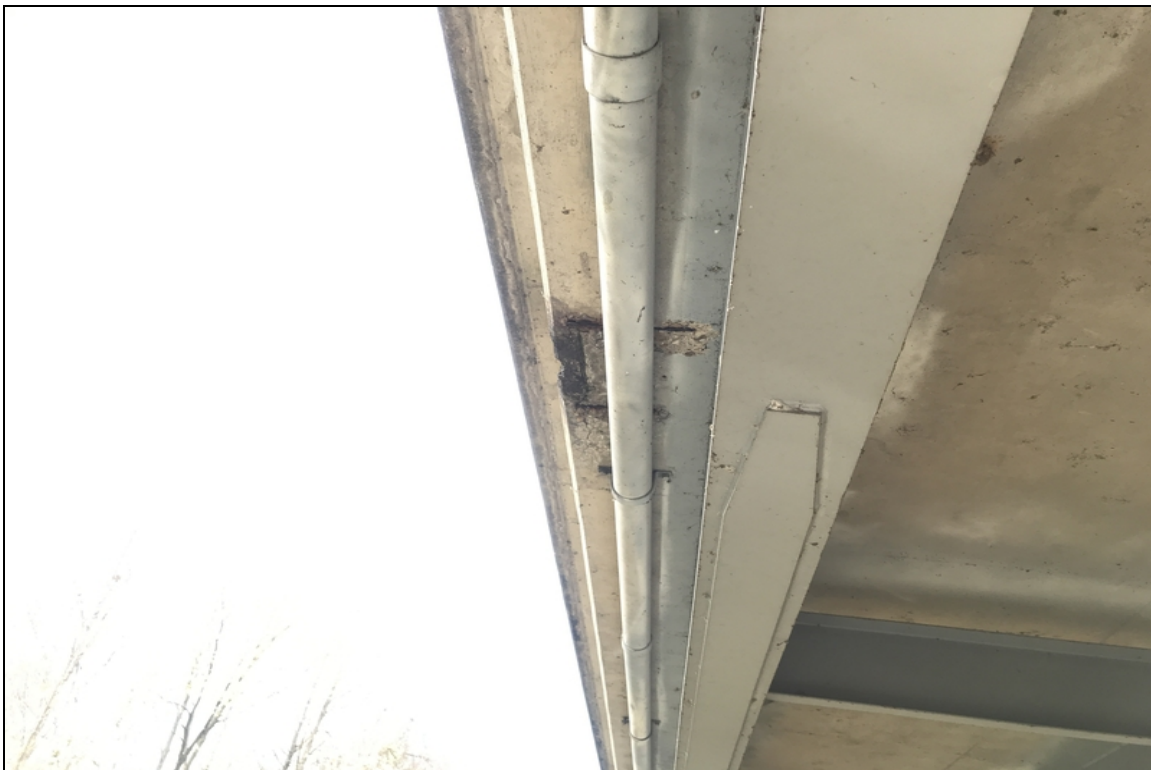
Span 2 has 2 spalls with exposed reinforcing steel in the soffits on the right side at the drains.

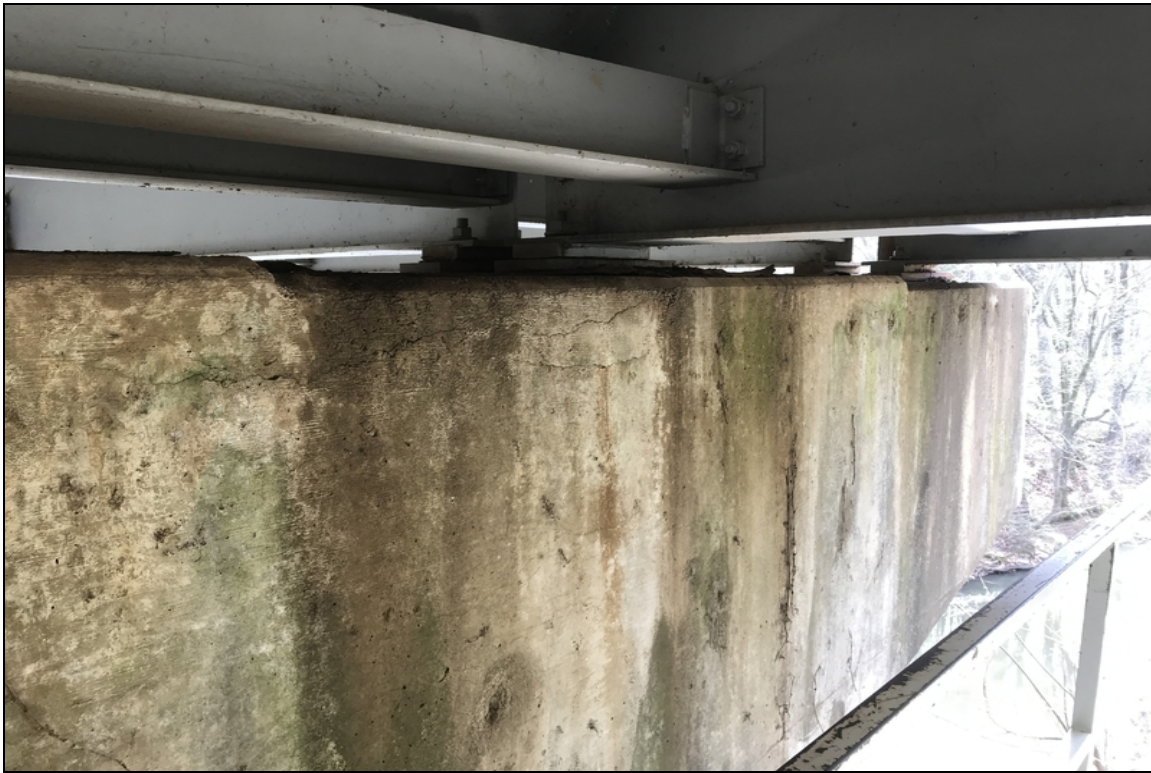
Bent 3 has horizontal cracking between girders 6 and 7. This is typical on back side of cap.

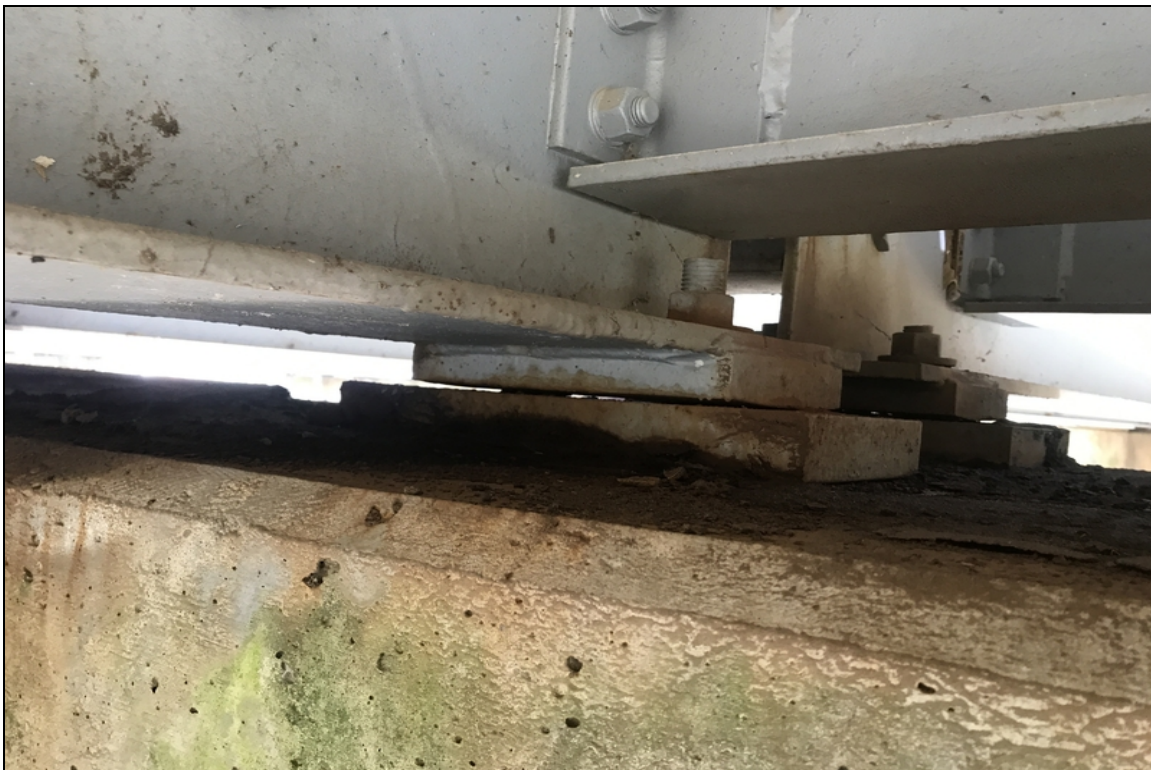
Moveable bearings at bent 3 have corrosion and some having pack rust. Bearings 4 back side and bearings 3 and 4 ahead side are floating.

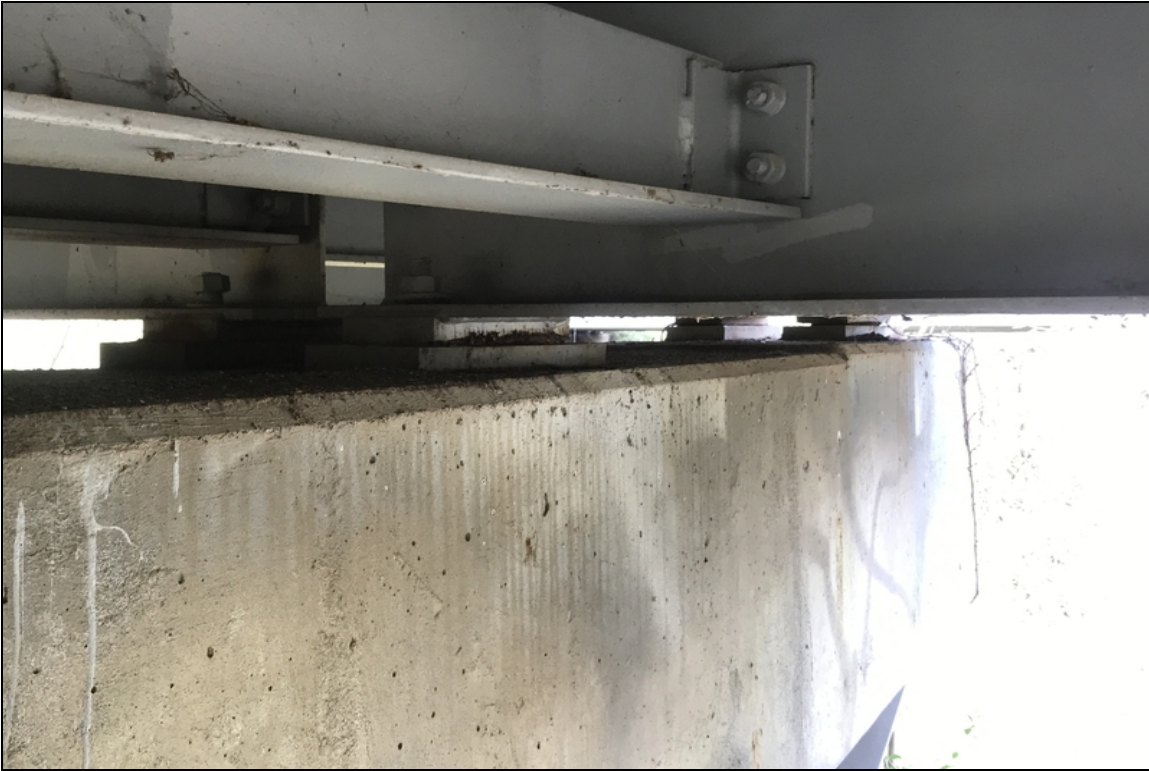
Bent 2 G2 bearing 2 has pack rust, this is typical at G 3, 4, 5.

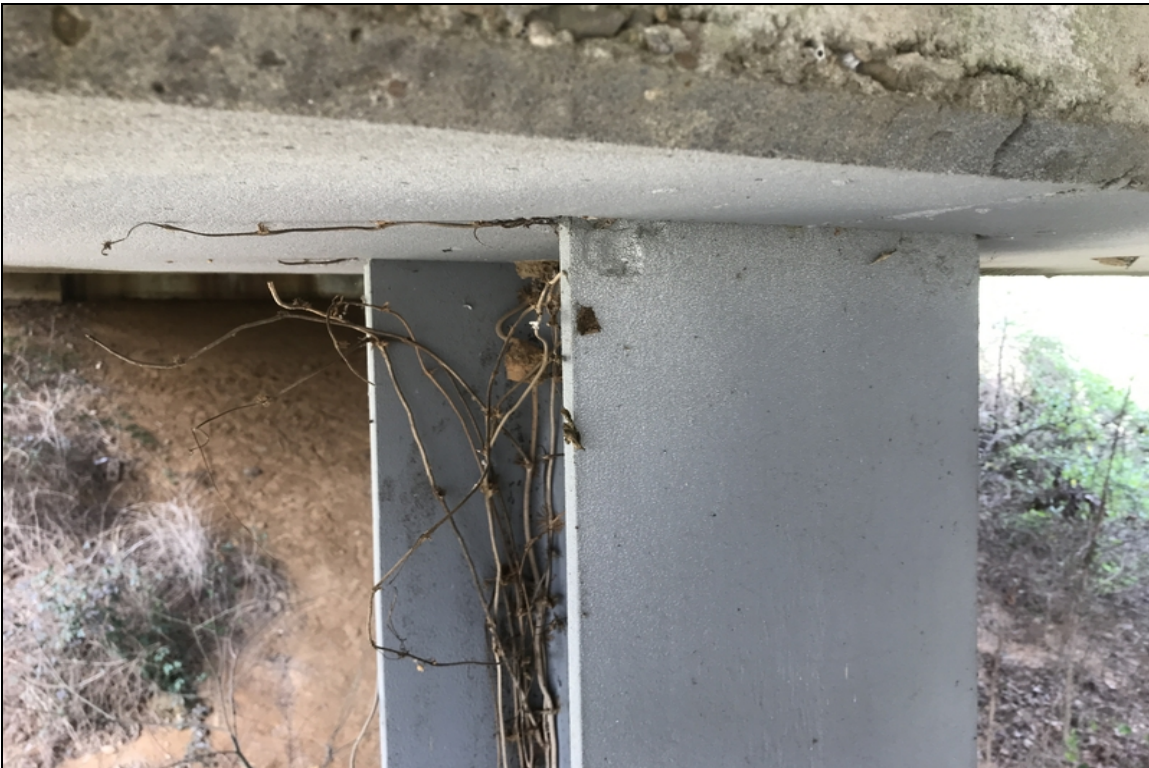
Bent 2 piles 5 and 7 has section loss at the top of piles.

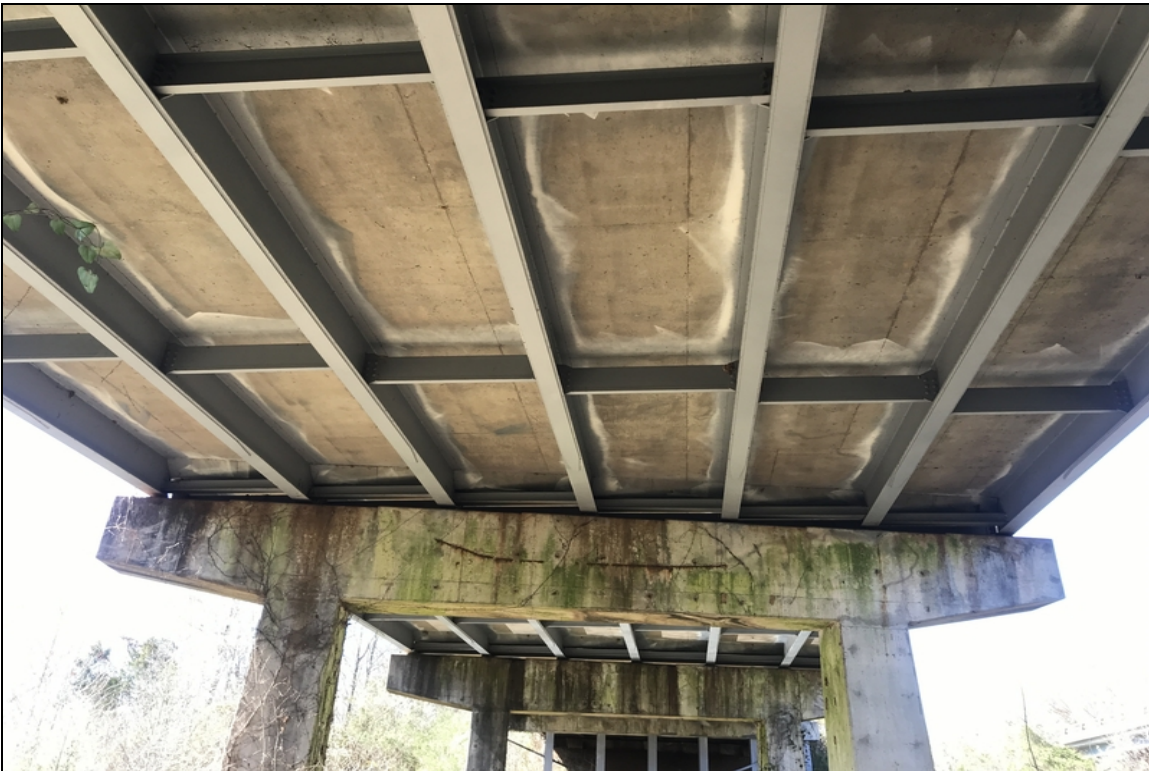
Typical view of under surface.

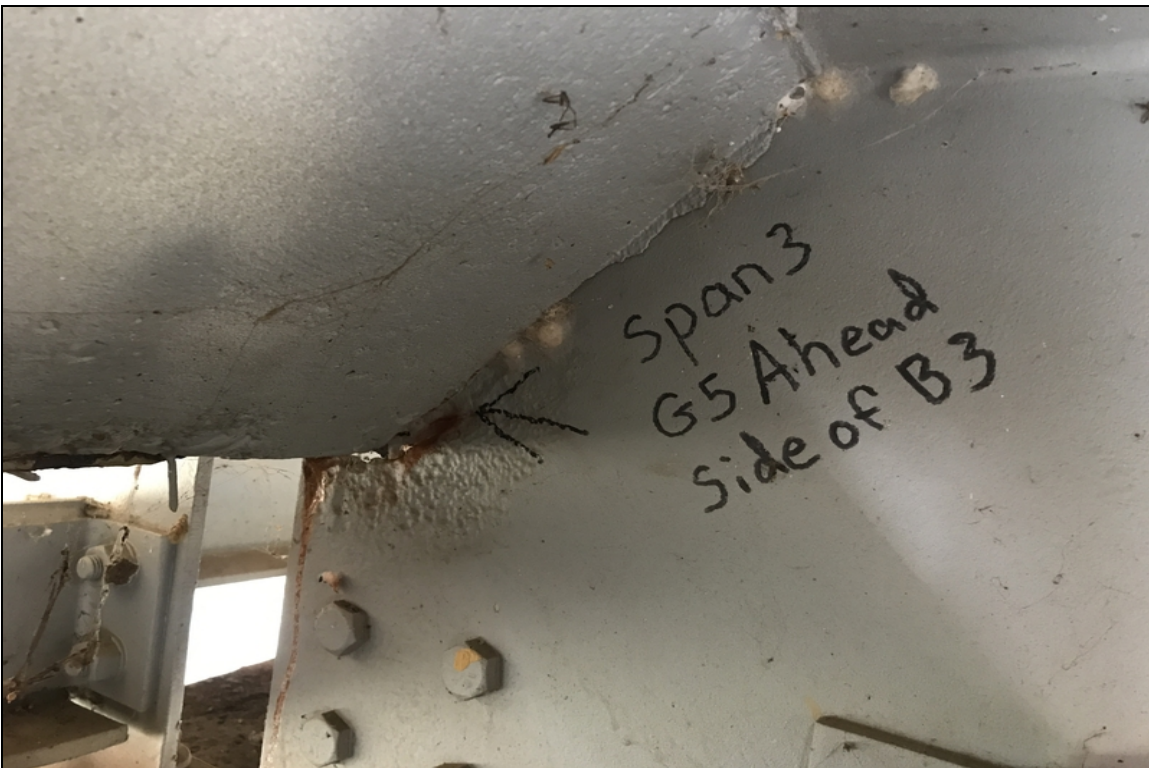
Span 3 Girder 5 ahead of bent 3 there is a crack in haunch area about an 1" long.

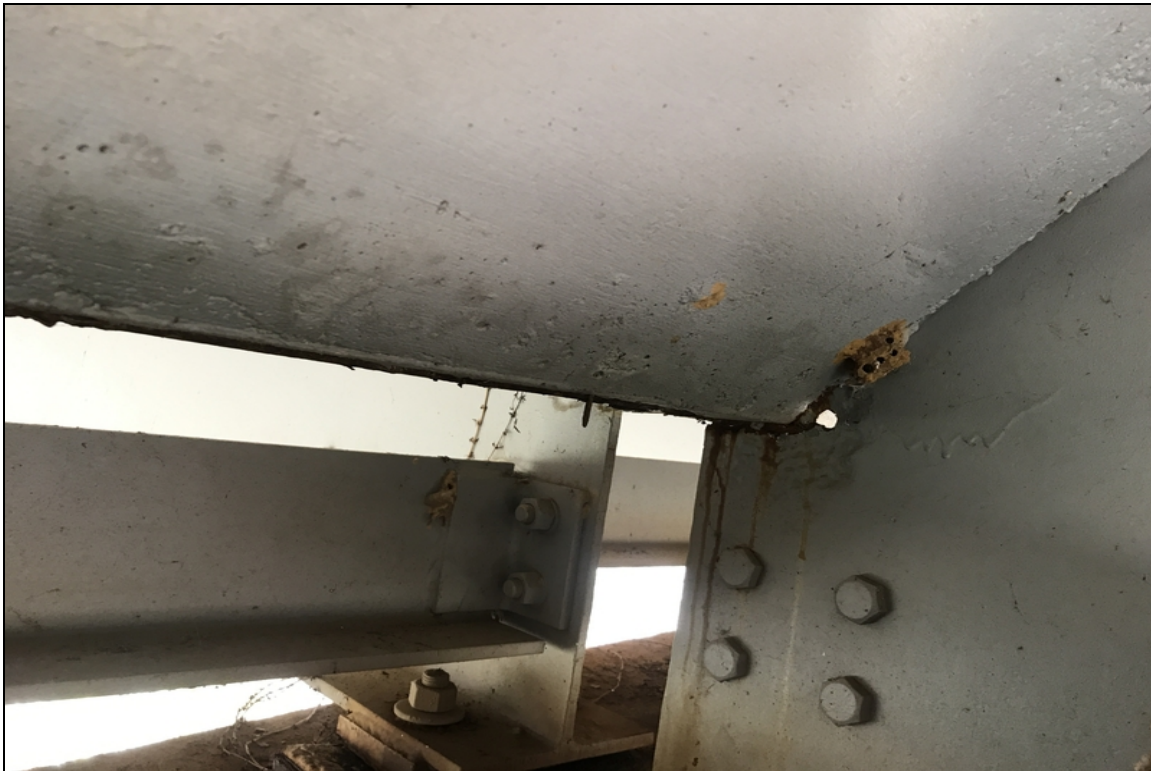
Bent 4 girders 3 and 4 on back side has holes in top of web in the haunch area.

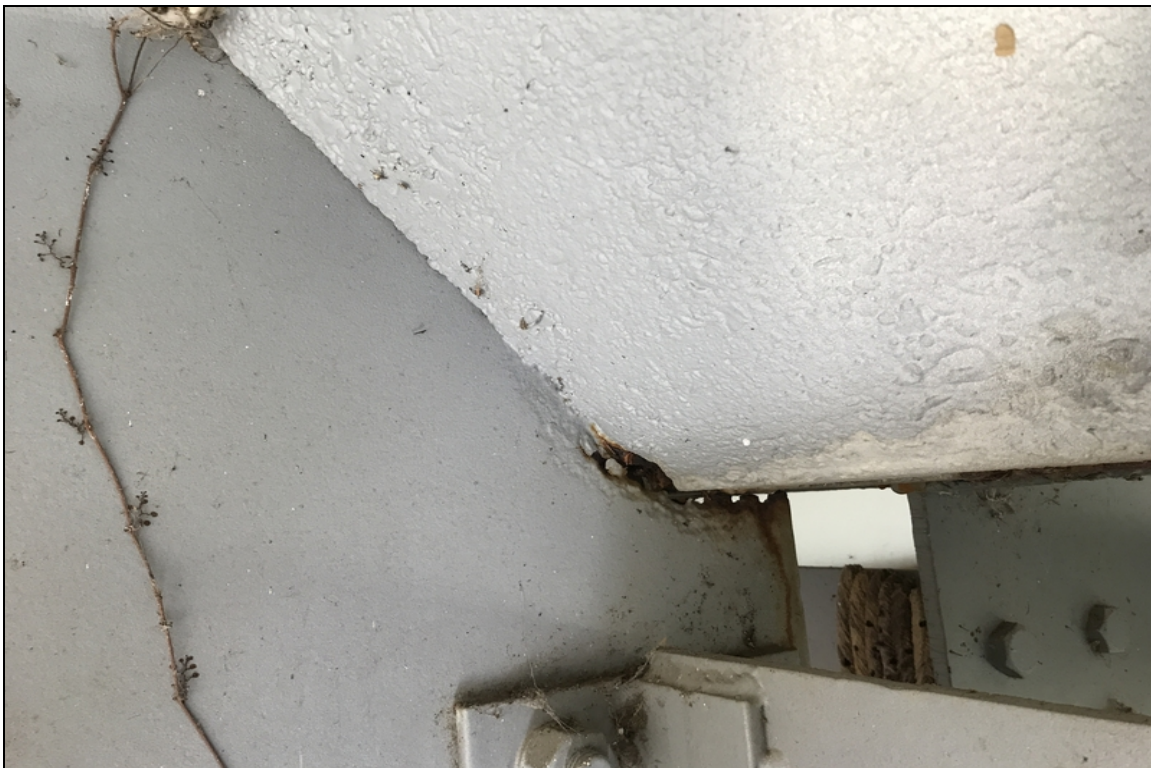
Bent 5 girder 6 has a hole in the haunch area. Girder 3 is the same on back side.

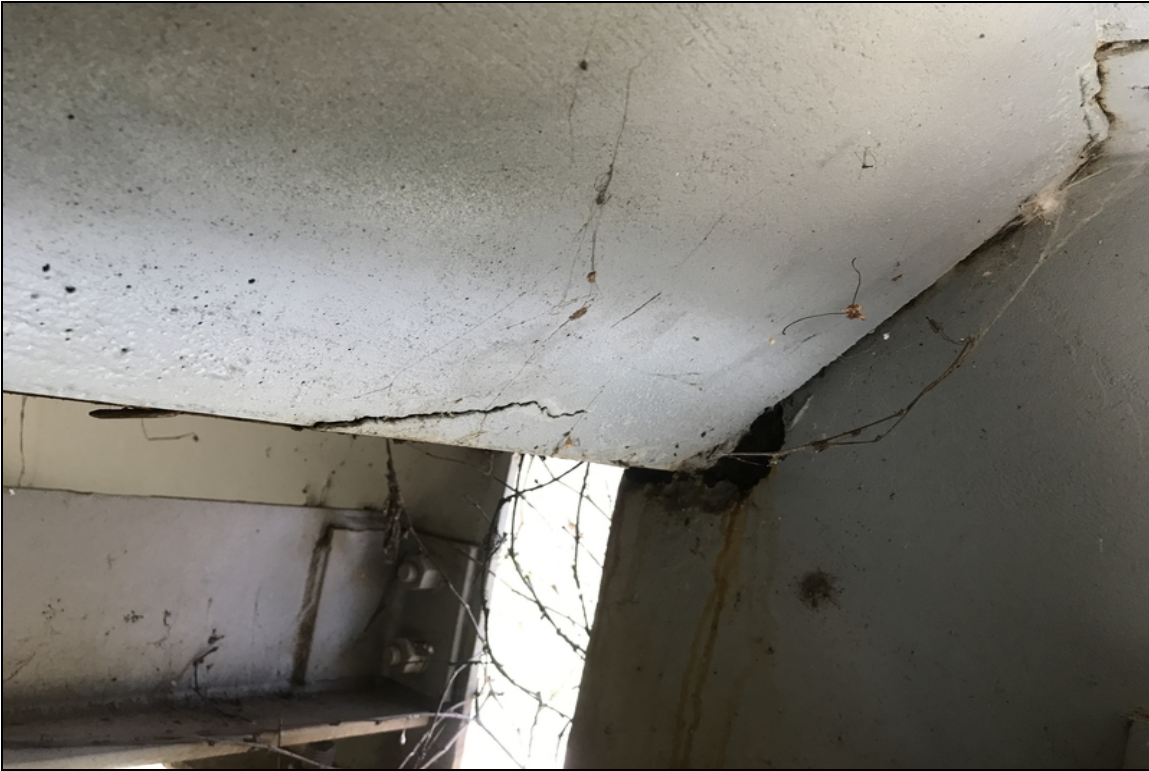
Bent 5 girder 7 has approximately 1/4" section loss in top of web in the haunch area. Girders 4 and 5 area the same. Back side.

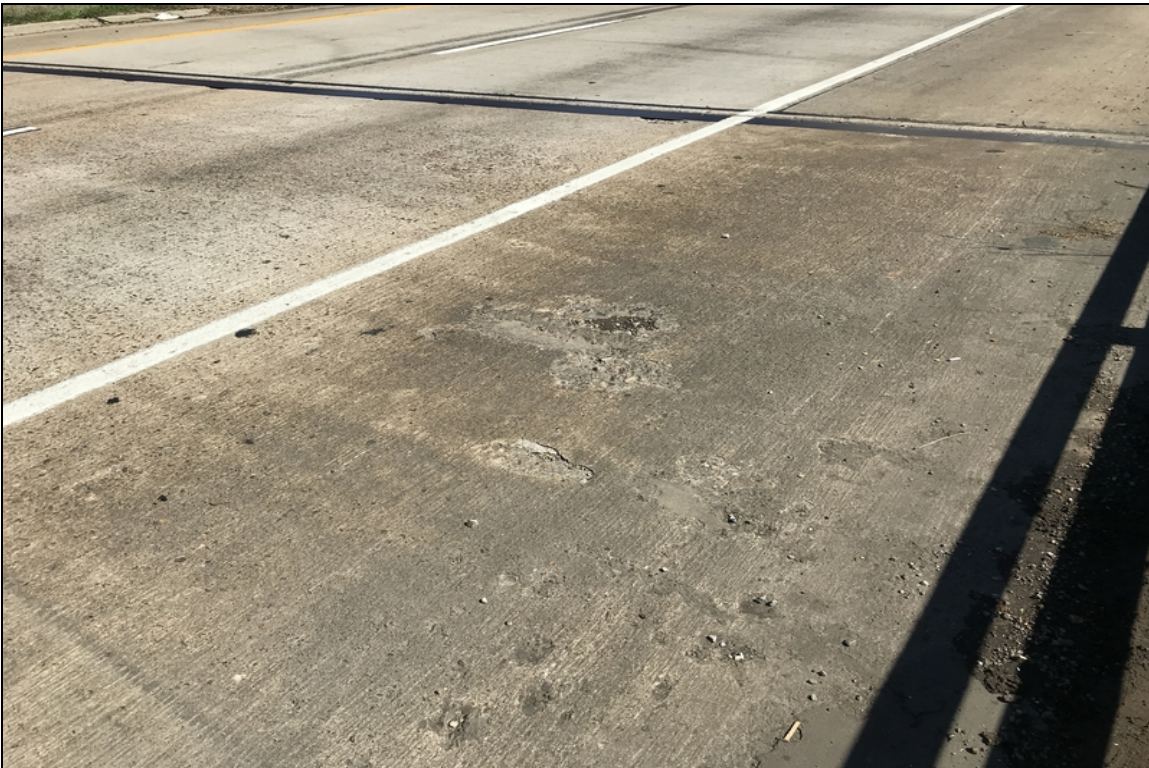
Span 5 deep abrasion in right lane.
