Bridge #B3947 (Routine)
I-40, EB LNS over Cabin Creek
Location: 0.73 M NW Of US 64

Team Lead: Kevin Milligan Inspection Date: March 09, 2020

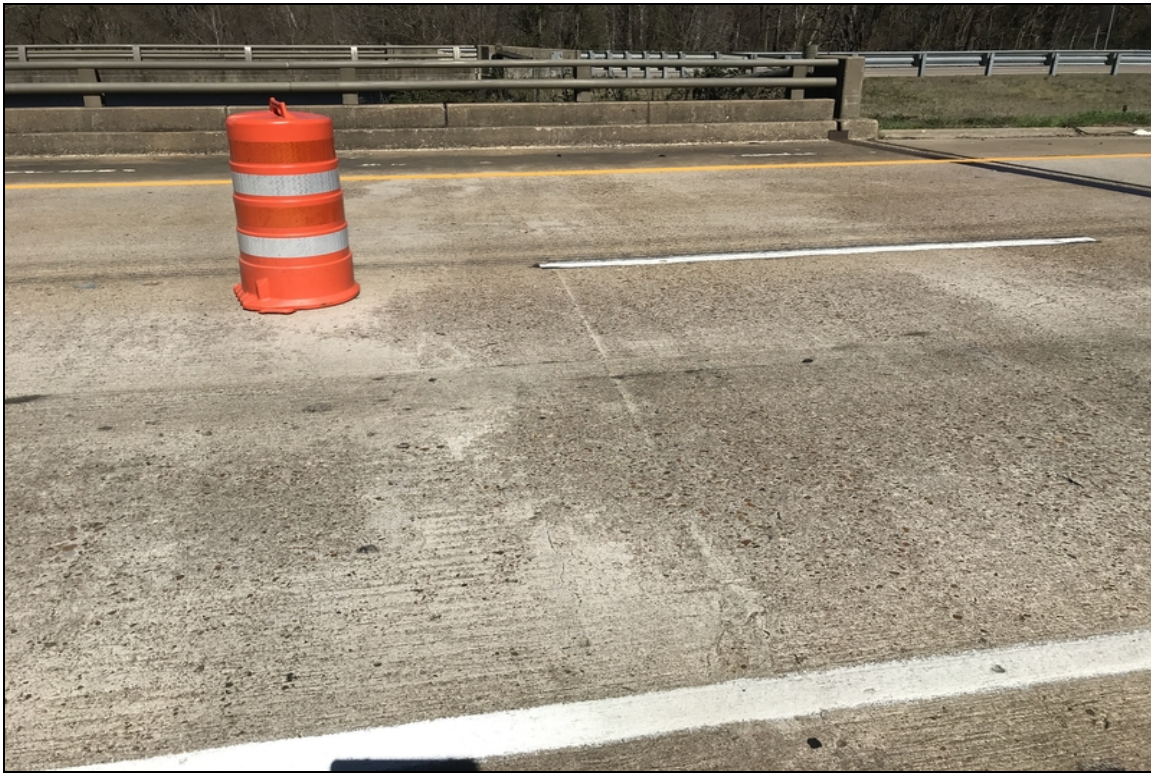
Span 5 large transverse cracks.

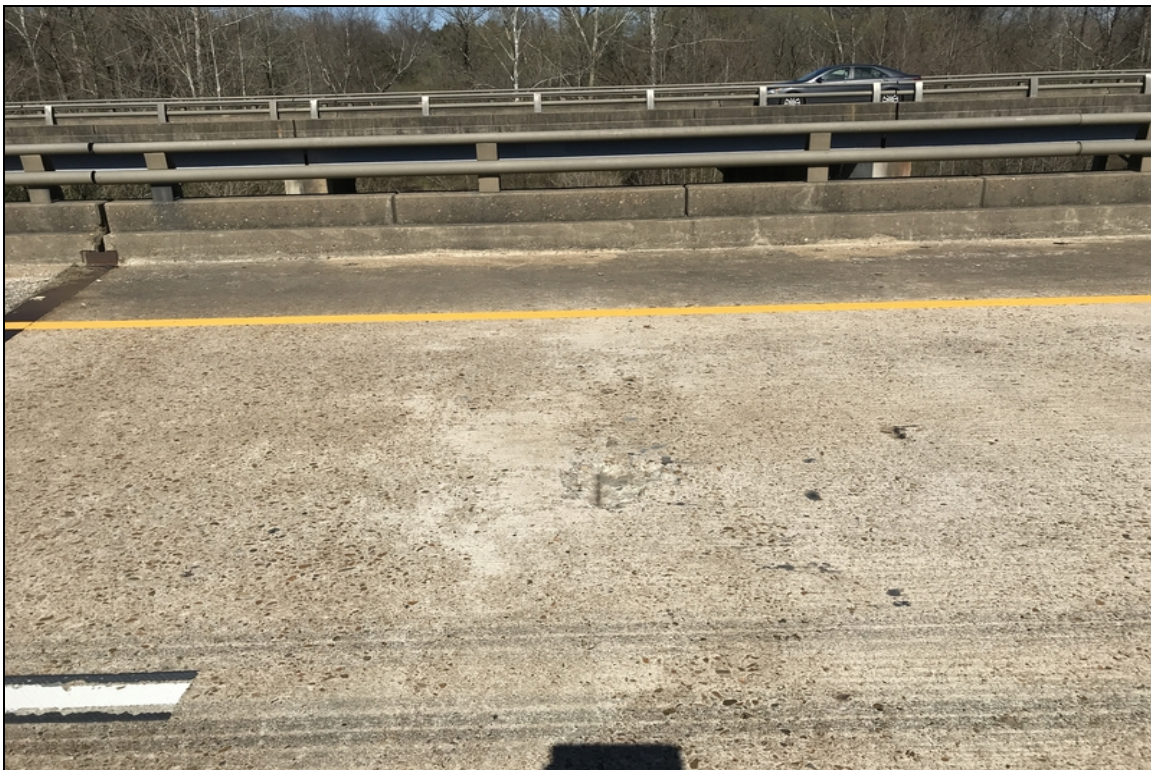
Span 3 left lane spall with exposed reinforcing steel.

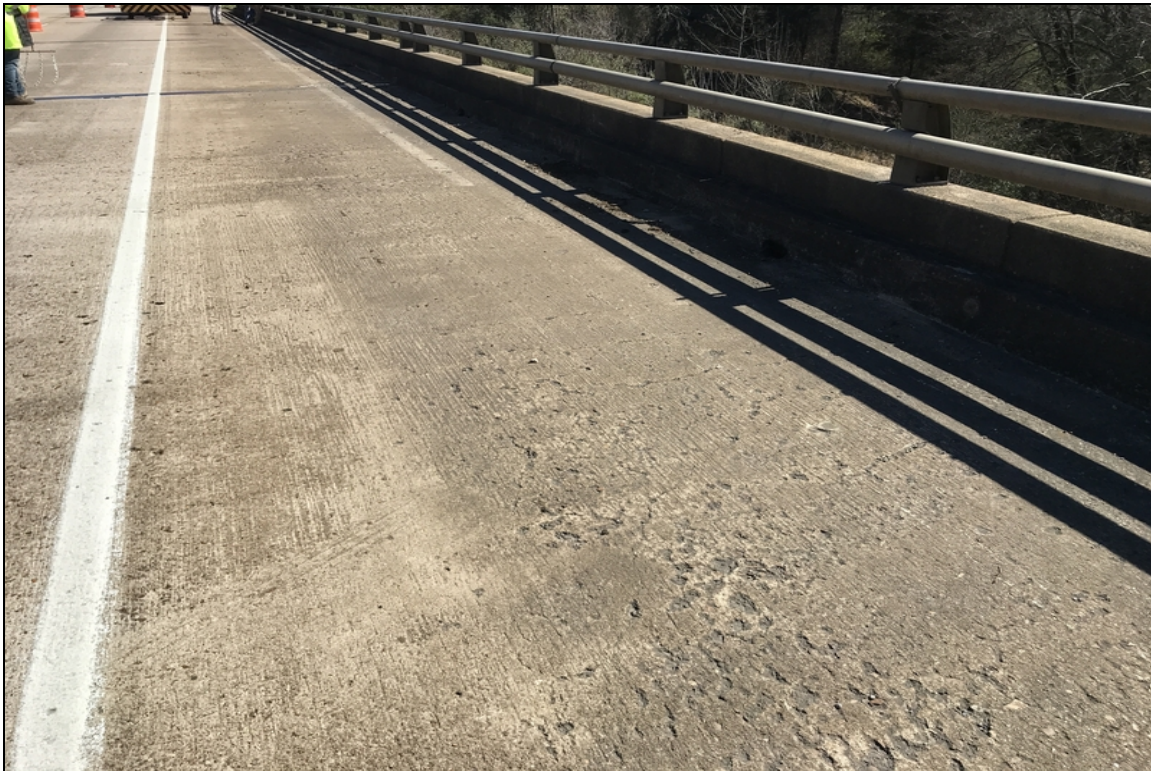
Abrasion along right shoulder this is typical.

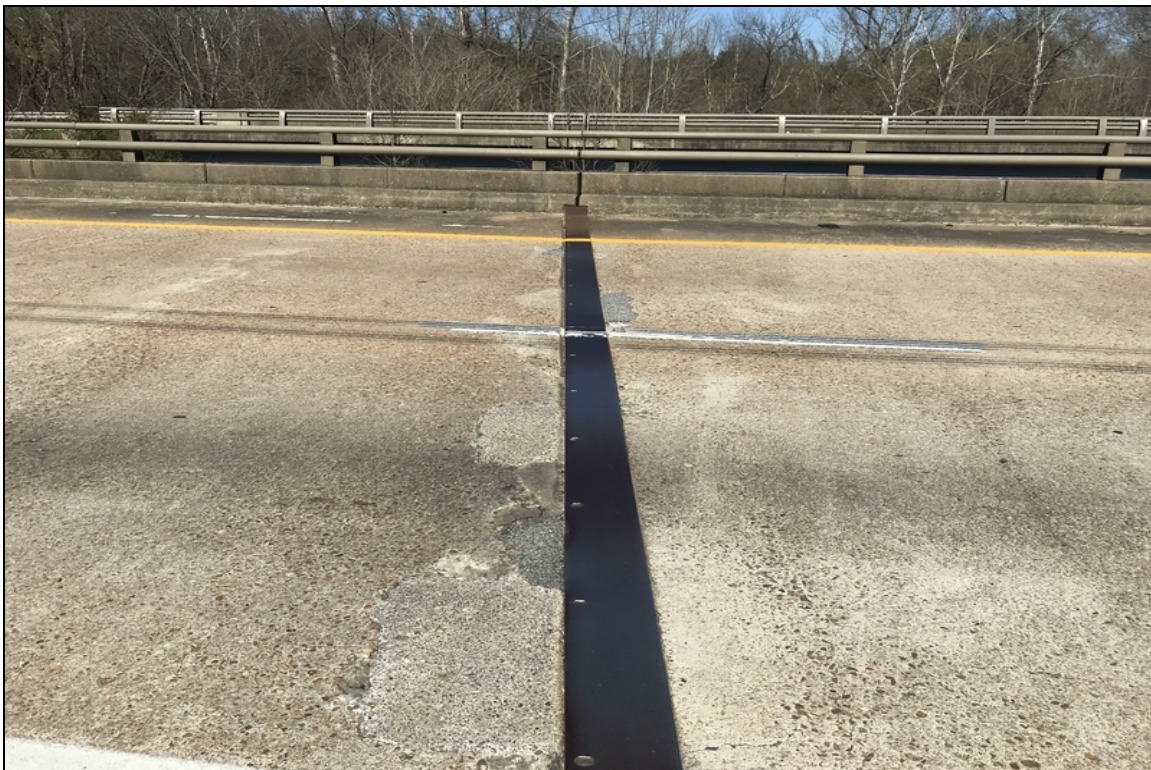
Bent 2 sound and unsound at assembly joint.

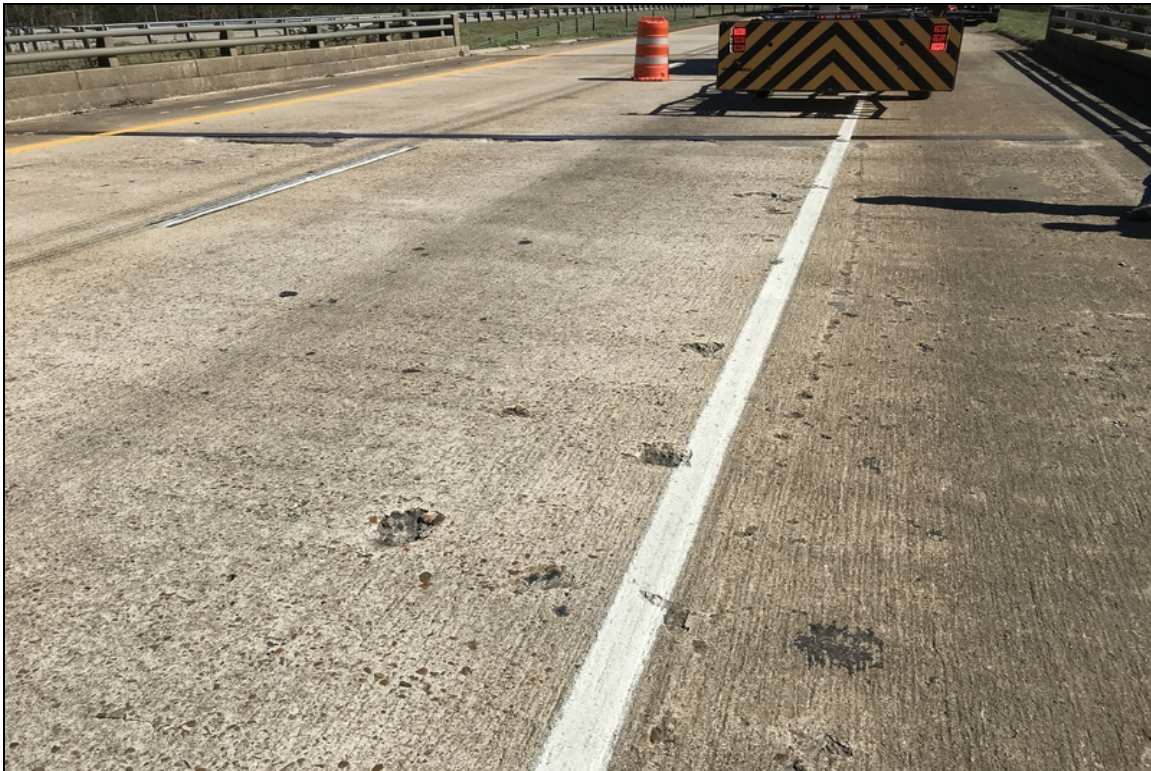
Span 4 shallow spalls in right lane.

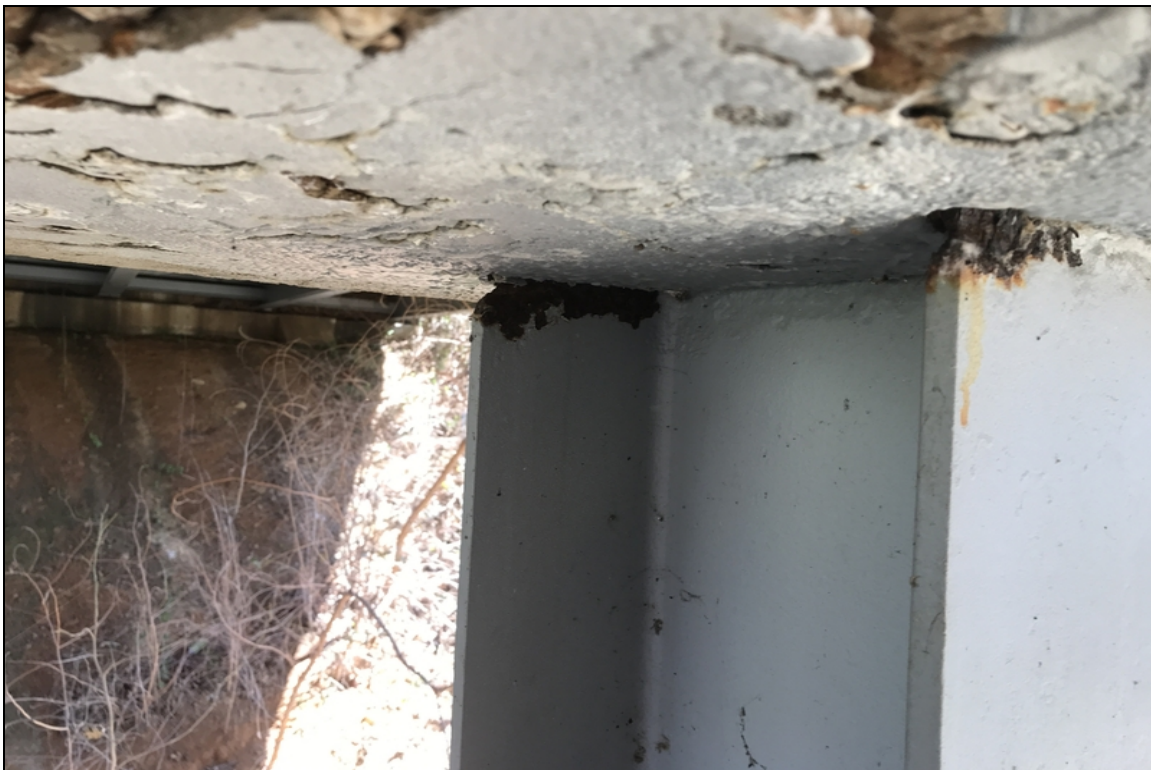
Bent 5 top of pile has section loss some up to knife edge.

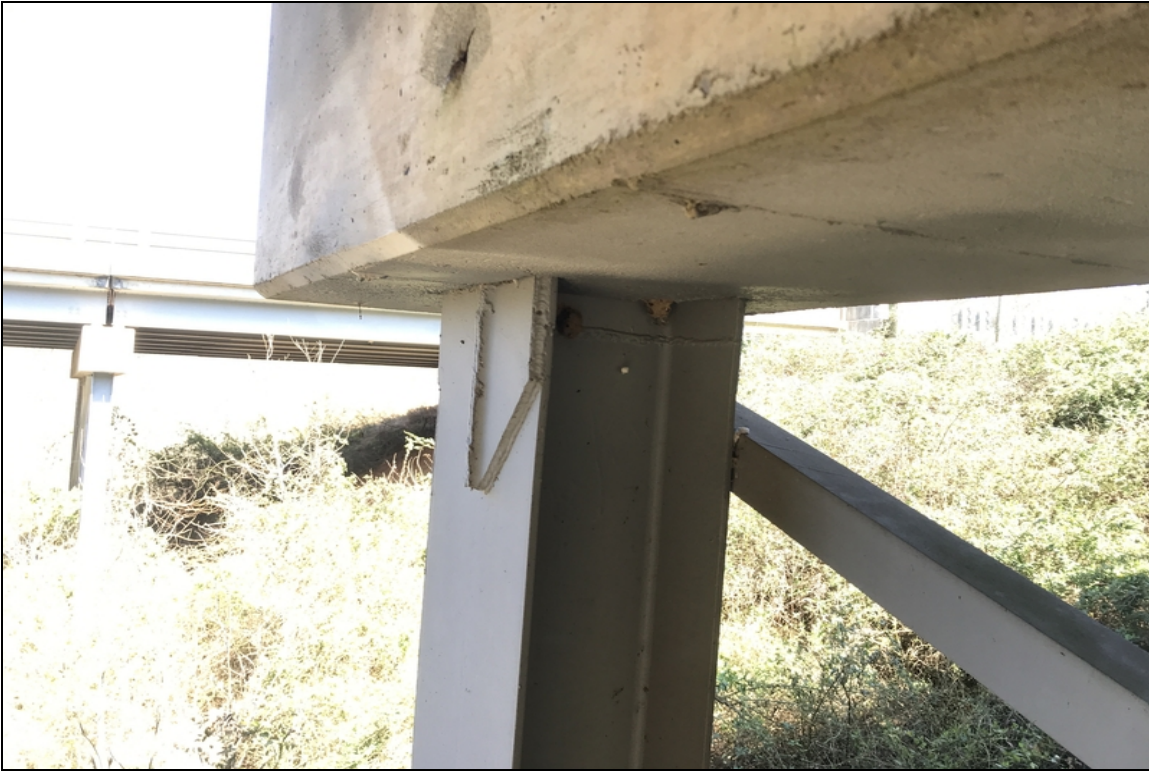
Bent 5 pile 1 has been repaired.

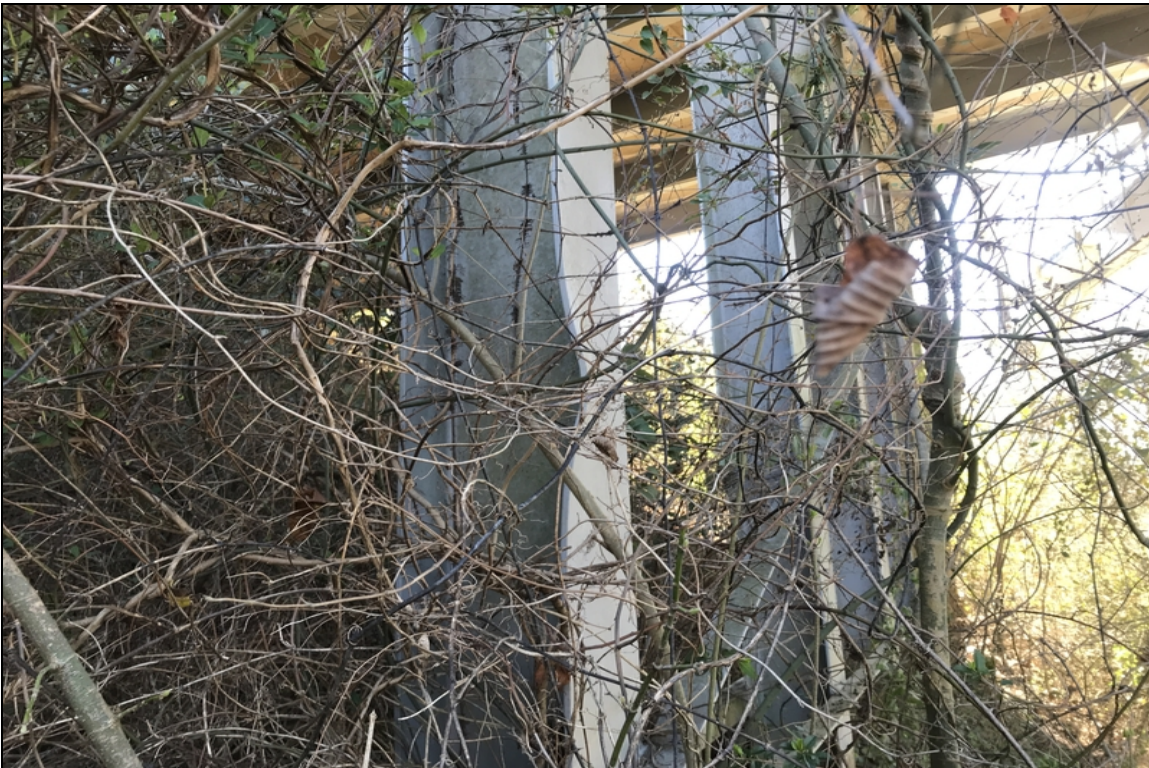
Bent 5 pile 1 has a bend in the flange approximately 5' above ground level.

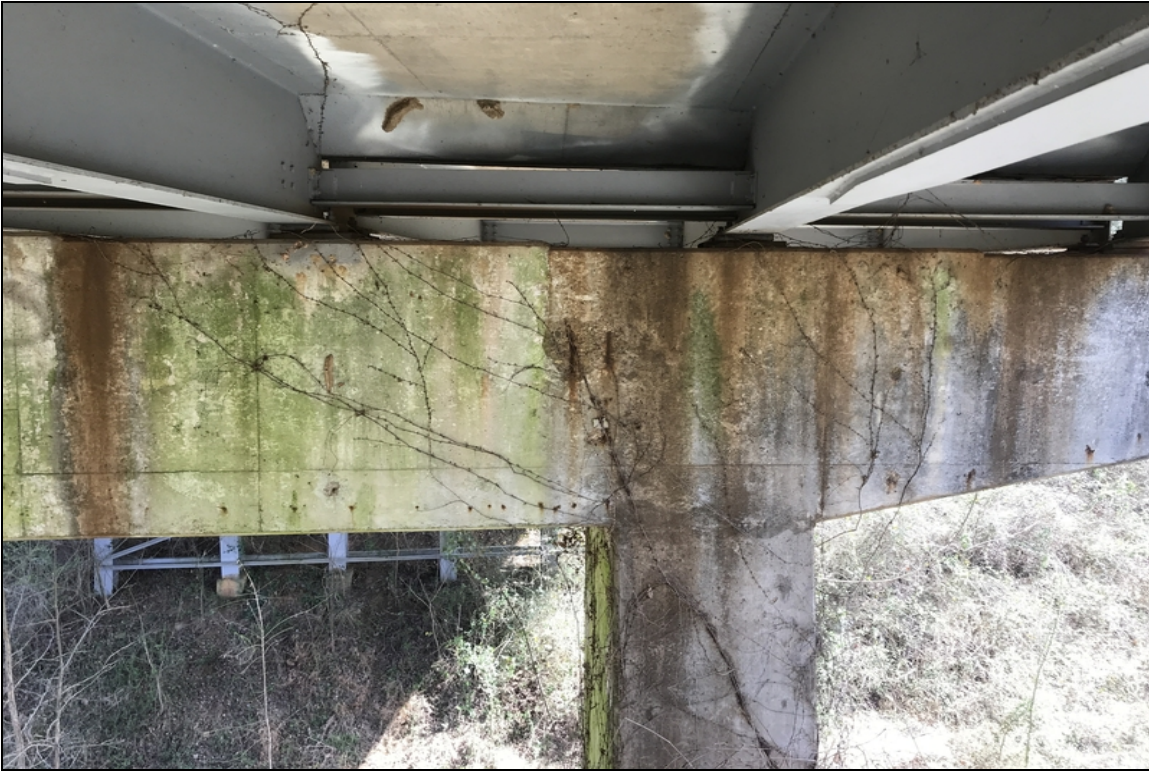
Bent 4 back side 2' spall with exposed reinforcing steel with section loss.

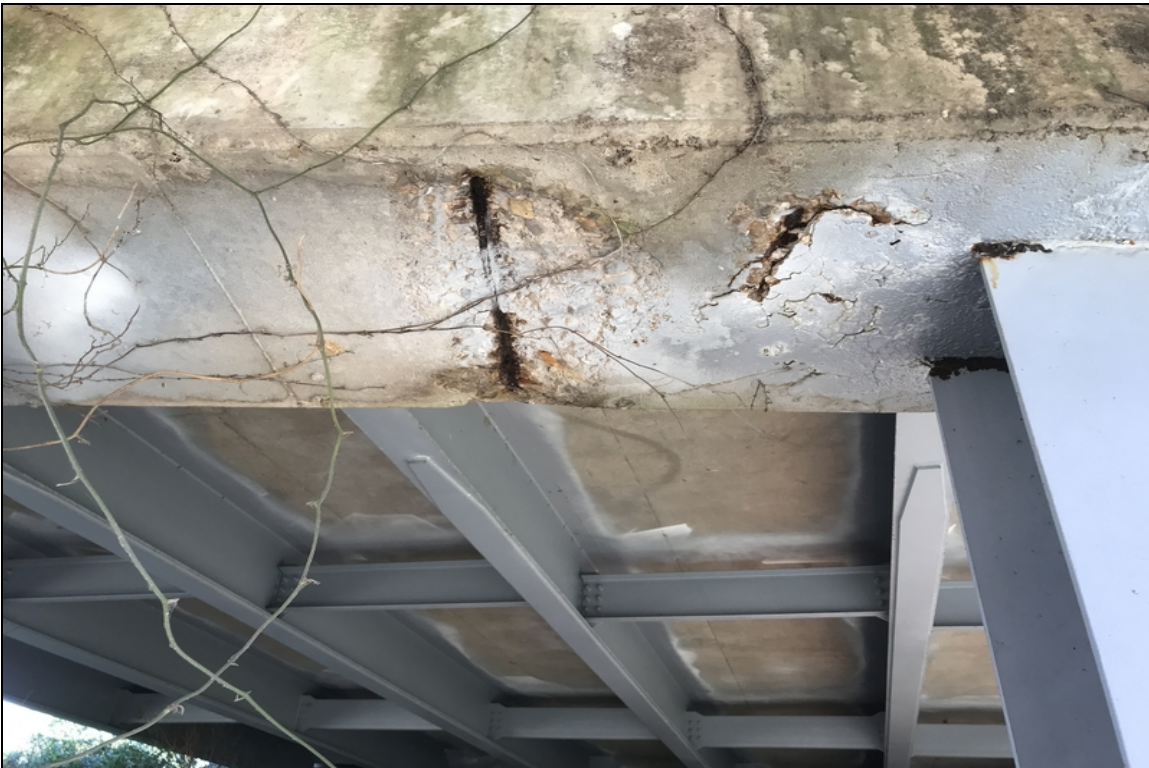
Bent 5 between piles 4 and 5 bottom of cap has a spall with exposed reinforcing steel.

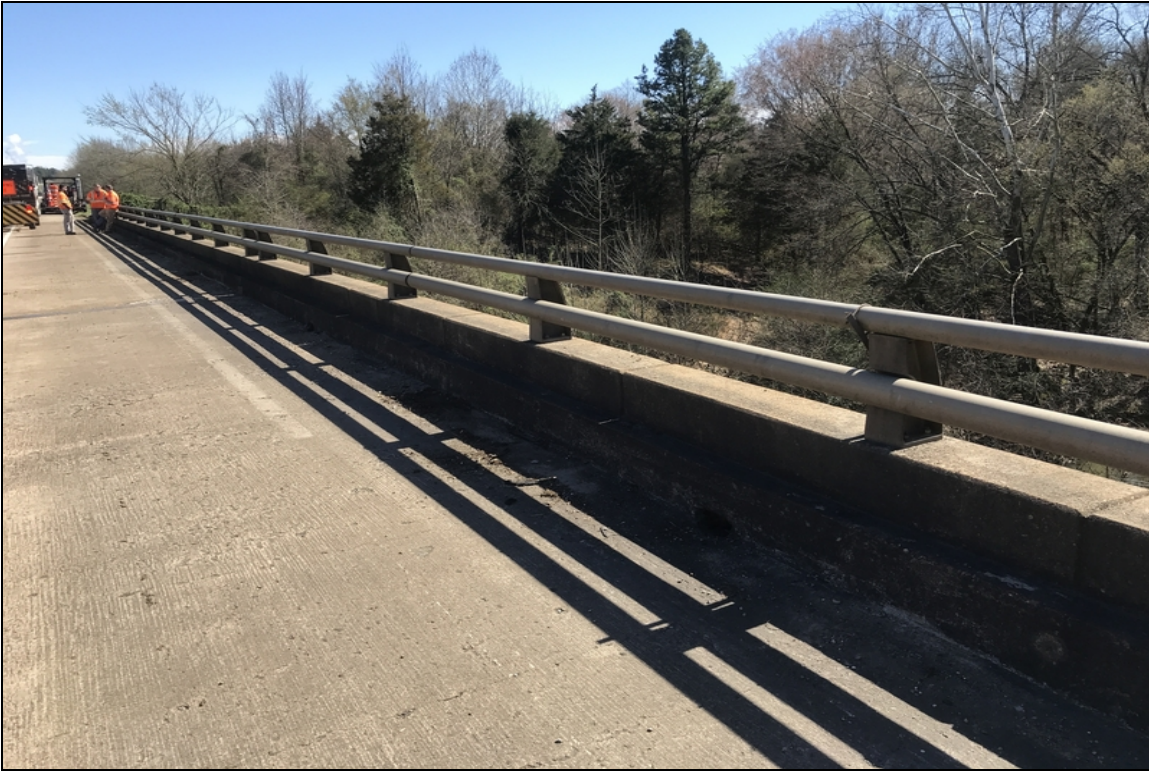
Typical condition of metal bridge rail.

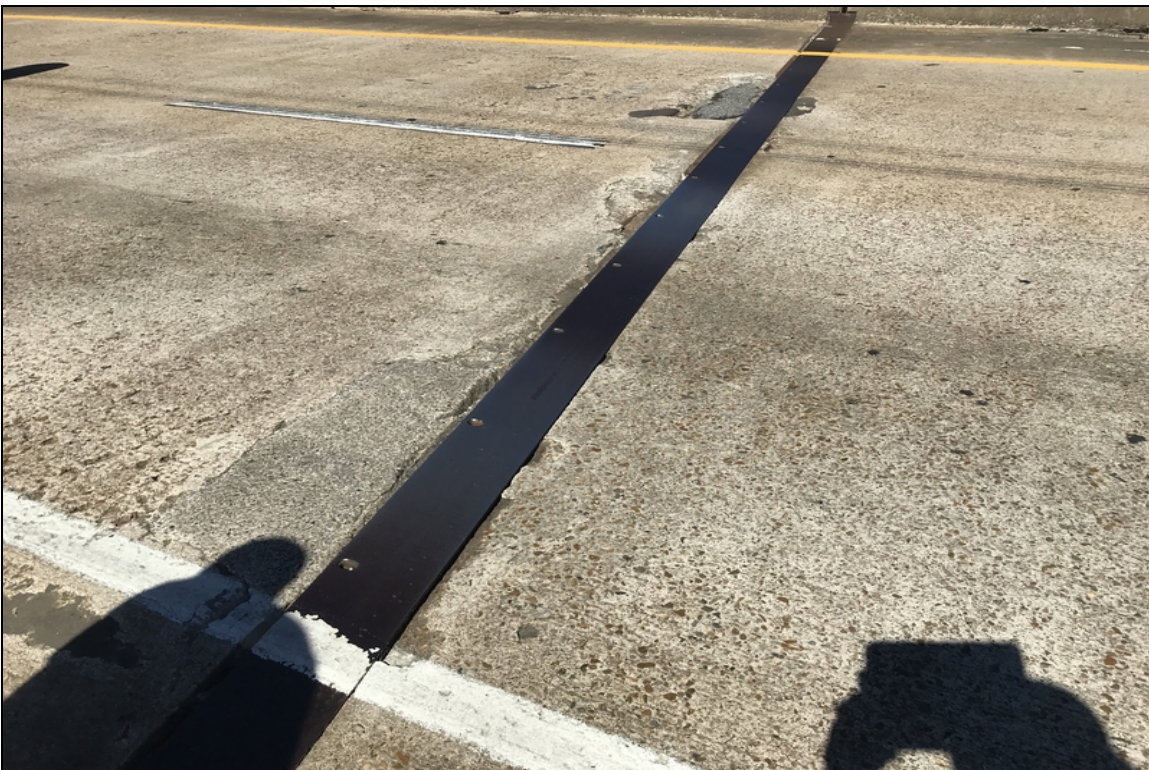
Bent 5 right lane has approximately 5' of loose joint armor.

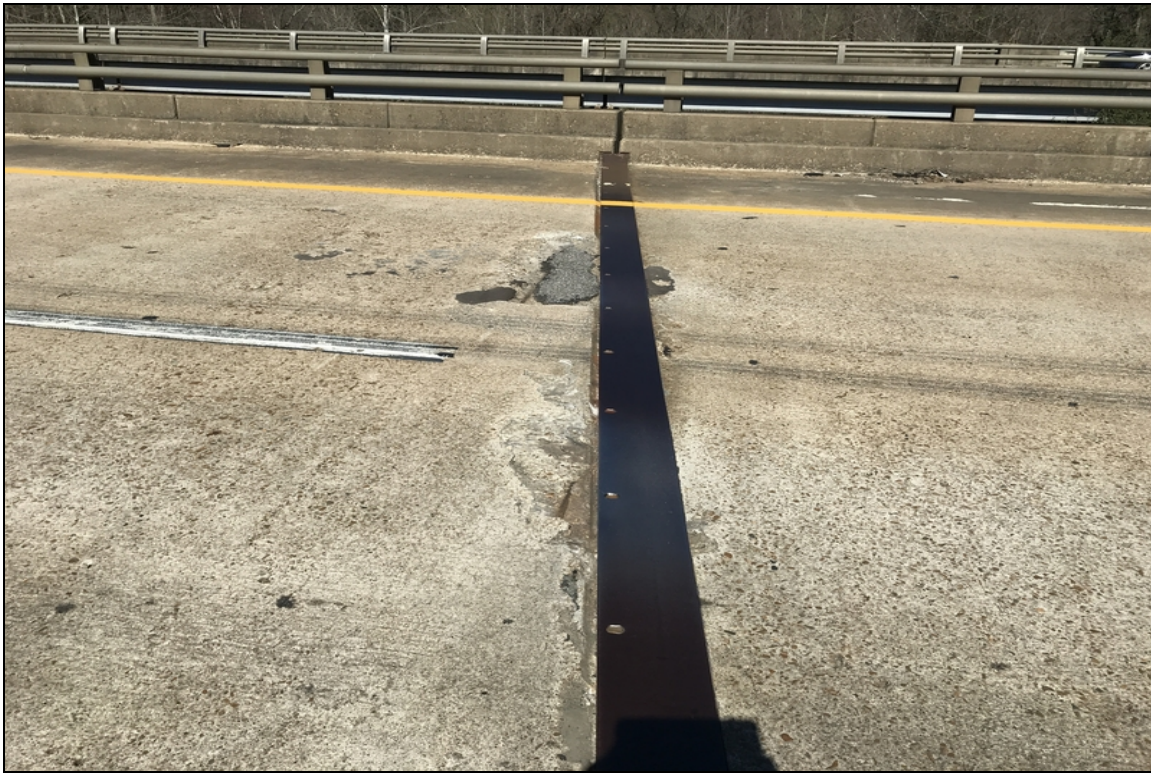
Span 4 large spalls in both lanes with exposed reinforcing steel.

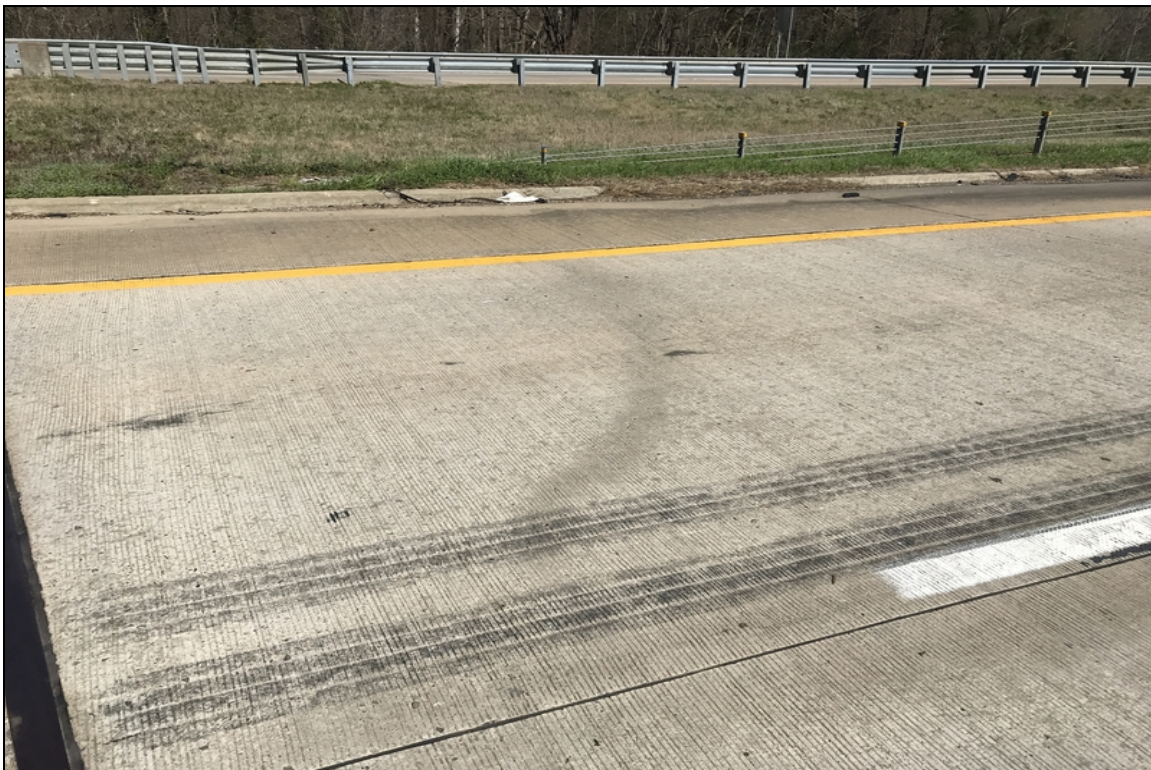
East approach has large transverse cracks.

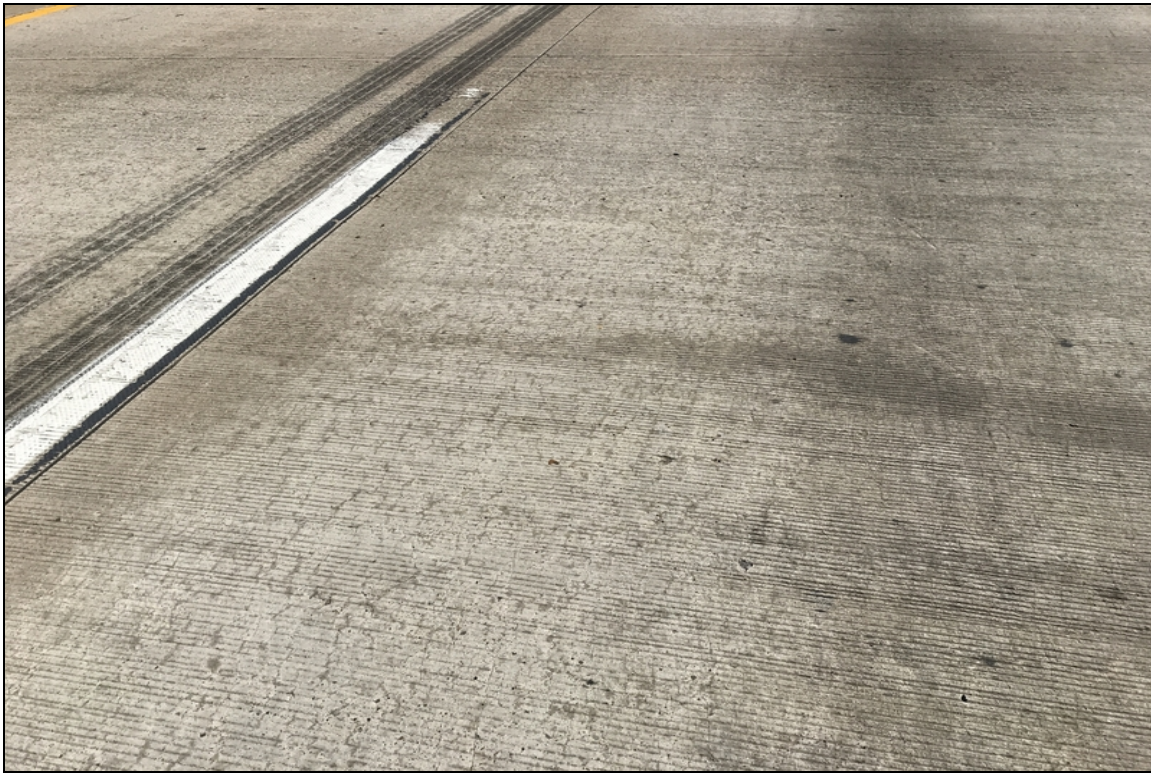
Typical map cracking in right lane in east approach.

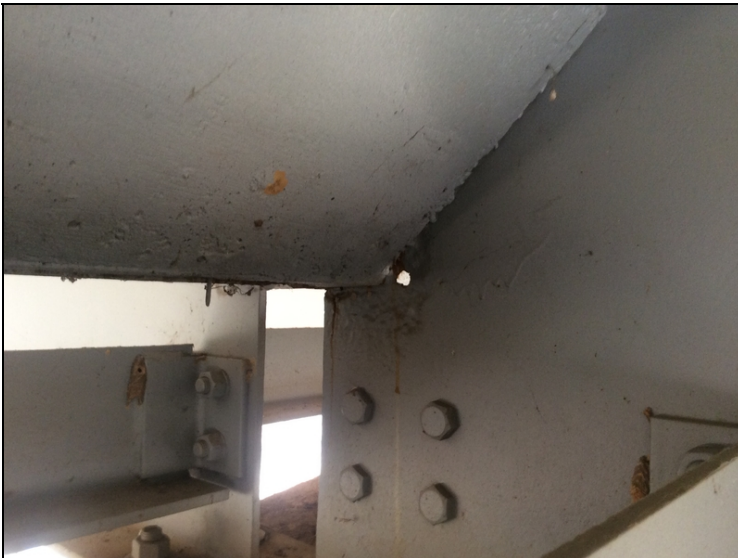
End of Beams, section loss in the web (small holes rusted completely through the web) below the concrete haunch area.
Location of beams with holes - ahead side of pier # 3, beam # 5
backside of pier # 4, beam # 4.
backside of pier # 5, beam # 6.

Pier #4, backside, beam #4, hole rusted through web at haunch area.

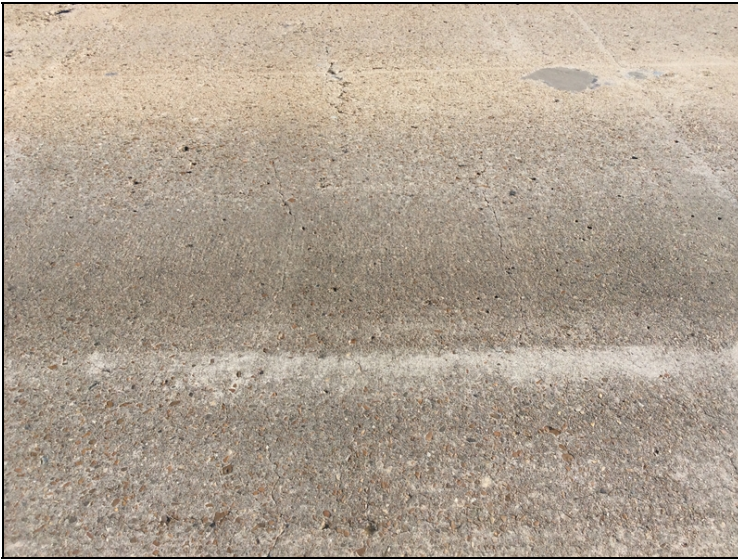
Typ. Cracking in Deck.

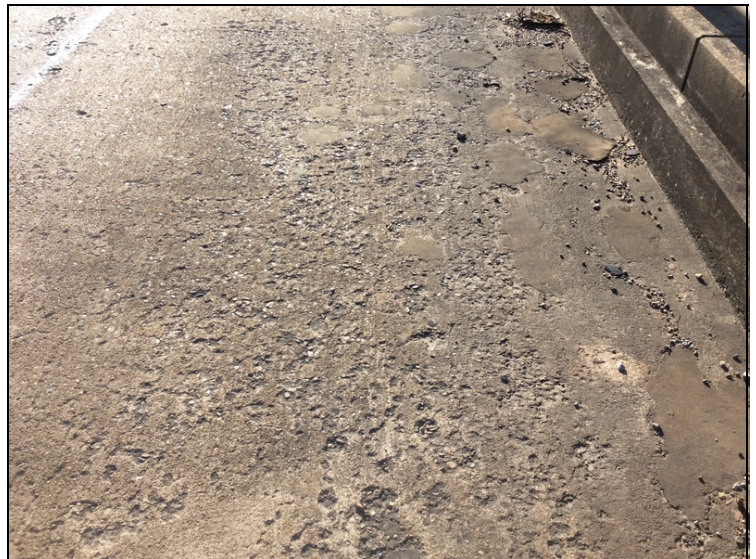
Typ. Scaling in Deck.

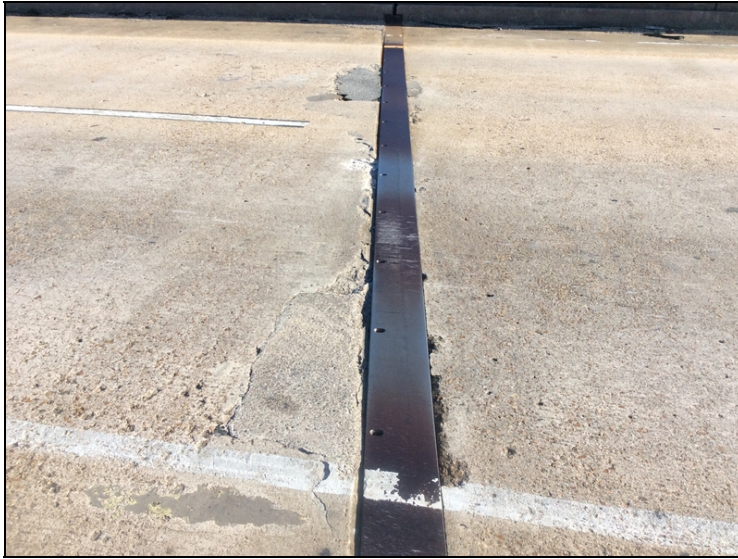
Typ. Delam, Cracking, Scaling & Spalling at Joints.

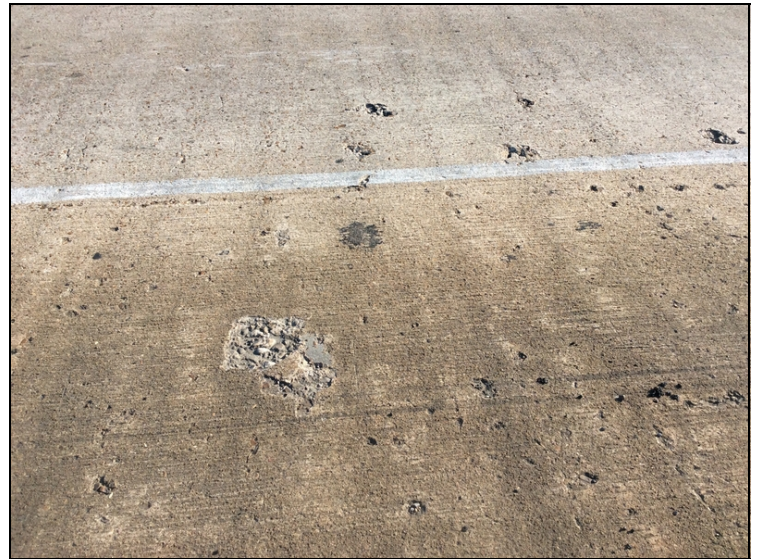
Typ. Delam, Cracking, Scaling & Spalling in Deck.

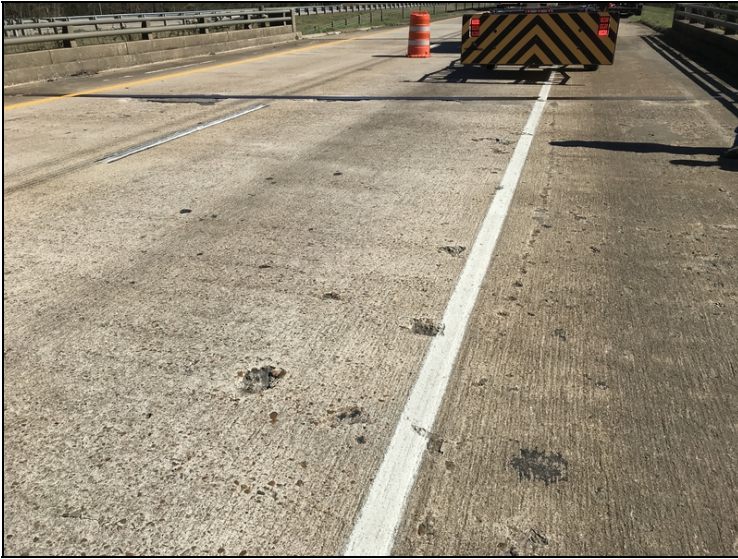
Span 4 shallow spalls in right lane.

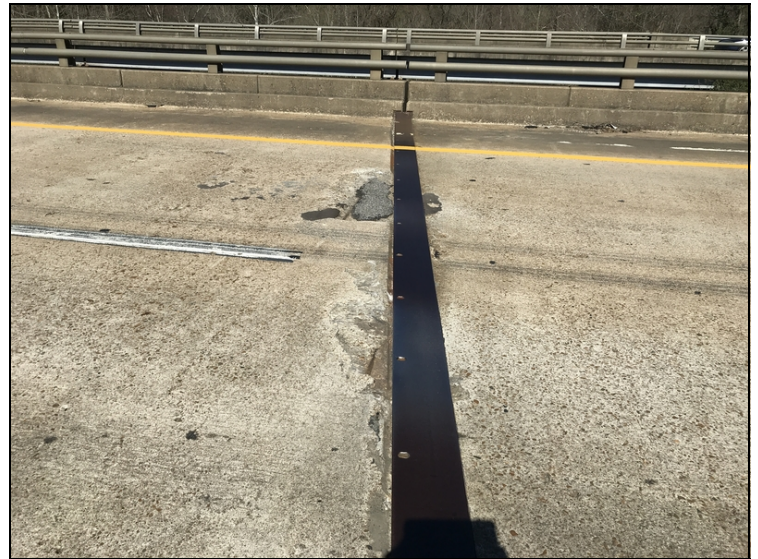
Large spall in span 4 both lanes at bent 5 with exposed reinforcing steel.
MINOR DELAM, CRACKING, SCALING & SPALLING THROUGHOUT DECK.

Span 4 large spalls in both lanes with exposed reinforcing steel.

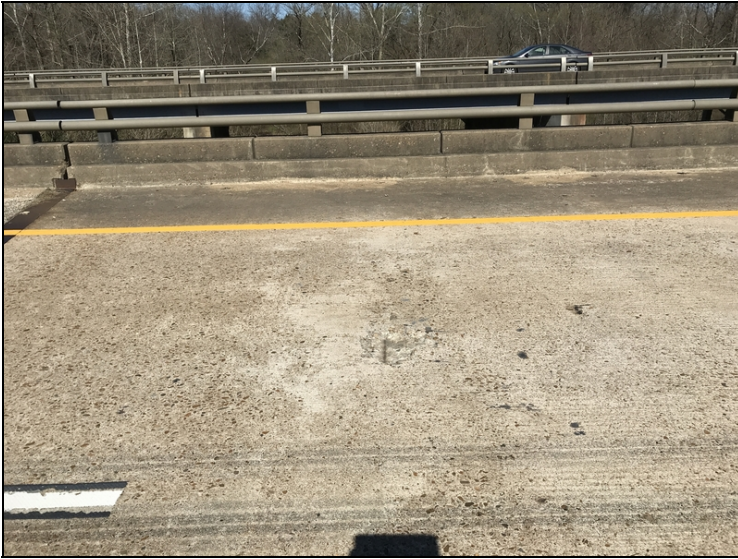
Span 3 left lane spall with exposed reinforcing steel.

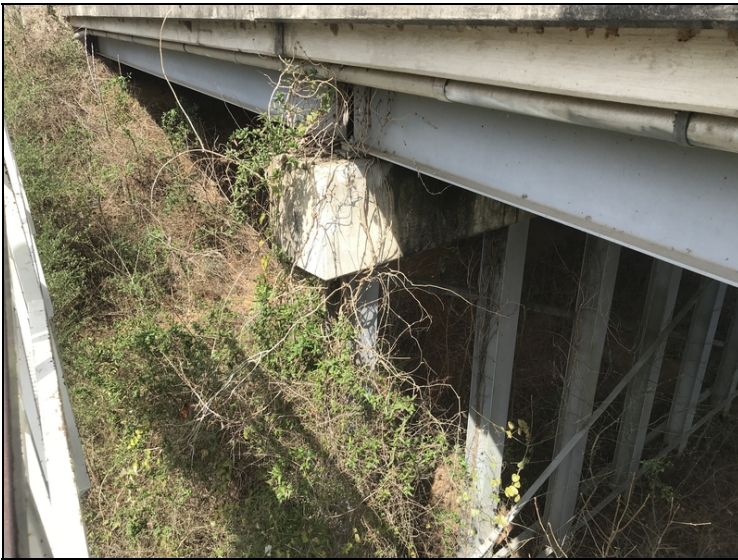
Vegetation at bent 2.

Bent 2 right vegetation up on cap and piles.

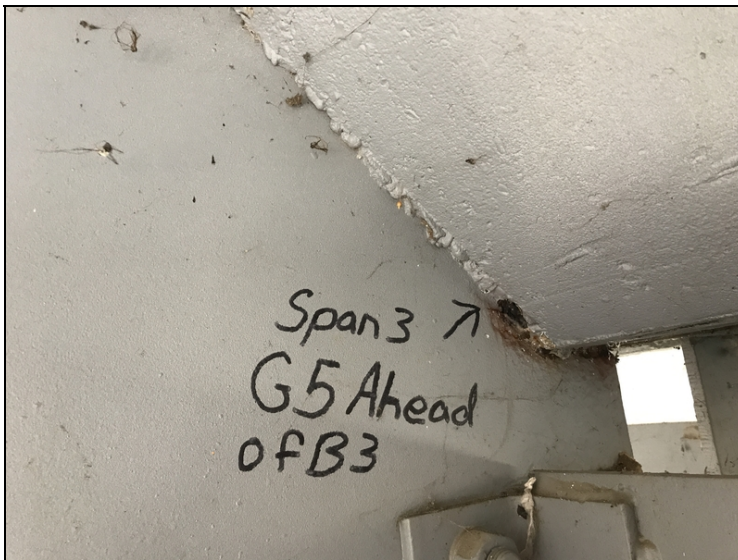
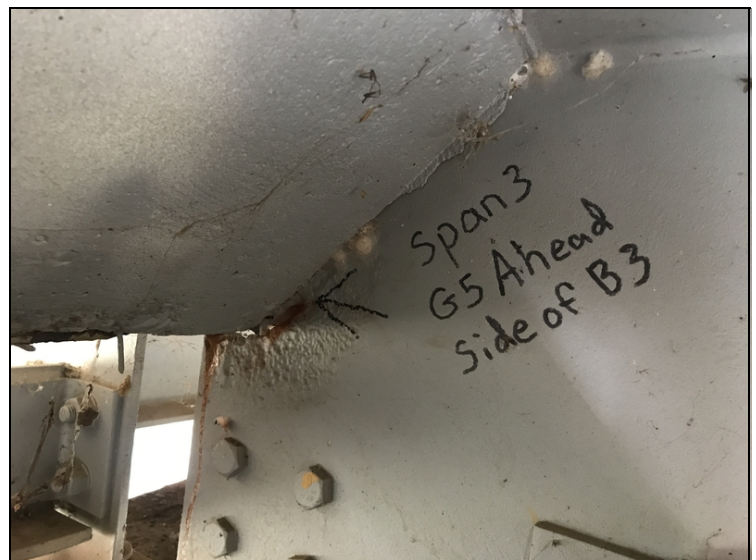
Crack in top of web at girder 5 bent 3 ahead side.

Span 3 Girder 5 ahead of bent 3 there is a crack in haunch area about an 1" long.

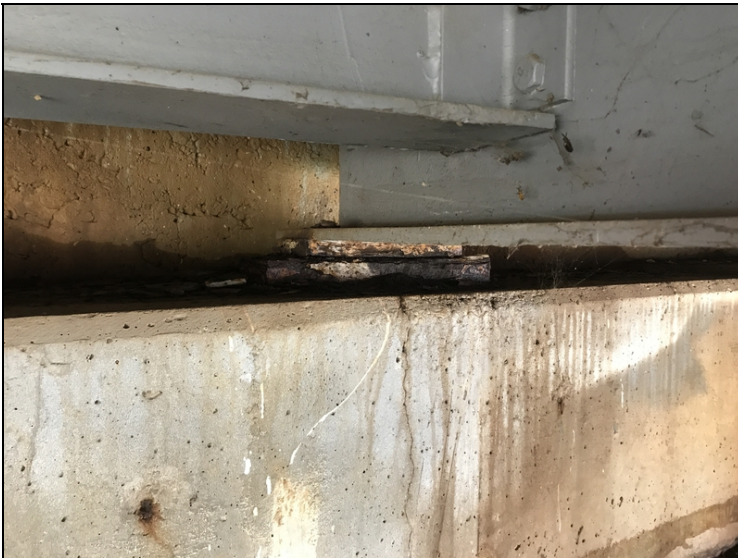
Floating bearings at the following locations Bent 1 bearings 2 thru 4, Bent 3 bearings 4 back side and bearings 3 and 4 ahead side. Bent 4 bearings 3 and 4 are floating at ahead side. Bent 6 bearing 4 is floating.

Bent 1 bearings 2 thru 4 are floating, making contact under load.

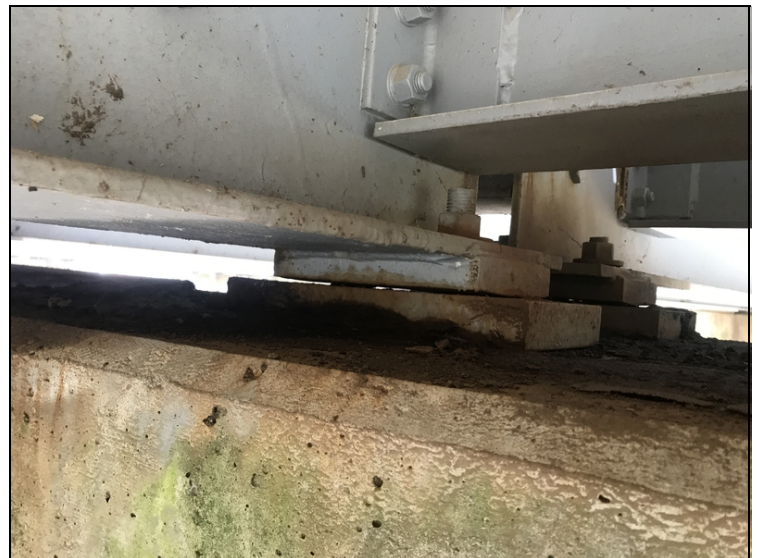
Moveable bearings at bent 3 have corrosion and some having pack rust. Bearings 4 back side and bearings 3 and 4 ahead side are floating.
