Bridge #A6868(Routine)

I-40 - SEC 21, WB over US 64 - SEC 5

Location: Jct US 64 & I-40

Team Lead: Kevin Milligan Inspection Date: March 02, 2020

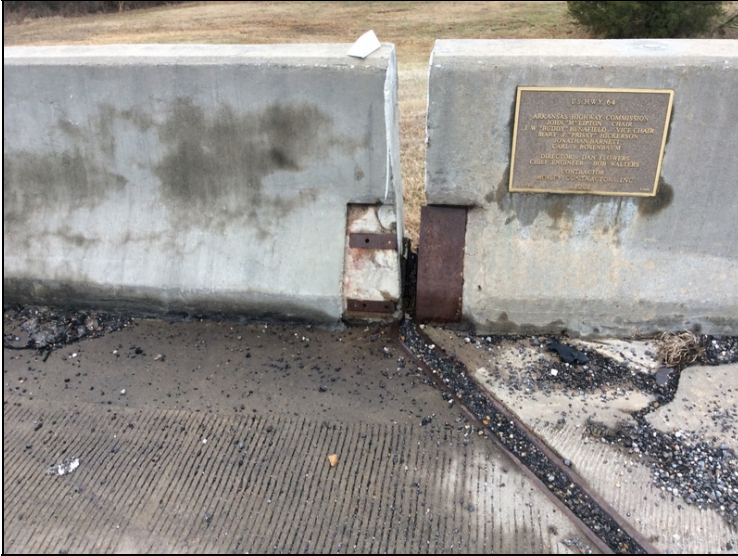
(331)							
KRM & ADC Date 3/3/2020 Concrete bridge railing has scattered vertical cracking, there is a spall on the railing at bent 3 left side.							
COND. 1 - 412 LF - MINOR VERTICAL CRACKING. SLIDE PLATE MISSING FROM LT. RAIL AT ABUTMENT 4.							
COND. 2 - 2 LF - MINOR SPALL W / REBAR EXPOSED IN LT. RAIL AT PIER 3 DUE TO IMPACT DAMAGE.

Left side, at east end of bridge.  
Slider plate missing from parapet wall.

Slide Plate Missing on Rail at Abutment 4 Lt. Side.

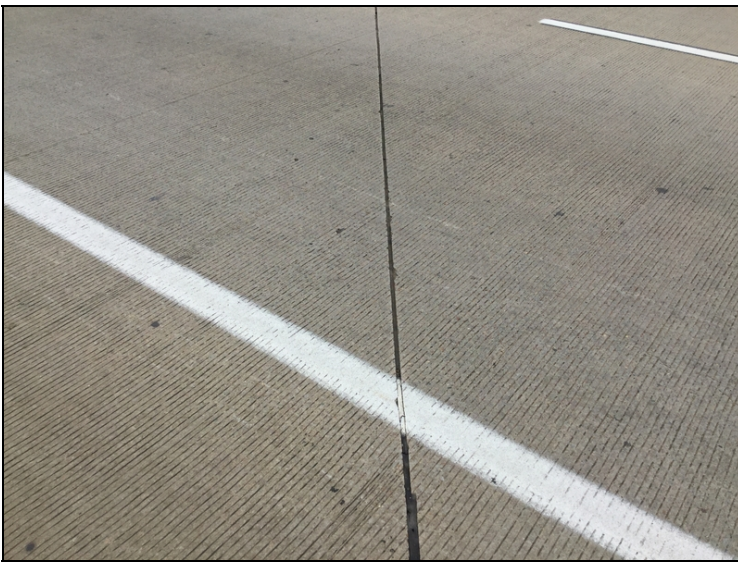
Missing sawn joint at bent 2 right lane Approximately 47'.  
Bent 3 has approximately 78' missing in both lanes.

Sawn joints at bent 2 are missing in the right lane, approximately 47'

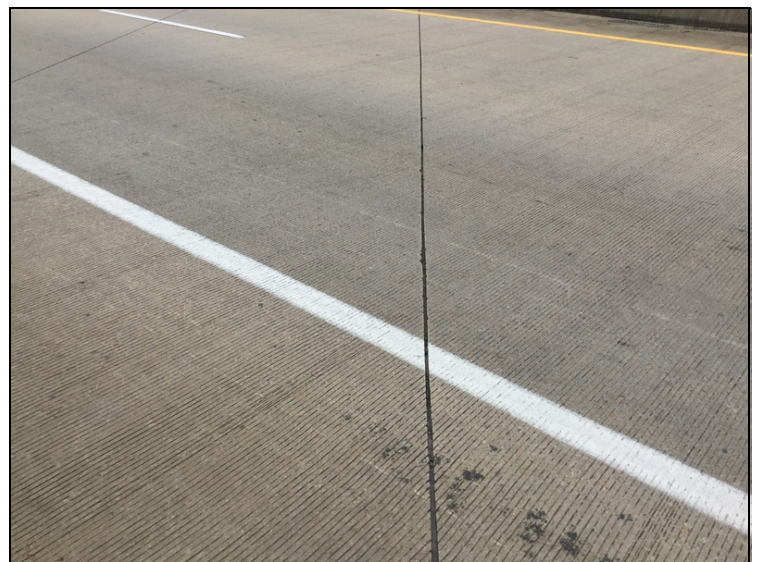
At bent 3 approximately 78' of missing sawn joints.
