Bridge #A3919(Routine)
I 40-SEC 32, WB LN over Friendship Rd.
Location: 4.05 MI E CONWAY CO LINE

Team Lead: William Wood Inspection Date: February 24, 2020

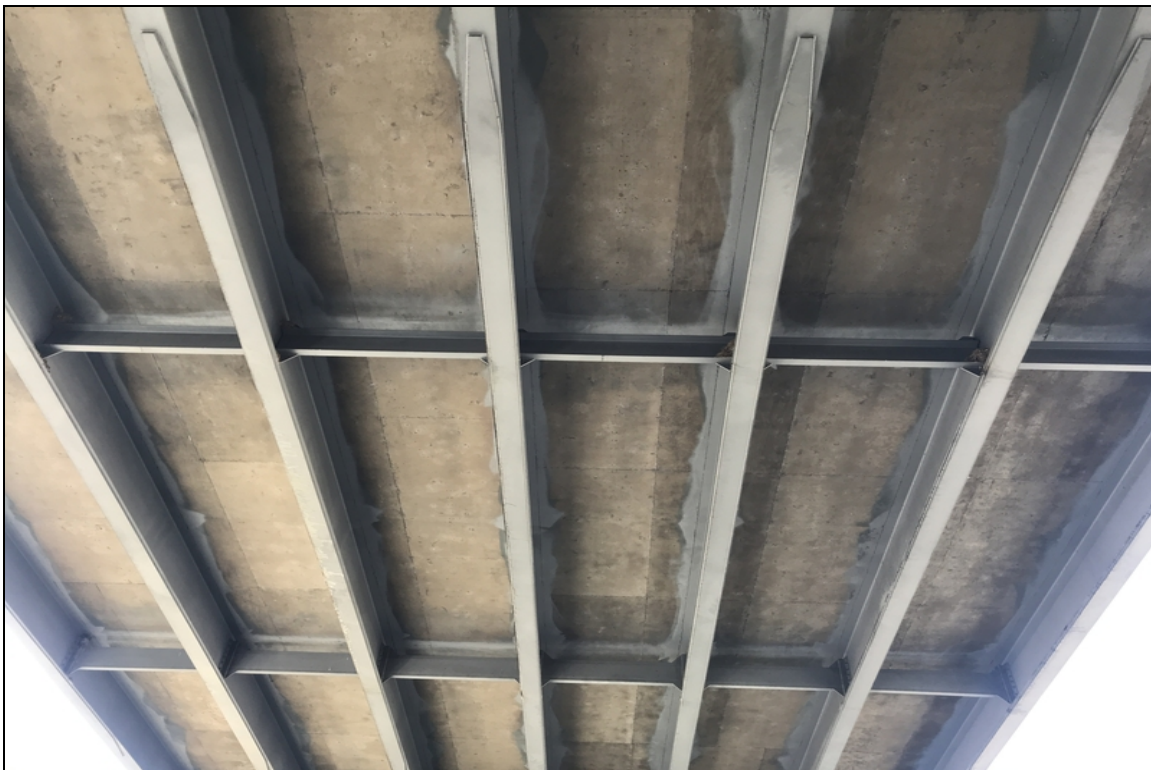
Typ. Condition of Soffit.

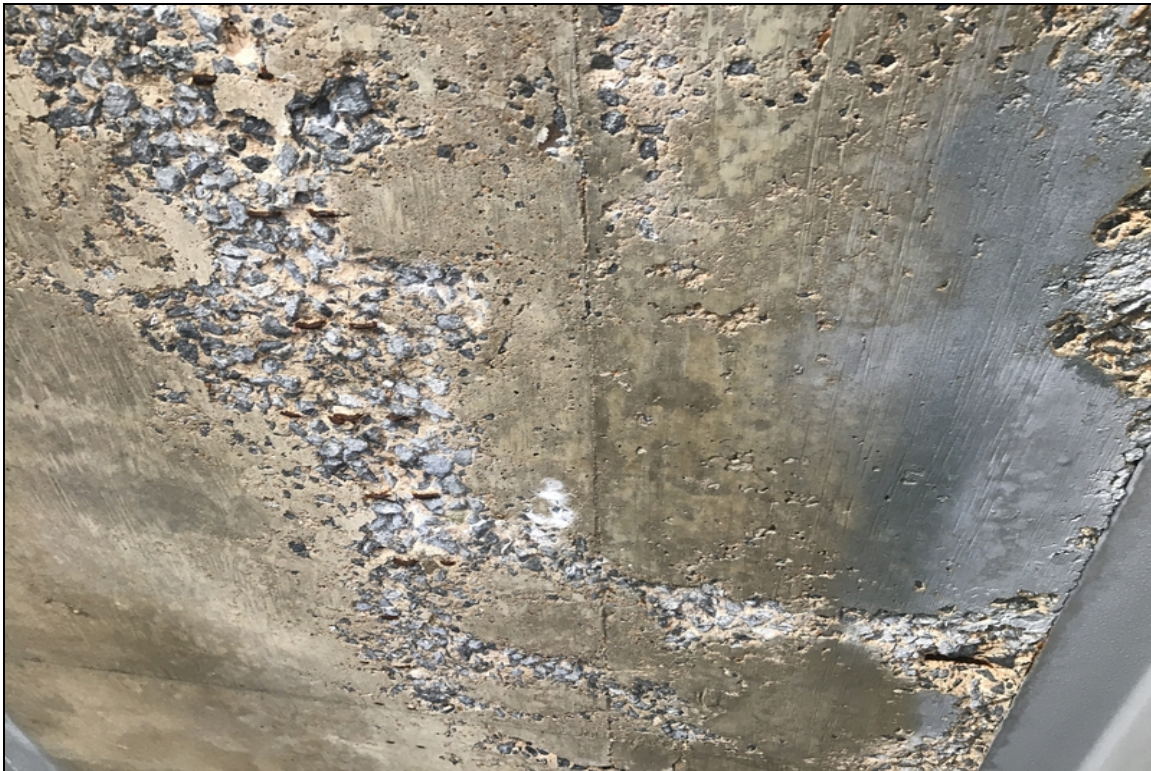
Typ. Scale in Soffit.

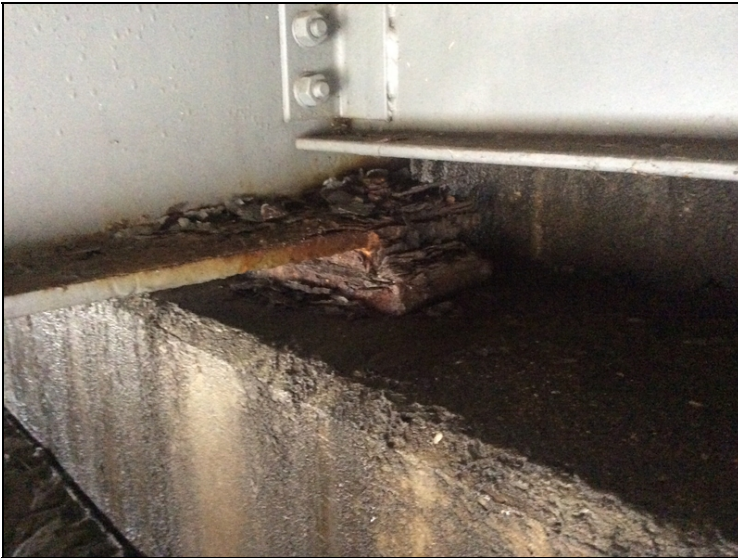
Some bearings at the abutments have moderate pack rust and some bearings are popping (lifting off their seats) when trucks cross.

Abut #1, Bearing #'s 3 & 4 - heavy pack rust and minor section loss. Others have minor and moderate pack rust.

Abut #1, bearing #4 - heavy pack rust.

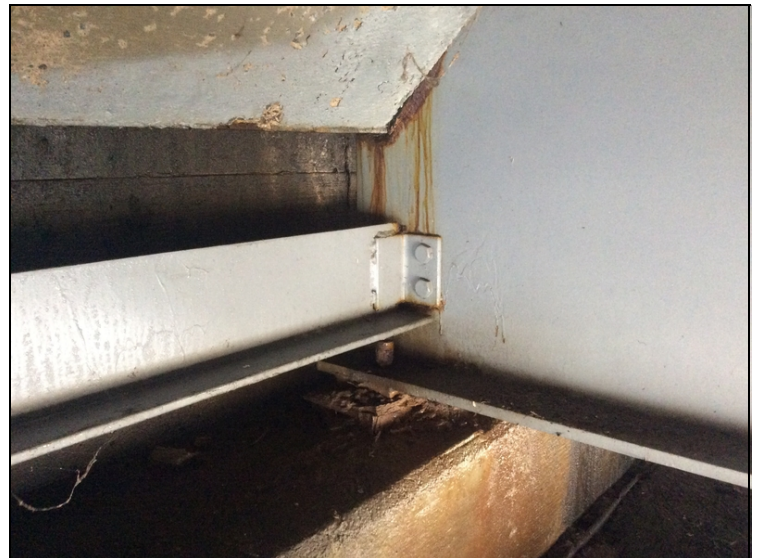
Abut #4, Bearing #'s 3 & 4 - heavy pack rust and minor section loss. Others have minor and moderate pack rust.

Abut #4, beam #3 - heavy pack rust on bearing,
Bearing B1 & B2 minor pack rust.

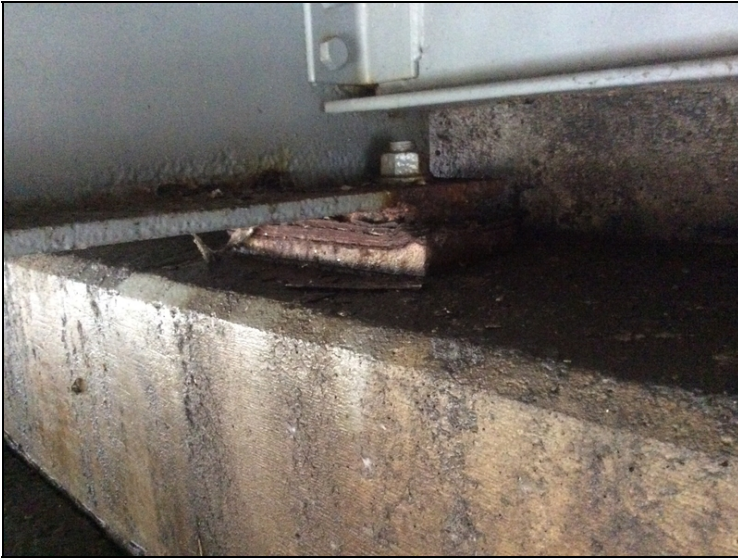
Abut #1, bearing #3 - heavy pack rust.

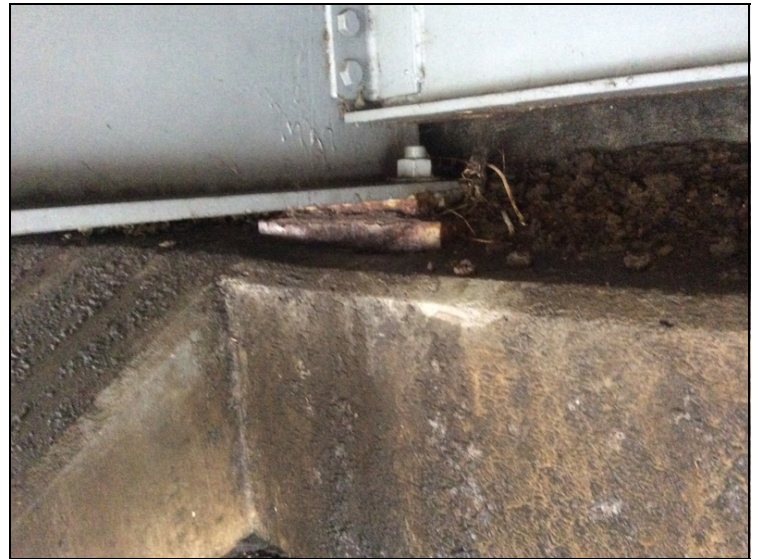
Abut #1, bearing #2 - moderate pack rust. B5 & B6 typical, B1 & B7 minor rust.

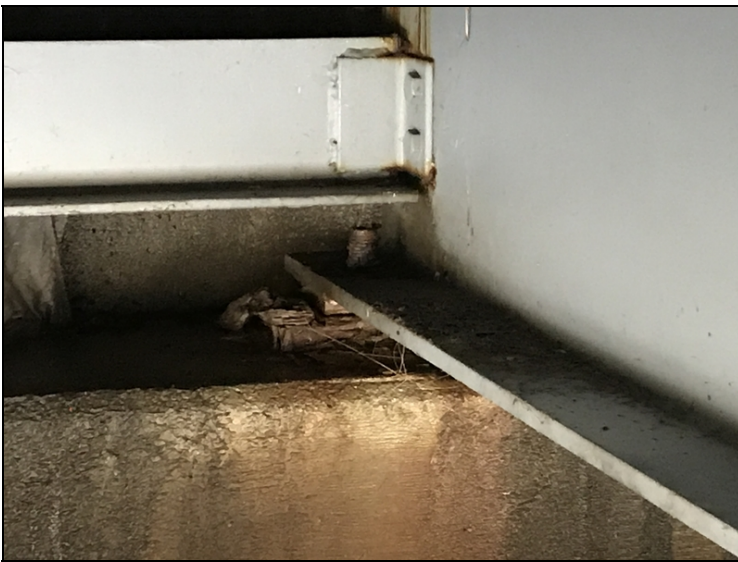
Span # 3, Beam # 5, 1st diaphragm ahead of pier # 3 - Two bolts missing where diaphragm connects to beam.
Beam 3 Abutment 4 Anchor Bolt Nut Missing.

Anchor Bolt Nut Missing on Beam 3 at Abutment 4.

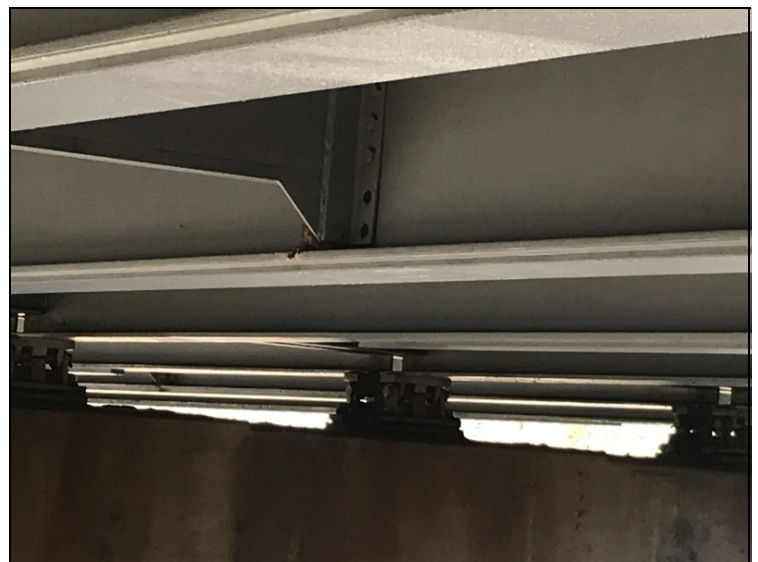
(107) MINOR TO MODERATE RUST & SECTION LOSS ON ENDS OF BEAMS. MAINLY IN HAUNCHED AREAS. 2 BOLTS MISSING ON BEAM 5 AT 1st DIAPHRAGM AHD OF PIER 3.							
205	Reinforced Concrete Column	EA	4	3	1	0	0
1090	Exposed Rebar	EA	1	0	1	0	0

Bolts Missing on Beam 5 Span 3.

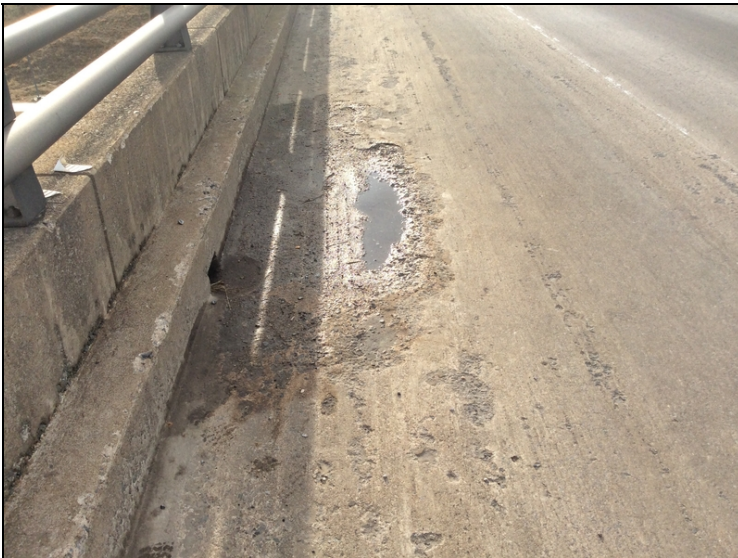
Span # 1 - Minor to moderate spall in left lane backside of joint # 2 (no rebar exposed), Scaling on right shoulder.

Span #1, left side - spall and scale

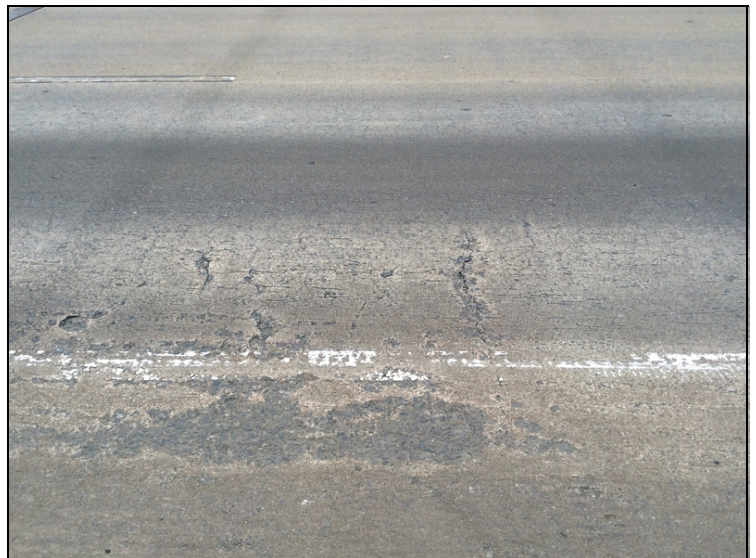
Moderate and a few major unsealed cracks in all spans.

Moderate and major unsealed cracks. Map cracking in outside lane and moderate scale.

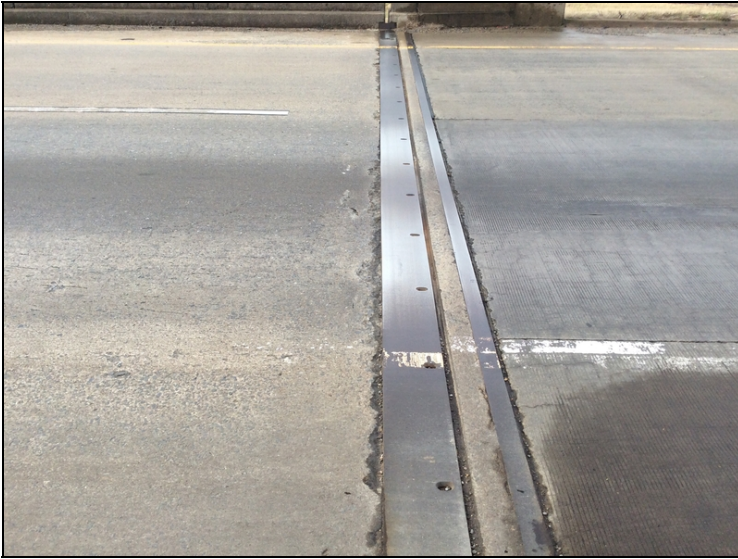
Minor spalls along the slide plate of all joints.

Joint #1 - minor spalls along the ahead side of slide plate. Typical at all joints

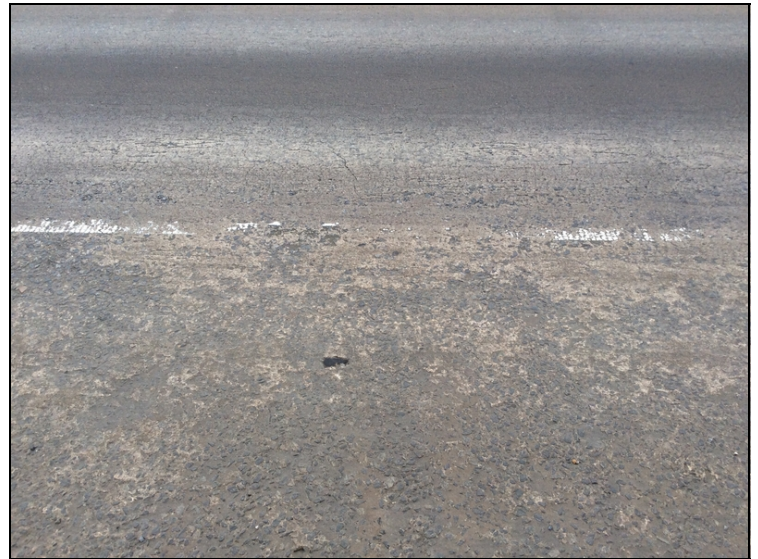
Map cracking mostly in outside lane.

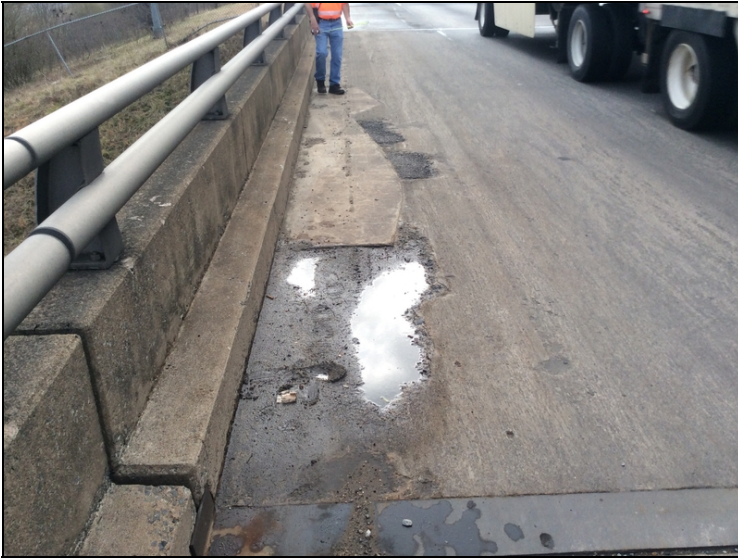
Span # 3 - Minor spall and patch area in left shoulder (no rebar exposed).

Span #3, left side - moderate spalls

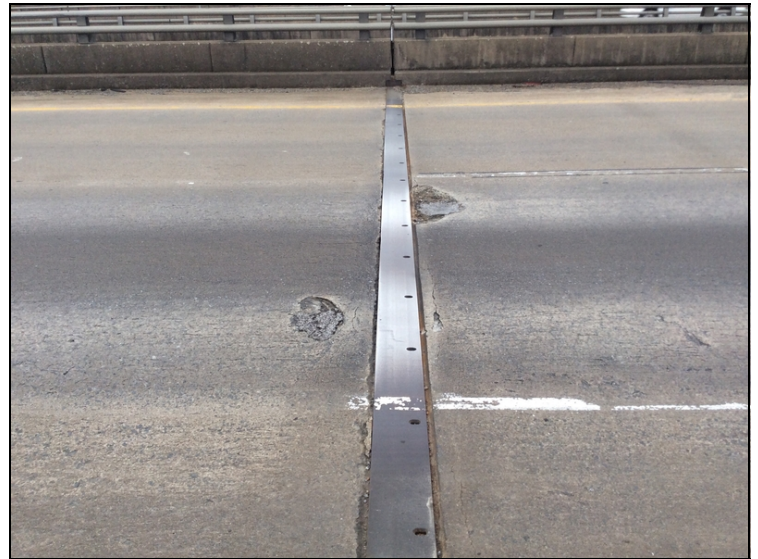
Joint #2 - 2 moderate spalls, minor spalls, delamination and cracks along slide plate.

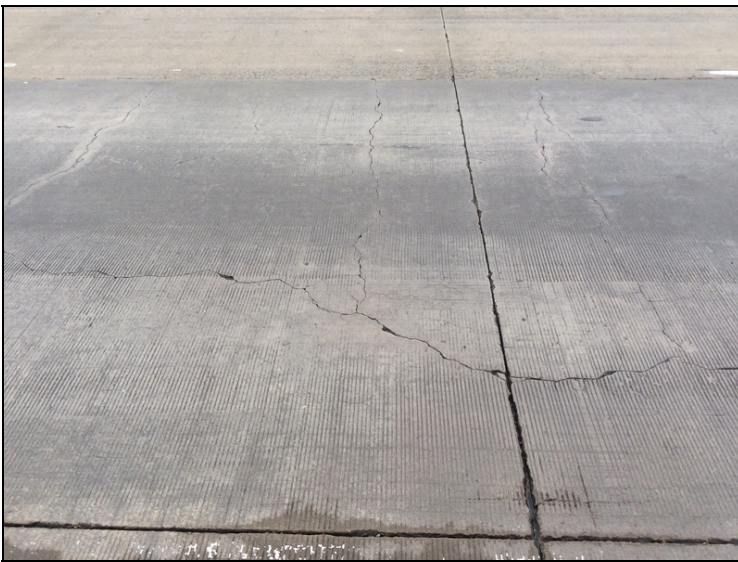
Beginning of Bridge

Approach slabs at both end of bridge have moderate and major unsealed cracks.

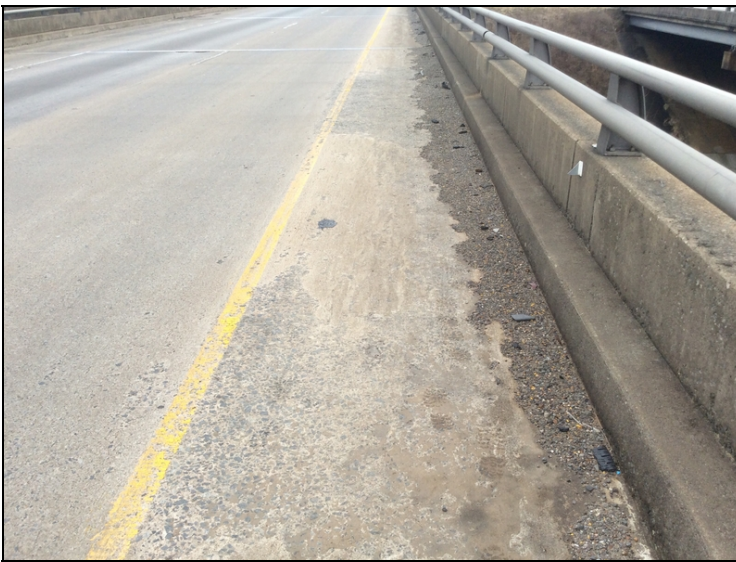
Dirt and gravel accumulation next to inside curb.

Dirt and gravel accumulating next to inside curb.

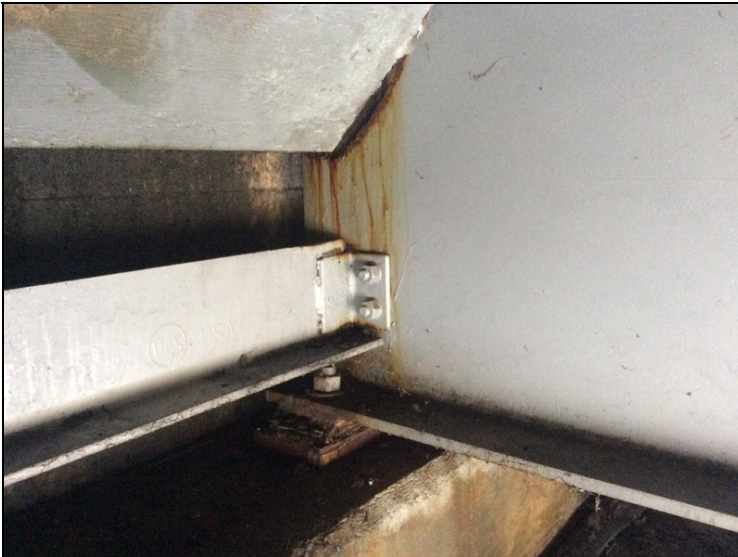
Moderate section loss in the web below the concrete haunch at the following locations.

Abut #1, Beam #3
Abut #4, Beam #'s 3 & 4

Abut #4, Beam #4 - moderate section loss in web below concrete haunch.

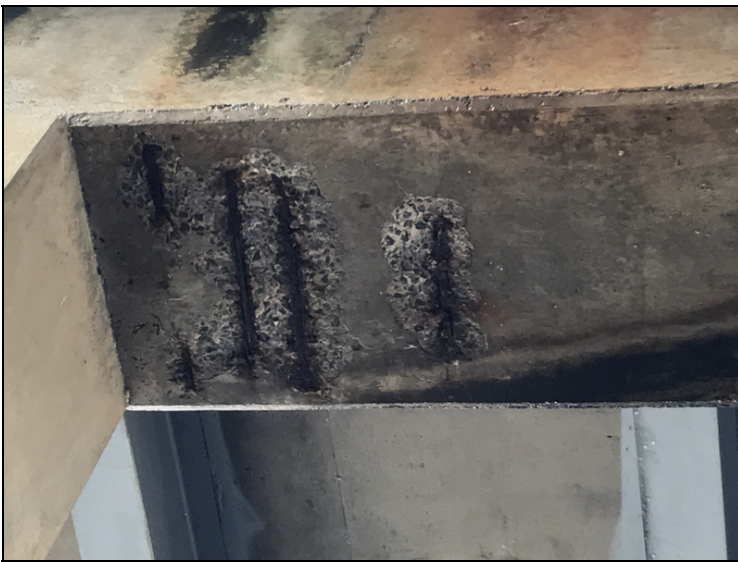
CAPS - MINOR CRACKING IN BOTTOM FACE OF CAP 3. MINOR DELAM, CRACKING & SPALLING W / REBAR EXPOSED IN BOTTOM FACE OF CAP 3 RT. SIDE NEXT TO COLUMN 2.

Delam, & Spalling W / Rebar Exposed in Bt Face of Cap 3.

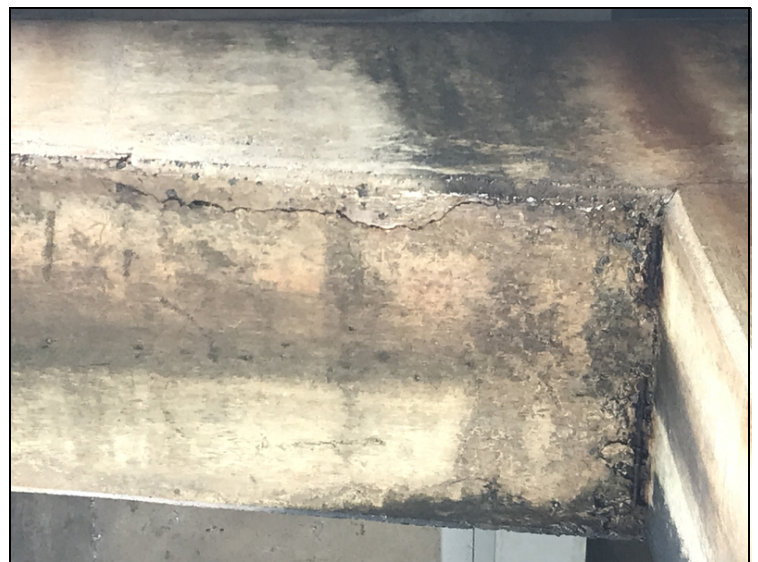
Typ. Cracking in Bt Face of Cap 3.

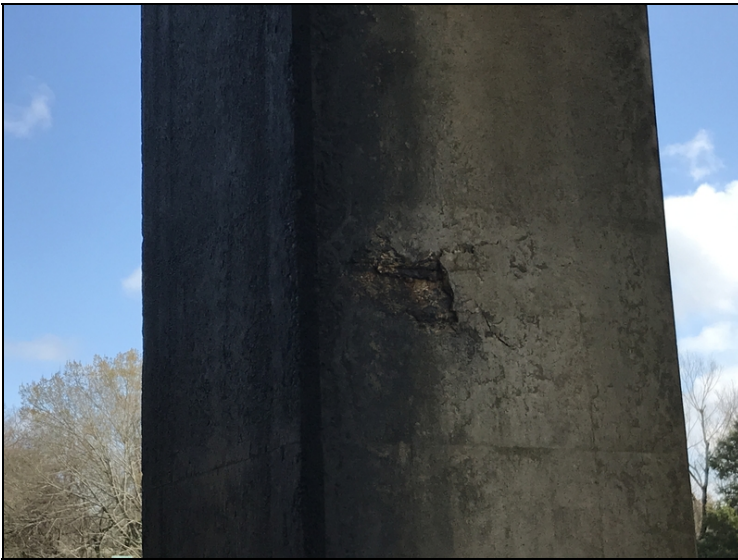
COLUMNS - MINOR DELAM & SPALLING W / REBAR EXPOSED IN COLUMN 1 RT. SIDE AT PIER 2.

Delam & Spalling W / Rebar Exposed in Column 1
Rt. Side at Pier 2.
