Bridge #B3919(Routine)
I 40-SEC 32, EB LN over Friendship Rd.
Location: 4.05 MI E CONWAY CO LINE

Team Lead: William Wood Inspection Date: February 24, 2020

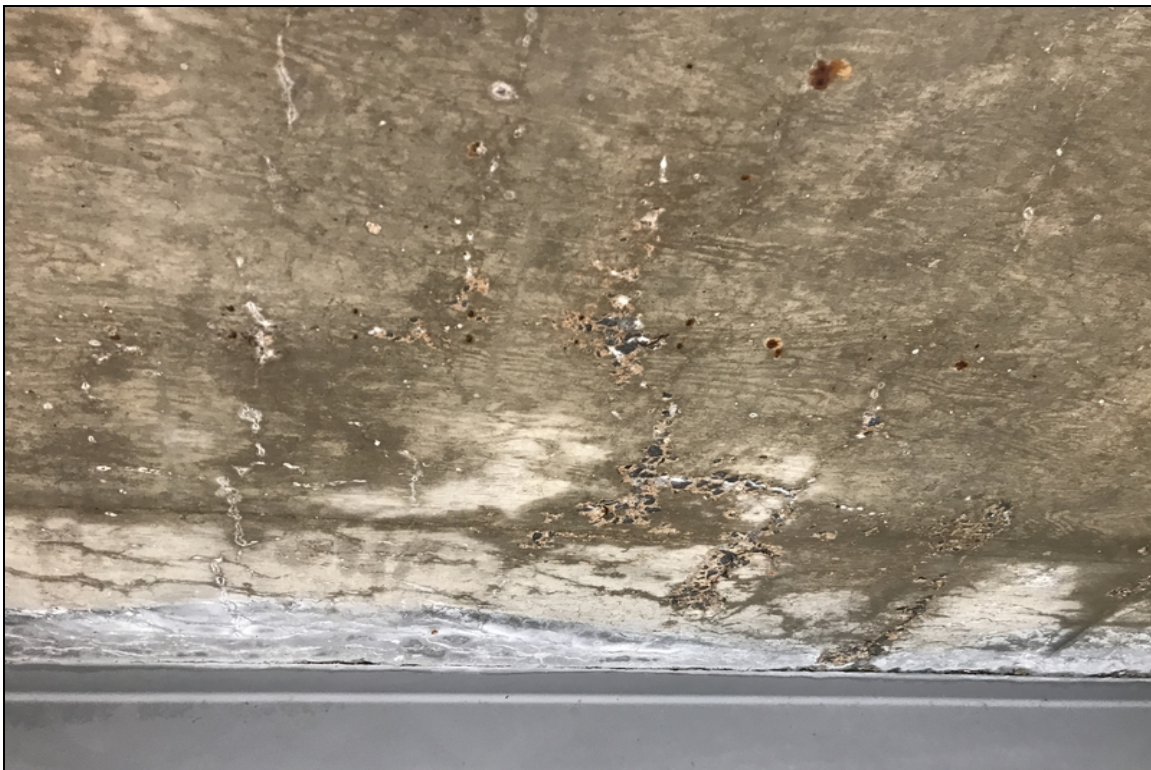
| ELEM | DESCRIPTION | UNITS | TOTAL | CS1 | CS2 | CS3 | CS4 |
|--|---|---|---|---|---|---|---|
| MINOR TO MODERATE DELAM, CRACKING, SCALING & SPALLING THROUGHOUT DECK. MINOR "D" CRACKING & SPALLING AT JOINTS. MINOR CRACKING W / EFFLOR, SCALING & SPALLING IN SOFFIT. | | | | | | | |

Typ. Condition of Soffit.

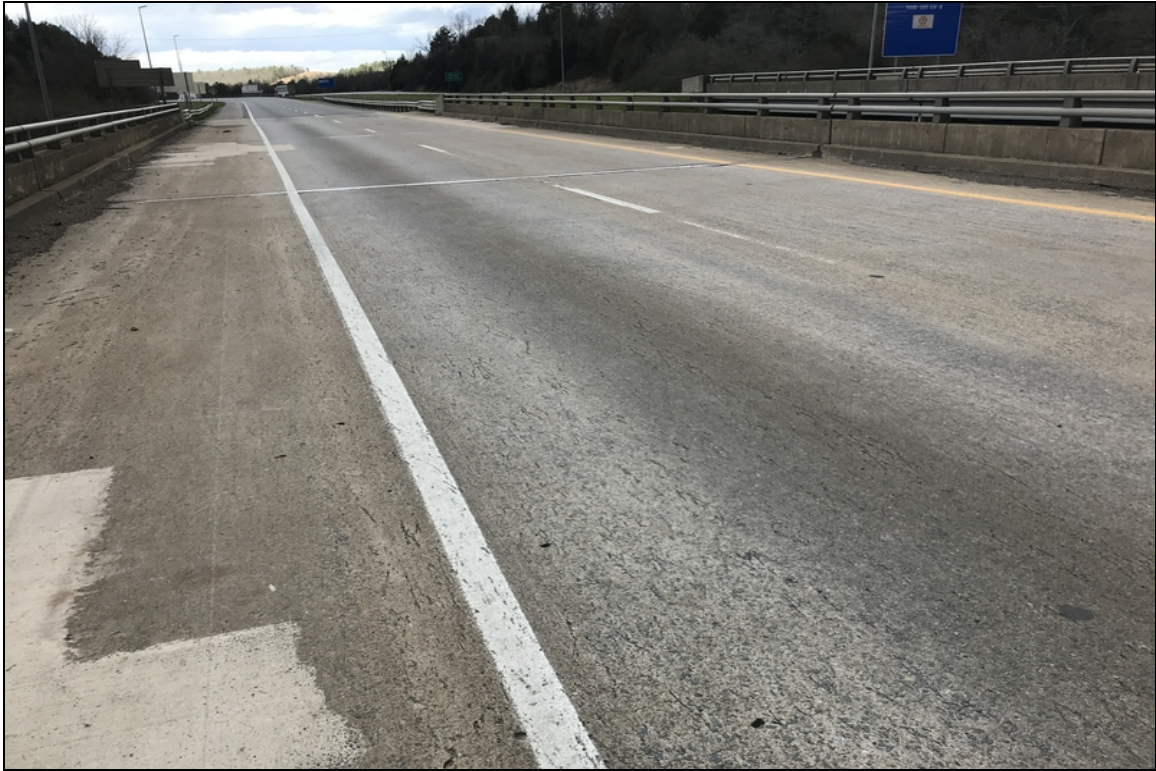
Typ. Condition of Deck.

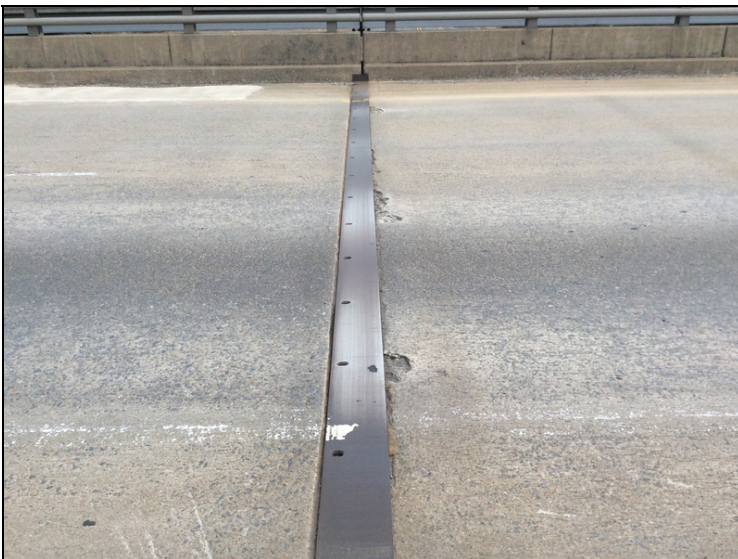
Span # 2 - Spalls cover a large area of the right shoulder, some rebar exposed. Minor spalls along joint # 2.

Joint #2, span #2 - minor spalls along ahead side of slide plate

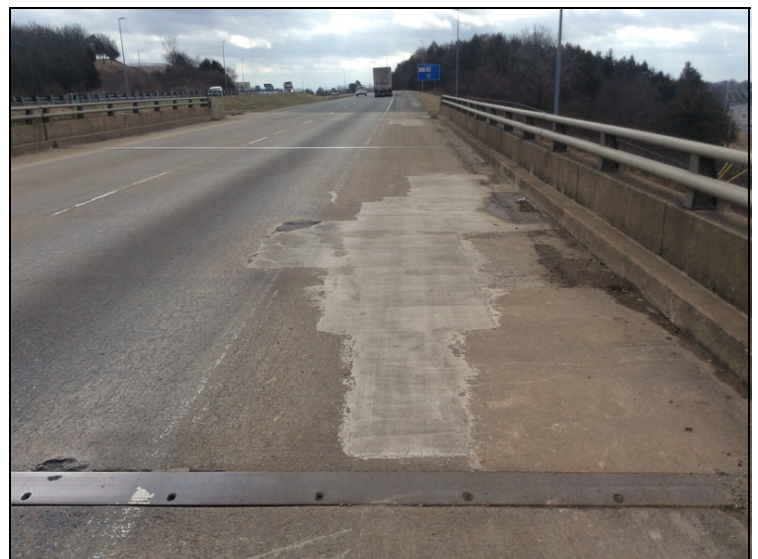
Span #2, right side - minor spalls around patch area and next to curb.

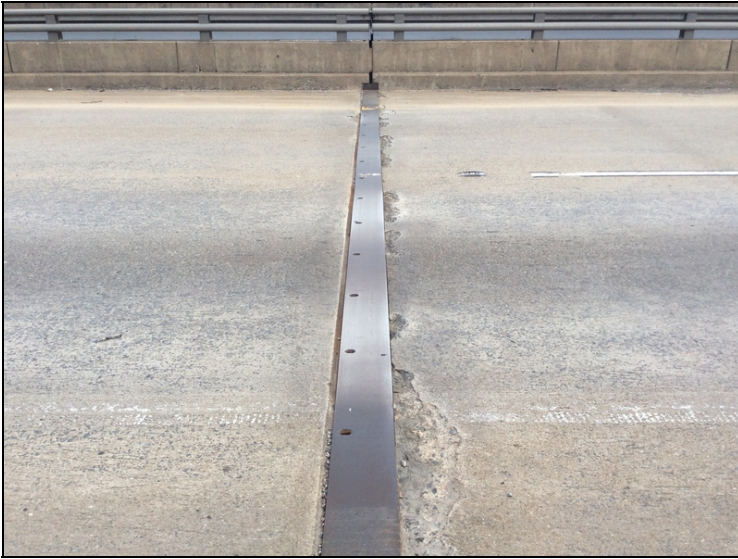
Span # 3 - Several minor spalls and 1 moderate spall along ahead side of joint # 3, no rebar exposed. Moderate spall with rebar exposed covering a large area and a patched area in the right shoulder.

Joint #3, span #3 - minor and moderate spalls
along slide plate

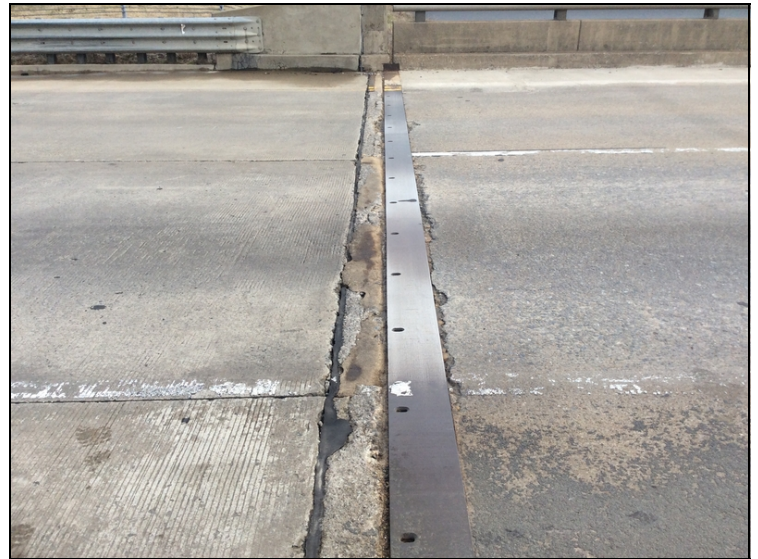
Head wall at abutment # 1 - Moderate spalls with rebar exposed.

Joint #1 - minor spalls in deck and head wall along
slide plate.

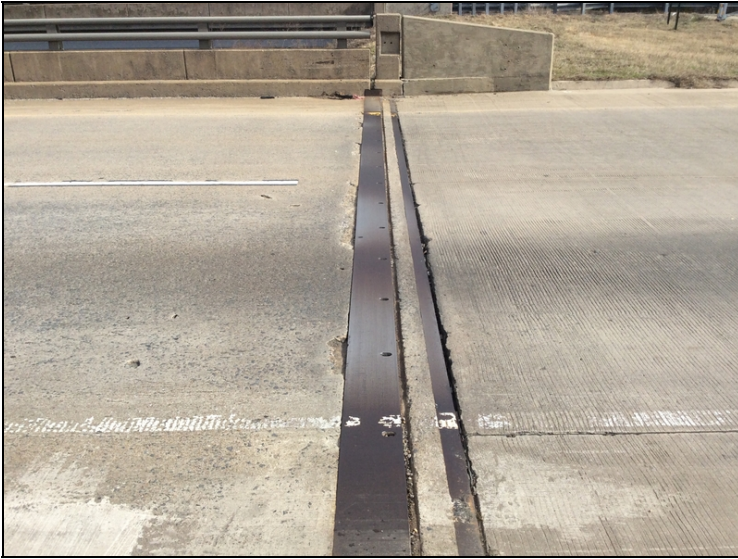
Joint #4 - minor to moderate spalls along the back side of slide plate.

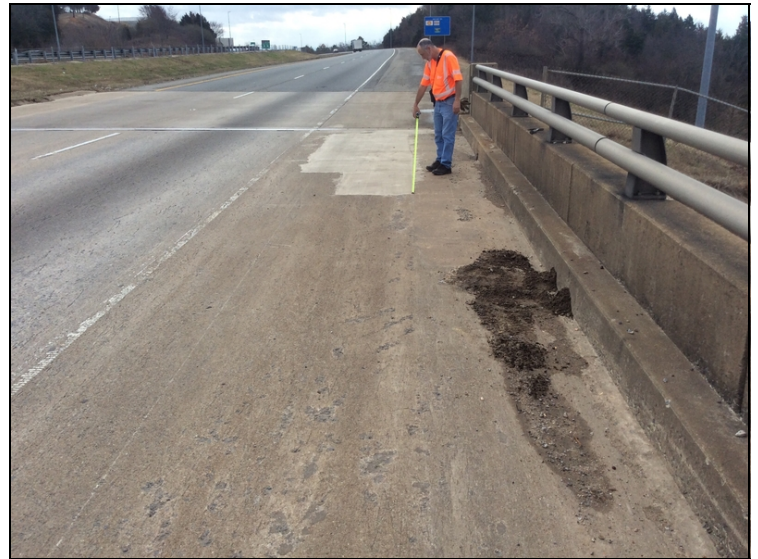
Span #3, right shoulder - moderate spall.

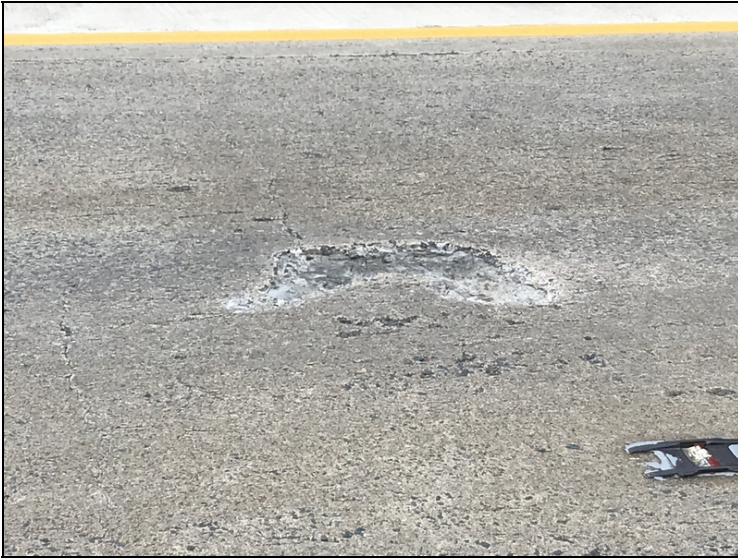
Span # 1 - Minor spalls along ahead side of joint # 1. Moderate spall with rebar exposed for the full length of the span in the left shoulder.

Minor Spalling in Span 1.

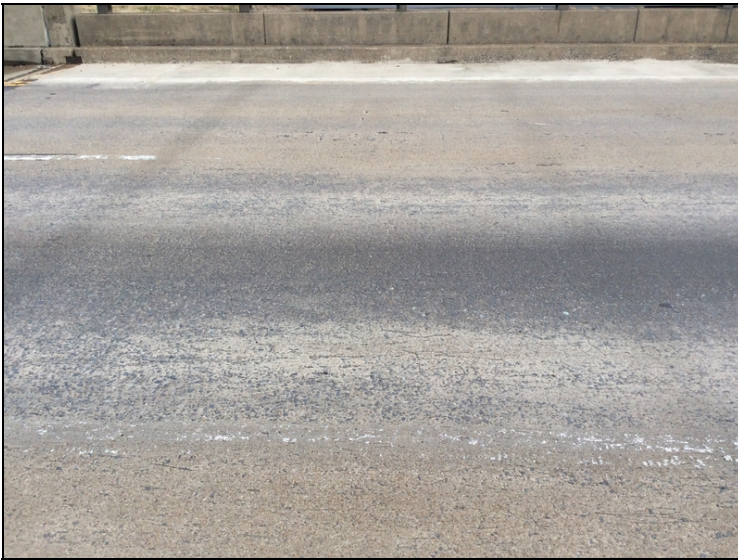
Deck

Minor and moderate unsealed transverse cracks throughout. Map cracking mostly in outside lane.

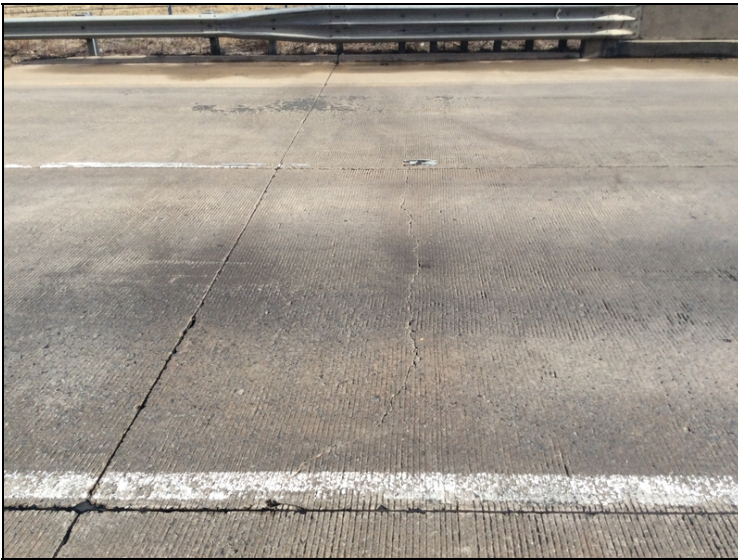
Approach at beginning of bridge

Approach Slab at both ends of bridge - moderate and major unsealed cracks.

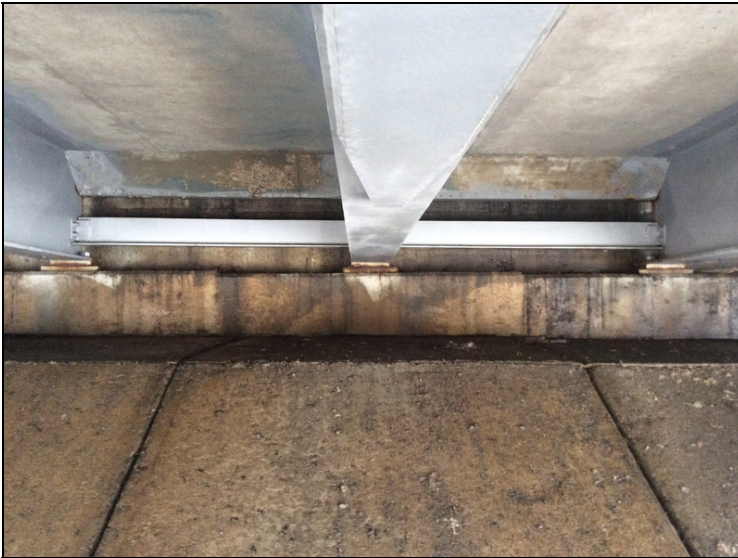
Abut #4

Abut #1, Bearings 2 thru 5 - Minor pack rust.
Abut #4, Bearings 3 thru 5 - Minor pack rust.
Minor rust on ends of beams at abutments at various locations.

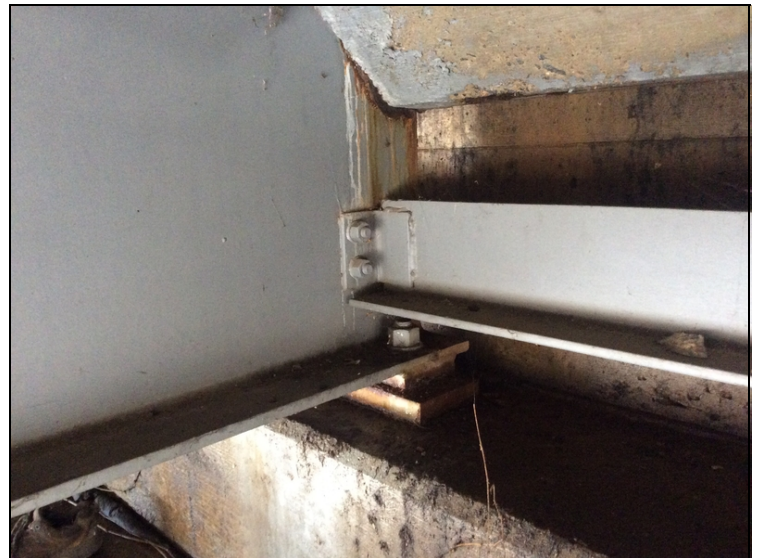
Abut #1, beam #4 - minor section loss in web.
Beam #5 typical. Bearings 2 - 5 minor pack rust.
B1, B6 & B7 minor rust.

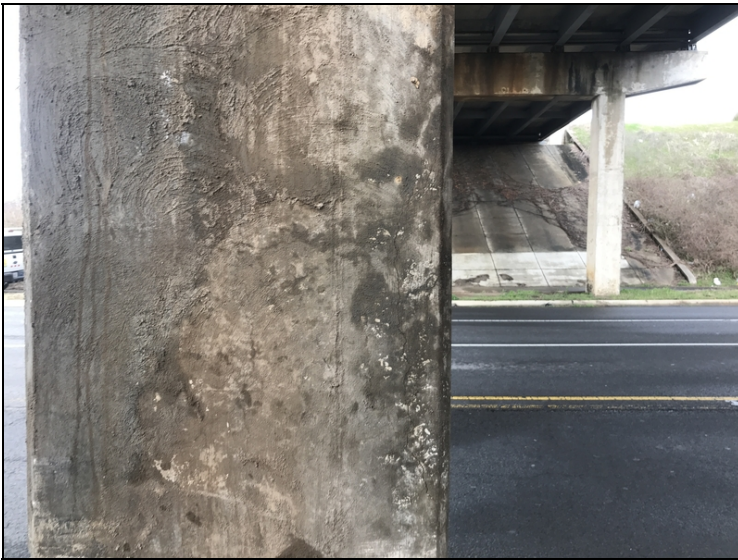
COLUMNS - MINOR CRACKING & SCALE IN ALL COLUMNS.

Typ. Cracking in Column 1 at Pier 2 & Column 2 at Pier 3.

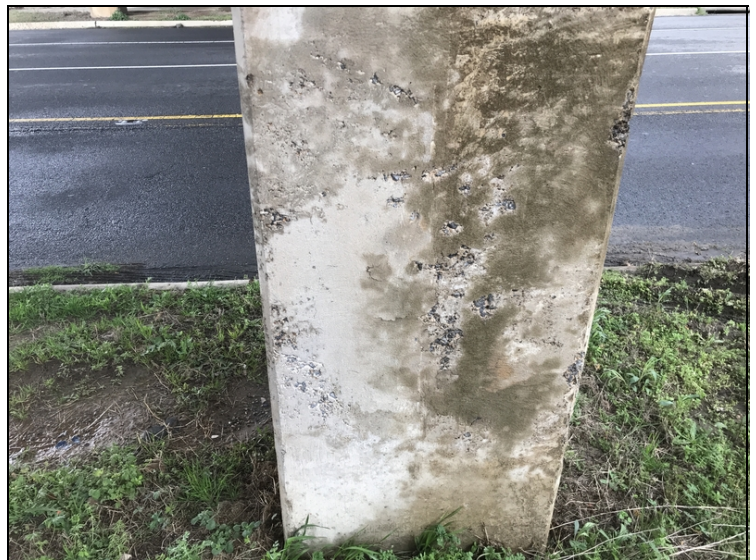
Typ Scale in Column 2 at Pier 2 & Column 1 at Pier 3.

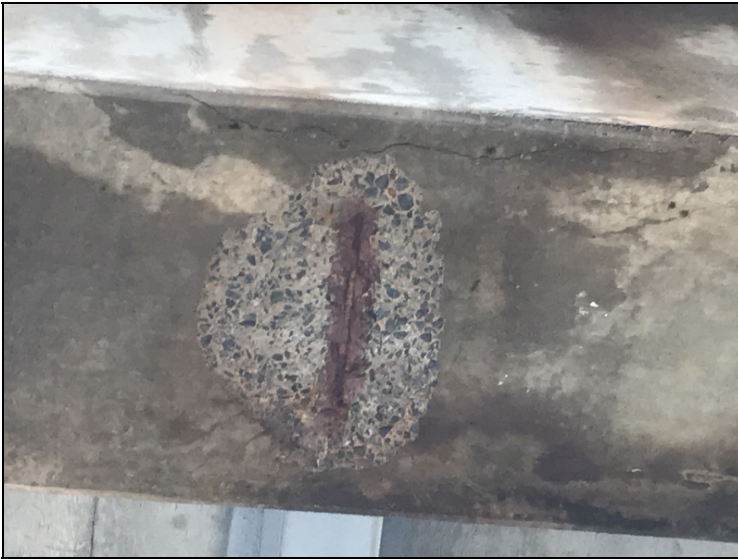
CAPS - MINOR DELAM, CRACKING & SPALLING W / REBAR EXPOSED IN BT. FACE OF CAP 3.
MINOR HORIZONTAL CRACKING IN CAP 2

Delam, Cracking & Spalling W / Rebar Exposed in
Bt Face of Cap 3.
