Bridge #05155(Underwater type 2, Routine)

SH 340 Benton 1 over LITTLE SUGAR CREEK

Team Lead: Nathan Rowland Inspection Date: May 06, 2020

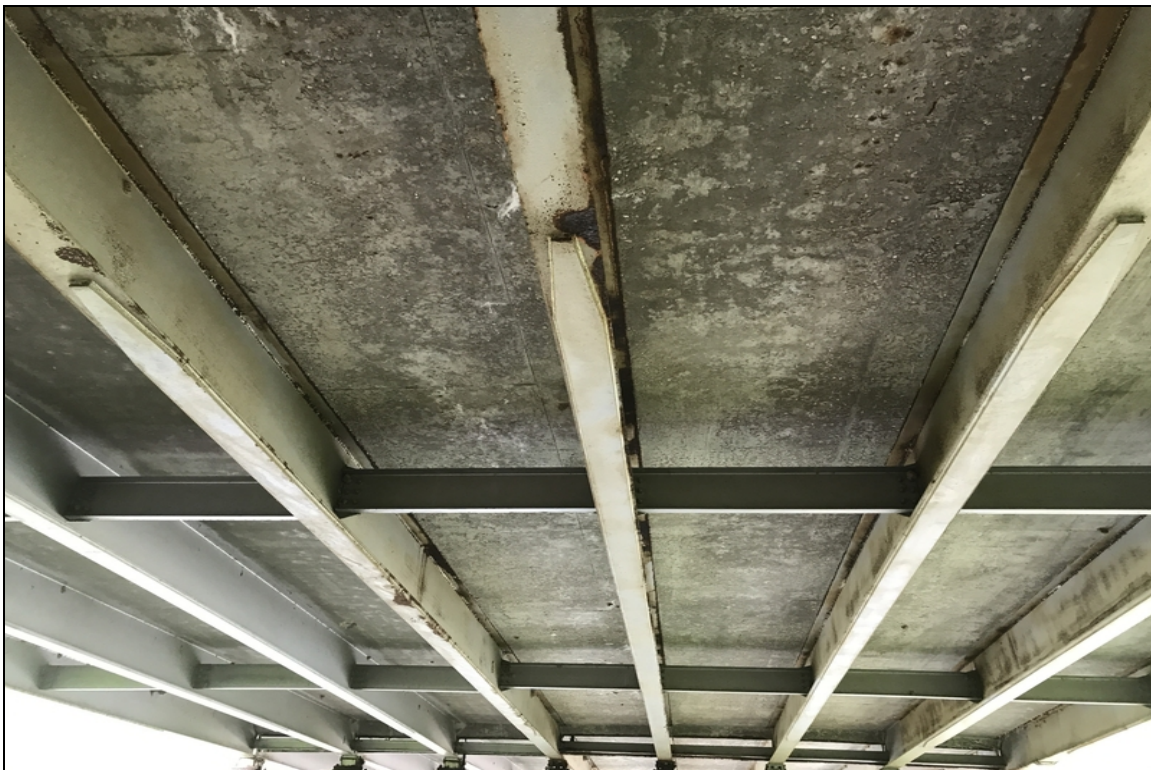
Span #4 undersurface of deck.

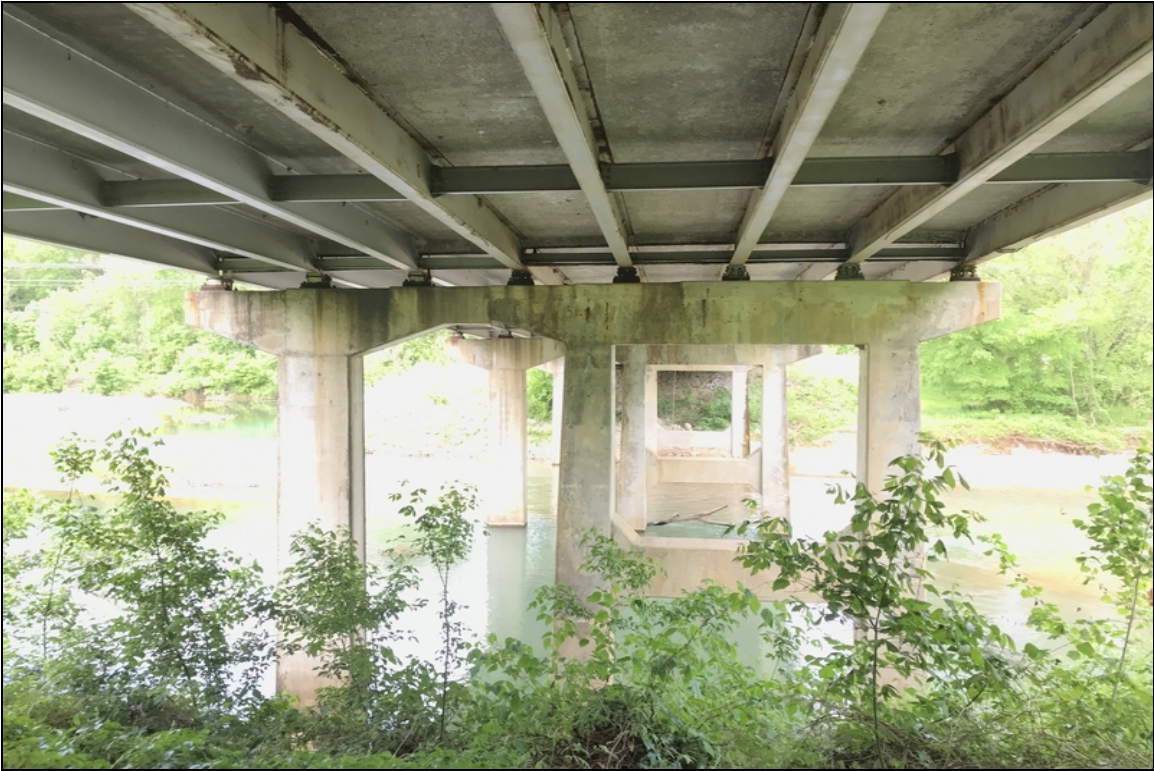
Bent #3 ahead side.

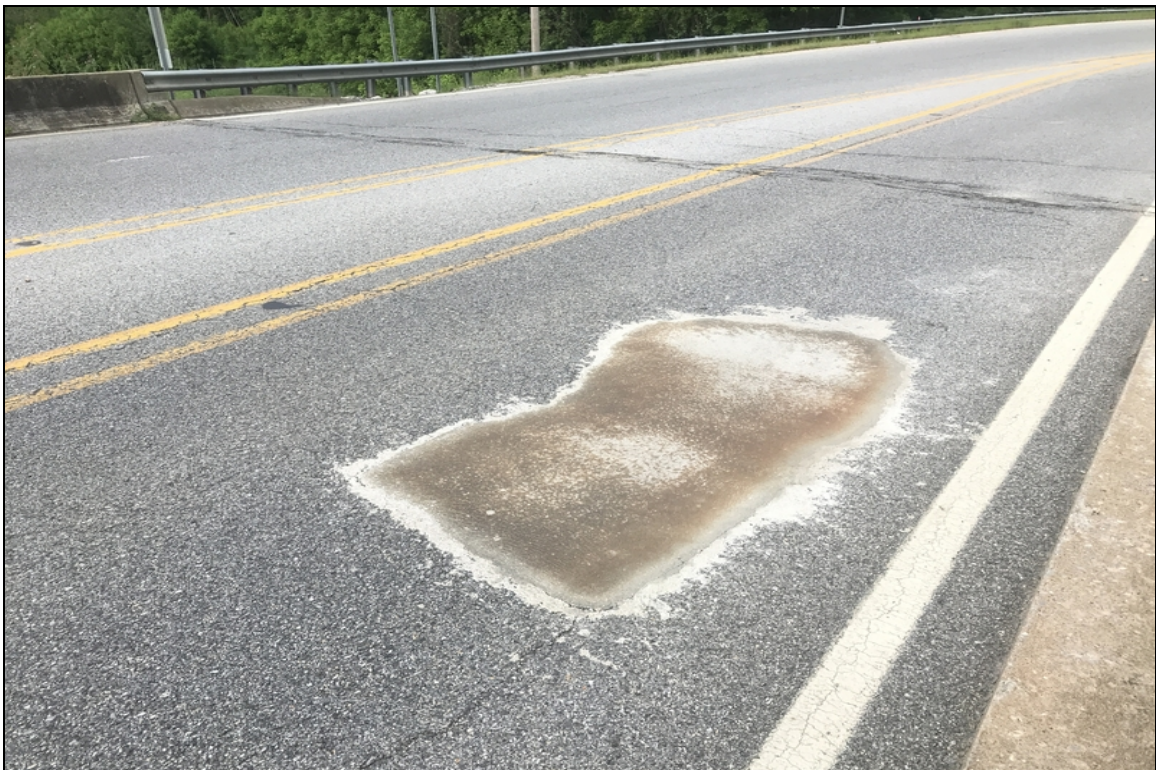
Large concrete patch span #1 left lane.

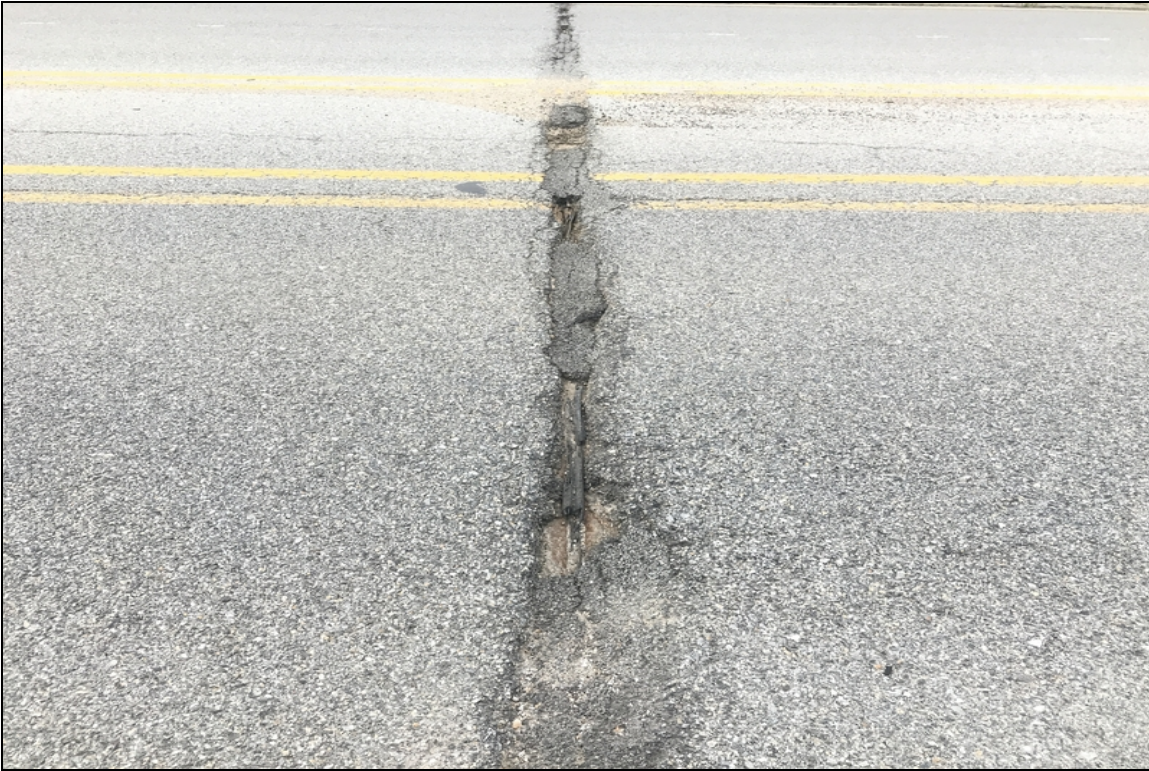
Condition of joint material & wearing surface at bent #1 joint.

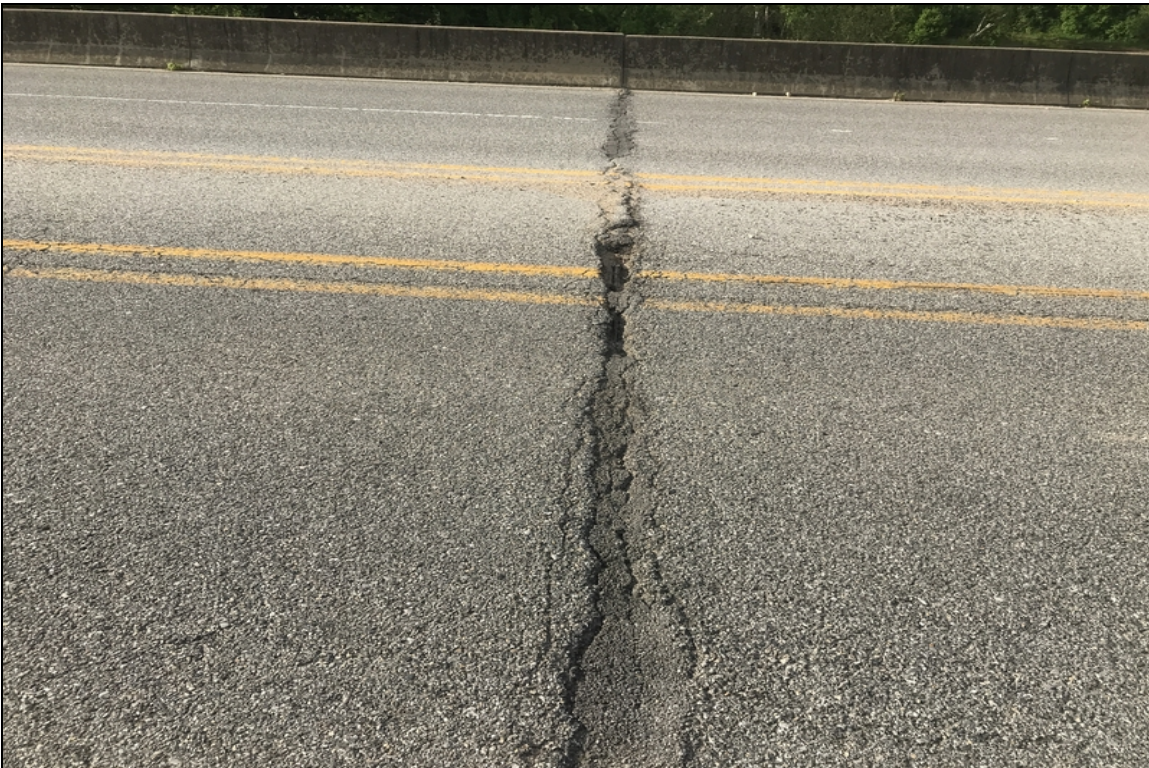
Condition of joint material & wearing surface at bent #2 joint

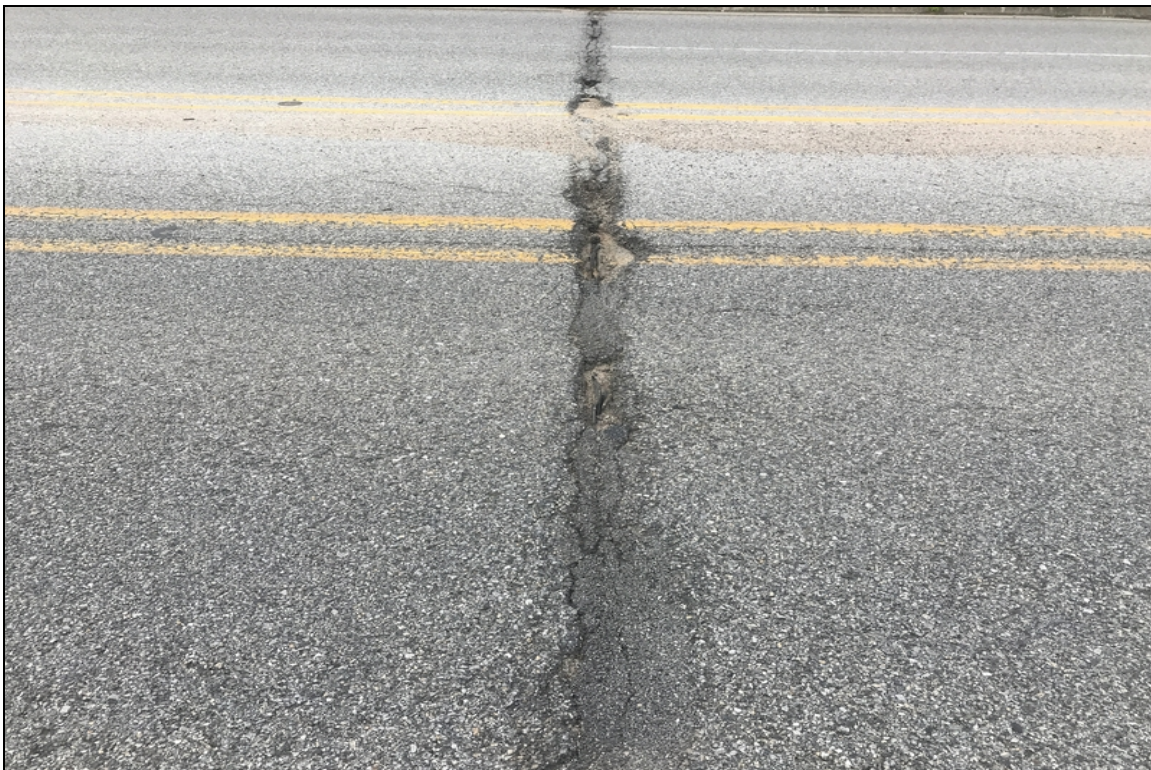
Condition of joint material & wearing surface at bent #3 joint

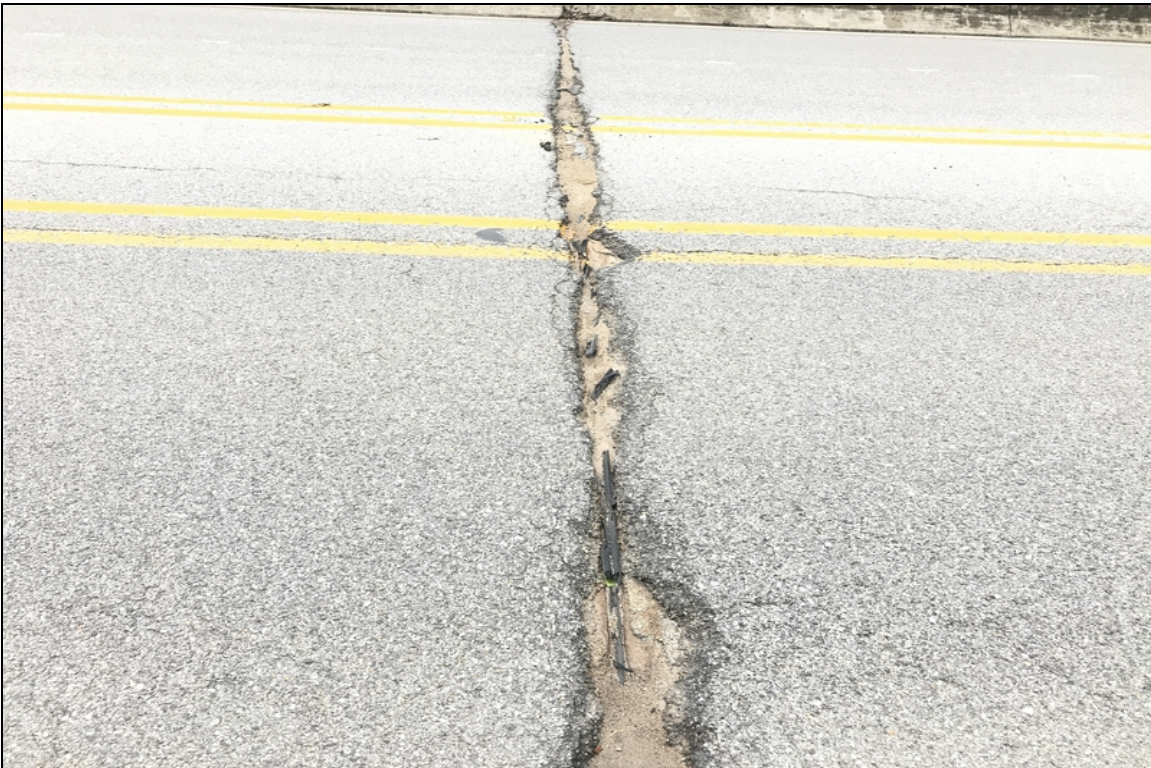
View of bent #1 joint displacement of asphalt overlay material.

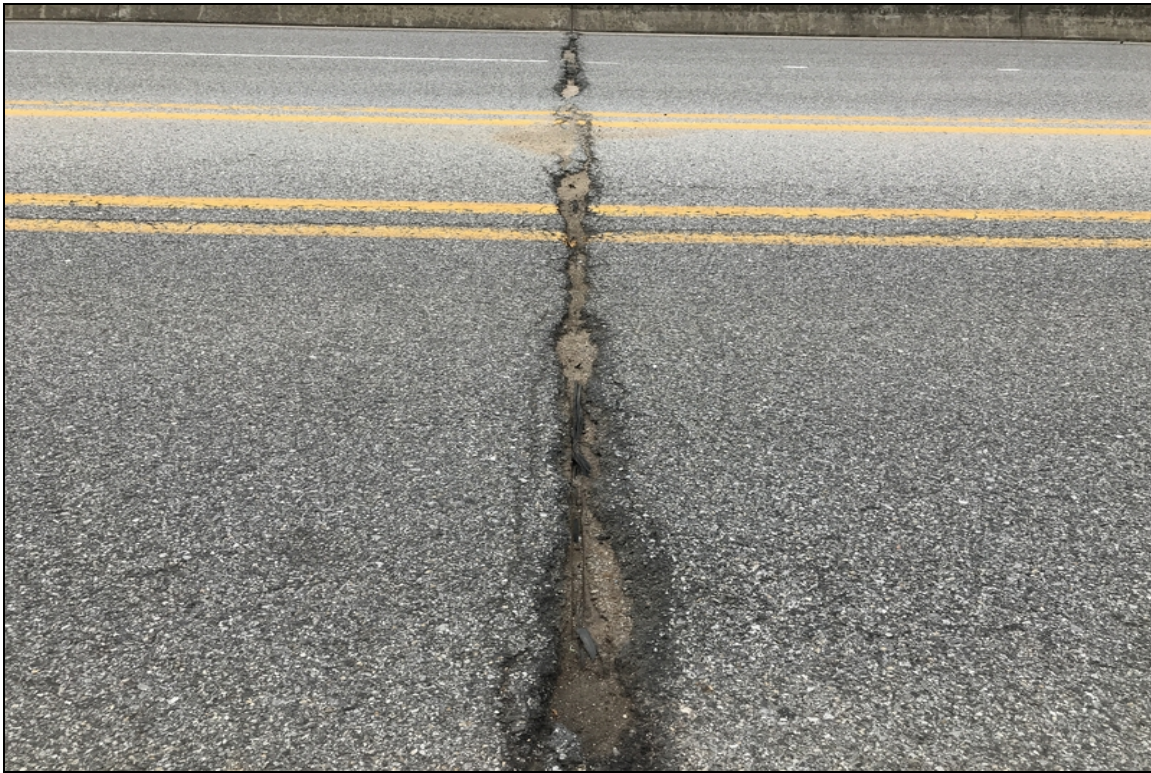
View of bent #2 joint displacement of asphalt overlay material.

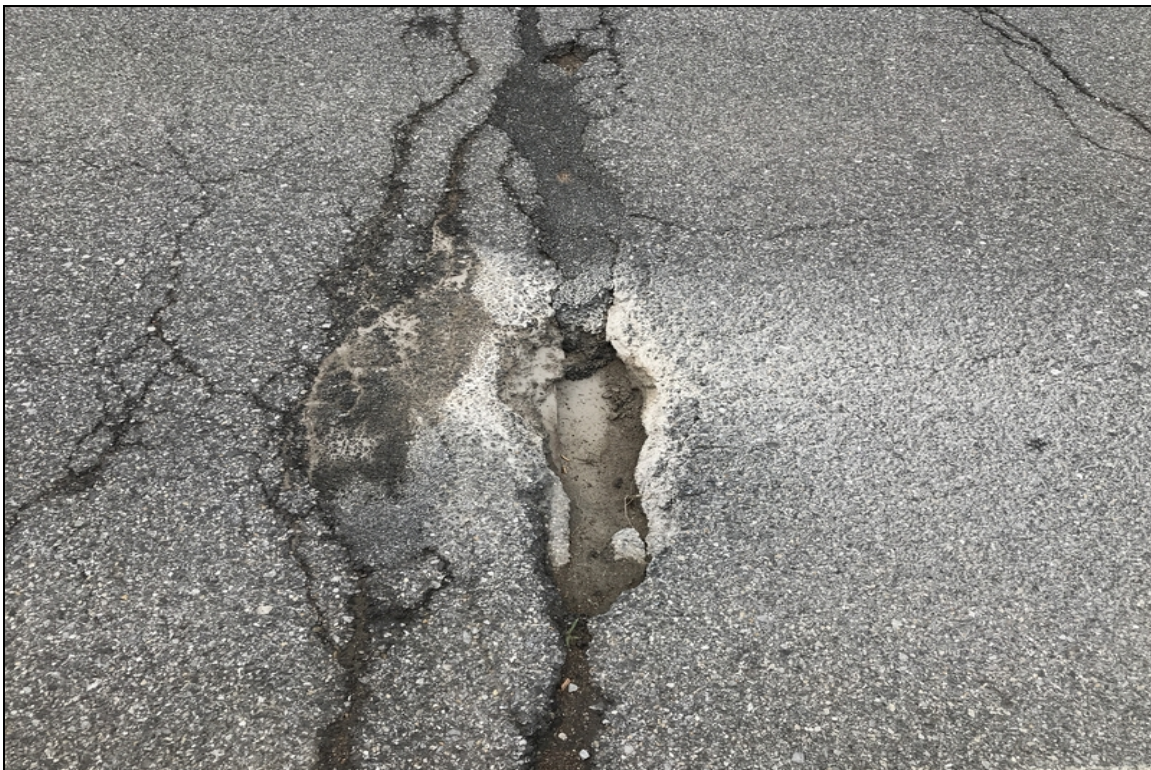
West approach roadway adjacent left side of abutment #1 pothole has formed.

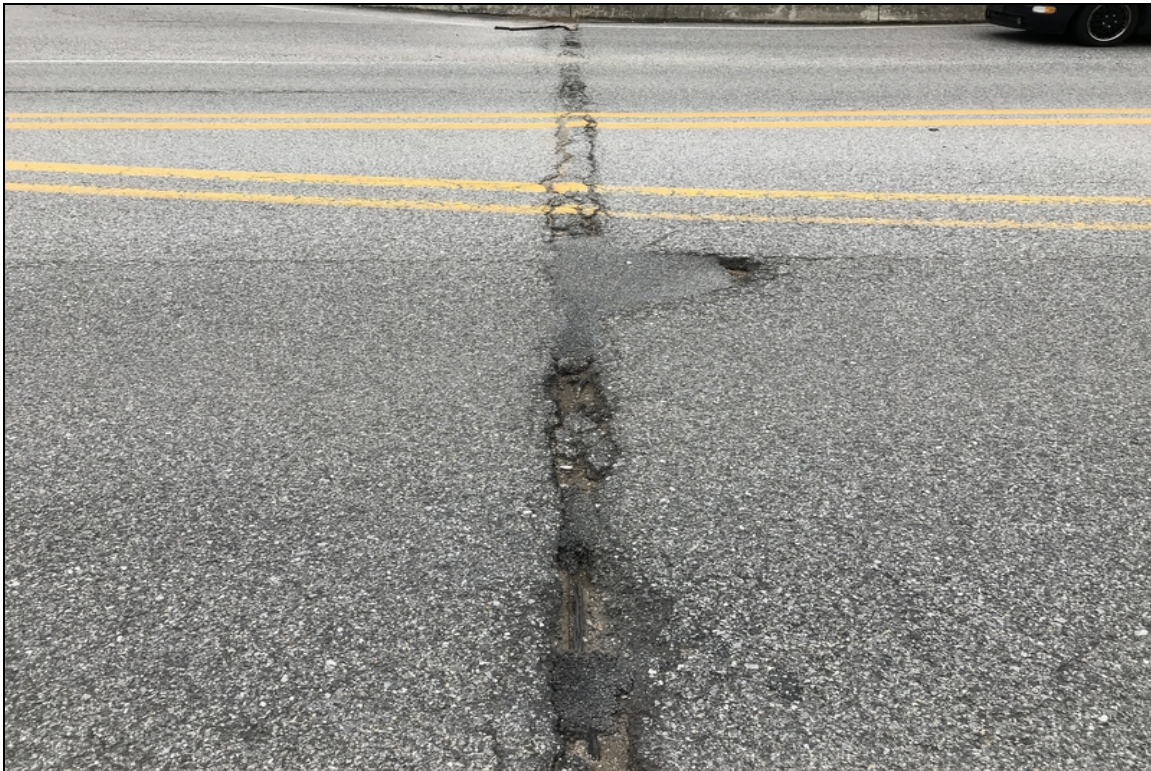
View of bent #4 joint displacement of asphalt overlay material.

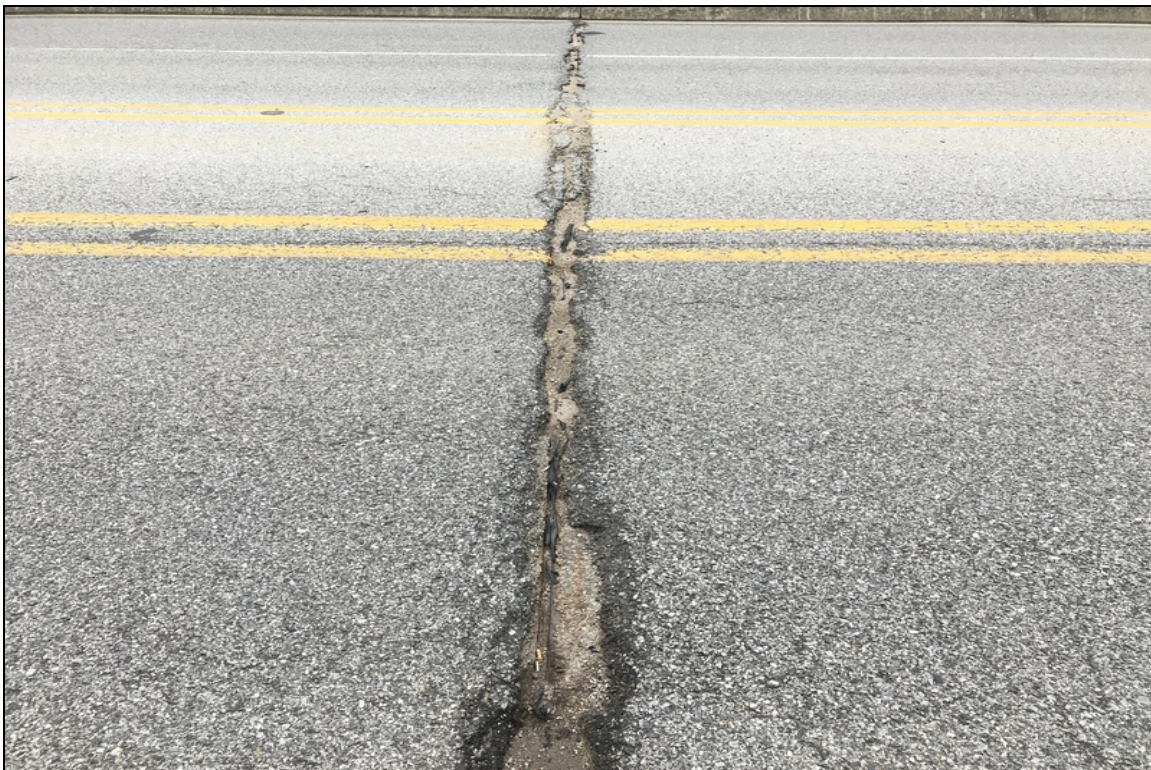
View of bent #3 joint displacement of asphalt overlay material.

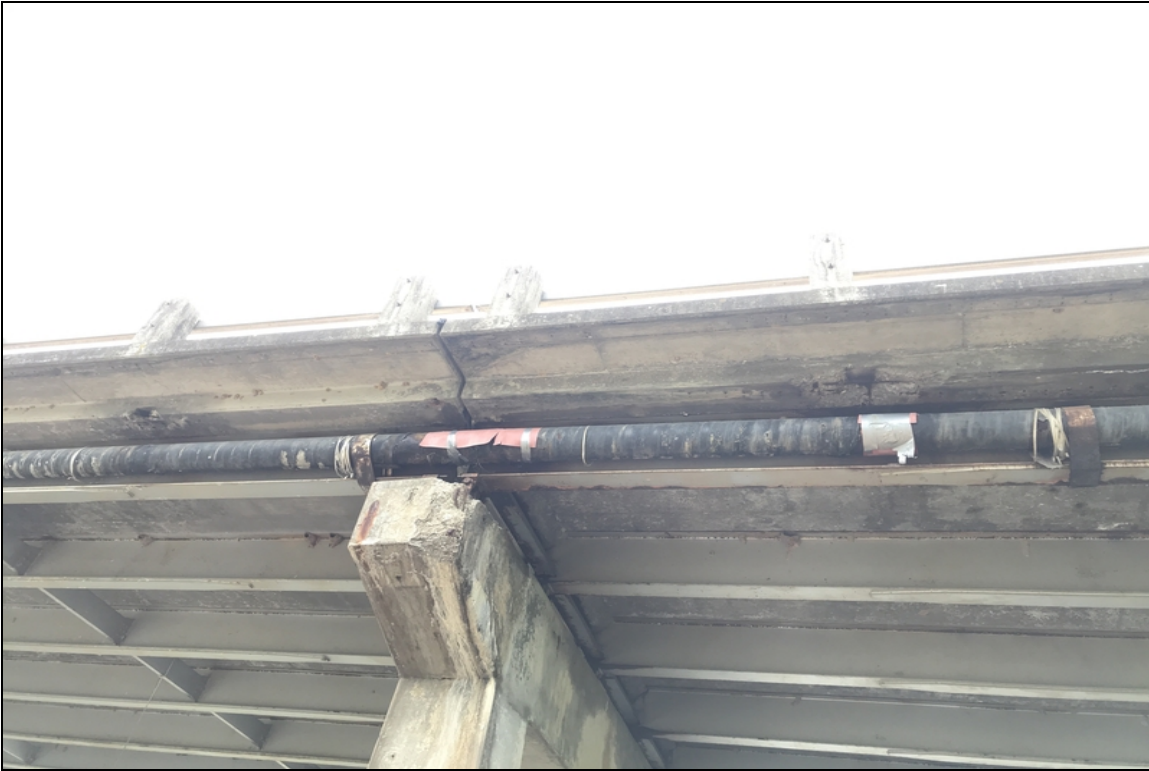
Typical exposed reinforcing steel around deck drains.

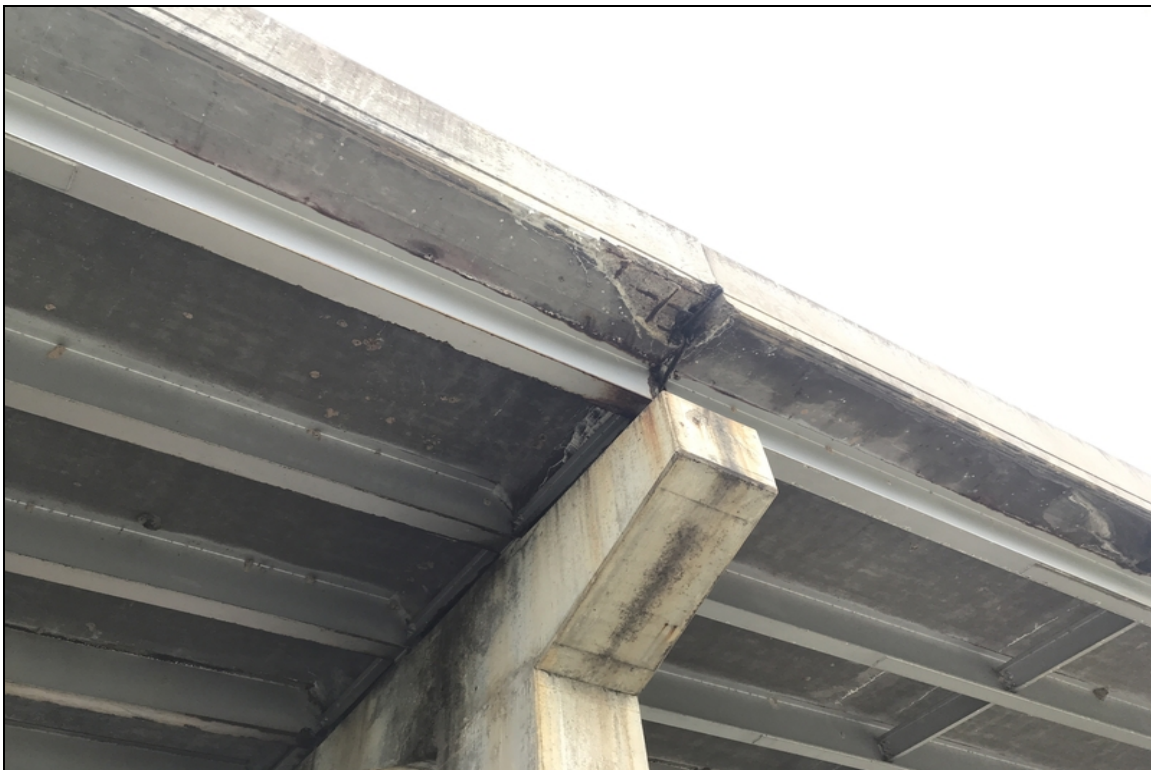
Right side of span #1 above bent #1 right spalling with reinforcing steel exposed.

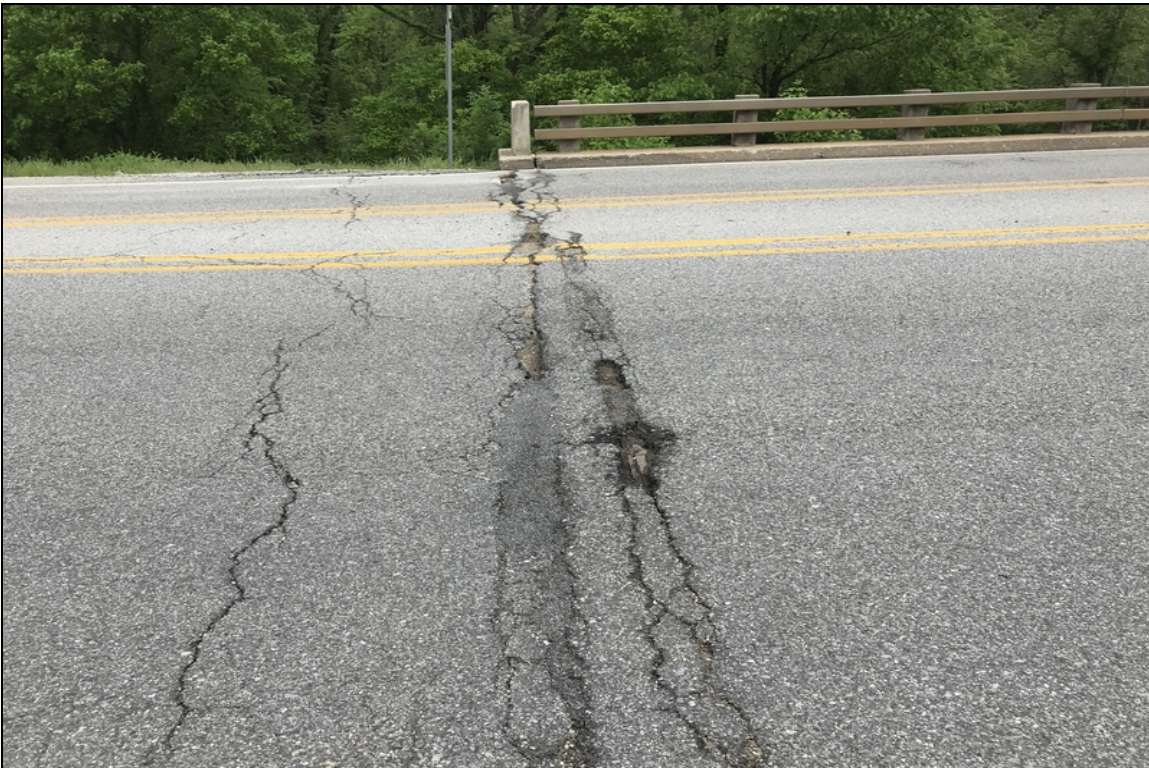
Asphalt surface at abutment #1 joint.

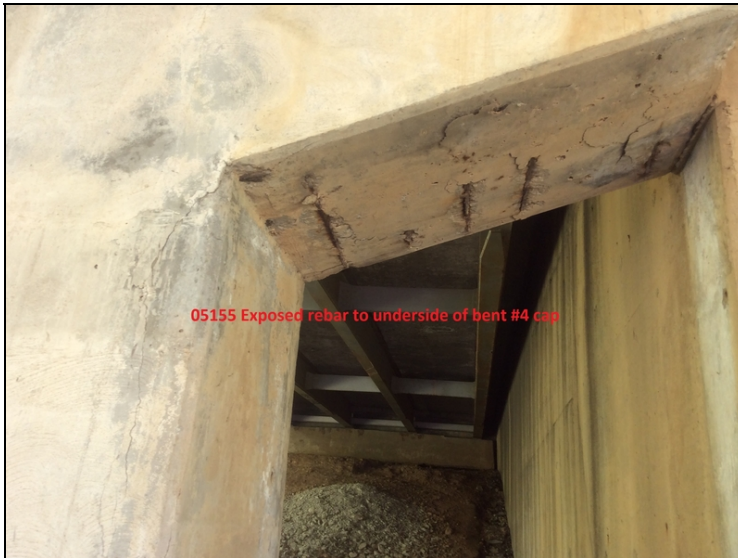
(234)							
5/6/2020 - WNR & DBM: -Bent #1 cap spalled with 3' rebar exposed, horizontal crack under girders #4 and #5, -Bent #1 cap left behind side has a large spalled area that propagates under bearing #1 in span #1 causing minor loss of bearing area. -Bent #4 cap right side underside has 8' exposed rebar. Discolored and beginnings of delamination to face of cap as well as horizontal cracking.							
302	Compression Joint Seal	LF	282	0	0	282	0
2310	Leakage	LF	282	0	0	282	0

Concrete caps bt #1, #2 and #4 have deterioration, delamination, horizontal cracking and spalls with rebar exposed

Bent #4 cap right undersurface has exposed rebar

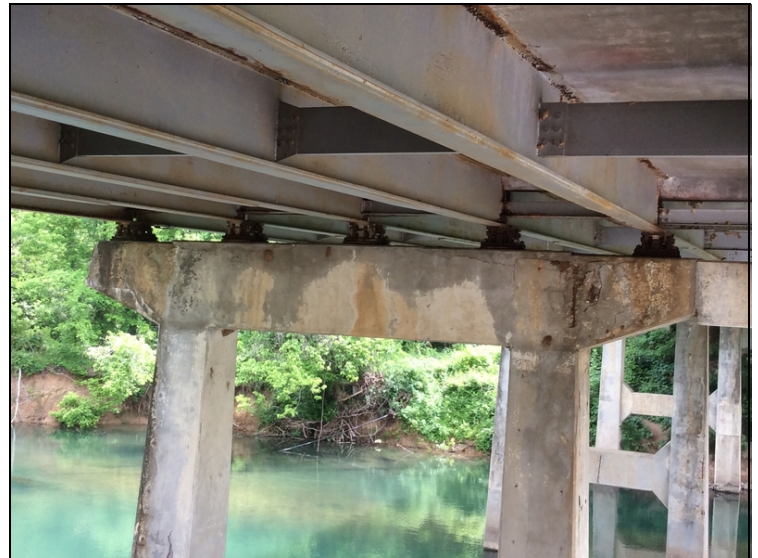
Cap at ahead side of bent #1

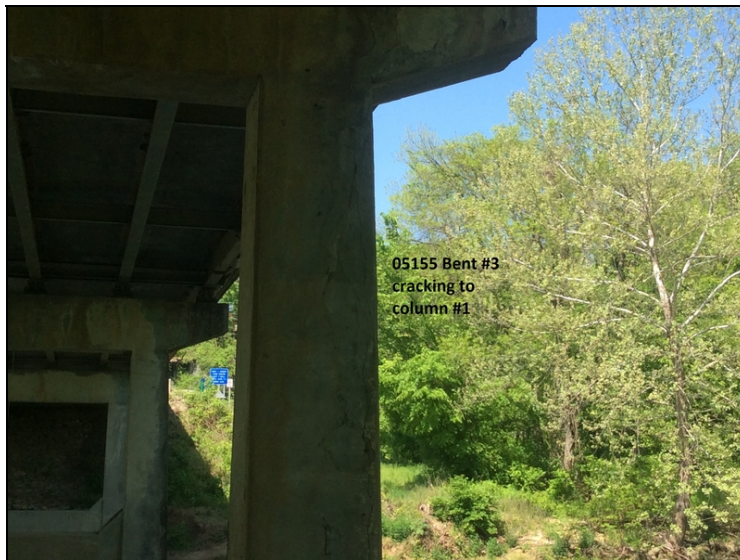
Bent #2 column #1,#2, Bent #3 columns #1,#2, Bent #4 column #1 and Bent #5 column #2 all have delamination, cracking and spalls with rebar exposed

Bent #3 ahead side of column #1 cracking.

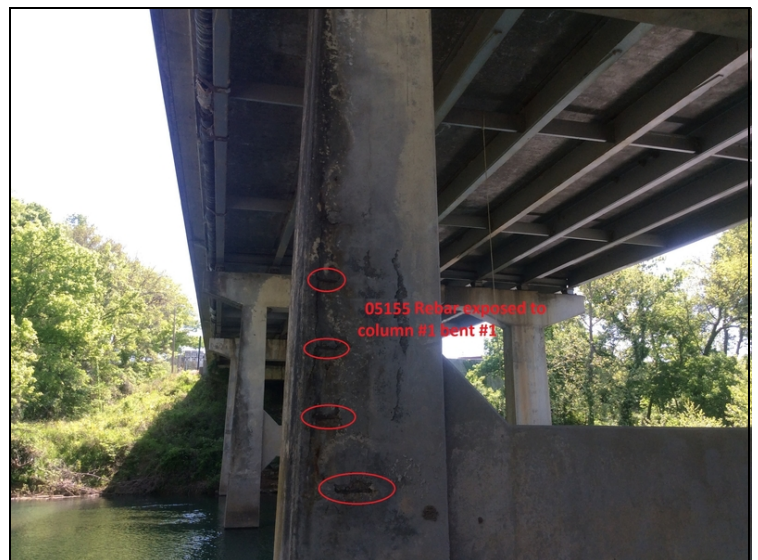
ELEM	DESCRIPTION	UNITS	TOTAL	CS1	CS2	CS3	CS4
5/6/2020 - WNR & DBM: Bent 1: -Column 1 behind side has areas of spalling with steel exposed in CS-3. -Column 2 right side has large areas of delaminations. -Column 1 behind side has a large vertical crack that propagates from the hammerhead juncture. Bent 2: -Column 1 behind side has scaling with minor aggregate loss. -Column 2 behind side has spalling with steel exposed that has section loss. -Column 3 behind side behind side large area of scaling. Bent 3: -Column 1 on the ahead side has approximately 25' of delaminated area propagating from the bent cap and has two areas of spalling with steel exposed with section loss. -Column 2 behind side near waterline has large spall due to loss of aggregate. Bent 4: -Column 2 behind side has a large full height vertical crack and delaminated area. Bent #1 column #1 has 15' vertical crack with rebar exposed, Bent #3 right column has 12' rebar exposed. Bent #4 left column has 2' rebar exposed near bottom, Right column has 10' vertical crack.

Bent #1 column #1 behind side spalling with steel exposed.

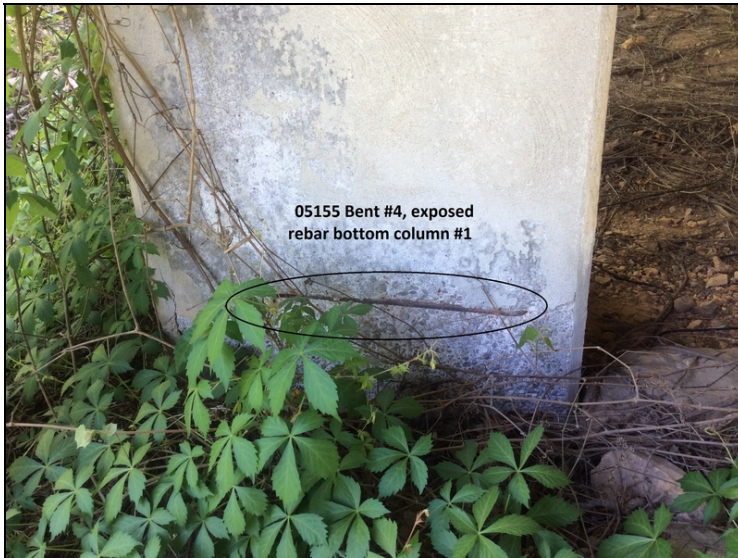
Bent #4 column #1 base of column shallow rebar exposed.

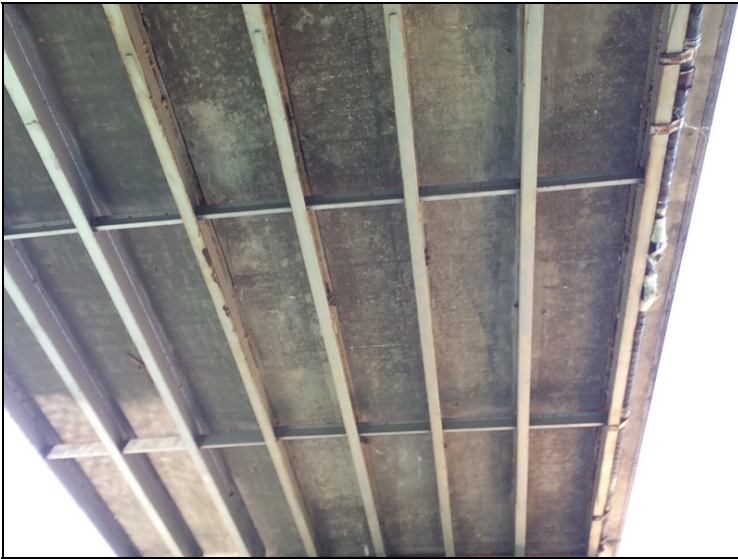
Steel superstructure all spans
Visible rust

steel superstructure active corrosion.

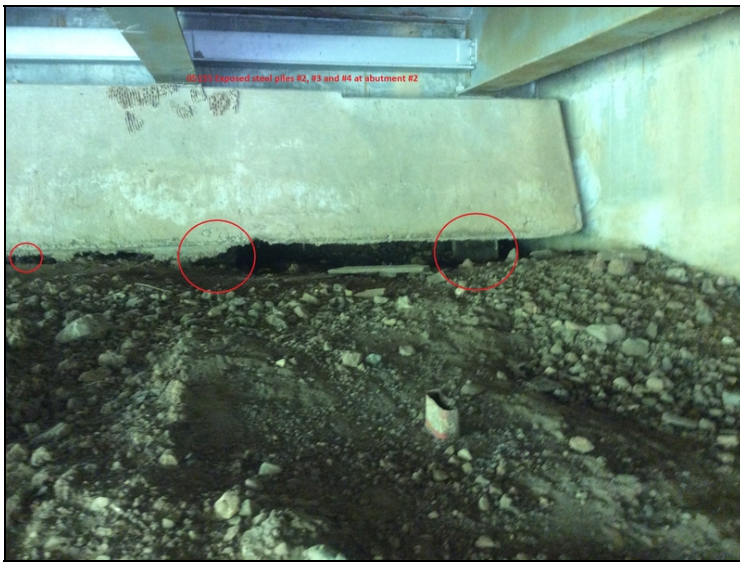
215	Reinforced Concrete Abutment	LF	167	155	12	0	0
4000	Settlement	LF	12	0	12	0	0
(215)							
5/6/2020 - WNR & DBM: Abutment #2 has 6-12" settlement towards right side exposing steel piles # 2,3,4.							
234	Reinforced Concrete Pier Cap	LF	155	93	51	10	1
1080	Delamination/Spall/Patched Area	LF	12	0	11	0	1
1090	Exposed Rebar	LF	10	0	0	10	0
1130	Cracking (RC and Other)	LF	40	0	40	0	0

Settlement at abutment #2 exposing steel piles #2 #3 and #4

Exposed steel pile #2, #3, & #4 at abutment #2

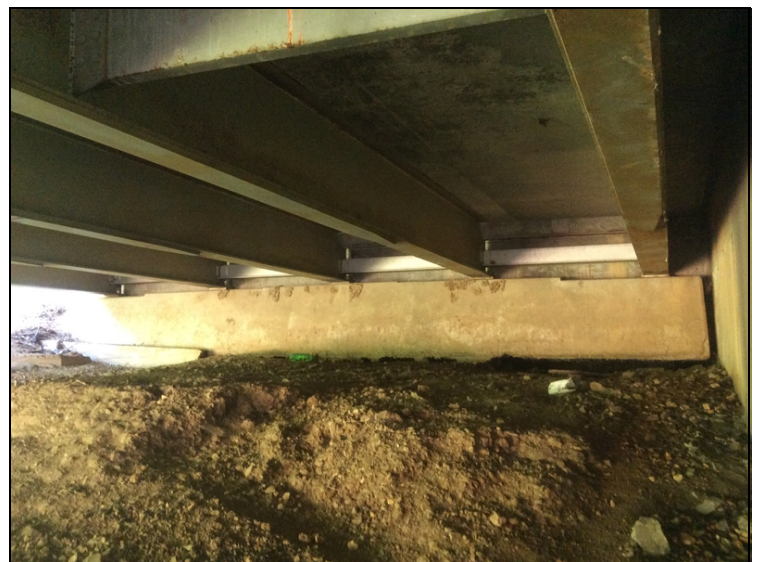
Abutment 2 left - settlement of end slope

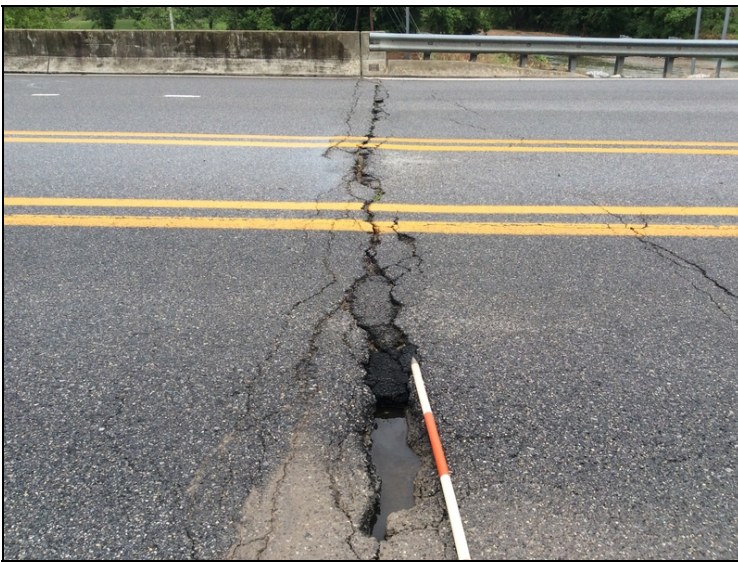
Deck - The ACHM driving surface is breaking apart over all expansion joints creating potholes in the driving surface.

West approach-Potholes.

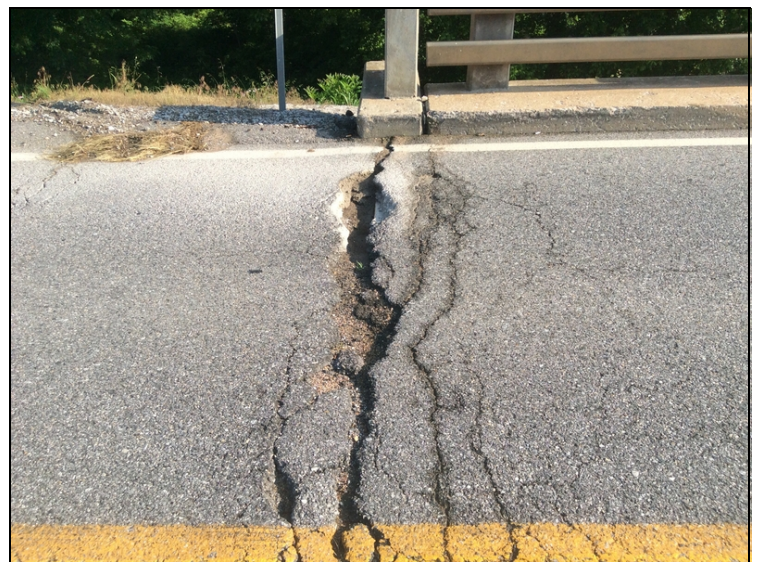
Abutment 2 left lanes approach roadway potholes.

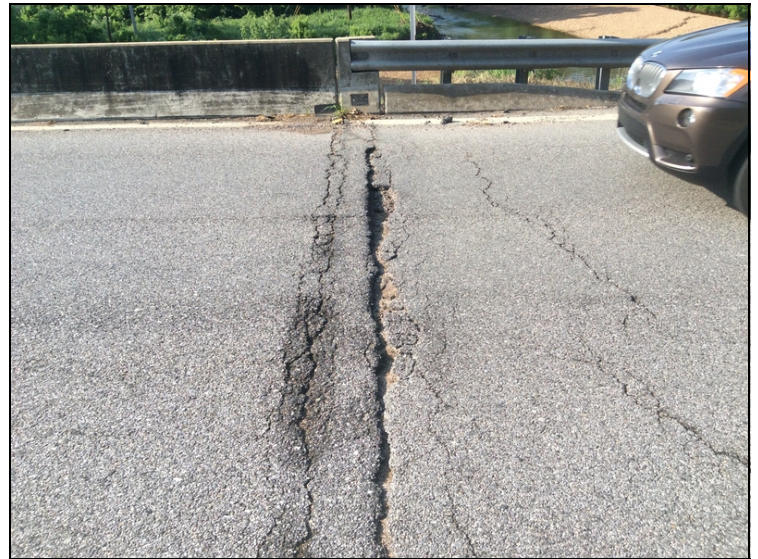
Abutment 1 right lanes approach roadway
potholes.

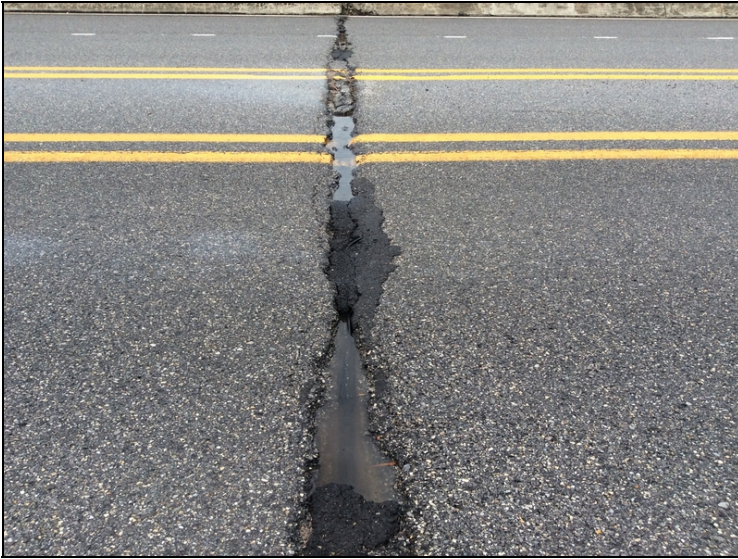
Bent #1-Potholes in ACHM driving surface.

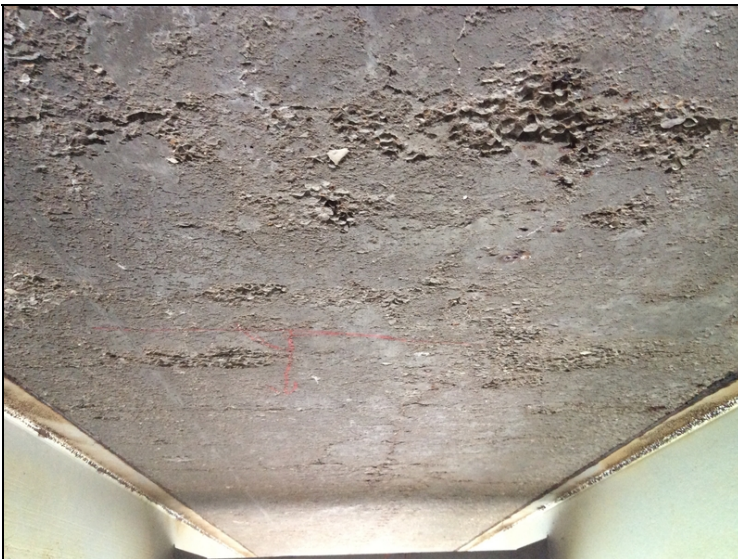
Deck - The undersurface of the deck in the original part of structure (bays #1 through #4) has large delaminated areas in spans #1 and #5. The undersurface has large areas of light / medium scaling in all spans indicating distress. Span #1, bay #4 has a 2'x2' area of spalling. Span #5, bay #3 has an 8" diameter spall with exposed reinforcing steel.

Span #1, bay #3-medium scaling with large delaminated area.

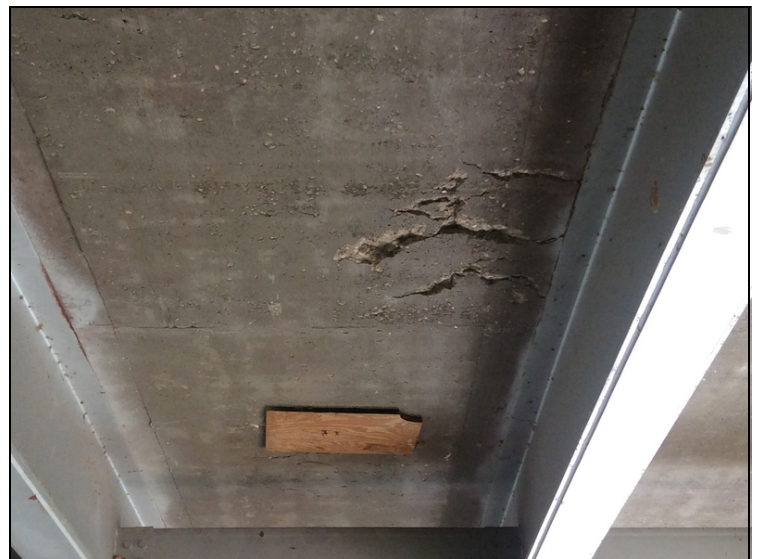
Span #1, bay #6-spalling in undersurface.

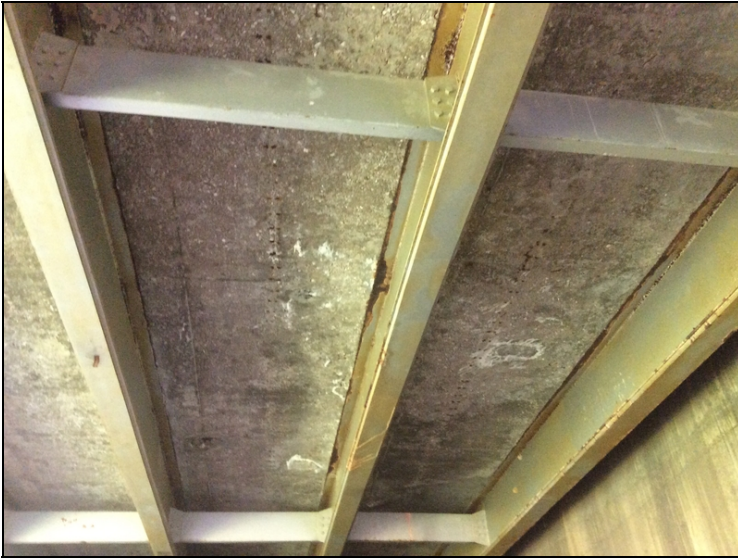
Span #5 bays #3 and #4 delaminated areas.

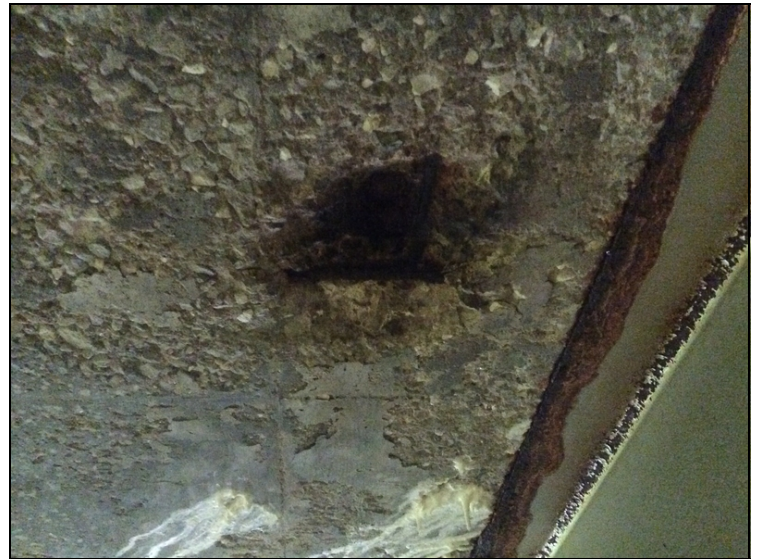
Span #5, bay #4-Spalling with exposed reinforcing steel.

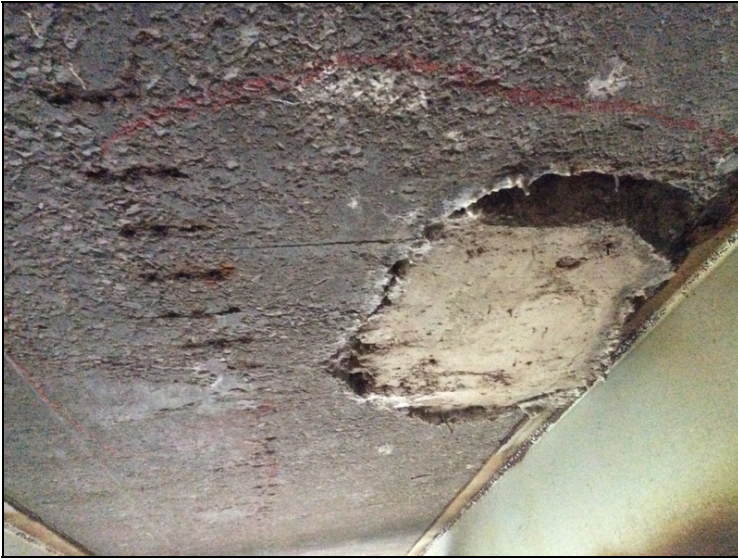
Span #1, bay #2-Delaminated area around repair.

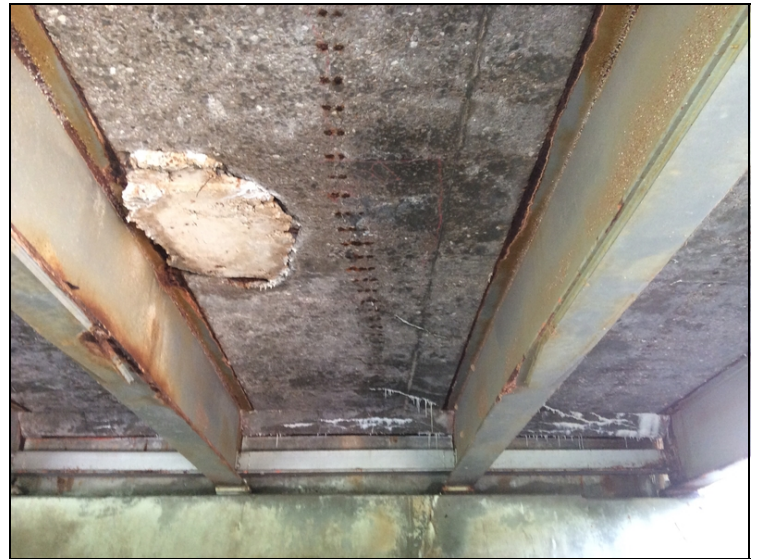
Span 1 bay 2 adjacent abutment 1 concrete patch.

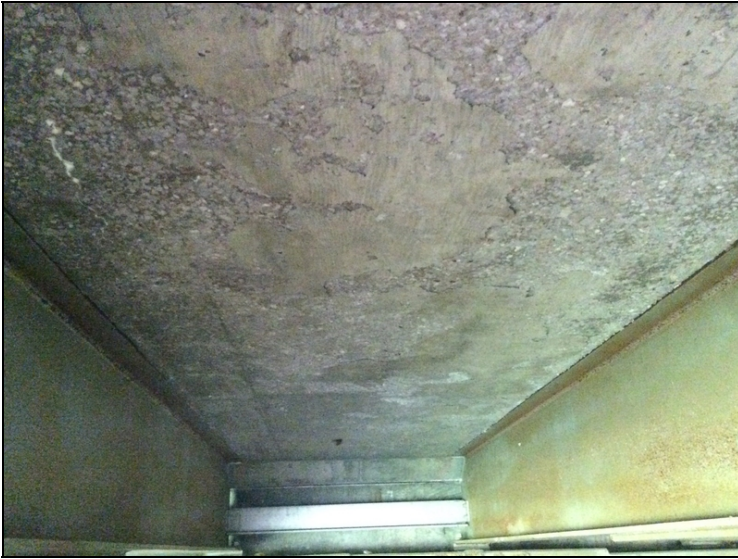
Scaling in undersurface typical.

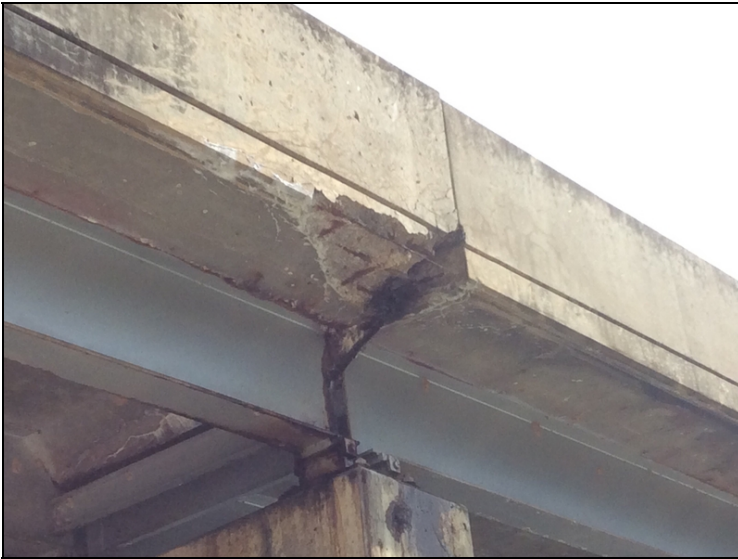
Deck - The overhang portion of the deck have areas of spalling with exposed reinforcing steel in several locations typically around deck drains.

Span #1, right side over bent #1-Spalling with exposed reinforcing steel.

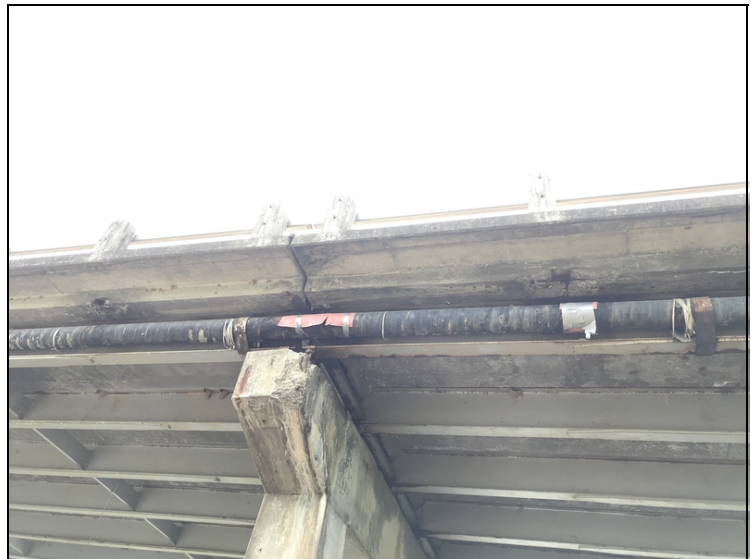
Typical exposed reinforcing steel around deck drains.

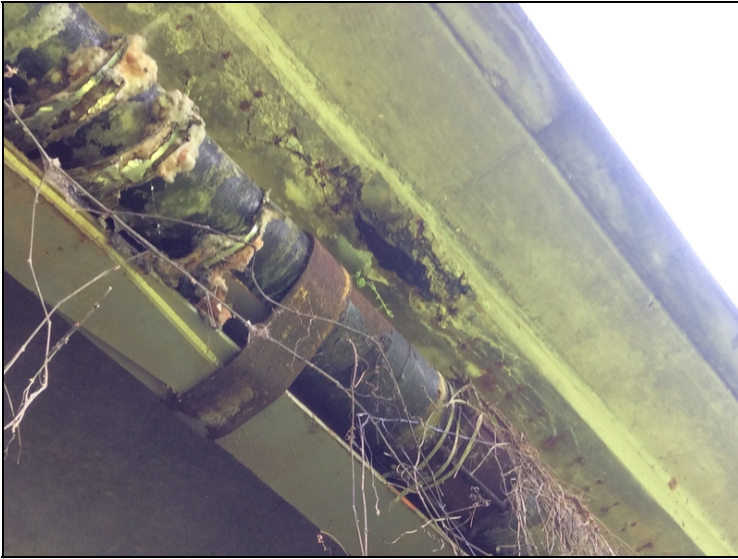
Span #5, Left side-Spalling around deck drains.
