**Bridge #M3230(Routine, Underwater type 2)**

**SH 340 Benton 2 over TANYARD CREEK**

**Location: .4 MI SW JCT SH 340-US 71**

**Team Lead: Benjamin Smith Inspection Date: August 21, 2019**

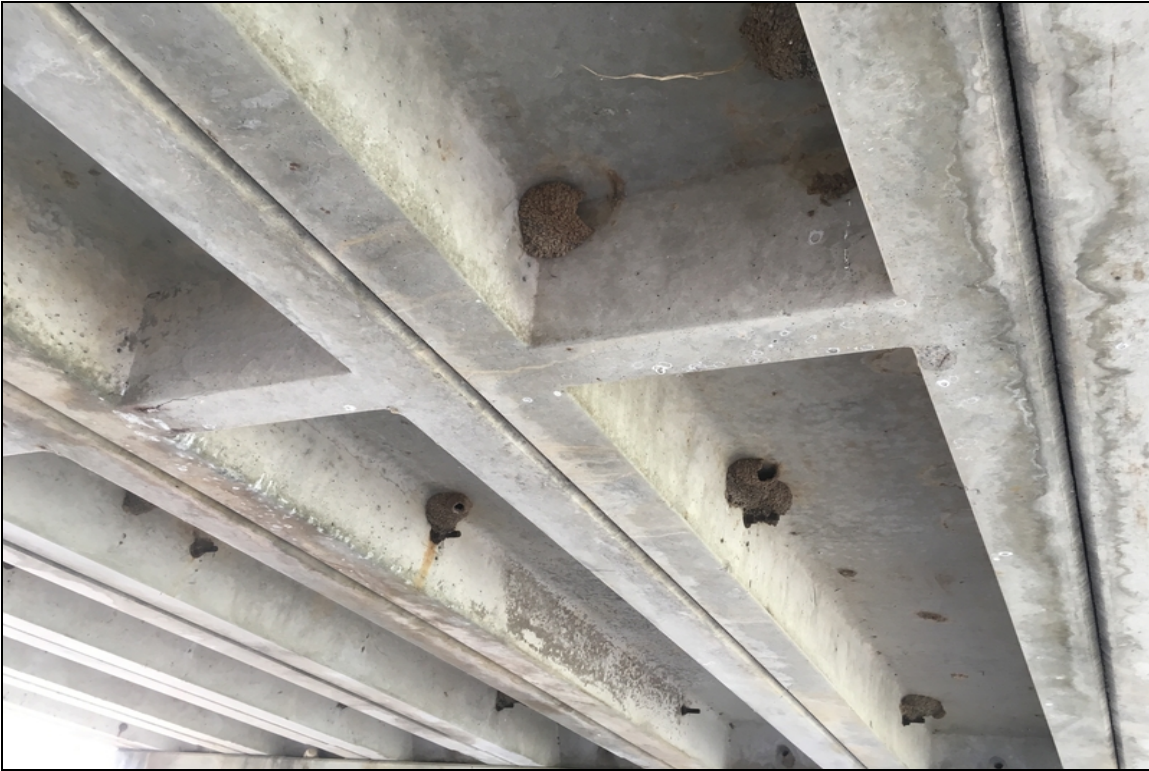
Typical view of the undersurface.

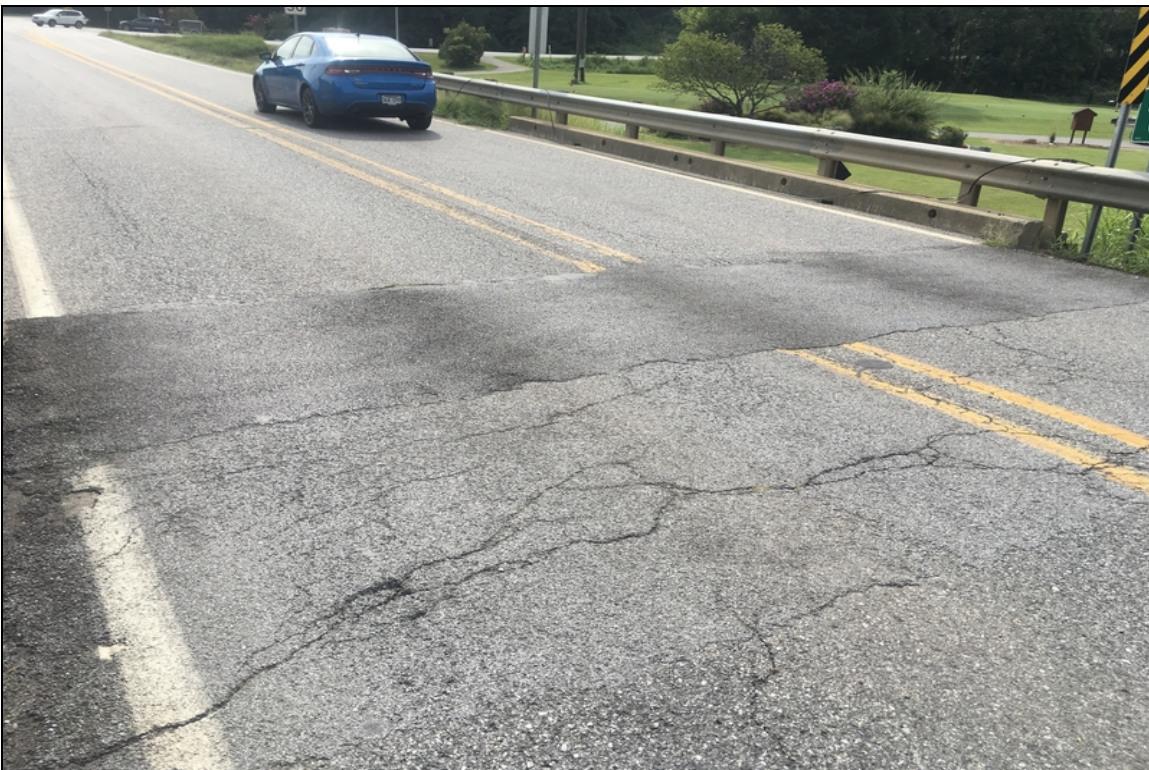
(16)							
8/21/19: Driving surface- The channel beams have a 3" ACHM wearing surface with longitudinal cracking in both lanes at this inspection.							
-The West approach roadway has minor settlement at the bridge end that has been repaired.							
Undersurface- No deficiencies noted.							
110	Reinforced Concrete Open Girder/Beam	LF	217	201	12	4	0
1080	Delamination/Spall/Patched Area	LF	12	0	12	0	0
1090	Exposed Rebar	LF	4	0	0	4	0

Repaired road way settlement at abutment #1

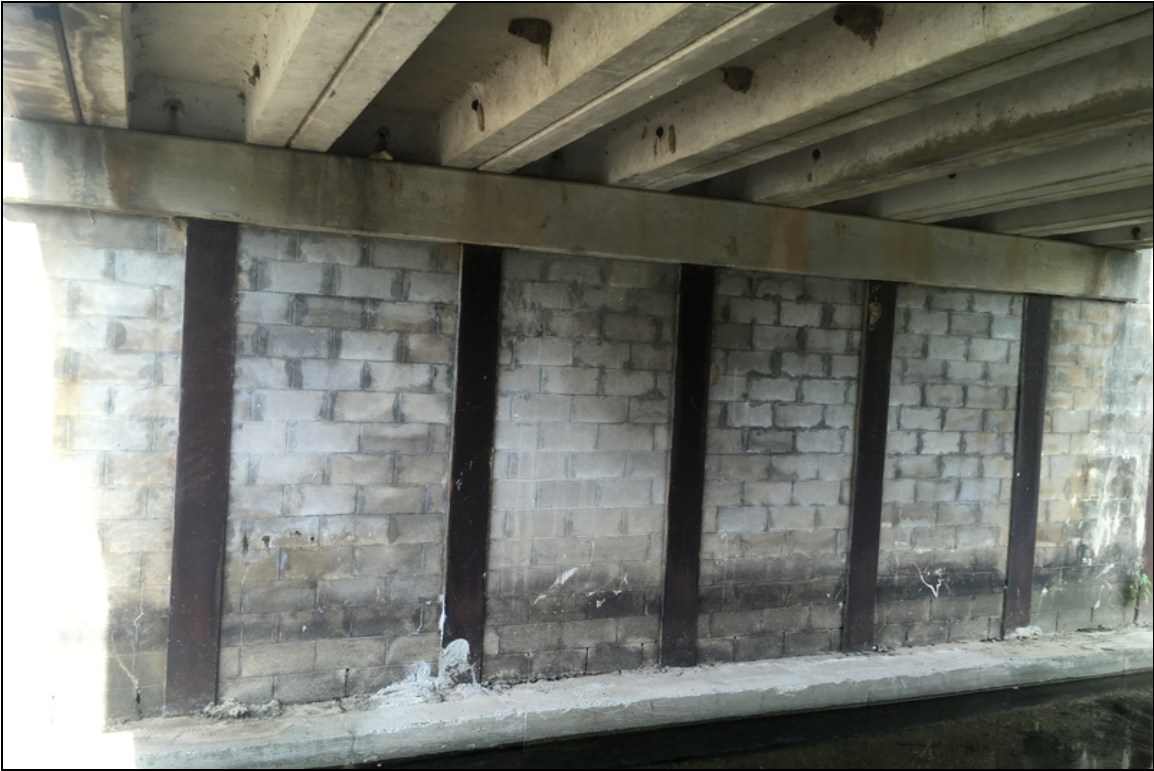
General view of abutment #1.

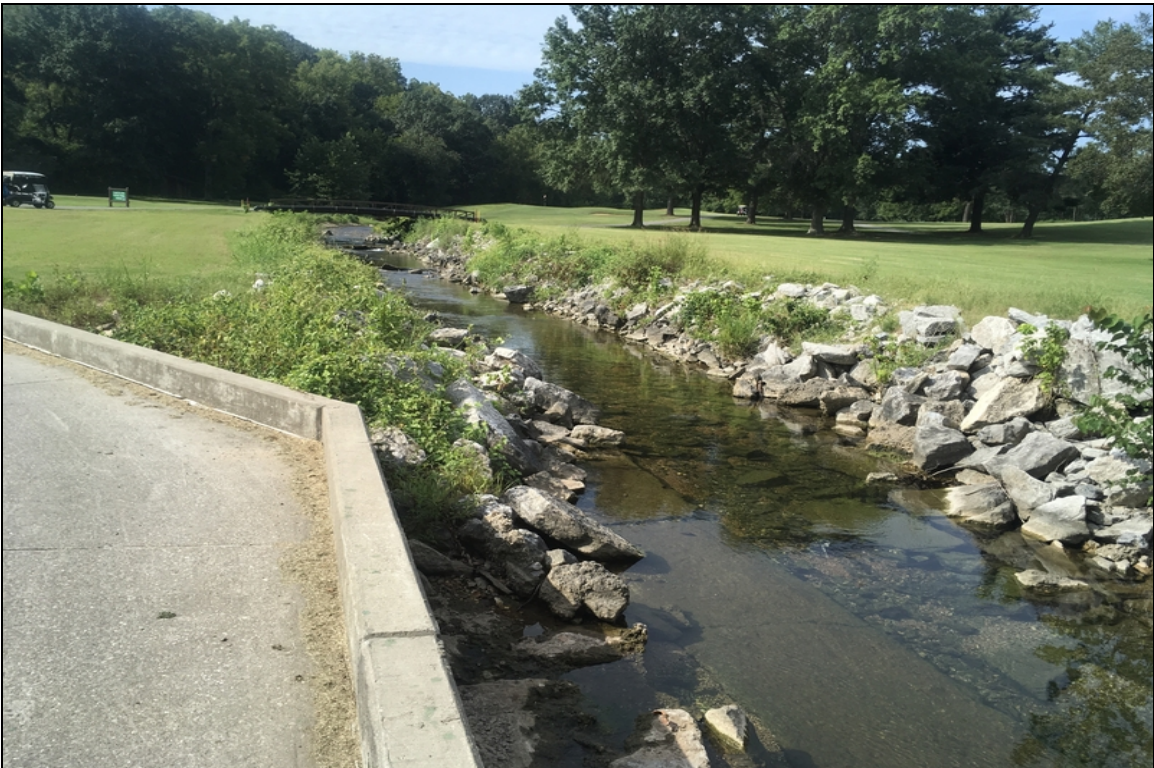
Upstream channel view.

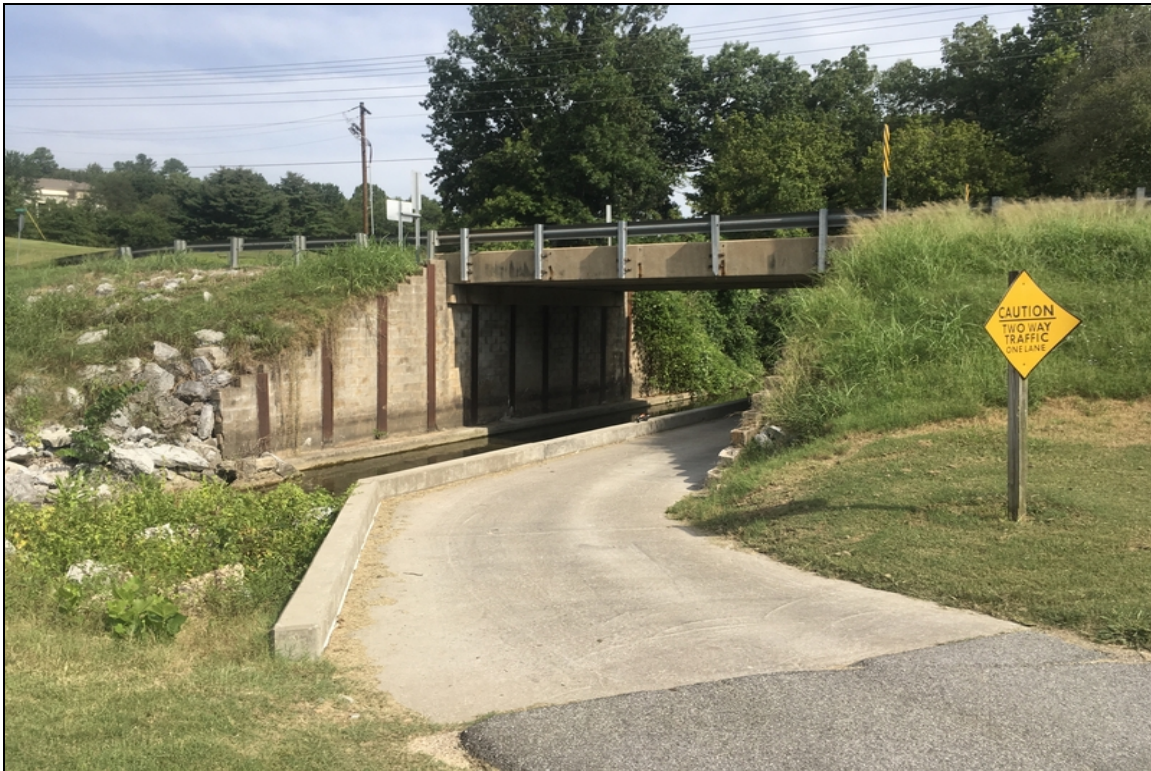
Elevation view. Log mile from left to right.

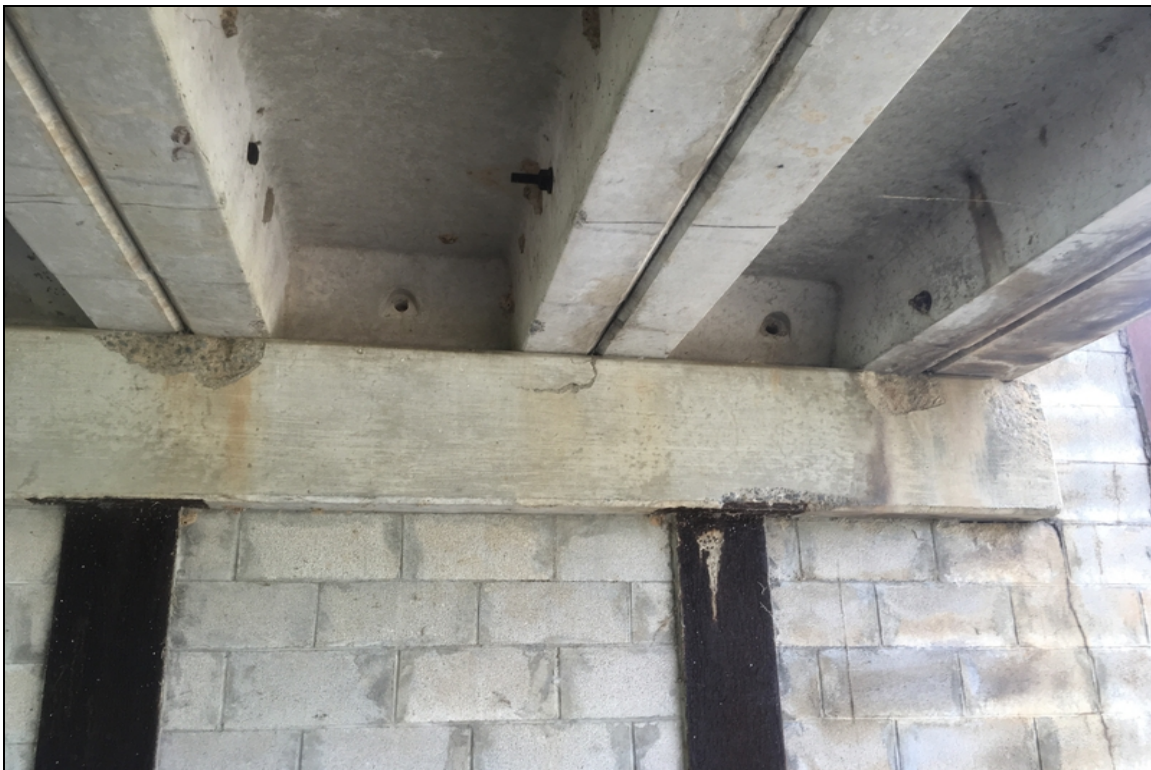
Spalling and delamination at the right end of pier cap #2.

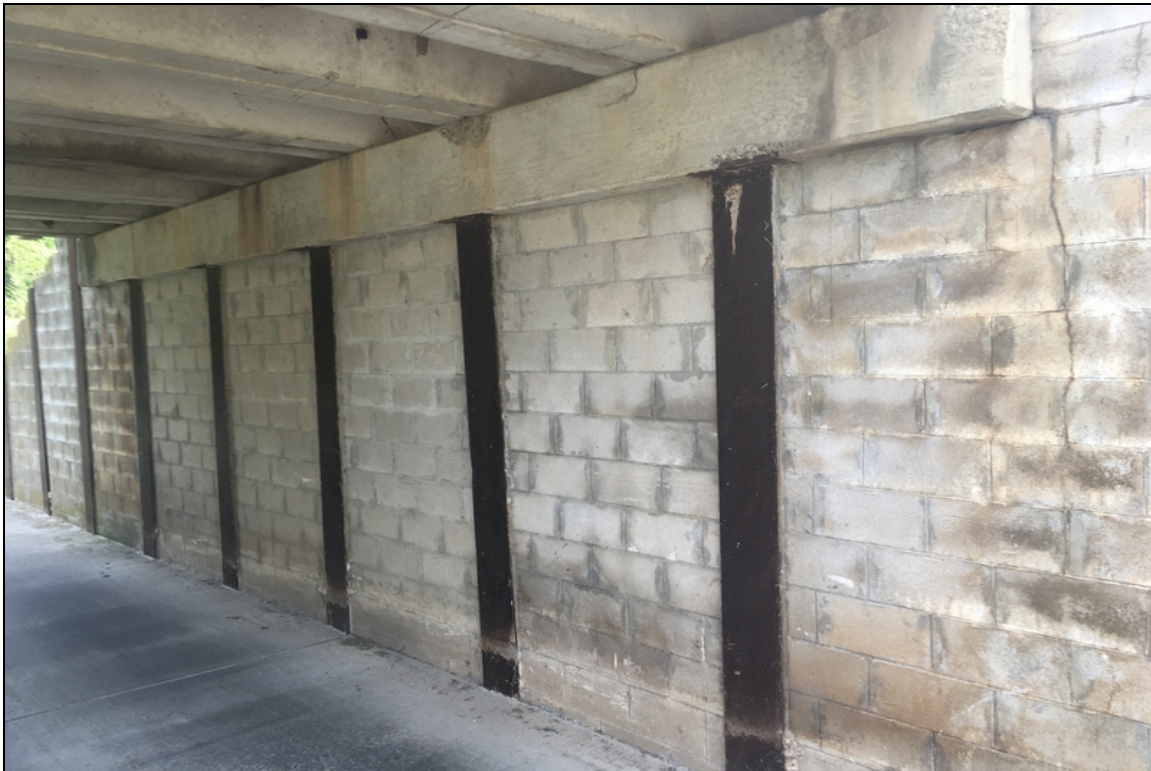
General view of abutment #2.

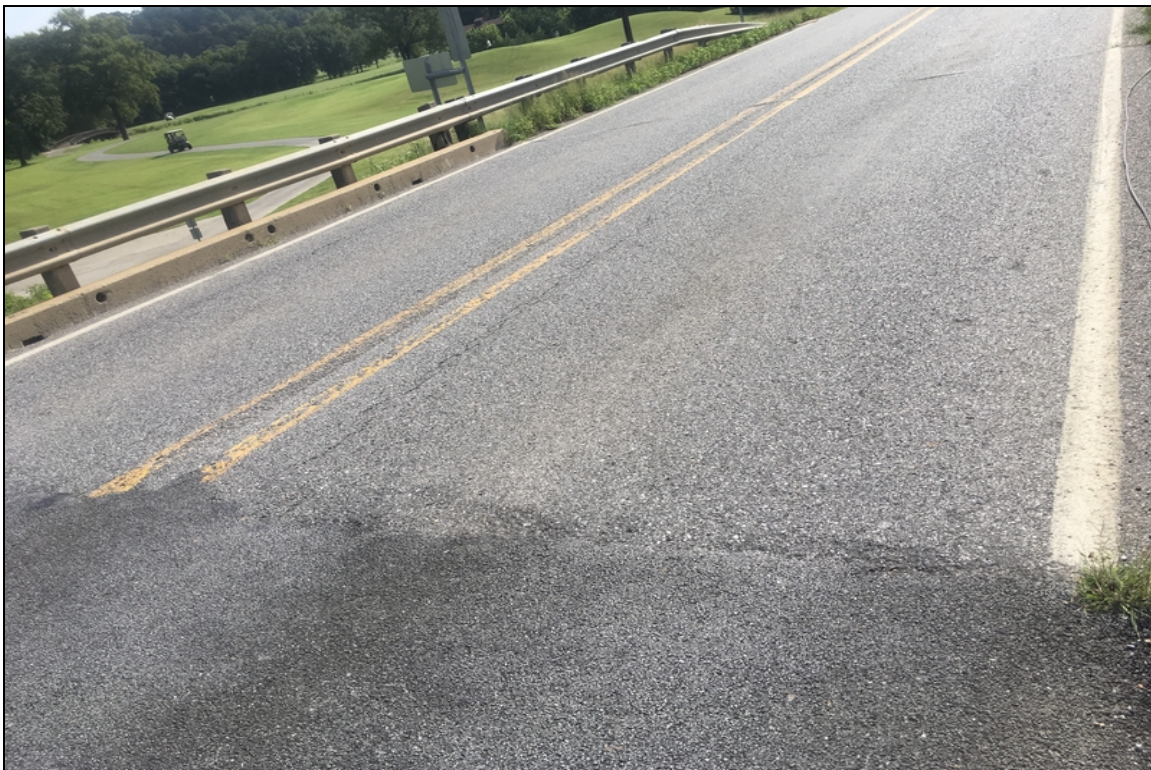
Typical view of driving surface.

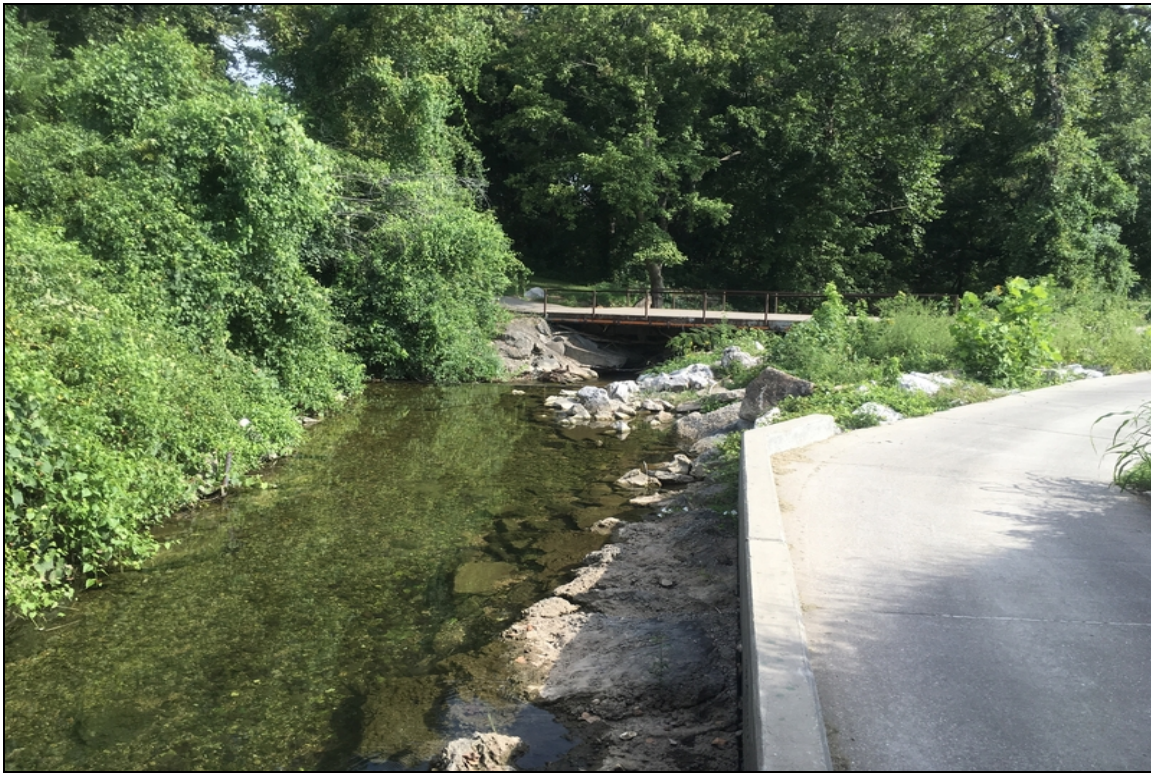
Downstream channel view.

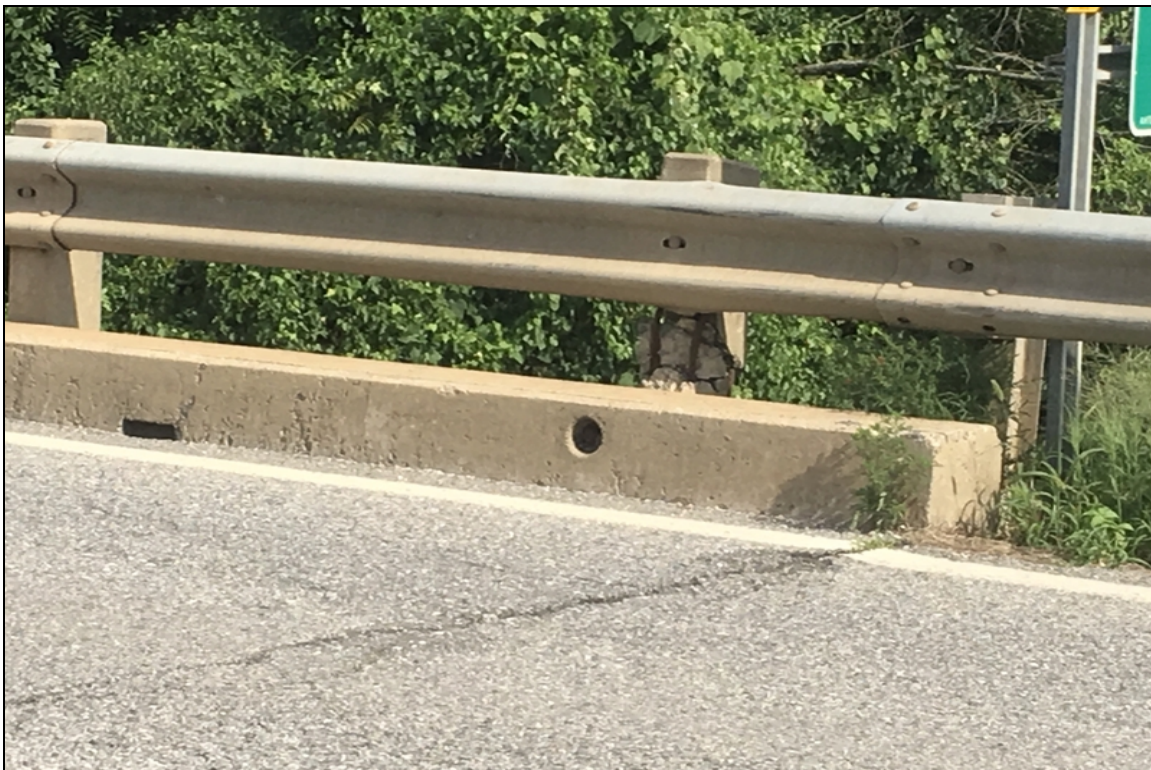
Post #5 along the left side of the structure is damaged.

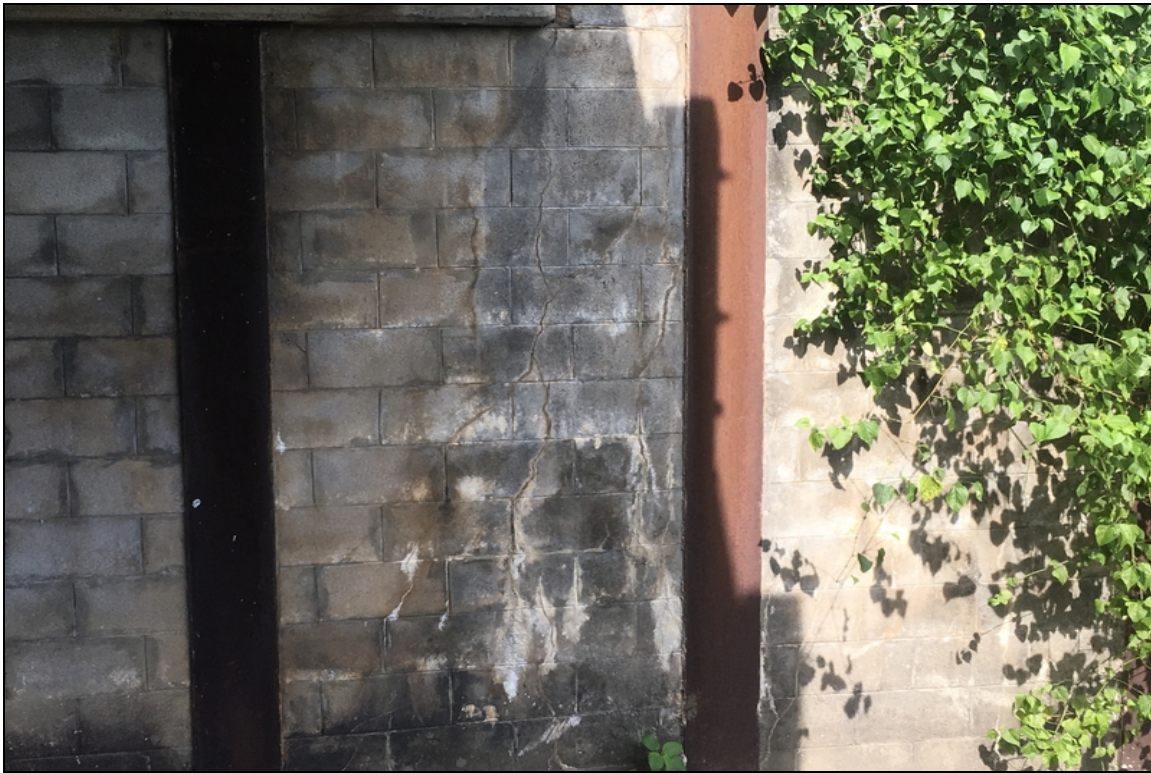
(218)							
08/21/19: The abutment is constructed with concrete cinder blocks and steel I-beam piles. The wing walls are not integral.							
-Abutment #1- The left side of abutment #1 and the Northwest wingwall has numerous diagonal cracks with efflorescence. The wing wall appears to be bulging at steel pile #2.							
Abutment #2- the right side of the vertical face has a crack that extends down from the corner of the pier cap, cinder block splitting was noted at this location. The steel piles have varying degrees of corrosion for 1' at the bottom of all 13 locations.							
220	Reinforced Concrete Pile Cap/Footing	LF	65	58	7	0	0
1120	Efflorescence/Rust Staining	LF	1	0	1	0	0
1130	Cracking (RC and Other)	LF	6	0	6	0	0

Vertical cracking with efflorescence on the left side of abutment #1.

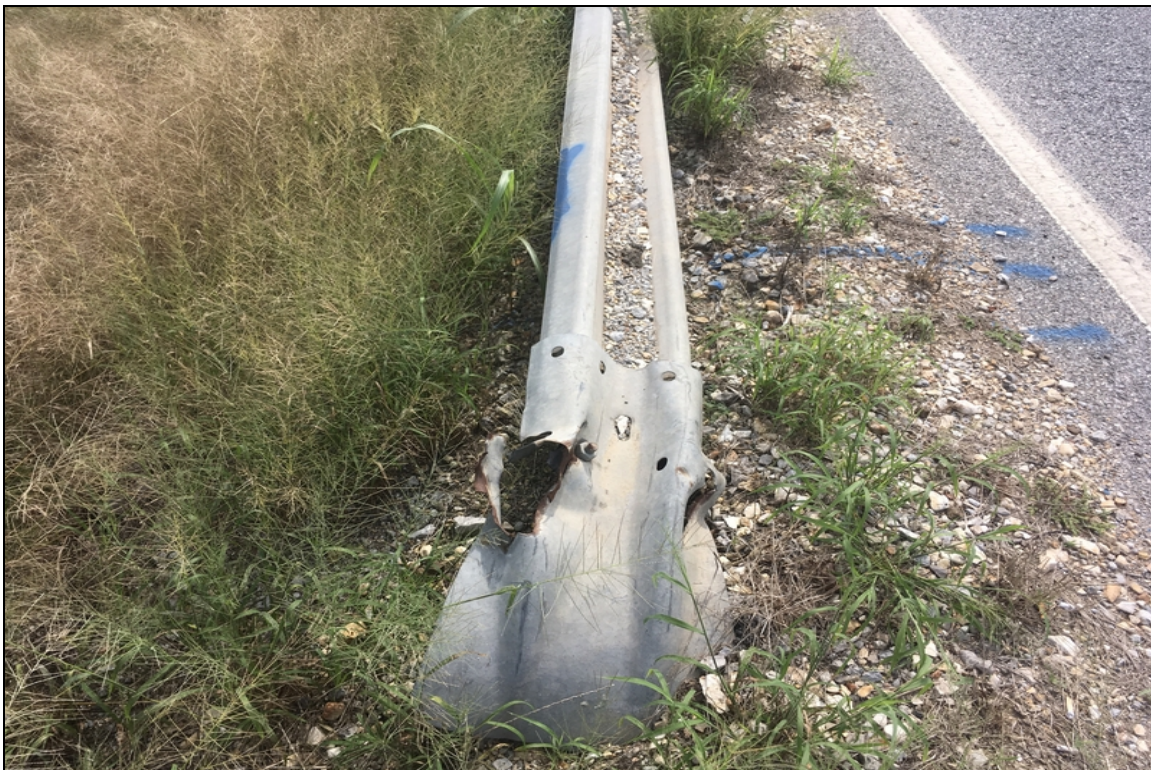
Torn end treatments at the abutment #1 end of the approach railing.
