# Bridge Inspection Report

**03309**  
**SH 21 Carroll**  
**over**  
**PINEY CREEK**

IDENTIFICATION		INSPECTIONS	
(1) STATE CODE	056 - Arkansas	(90) INSPECTION DATE	07/15/2019
(8) STRUCTURE NUMBER	03309	(91) DESIGNATED INSPECTION FREQUENCY	24

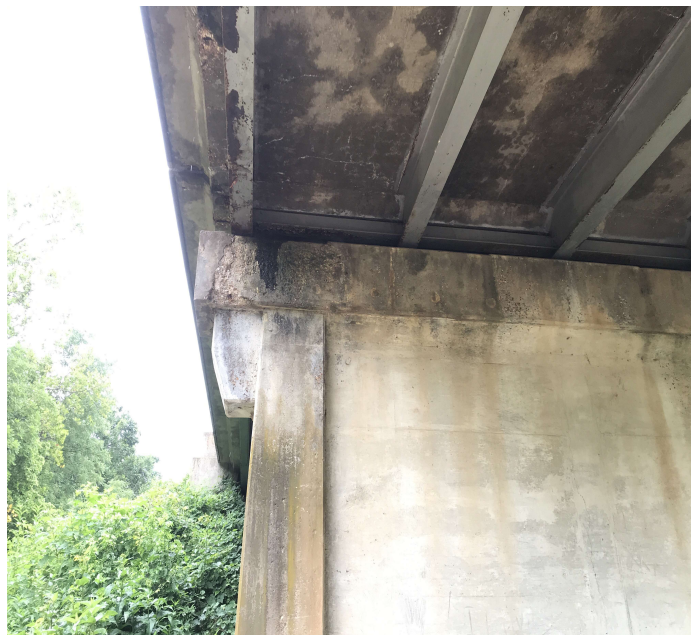
Bents #2 & #3 both have minor deterioration to right and left end of caps, with horizontal delaminations at the top edge of the caps at the mid section.

PHOTO 1      Description      Bent #3 cap left behind side spalling and delaminated areas.

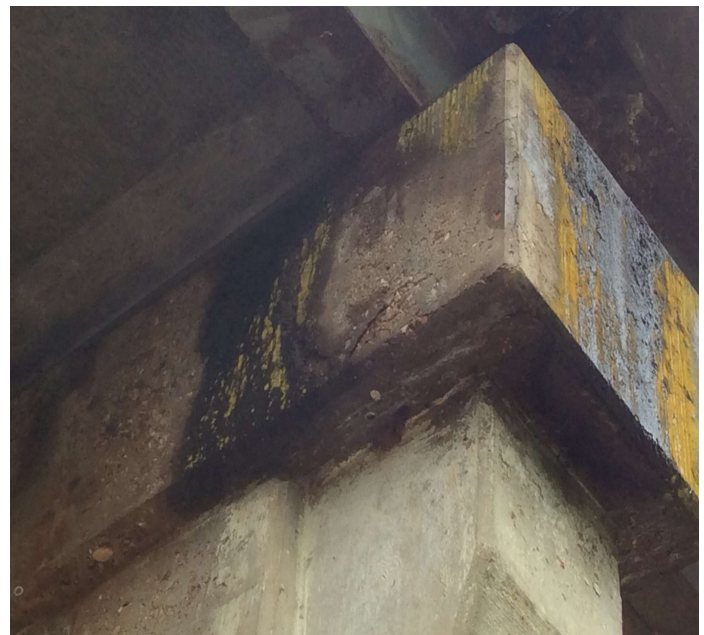
PHOTO 2      Description      Deterioration of right end of bent #2 cap

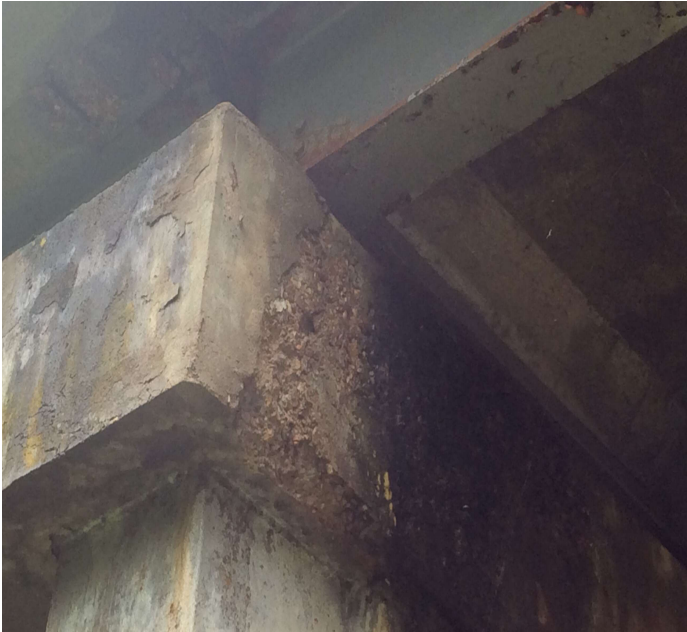
PHOTO 3      Description      Deterioration to left end of bent #3 cap

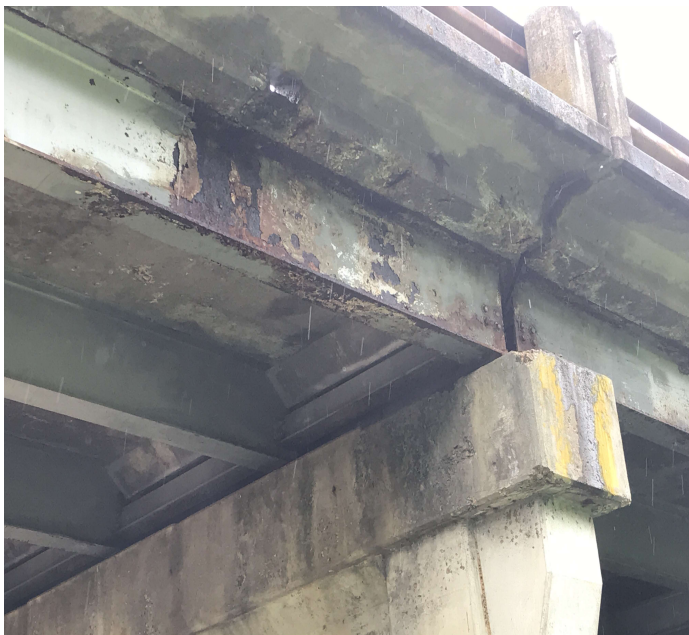
The bottom flange, bearings, and ends of all beams have corrosion below the assembly joint areas due to leaking joint seals.

PHOTO 1      Description      Span #3 girder #5 typical end of girder corrosion

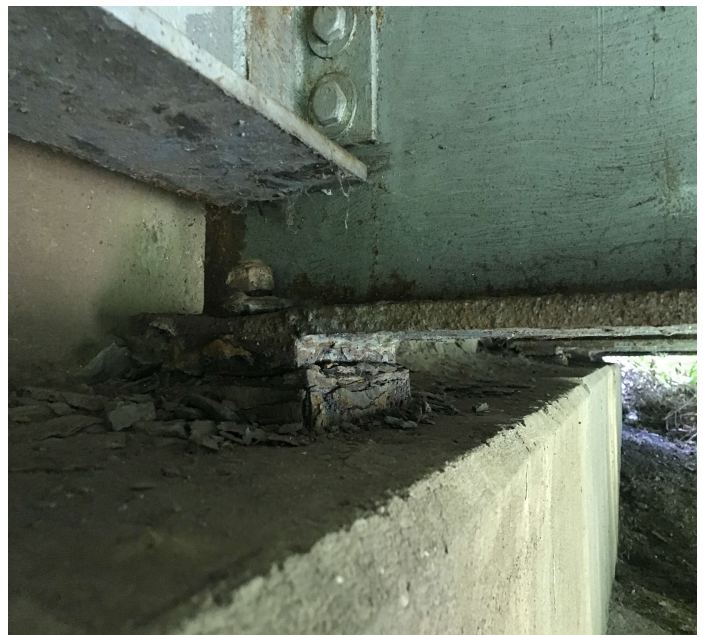
PHOTO 2      Description      Typical condition state of flaking rust to bearings due to leakage through joints.

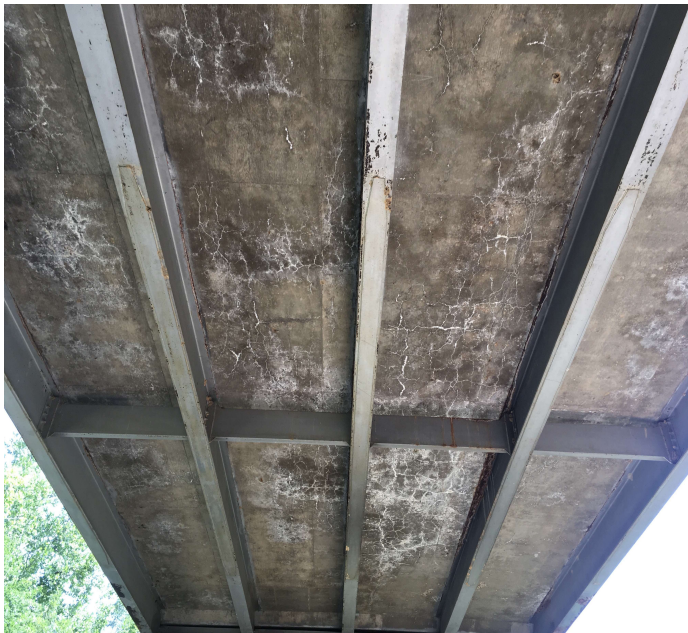
PHOTO 1 Description

Spans #2,3,4 have numerous patched or delaminated areas for most of the span area.

Spans #1,2,4 have small pot holes with rebar exposed.

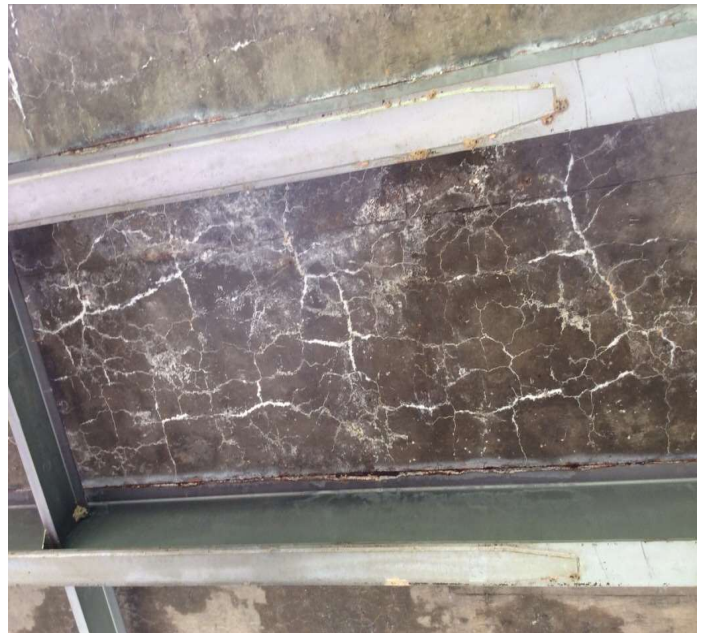
Spans #1,2,3 and #4 - have heavy concentrations of map cracking with efflorescence leaching in the deck soffit.

PHOTO 2 Description Efflorescence cracking with leakage between girders #3,#4 in deck soffit.

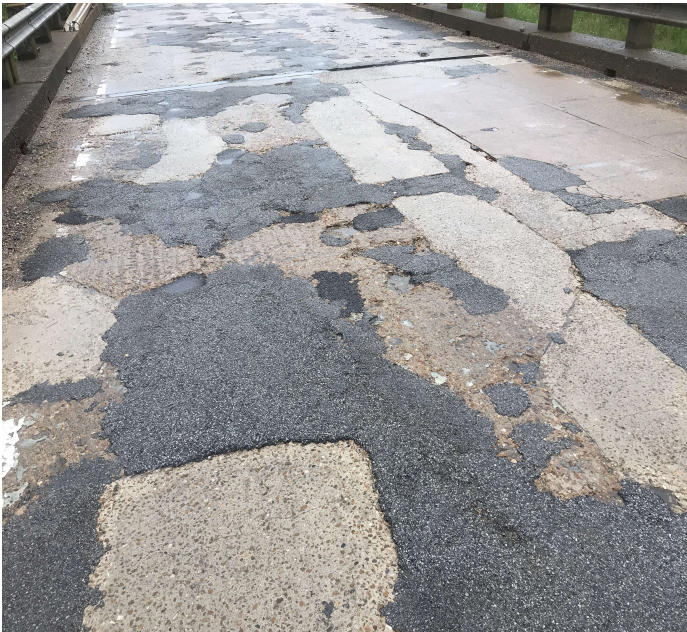
PHOTO 4 Description Span #3 typical spalled patched areas.

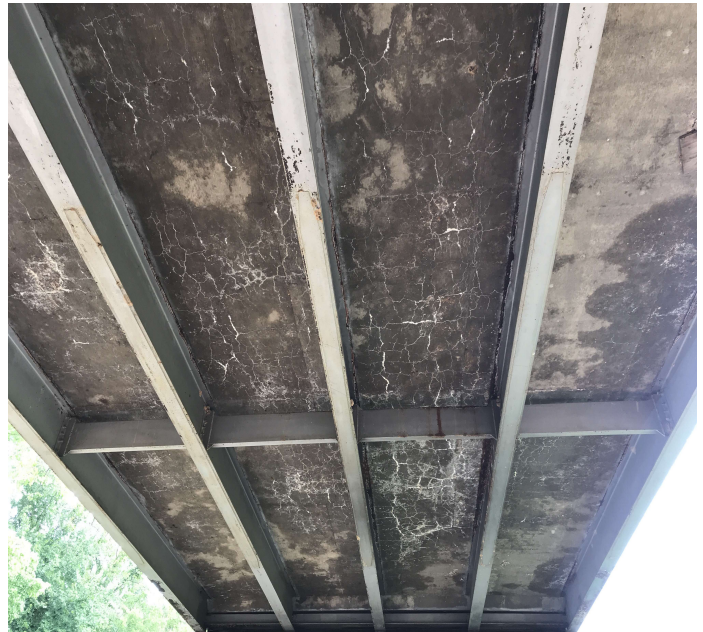
PHOTO 6 Description View of span #3 efflorescence.

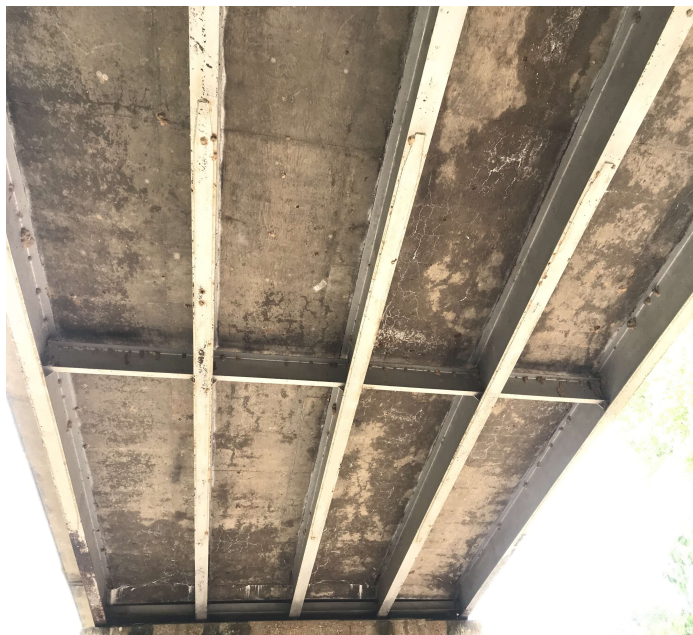
PHOTO 7      Description      Span #2 undersurface.

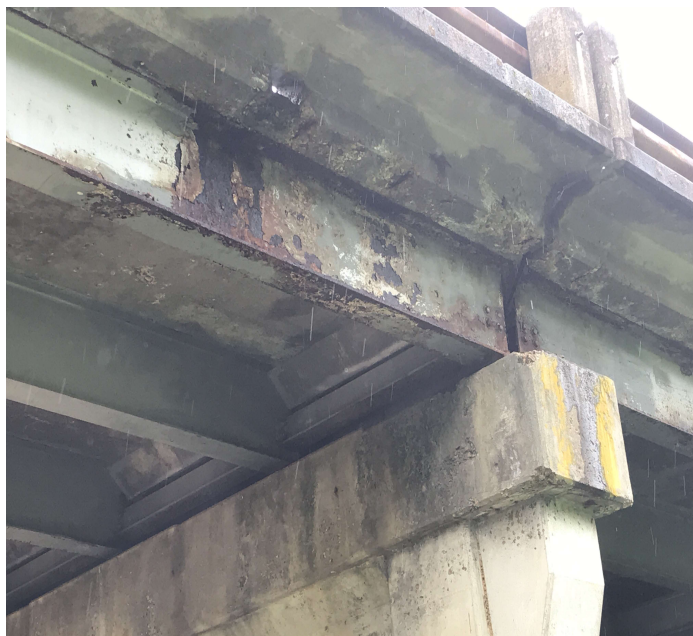
PHOTO 8      Description      Span #3 girder #5 typical end of girder corrosion
