Bridge Inspection Report

07153
SH 21 Carroll
over
Osage Creek

Structure Number: 07153

Facility Carried: SH 21 Carroll

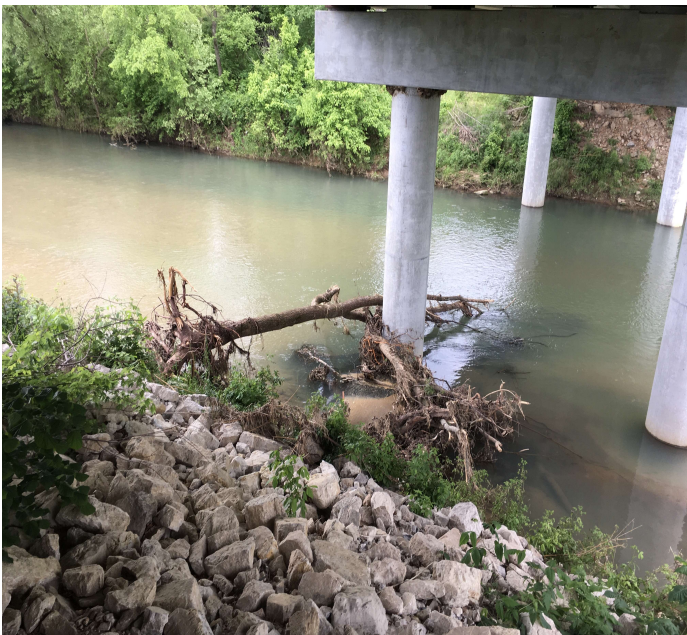
Column #2 of bent #2 has drift accumulation.

PHOTO 1 Description Drift accumulation on the right column of bent #2.
