# Bridge Inspection Report

**00677**

**SH 178 Marion  
over  
FALLEN ASH**

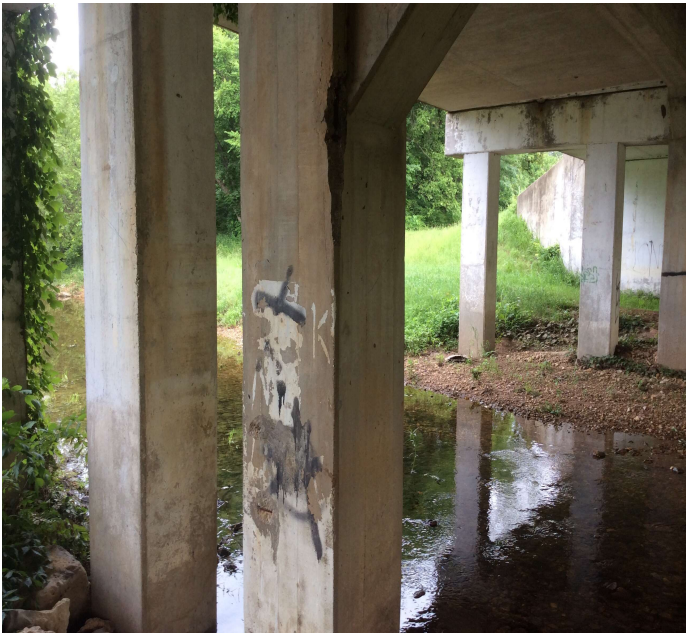
Bent #1 columns #3 has exposed rebar

PHOTO 1      Description      Bent #1 column #3 has 18" exposed rebar

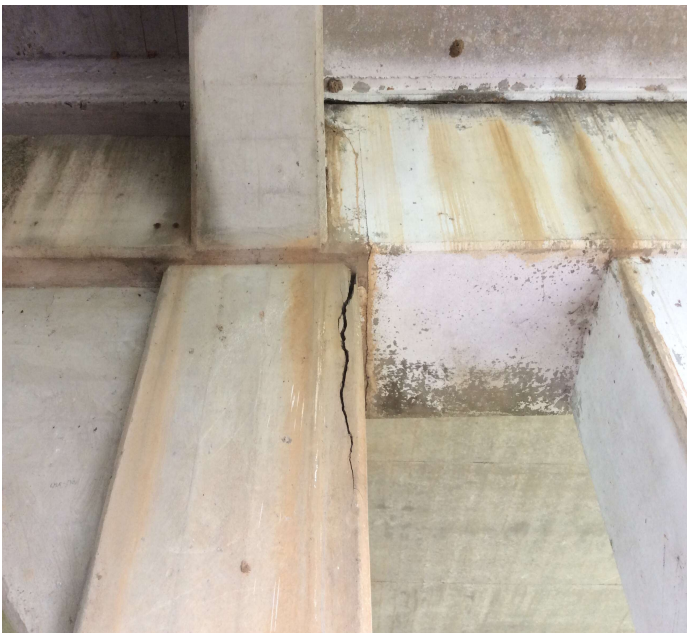
Bent #2 has crack in columns #3 & #4

PHOTO 1      Description      Bent #2 crack in column #4

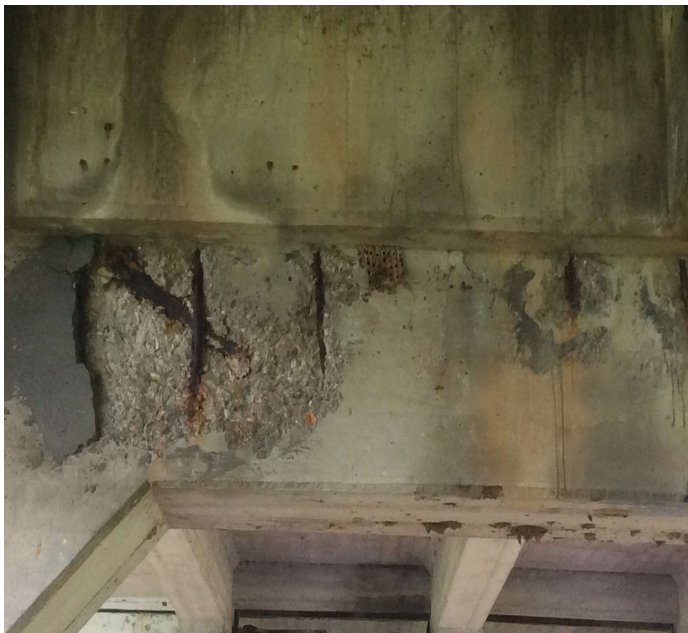
Bent #1 cap has 5' of rebar exposed. Bent #2 cap has 24" of exposed rebar

PHOTO 1      Description      5' exposed rebar to bent #1 cap

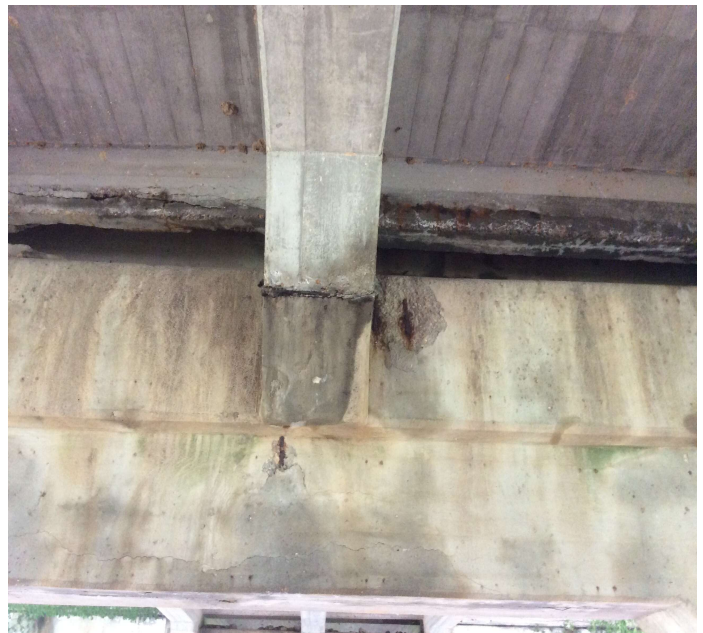
PHOTO 2      Description      Bent #2 cap has 24" of rebar exposed

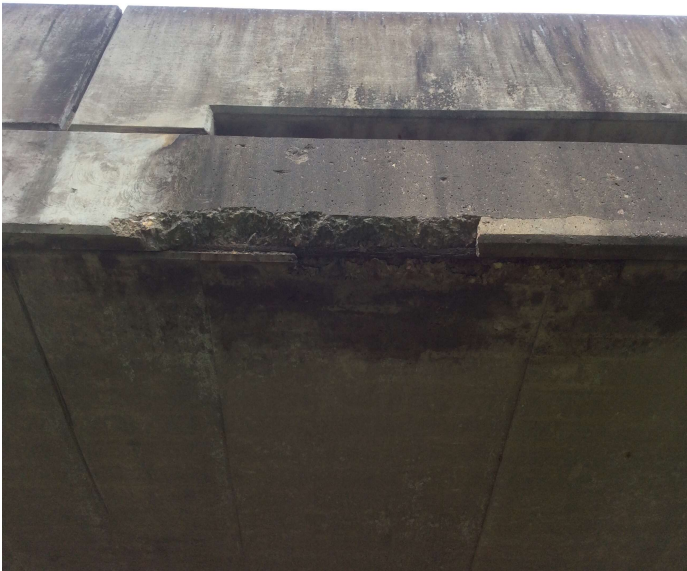
Soffit spall right side of span #3

PHOTO 1      Description      Right side span #3 soffit has 6' exposed rebar
