# Bridge Inspection Report

**03636**  
**SH 12 Benton**  
**over**  
**BEAVER LAKE**

## Bridge Inspection Report

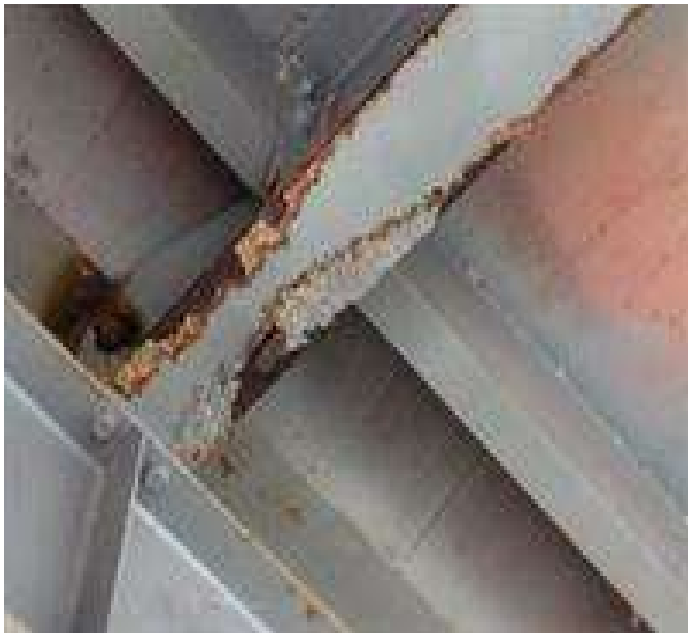
PHOTO 1      Description      Span #5 right stringer

Superstructure / expansion joints - The superstructure has areas of corrosion to girders at the splice connections and to webs of girders adjacent to the pin and hanger assemblies and to exterior sides of webs where water from the deck drains discharge onto the superstructure.

The finger joint assemblies, ends of stringers and floor beams in spans #5 and #8 have heavy corrosion with thick flaking rust.

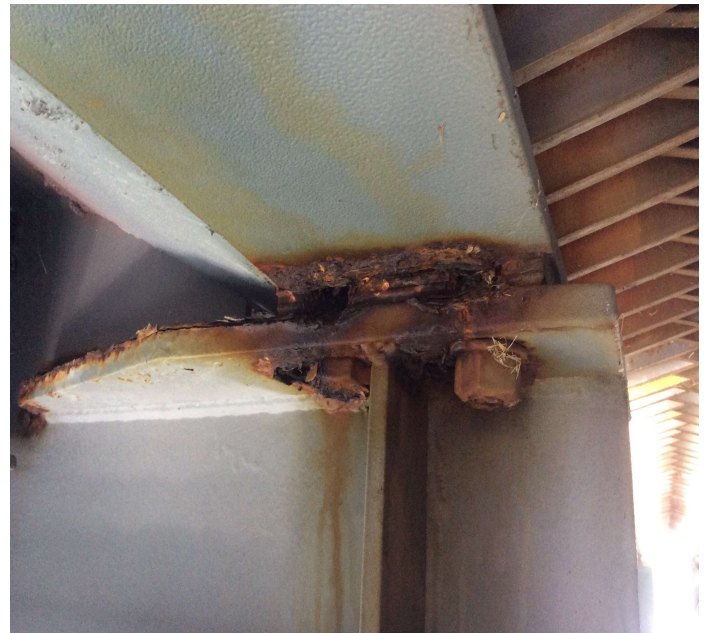
PHOTO 2      Description      Corrosion at stringer/finger joint connection.

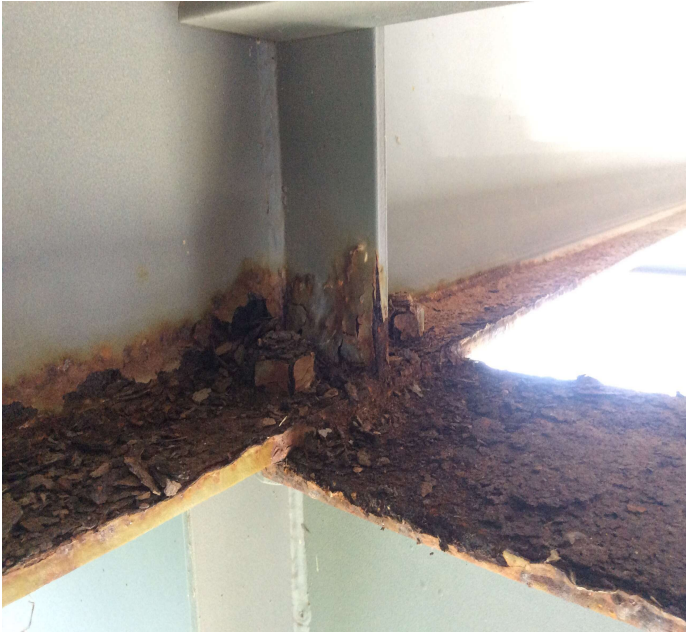
PHOTO 3      Description      Corrosion at stringer / floorbeam connection.

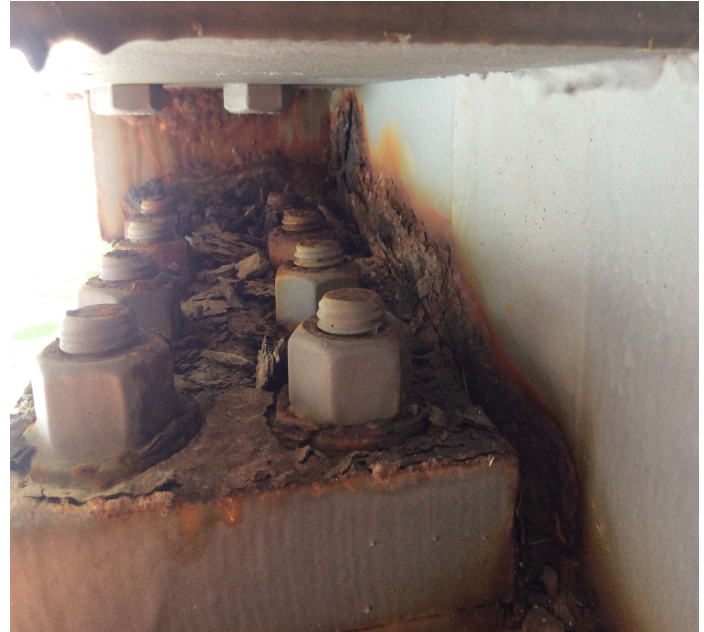
PHOTO 5      Description      Corrosion to girder adjacent to pin and hanger assembly.

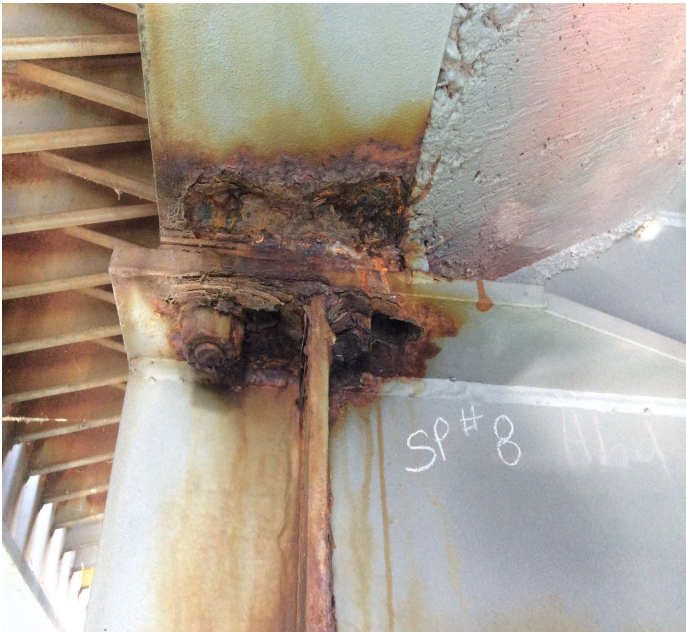
PHOTO 4      Description      Corrosion at stringer / floorbeam connection.

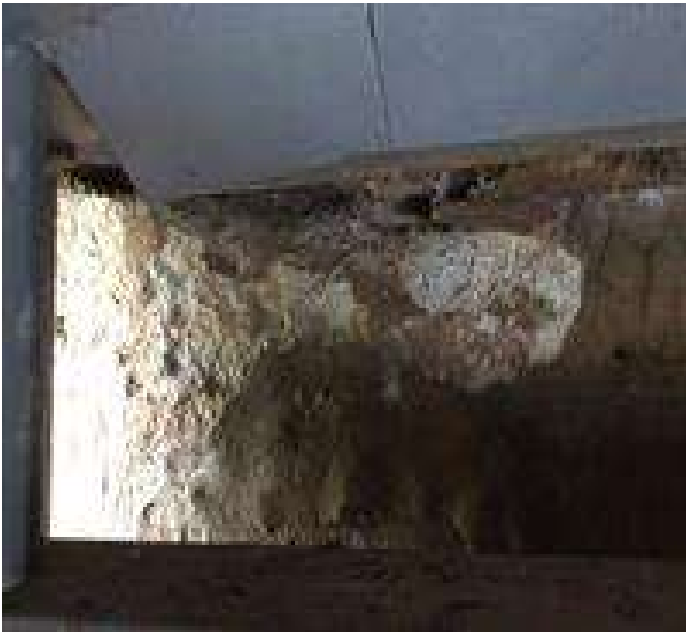
PHOTO 1      Description      Abut #2 left top corner

Abutment #2 Left side Breastwall and assembly joint  
Large spall and loose anchorage in assembly joint

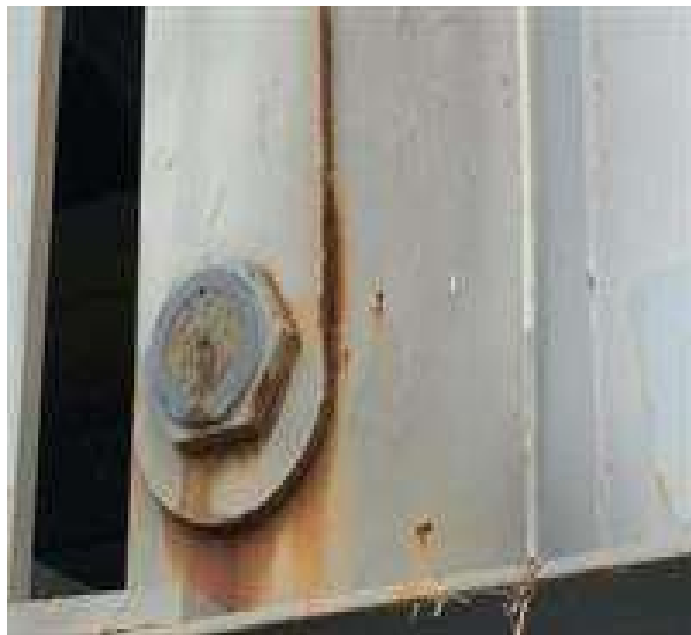
PHOTO 1      Description      Span #5 Lower Hanger Assembly

Pin and Hanger assemblies - The pin and hanger assemblies have corrosion with pack rust between the hanger bars and webs of girders at the lower pin connections.

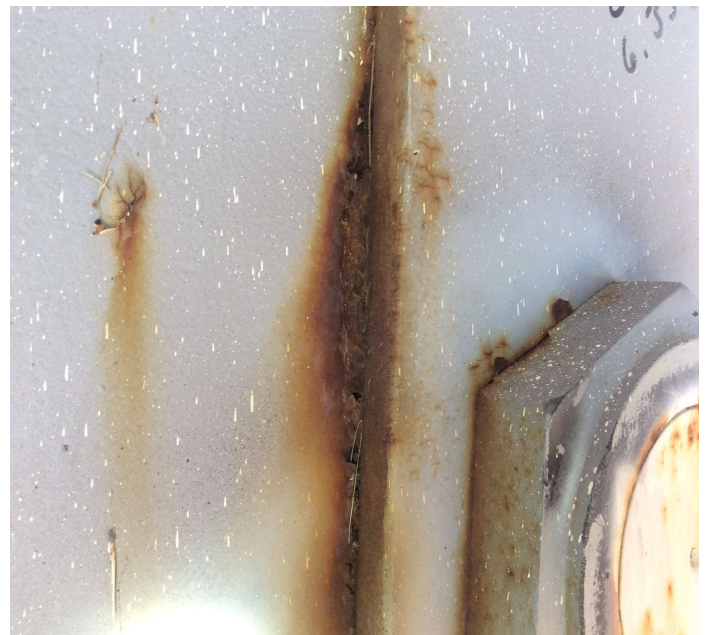
PHOTO 2      Description      Corrosion with pack rust to pin and hanger assemblies.

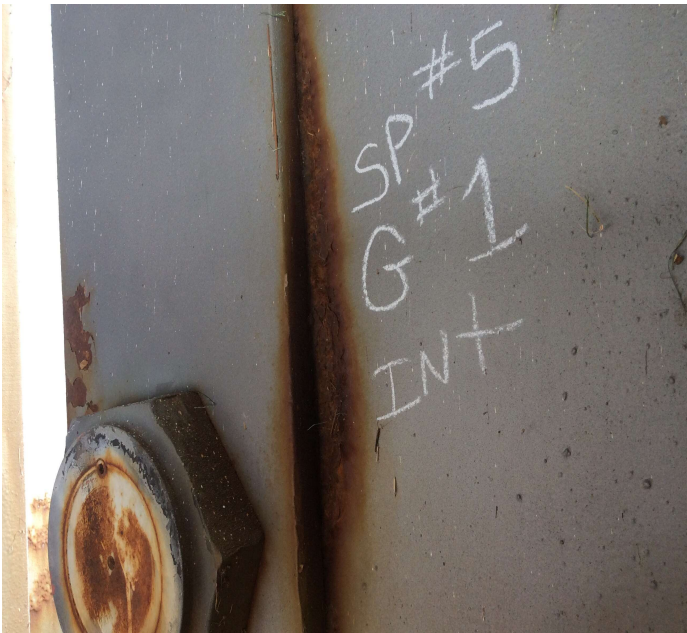
PHOTO 3      Description      Corrosion with pack rust to pin and hanger assemblies.

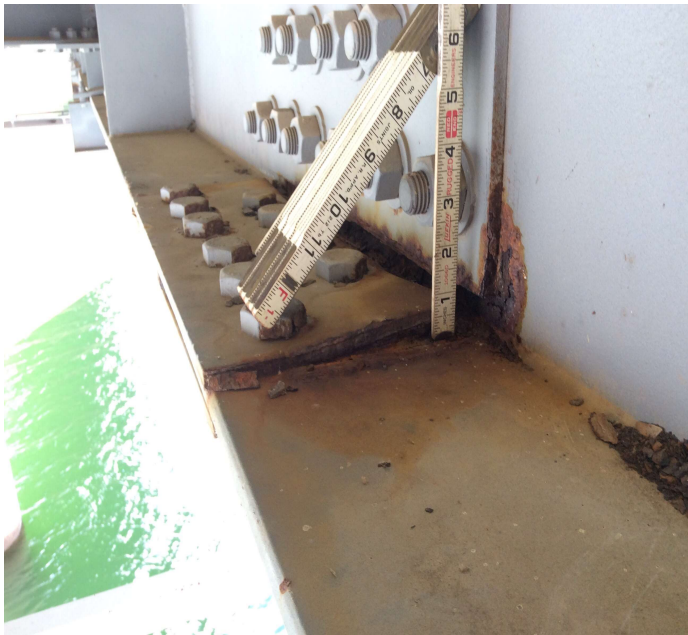
PHOTO 1 Description

The splice plate connections for girders # 1 and # 2 have paint failure with active corrosion and pack rust with out of plane bending to the interior side bottom flange splice plates in several locations. Most notable areas are girder # 1 of span # 7 at splice # 2 which has approximately 1/2" pack rust at the bottom flange interior connection plate that has caused out of plane bending to the connection plate.

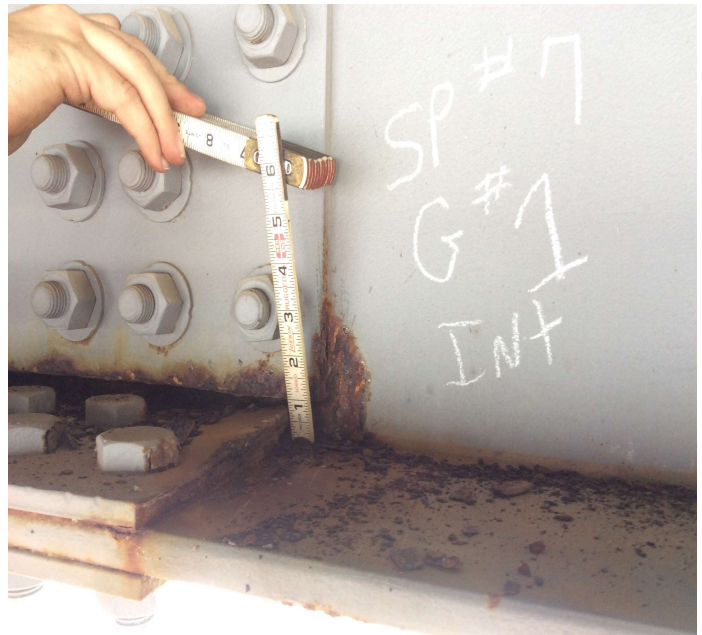
PHOTO 2 Description Pack rust with out-of-plane bending to connection plate.

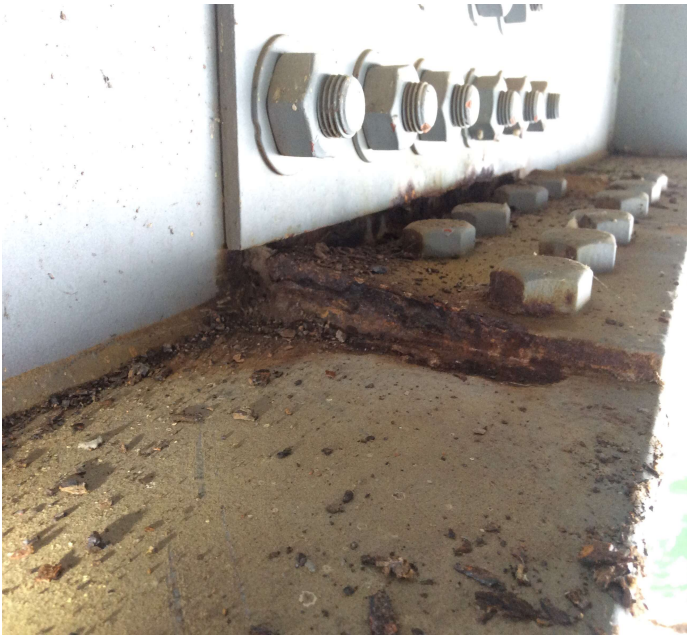
PHOTO 3      Description      Pack rust with out-of-plane bending to connection plate.

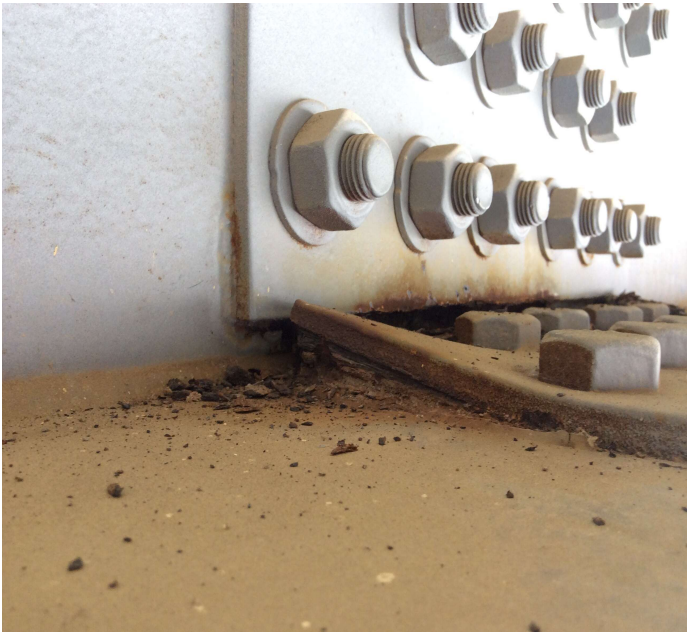
PHOTO 4      Description

Girders # 1 and # 2 of span # 9 at splice # 1 interior bottom flange splice plates at splice # 1 have pack rust with out of plane bending to the interior bottom flange splice plates.

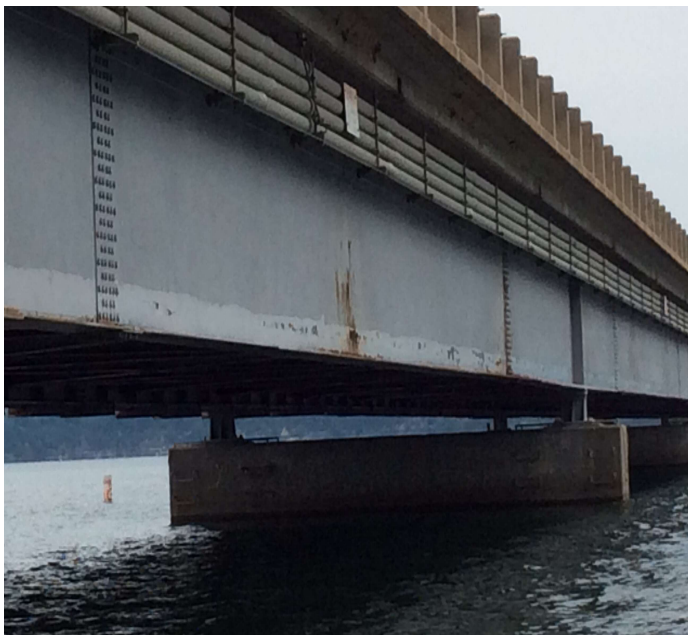
PHOTO 1      Description      Span #2 minor section loss to bottom flange and lower 1/2 of web in girder #1

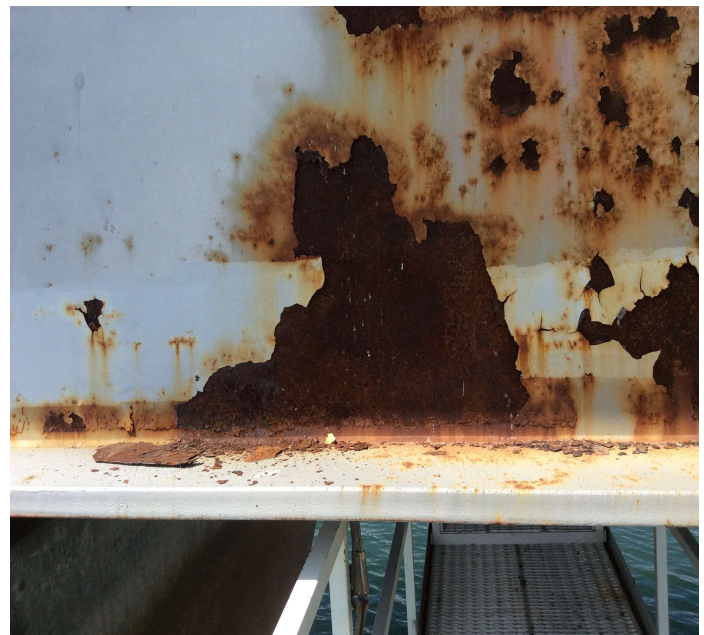
PHOTO 2      Description      Span #12, girder #2 approximately 5' from bent #11 has corrosion with pitting to exterior web.

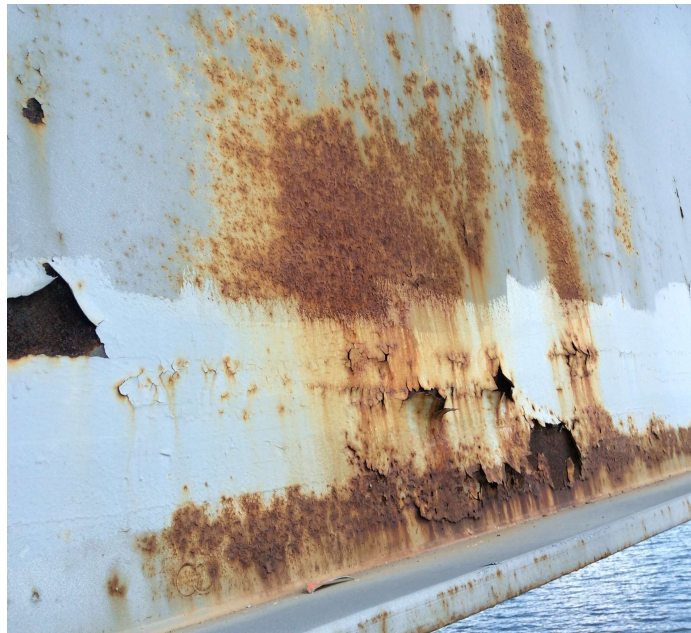
PHOTO 3      Description      Span #5, girder #1, paint failure and corrosion.

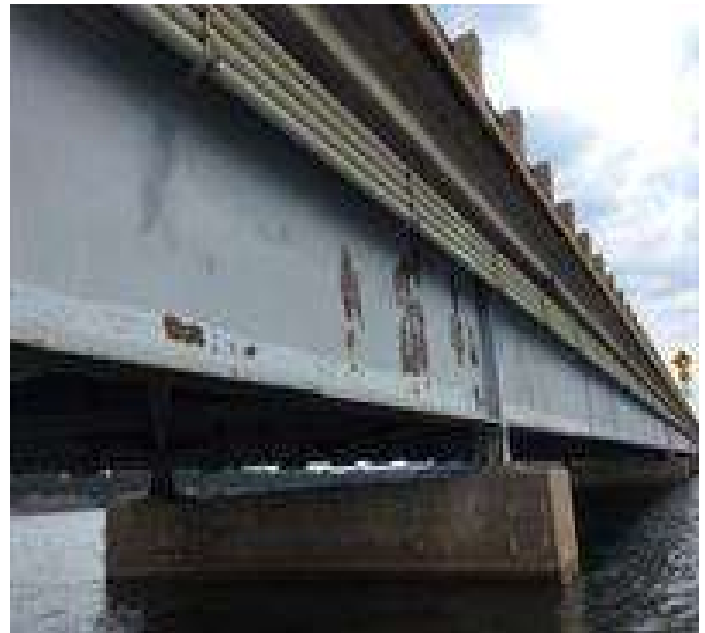
PHOTO 5      Description      Paint condition right side

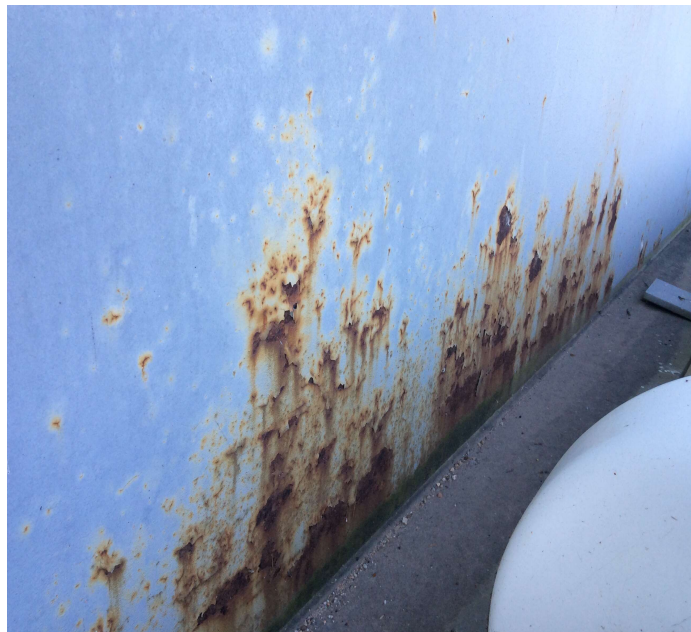
PHOTO 4      Description      Span #2, girder #1, adjacent to splice plate #2. Corrosion to exterior side.

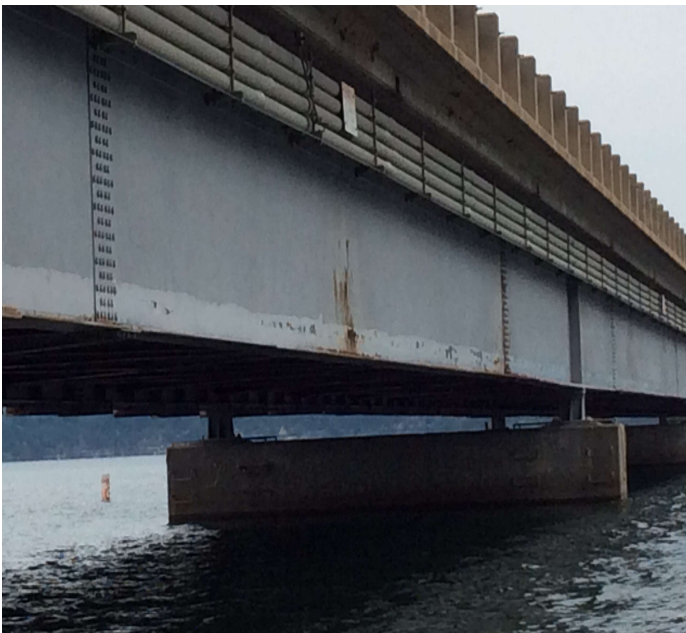
Span #2, Girder #1 bottom flange 35' back of pier #2-corrosion with minor pitting.

PHOTO 1      Description      Span #2 minor section loss to bottom flange and lower 1/2 of web in girder #1

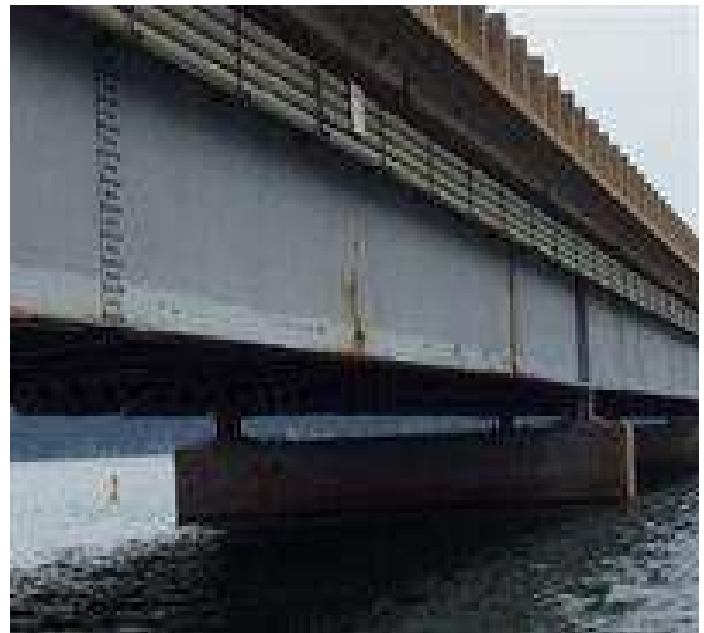
PHOTO 2      Description      span #2 corrosion with minor section loss

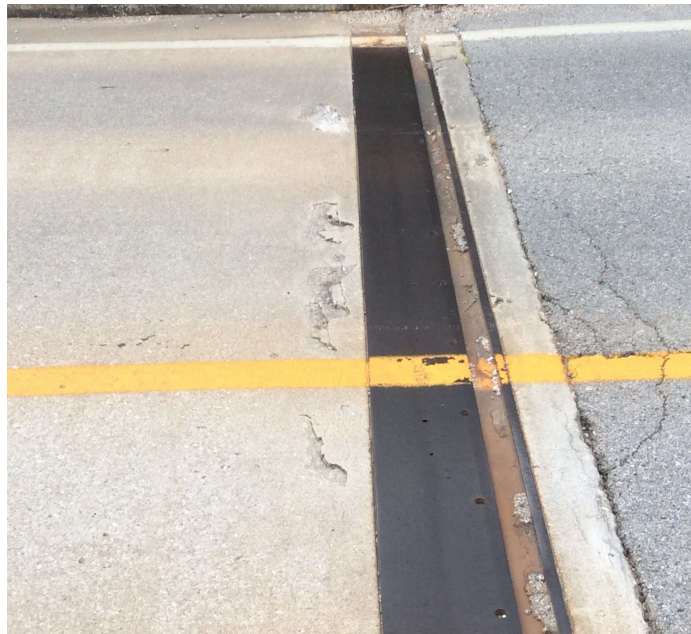
PHOTO 1      Description      Spalling adjacent to abutment #1 sliding plate assembly.

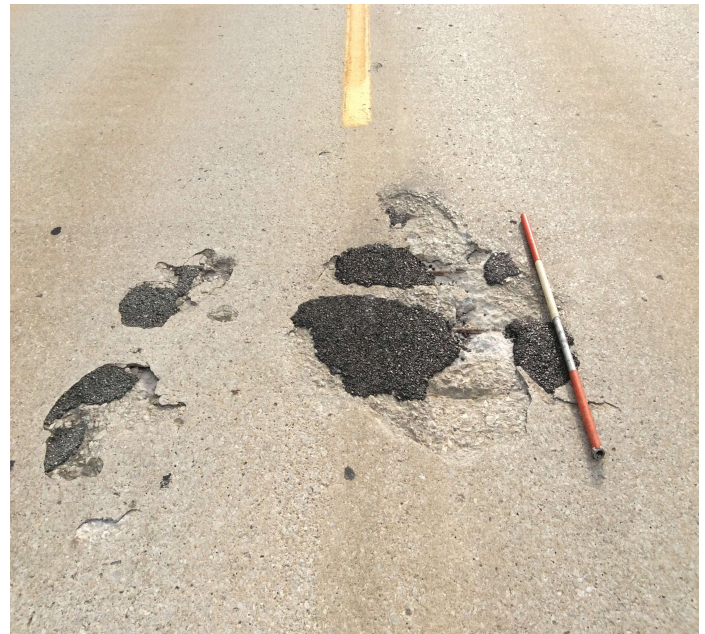
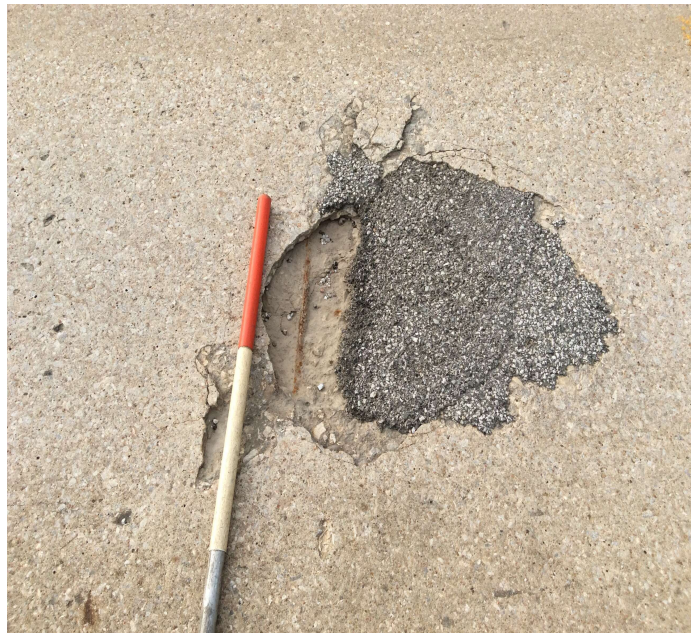
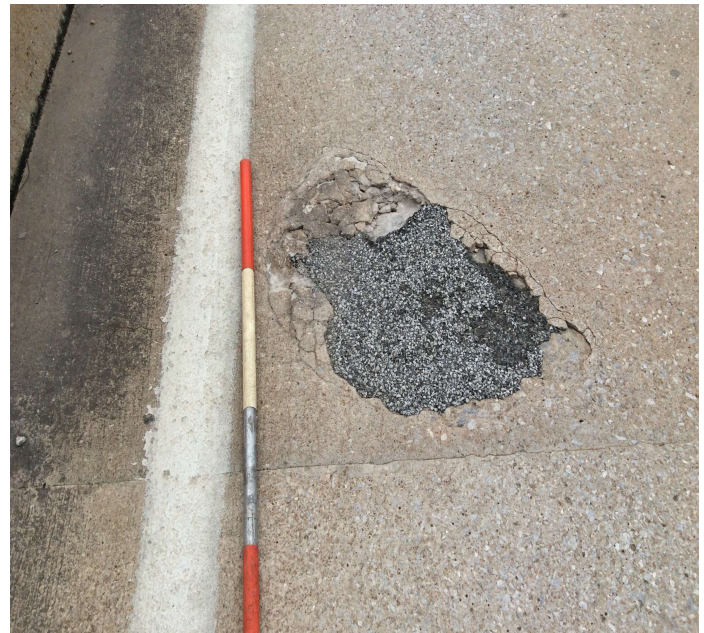
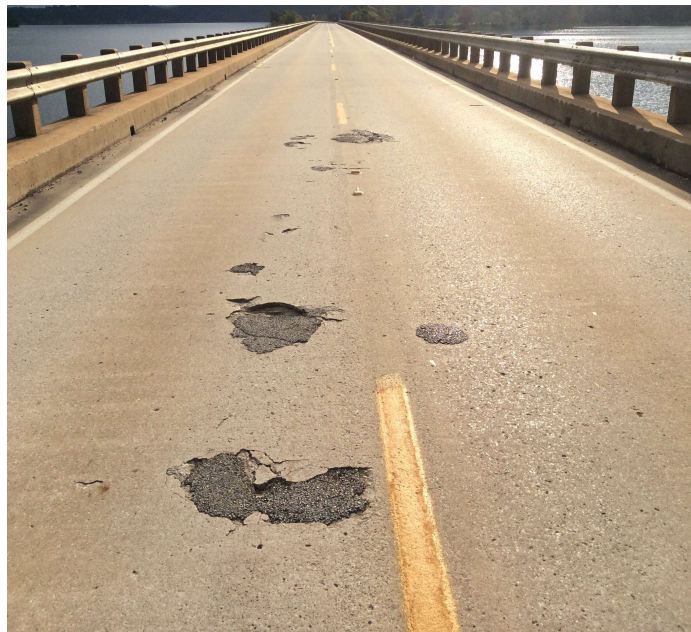
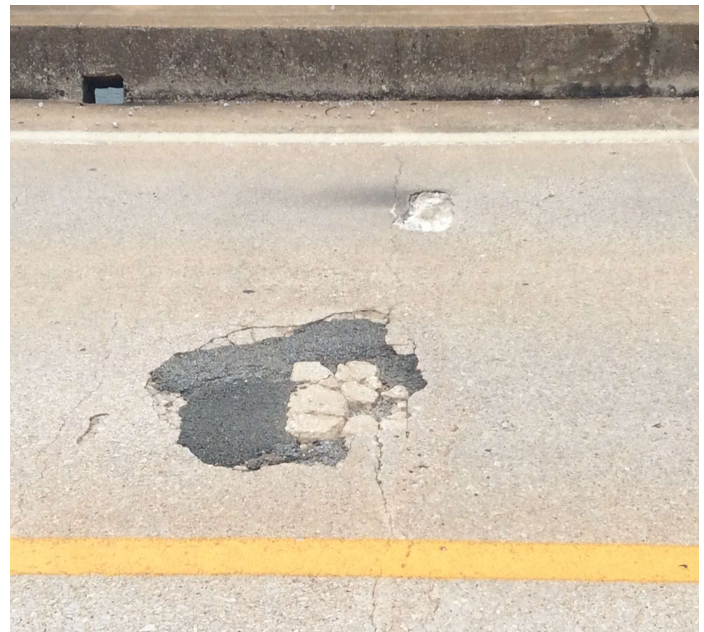
Deck - The deck has spalling and delaminated areas in several locations. Spans #6 and #7 have large areas of spalling over bent #6 with failing asphalt repairs and exposed reinforcing steel in locations. The area surrounding the spalls is delaminated in several locations. The gutters have numerous delaminated areas throughout.

PHOTO 2      Description      Deck spalling typical.
