Bridge Inspection Report

A5984
I-49 SB L Benton
over
CORD 831-G

Structure Number: A5984

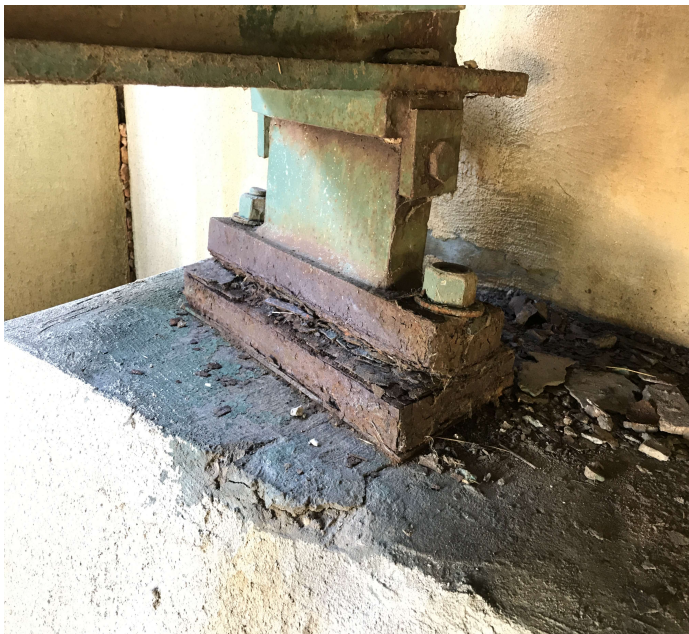
Moveable bearings - The moveable bearings over both abutments have corrosion with thick pack rust between the rocker devices and masonry plates.

PHOTO 1 Description Bearings #6 abutment #1 pack rust.

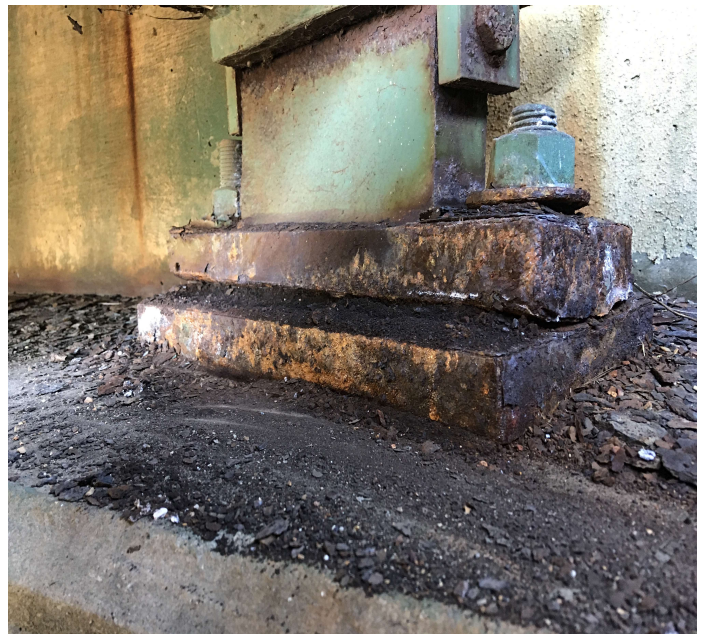
PHOTO 2 Description Abutment #2 bearing #6 flaking rust.

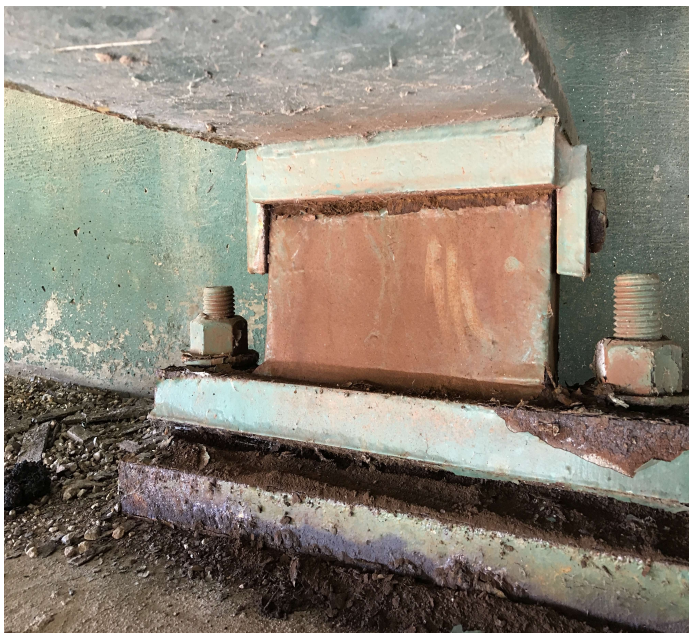
Bearing #3 over abutment #2 appears to have wear in the bolted connection that attaches the beam to the bearing device. The bearing has significant movement under live load.

PHOTO 3 Description Abutment #2 bearing #2 fretting between rocker and sole plate.

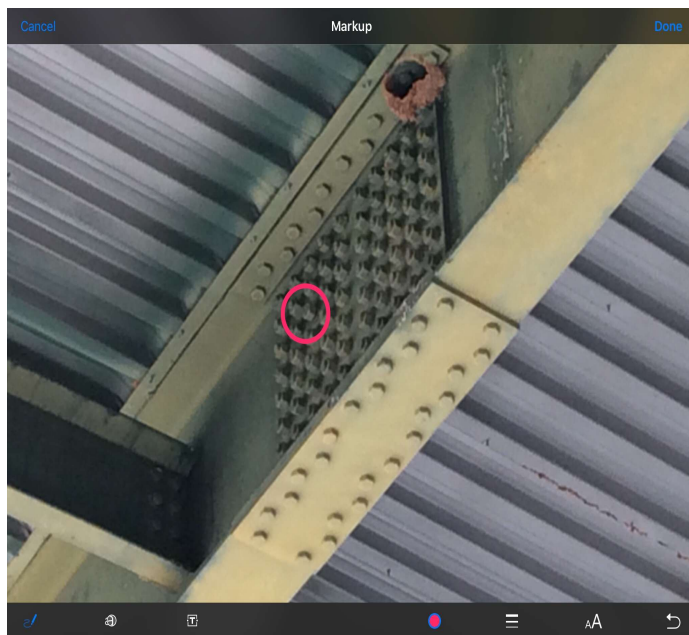
Superstructure - Span #2, Girder #2 has one loose bolt in the vertical splice plate.
Span #3, Girders #4 and #6 have one loose bolt in the bottom flange splice plate connection.

PHOTO 1 Description Span #2 Girder #2 vertical splice plate - loose bolt.

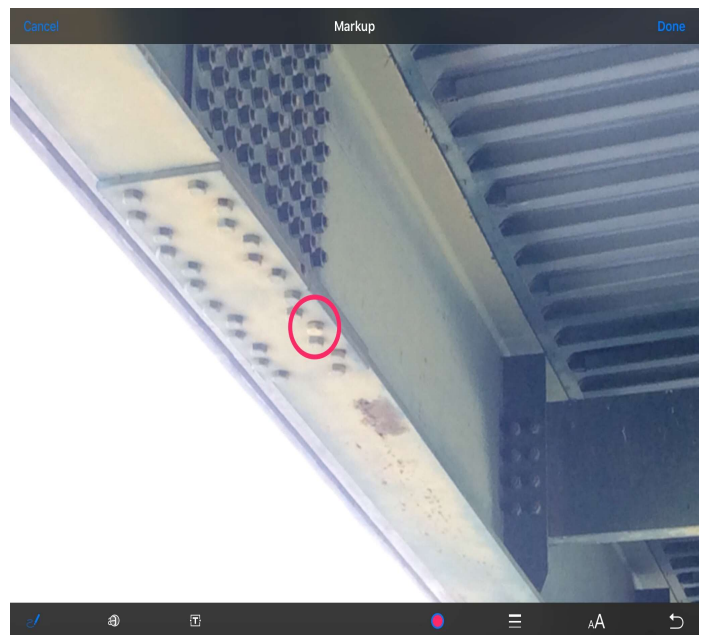
PHOTO 2 Description Span 3, Girder 6 bottom splice plate - loose bolt.

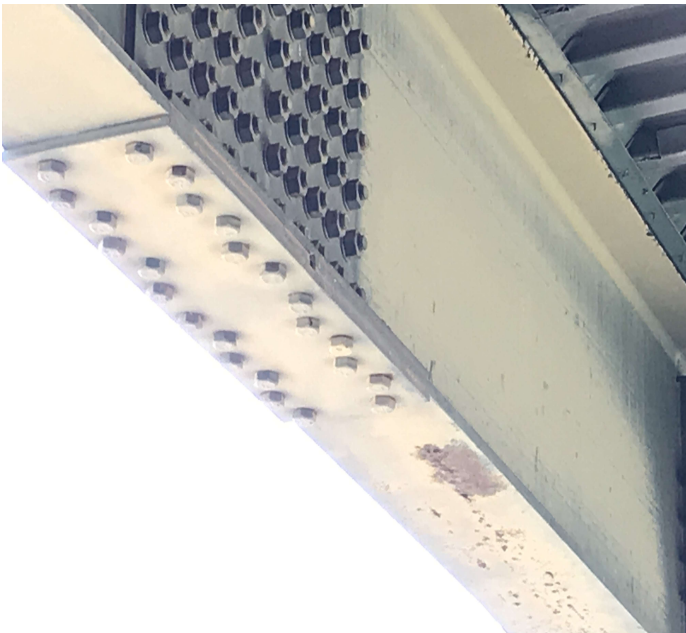
PHOTO 3 Description Span #3, Girders #6 have one loose bolt in the bottom flange splice plate connection.

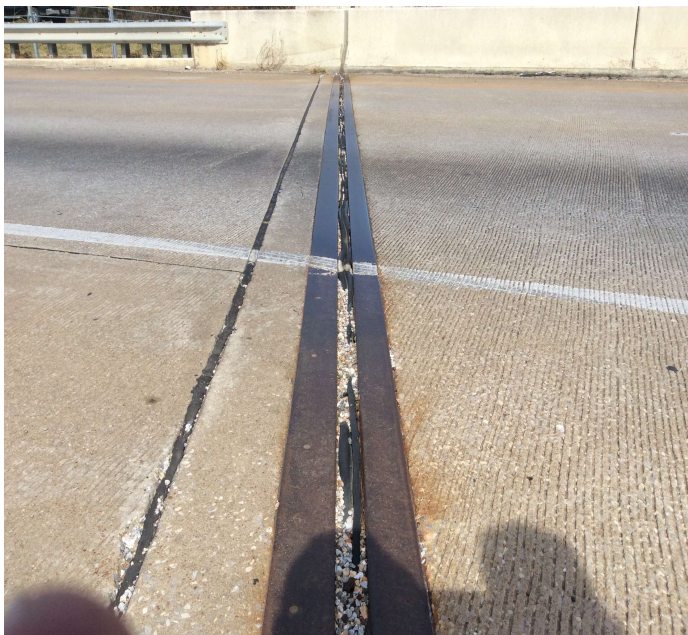
Deck expansion joints - Compression joint seals are deteriorated with areas of cracking and dirt and debris impaction that has caused the seals to separate from the assemblies allowing water to leak onto the superstructure.

PHOTO 1 Description Dirt and debris in expansion joint assemblies.

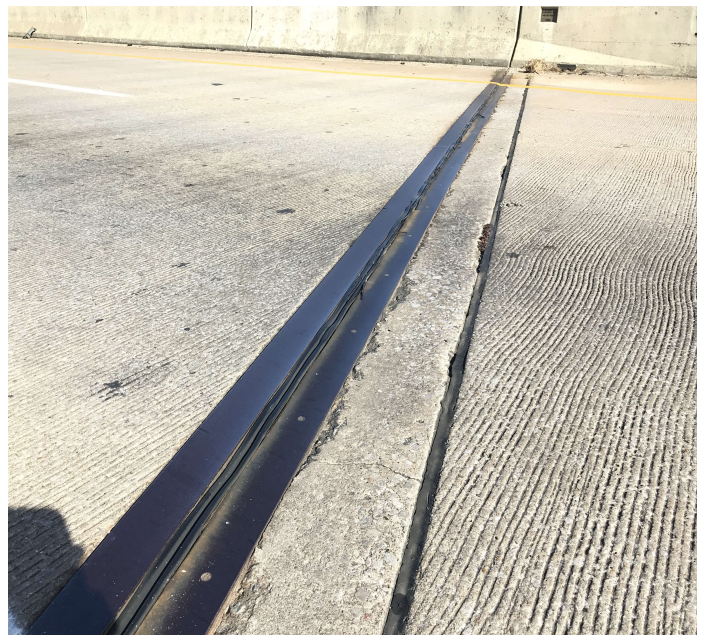
PHOTO 2 Description Abutment #1 expansion joint tearing and cracking

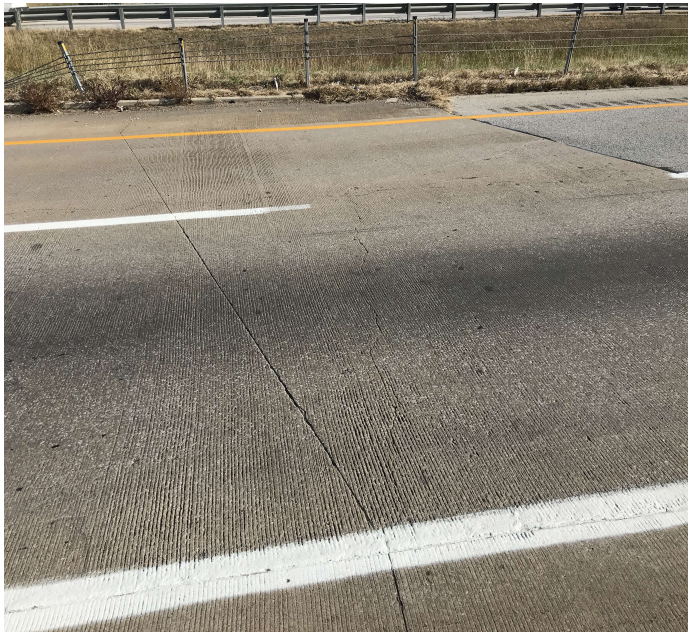
Deck / Approach slabs - The driving surface of the deck has sealable longitudinal and transverse cracking in all spans. The North and South approach slabs have sealable longitudinal, transverse and random cracking.

PHOTO 1 Description Longitudinal and transverse cracking in south approach slab

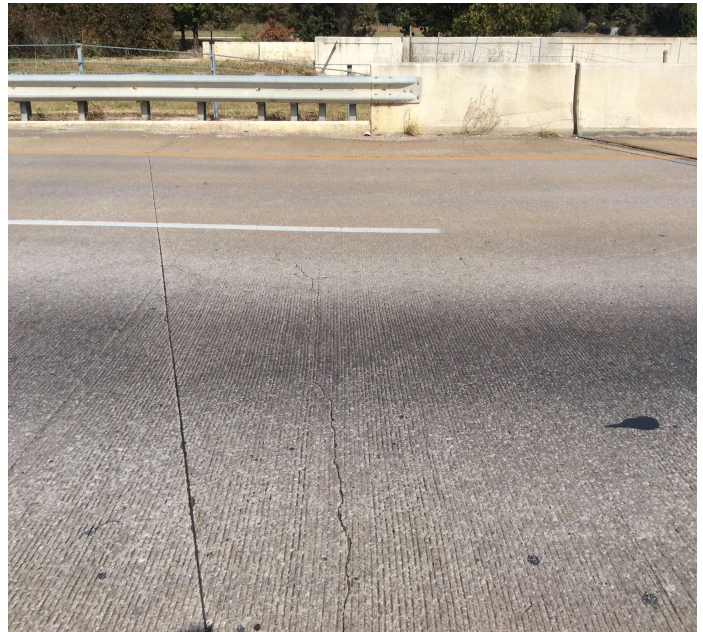
PHOTO 2 Description North approach slab-Transverse cracking.

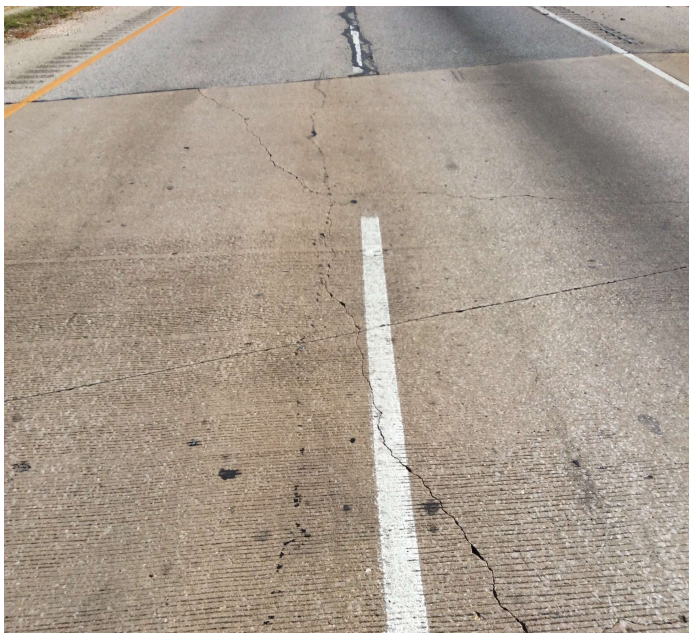
PHOTO 3 Description South approach slab-Longitudinal cracking.

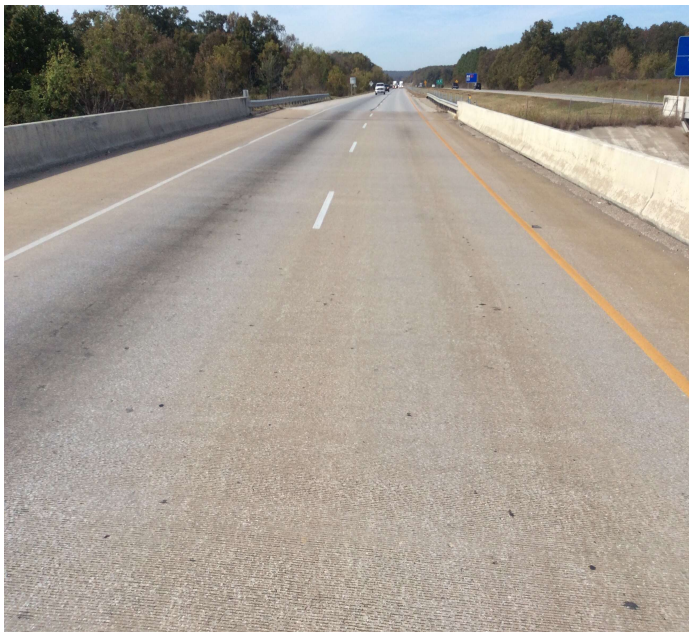
PHOTO 4 Description Deck has sealable cracking in all spans.

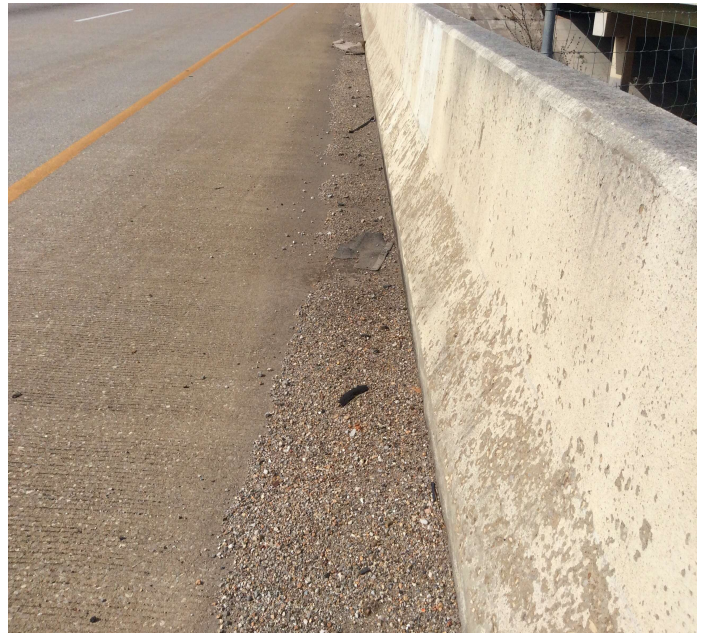
PHOTO 2 Description Dirt and debris in right gutter.
