Bridge #00680(Underwater type 2, Routine)

SH 66 Searcy over COVE CREEK

Location: 0.003 MI E JCT 65 LESLIE

Team Lead: Benjamin Smith **Inspection Date:** September 19, 2022

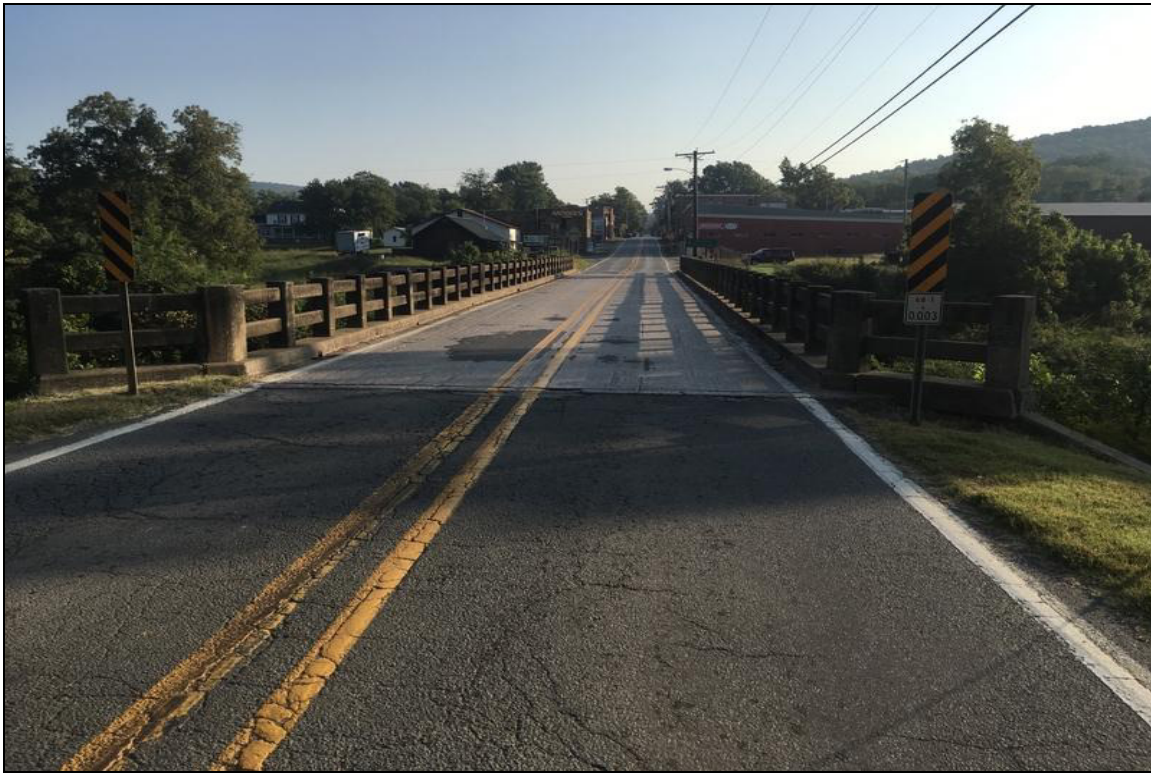
Approach view in direction of log mile.

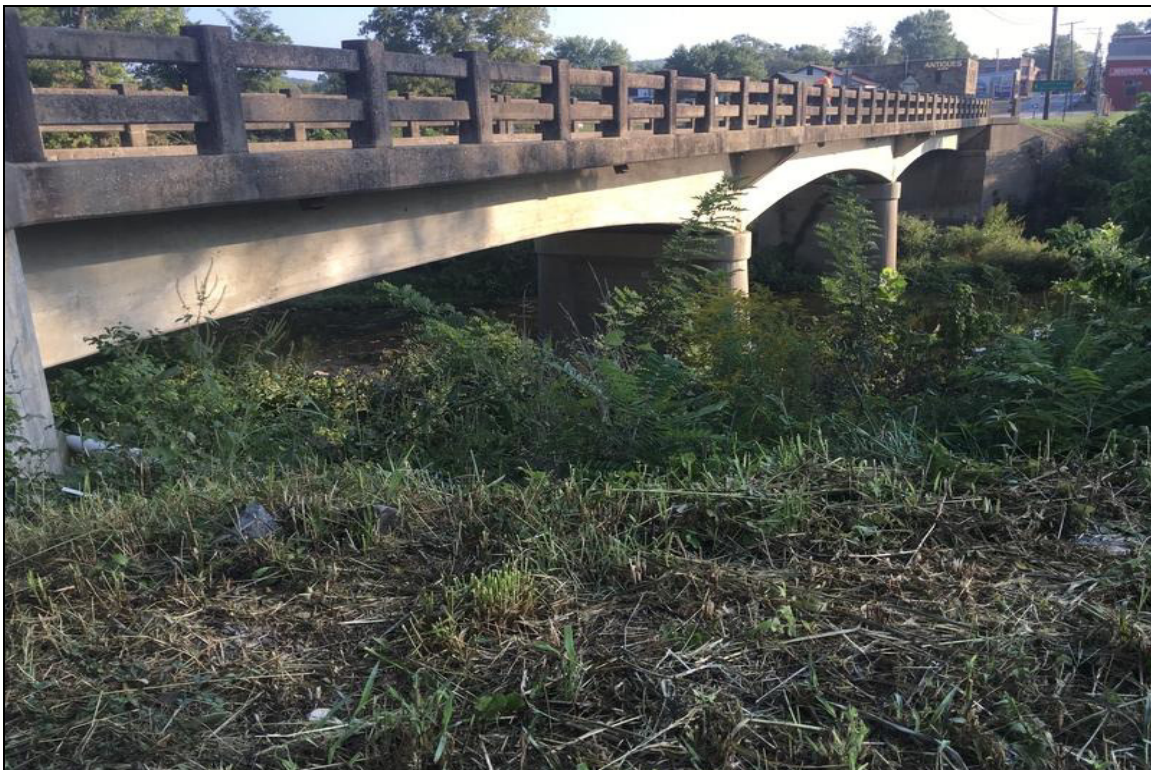
Elevation view. Log mile from left to right.

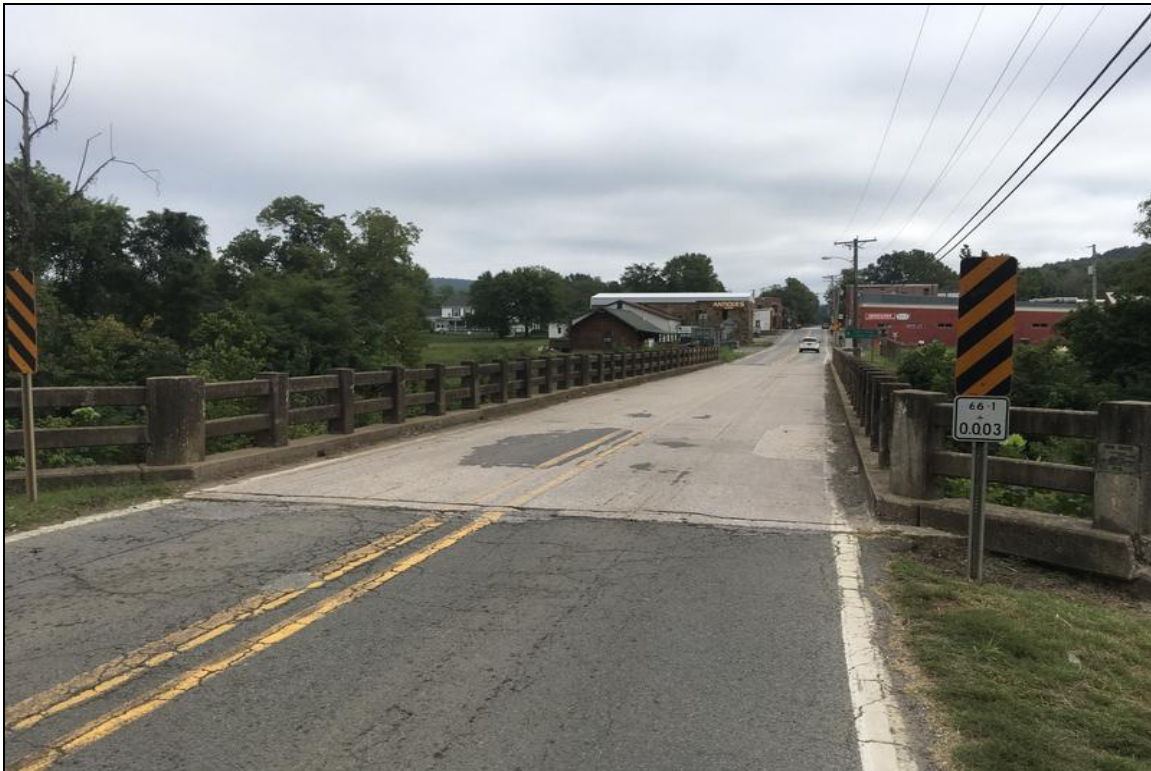
Approach view in direction of log mile.

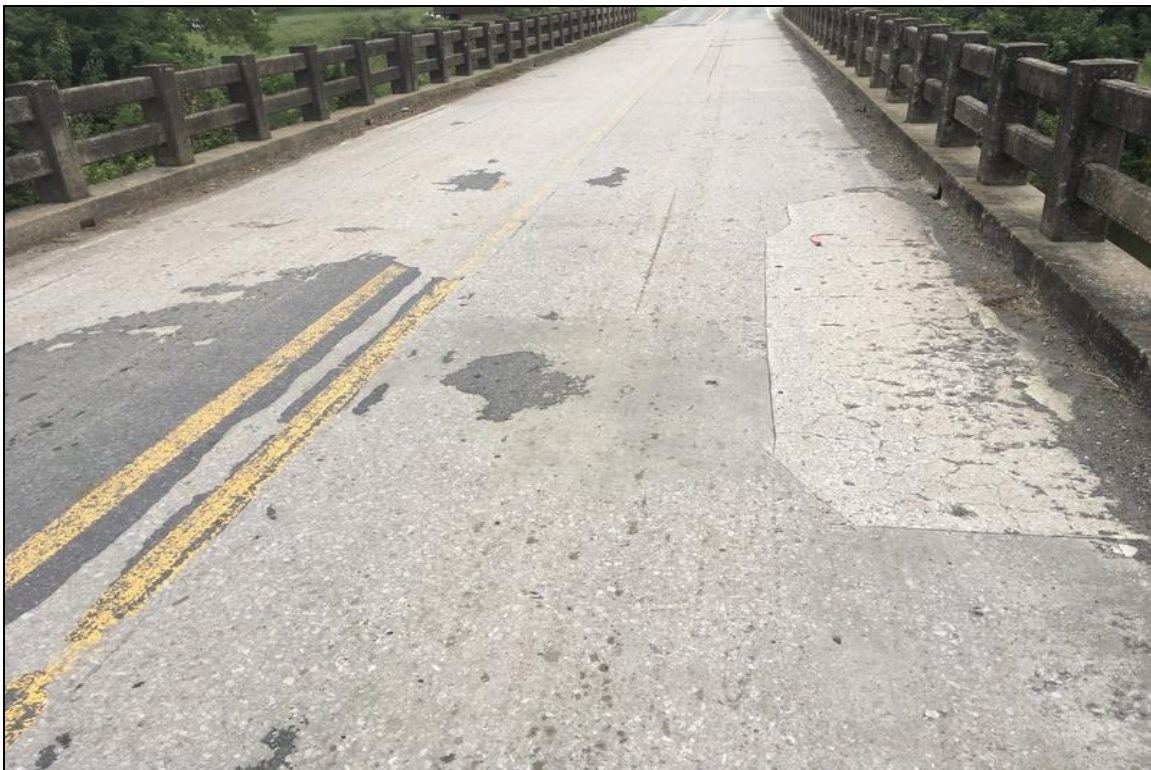
(16)							
Driving surface- the bare concrete deck has been roto-milled in the past, and has scarring.							
Left lane- has 177' of delamination cs3 with 152' of hairline map cracked areas. The deck has wear for the full width of the lane.							
Right lane- has 178' of delamination cs3 with 106' of hairline map cracked areas. The deck has wear for the full width of the lane. The vertical face of the curb has 12' of shallow exposed rebar.							
Undersurface-							
Span #1-The left overhang has 1' of shallow exposed rebar near midspan.							
Span #2- The left overhang has 1' of shallow exposed rebar near the first drain area, and 2' of exposed rebar near the end of the span.							
Span #3- the deck cantilevers on the left and right sides have spalling with exposed rebar.							
110	Reinforced Concrete Open Girder/Beam	LF	334	325	0	9	0
1080	Delamination/Spall/Patched Area	LF	5	0	0	5	0
1090	Exposed Rebar	LF	4	0	0	4	0

Typical view of the driving surface.

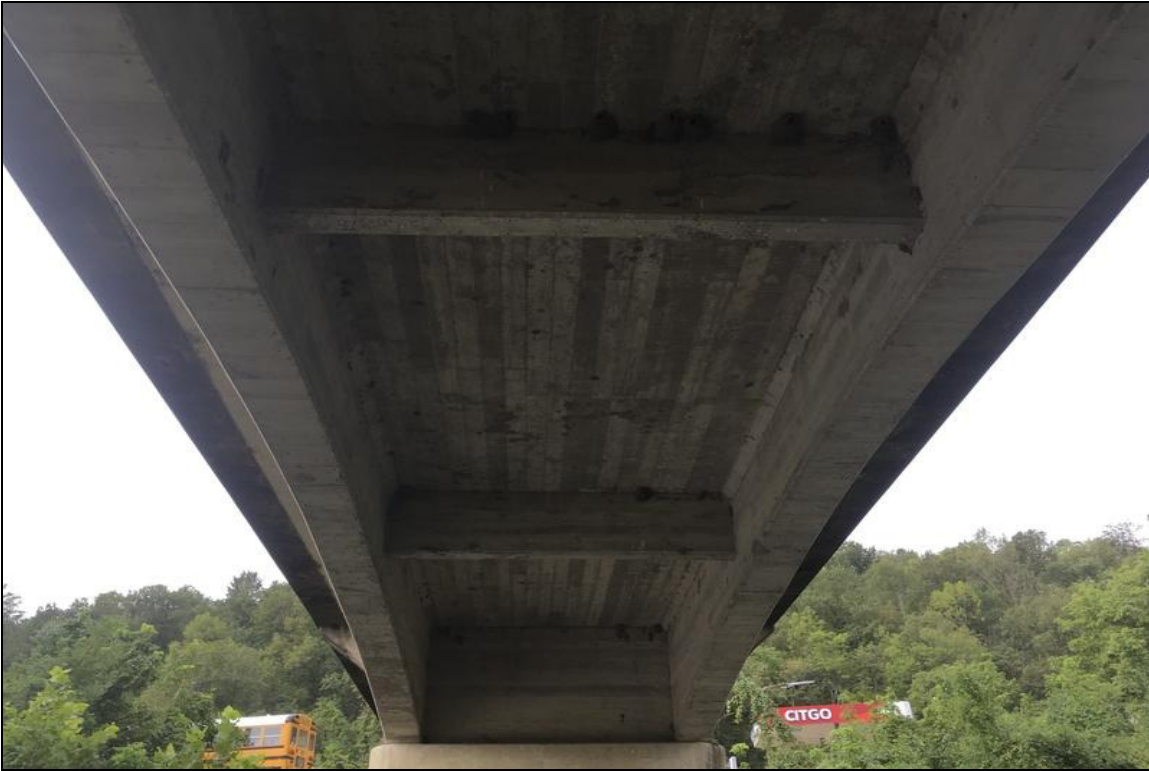
Typical view of undersurface.

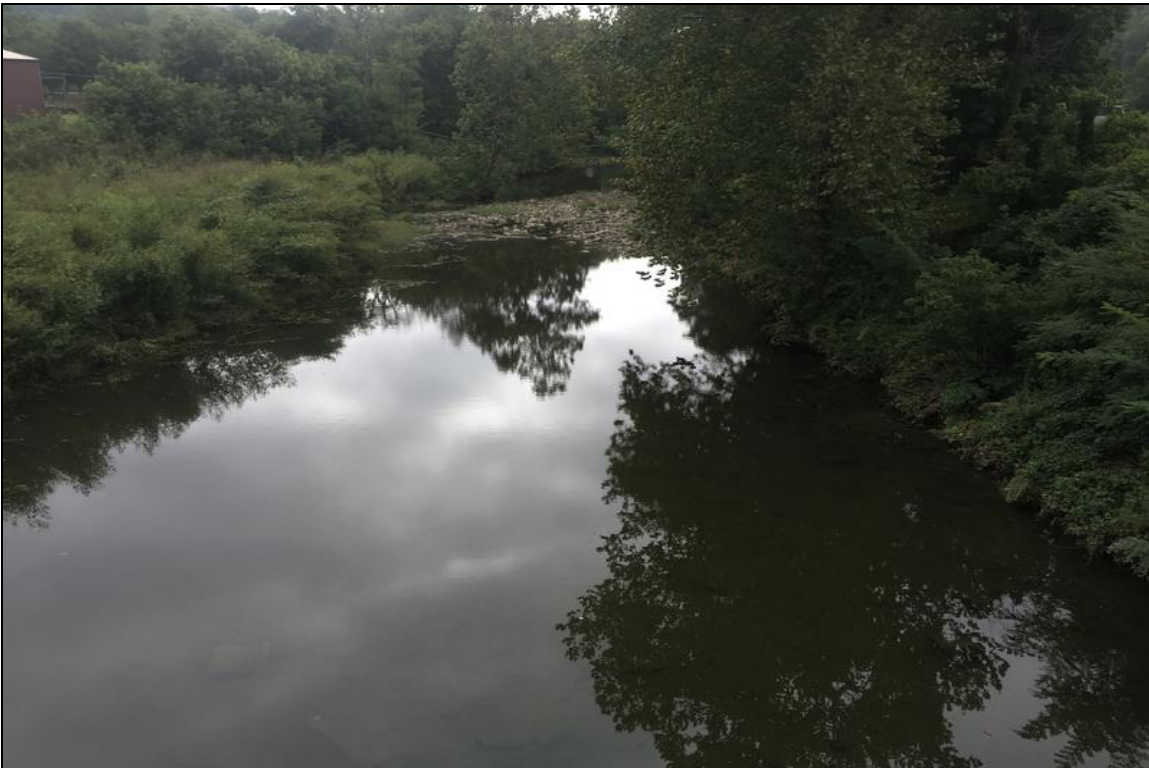
Upstream channel view.

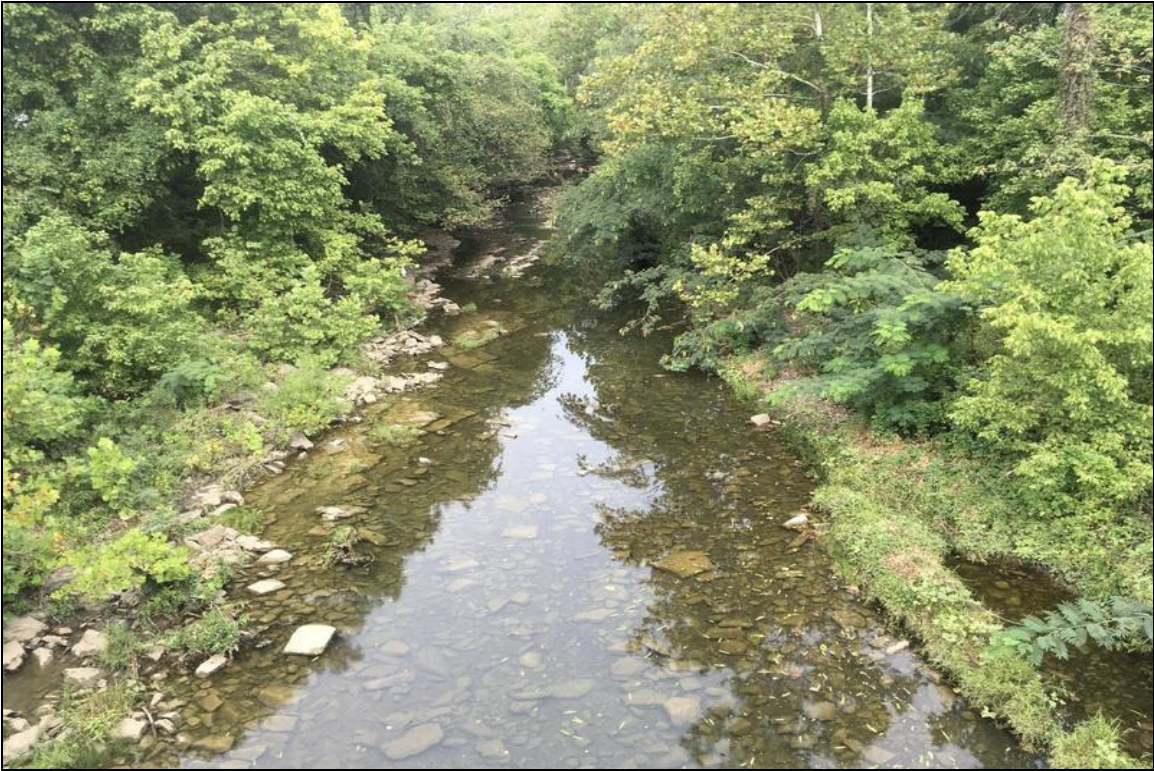
Downstream channel view.

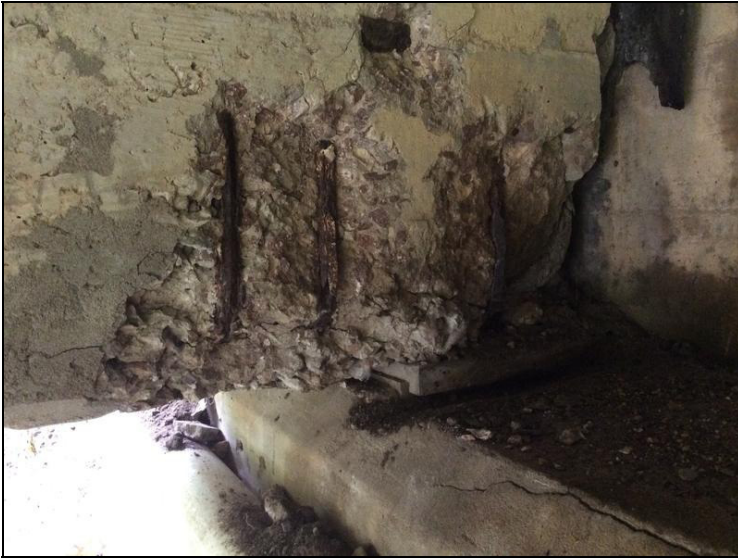
Tee beam #2 has spalling with rebar exposed over abutment #1 on the interior side.

Inside view of girder #2 over abutment #1

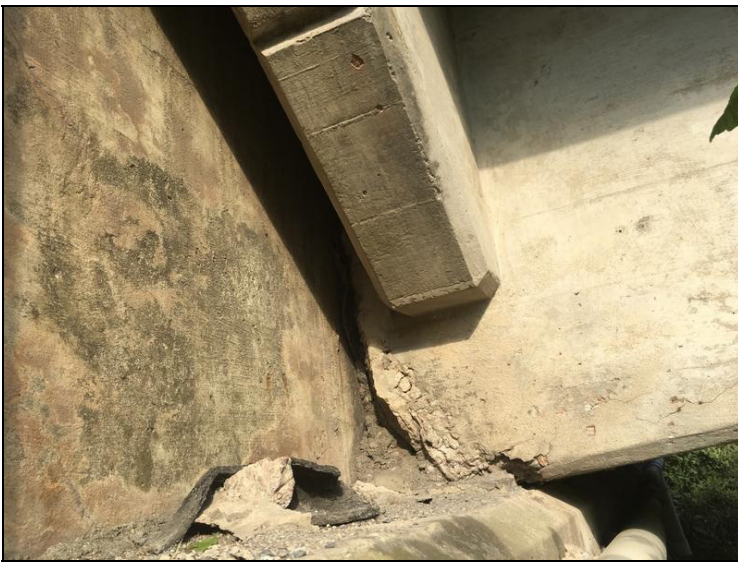
(110)							
Two beam variable depth tee beam system.							
Span #1- beam #1 has 1' of patched area over the bearing on the interior side.							
Beam #2 has spalling with 2' of rebar exposed at the beginning of the span over the abutment, the beam appears to be crushing and the bottom edge of the tee is nearly in contact with the top of the abutment. Both tee beams have vertical hairline flexure cracking.							
Span #2-							
Beam #2 has 2' of delamination on the exterior face over pier #2. The diaphragm above pier #2 has spalling with rebar exposed. Both tee beams have vertical hairline flexure cracking.							
Span #3- beam #1 has a small area of honeycombing with a small area of exposed rebar at the beginning of the span.							
Beam #2- has delamination for 2' at the end of the beam and is showing signs of crushing at the end of span #3 over the abutment #2 bearing. Both beams have vertical hairline flexure cracking.

Tee beam #2 at abutments #1 and #2 has cracking at the bridge seat. The tee beam is nearly in contact with the top of the abutment wall at abutment #1.

View of the exterior bearing area of beam #2 over abutment #1. Showing deterioration and crushing. The bottom edge of the tee is nearly in contact with the top face of the abutment

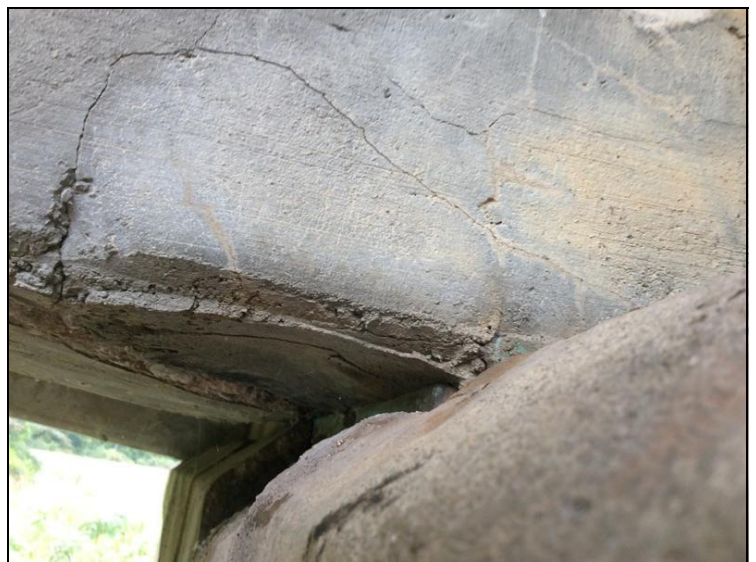
Small amount of Crushing at girder#2 at abutment #2.
