Bridge #05518(Routine)

US 65 Searcy over HALF-BR SPAN SLIDE AREA

Location: 1.10 MI SO JCT SH 27

Team Lead: Benjamin Smith Inspection Date: September 19, 2022

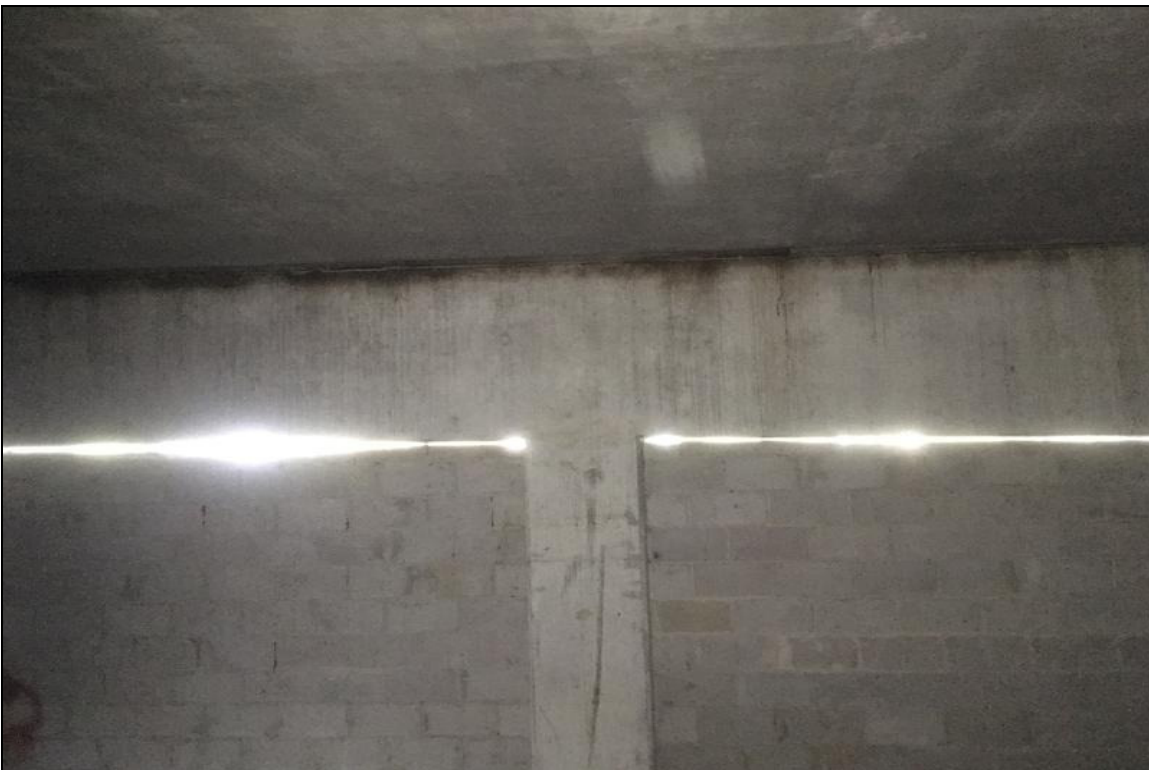
Typical view of the pier cap and columns.

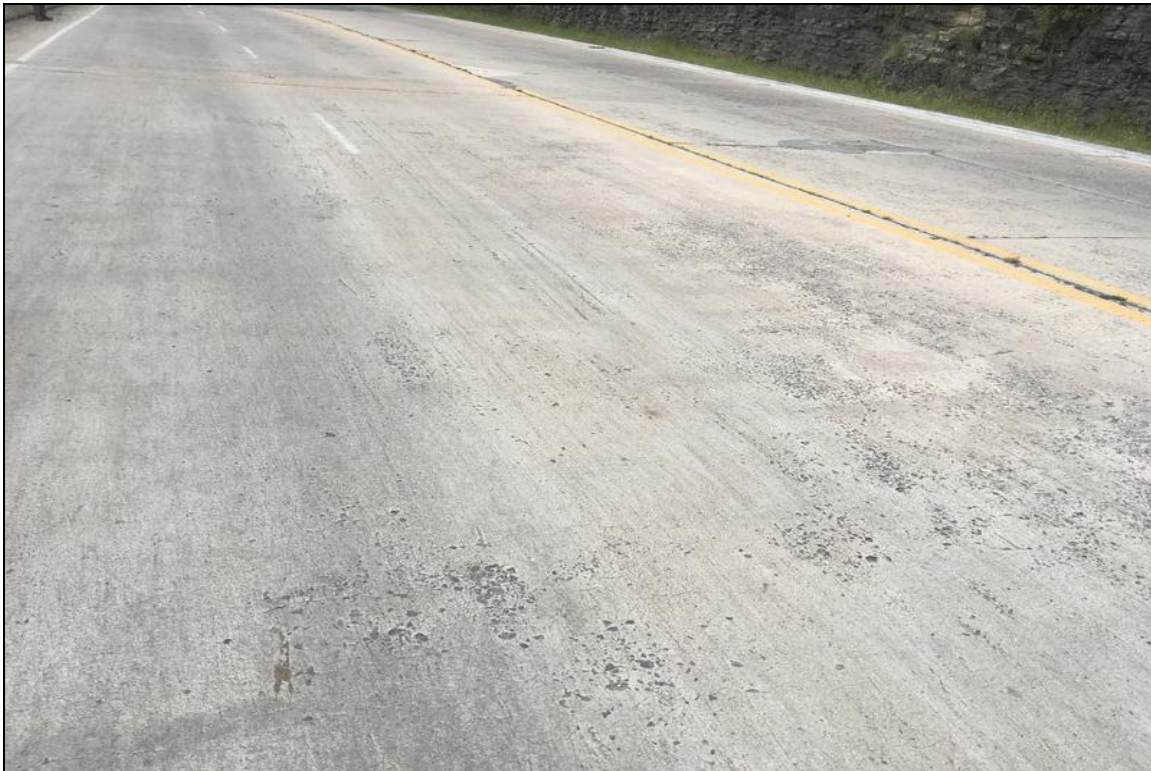
Typical view of driving surface.

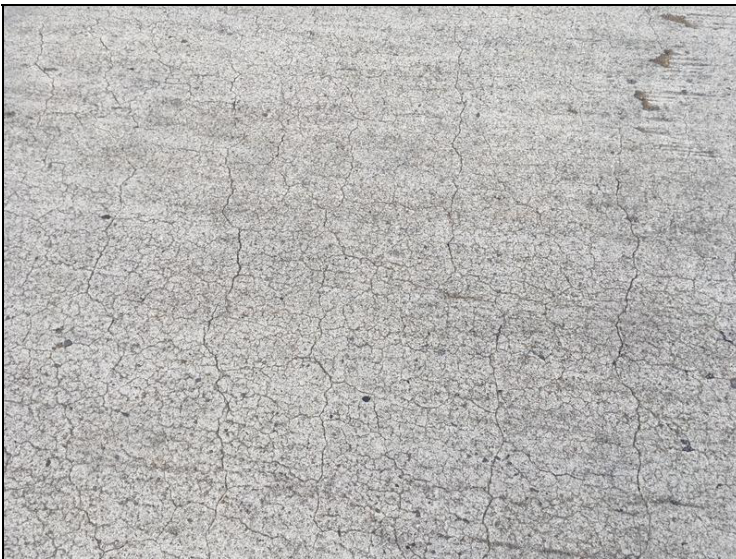
The driving surface of the deck has a heavy concentration of hairline map cracking for the length and width of both lanes. The patched areas in the right driving lane are unsound and are becoming loose. The right driving lane has a 2" deep by 6" diameter pot hole.

Map cracking in the deck driving surface. Typical of the entire deck.

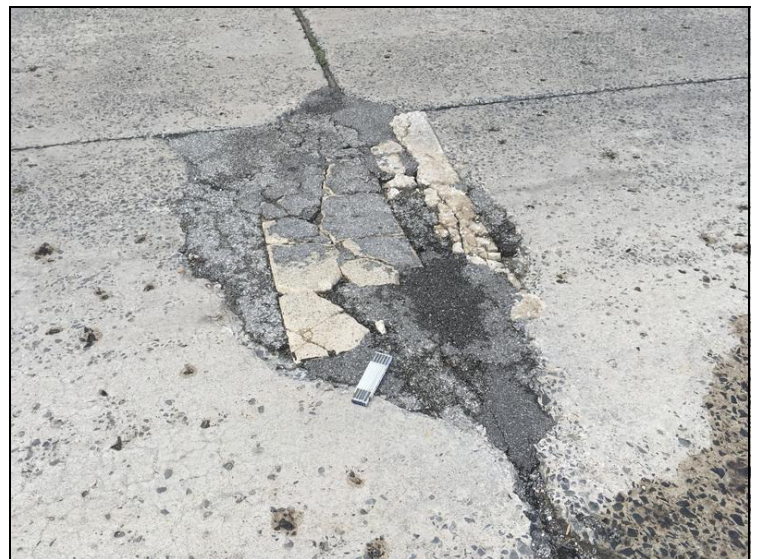
Unsound patched area in the right lane. Typical of several locations.

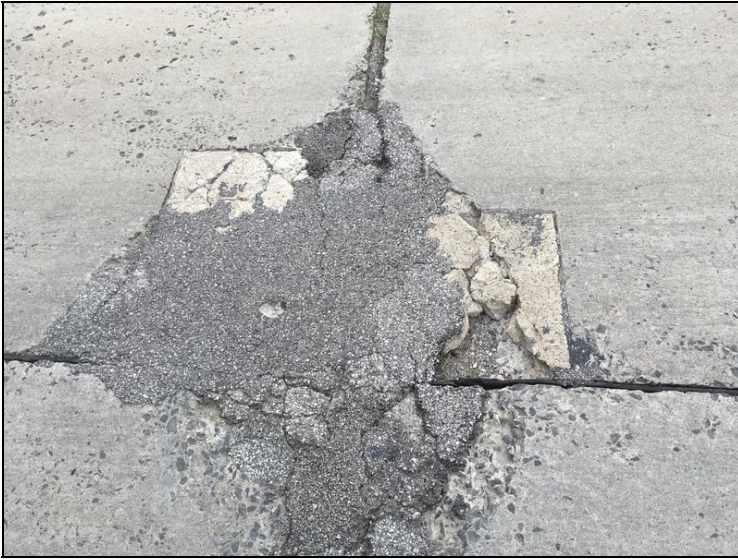
Patched area in the right lane has a large spall.

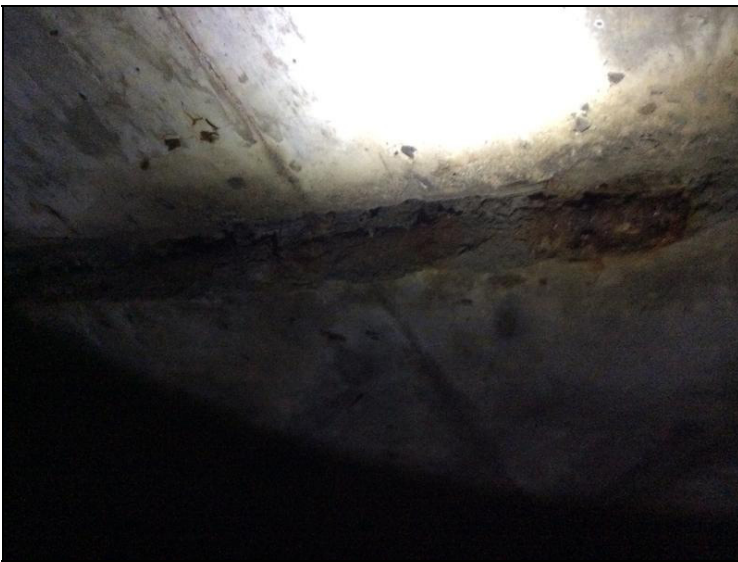
The left end of joint area #2 has a spall with exposed rebar on the interior.

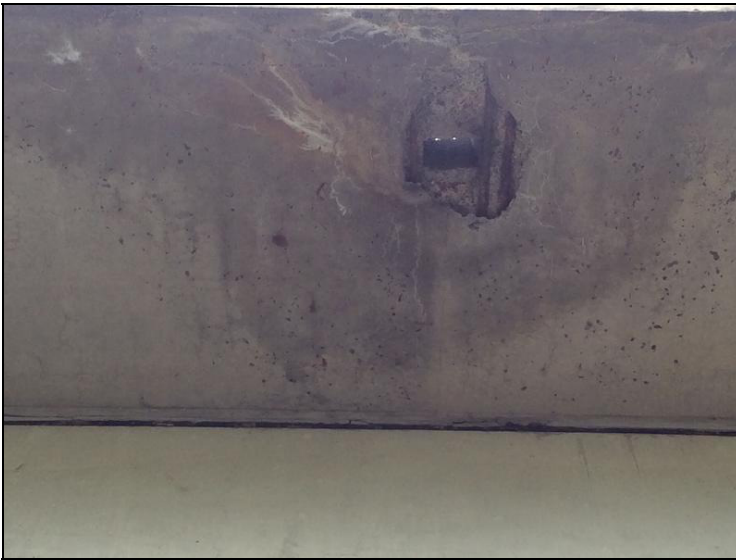
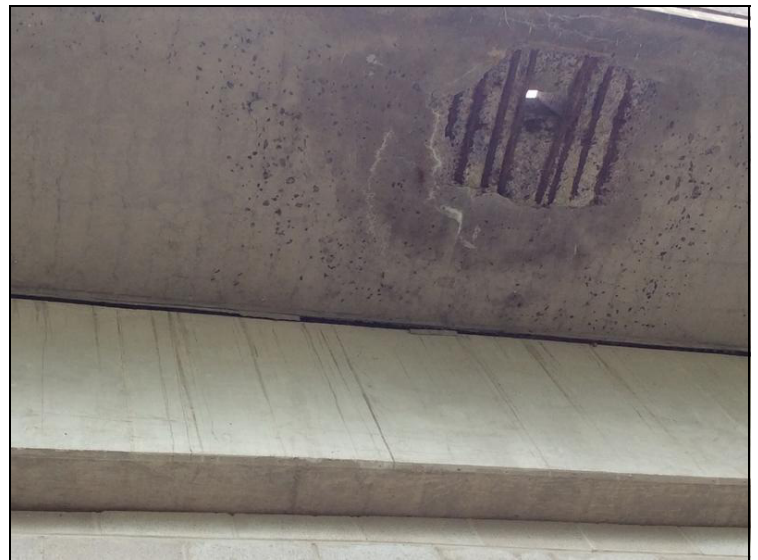
The left deck over hang has spalls with rebar exposed at some of the drain areas.

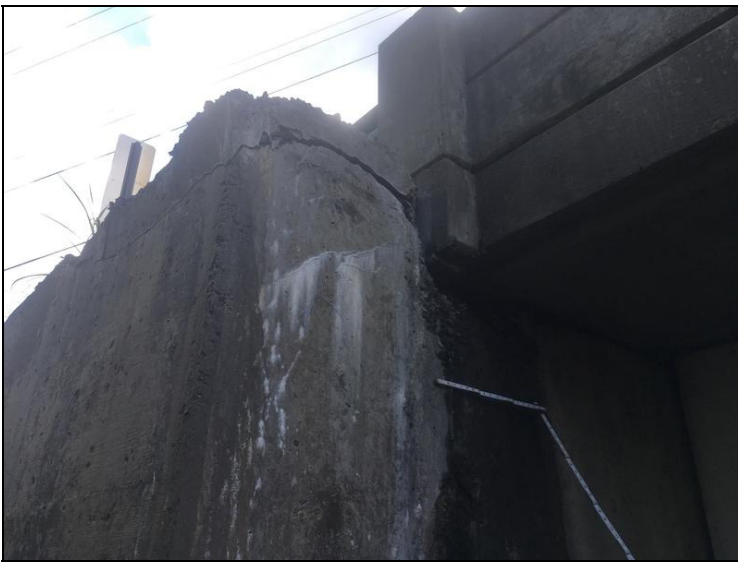
ELEM	DESCRIPTION	UNITS	TOTAL	CS1	CS2	CS3	CS4
<p>Abutment #2- the left corner has 13' of deterioration with 3' of efflorescence cracking at top left corner.</p> <p>West retaining wall abutment- has 11' of vertical cracking with 1' of efflorescence cracking.</p>							
234	Reinforced Concrete Pier Cap	LF	193	178	11	4	0
1080	Delamination/Spall/Patched Area	LF	2	0	0	2	0
1090	Exposed Rebar	LF	2	0	0	2	0
1130	Cracking (RC and Other)	LF	11	0	11	0	0
<p>(234)</p> <p>Pier cap #1 runs longitudinally along the outer edge of the structure.</p> <p>The cap has 11 vertical hairline cracks, 1' of exposed rebar at the beginning underside of the cap and 1' of exposed rebar on the outside near the cap joint.</p> <p>The cap has a spall at the area where the caps join together.</p>							
302	Compression Joint Seal	LF	120	35	0	85	0
2310	Leakage	LF	85	0	0	85	0
<p>(302)</p> <p>Abutment #1 seal- has areas of cs3 leakage.</p> <p>Compression joint area #1- is leaking for the width of the structure. Heavy bat activity was noted in the joint.</p> <p>Compression joint area #2- is leaking for the width of the structure. Heavy bat activity was noted in the joint.</p> <p>Abutment #2 seal- did not appear to be leaking.</p>

The abutment #1,2 turn back wings have large areas of spalling and concrete deterioration along the tops of the walls.

The left corner of abutment #2 has 13' of spalling, deterioration, and efflorescence cracking

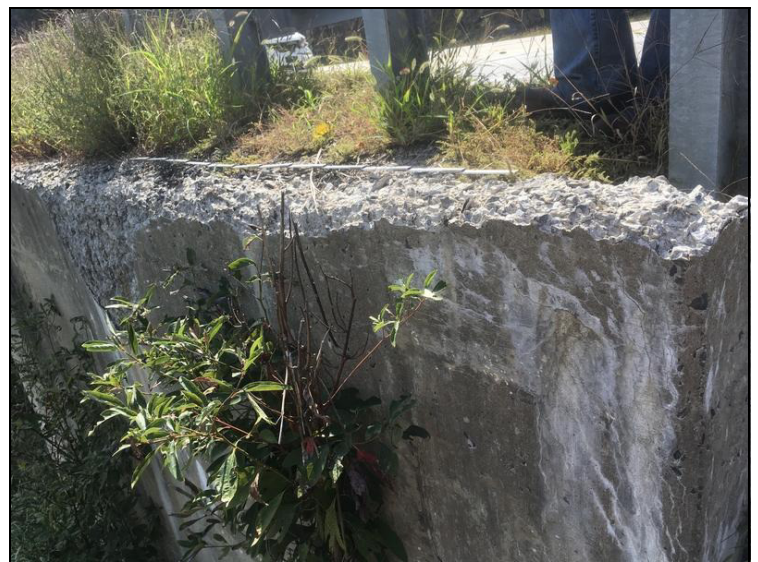
(215)							
Abutment #1- has an 11' long horizontal hairline crack on the left interior. The left retaining wall has spalling and deterioration along the top edge for 14', no rebar exposed.

The top edge of the left retaining wall at abutment #1. Showing deterioration with no rebar exposed for 14'
