Bridge #07202(Underwater type 2, Routine)

US 65 Searcy over Cove Creek

Location: 6.18 Mi So. JCT Hwy 27

Team Lead: Benjamin Smith **Inspection Date:** June 07, 2022

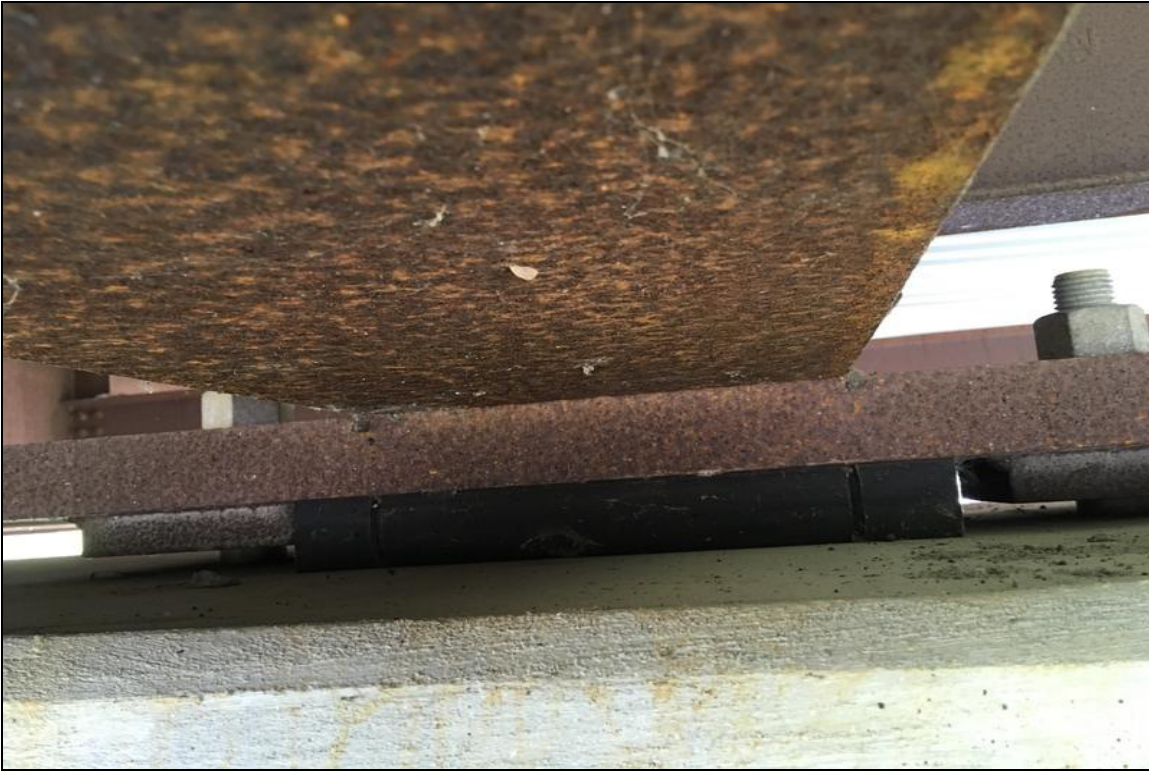
Bearing condition at bent #1. Typical of all 5 at this location.

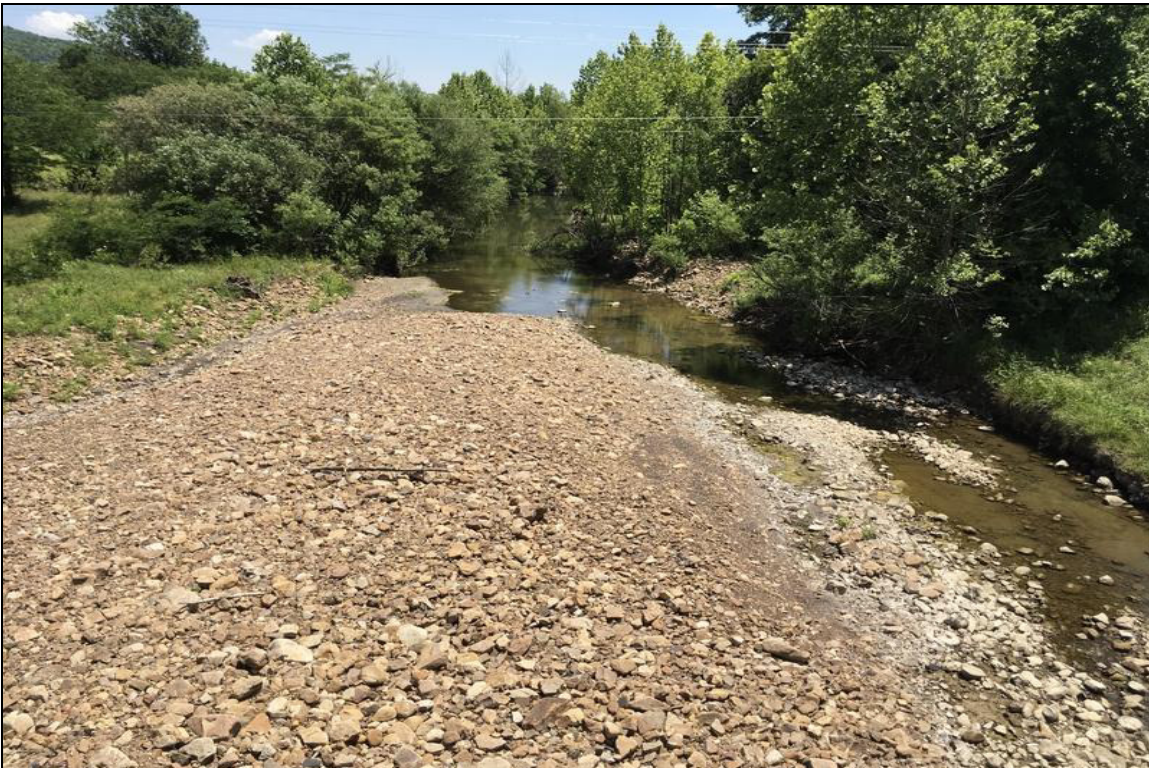
Downstream channel view.

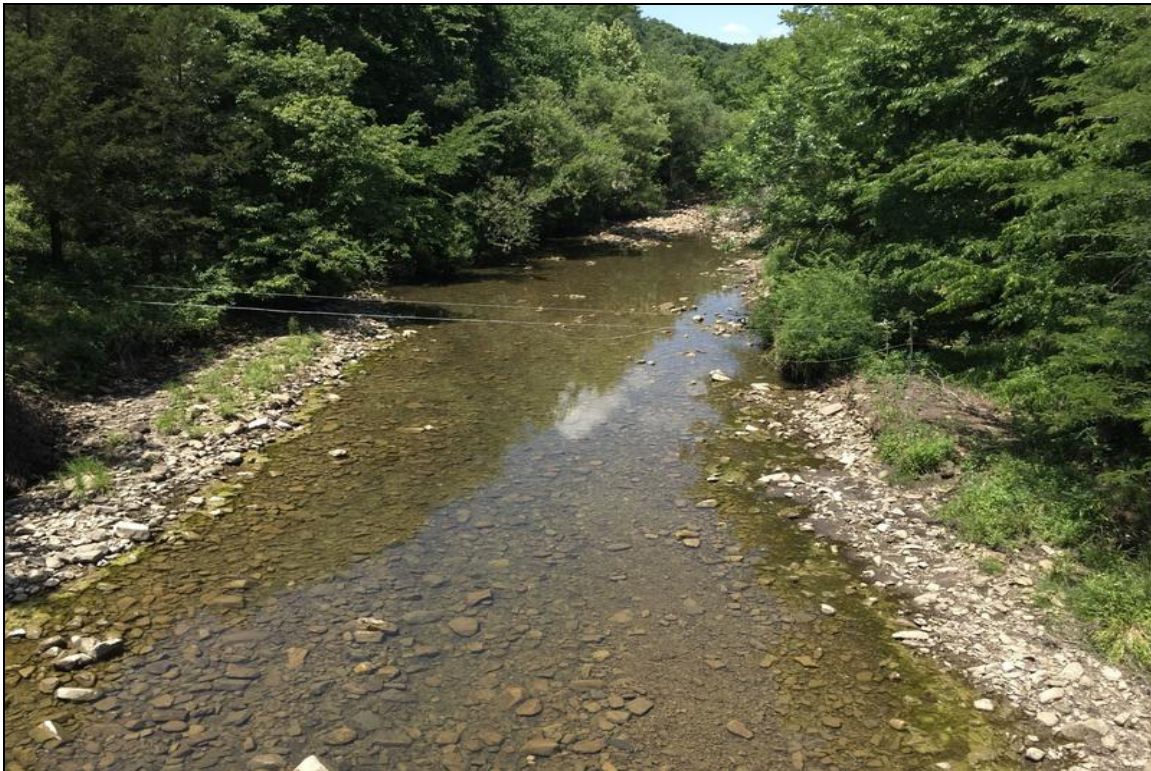
Upstream channel view.

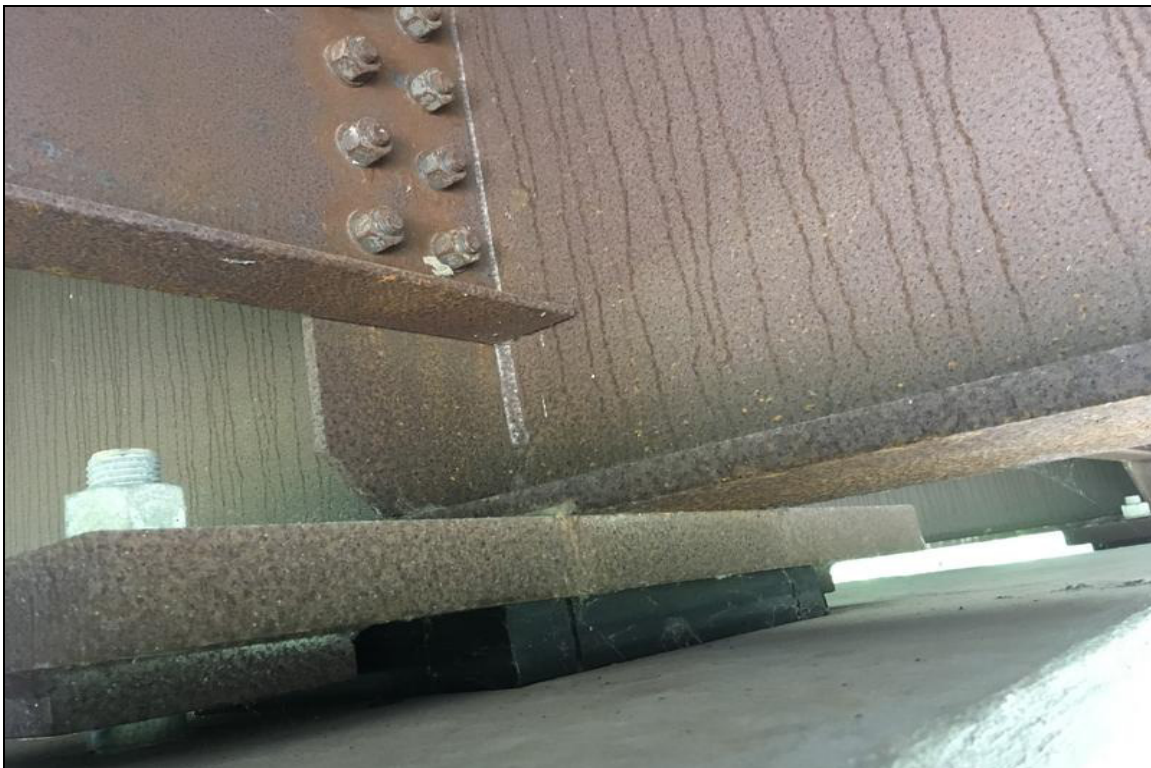
View of the bearing condition at bent #2. Typical of all 5 at this location.

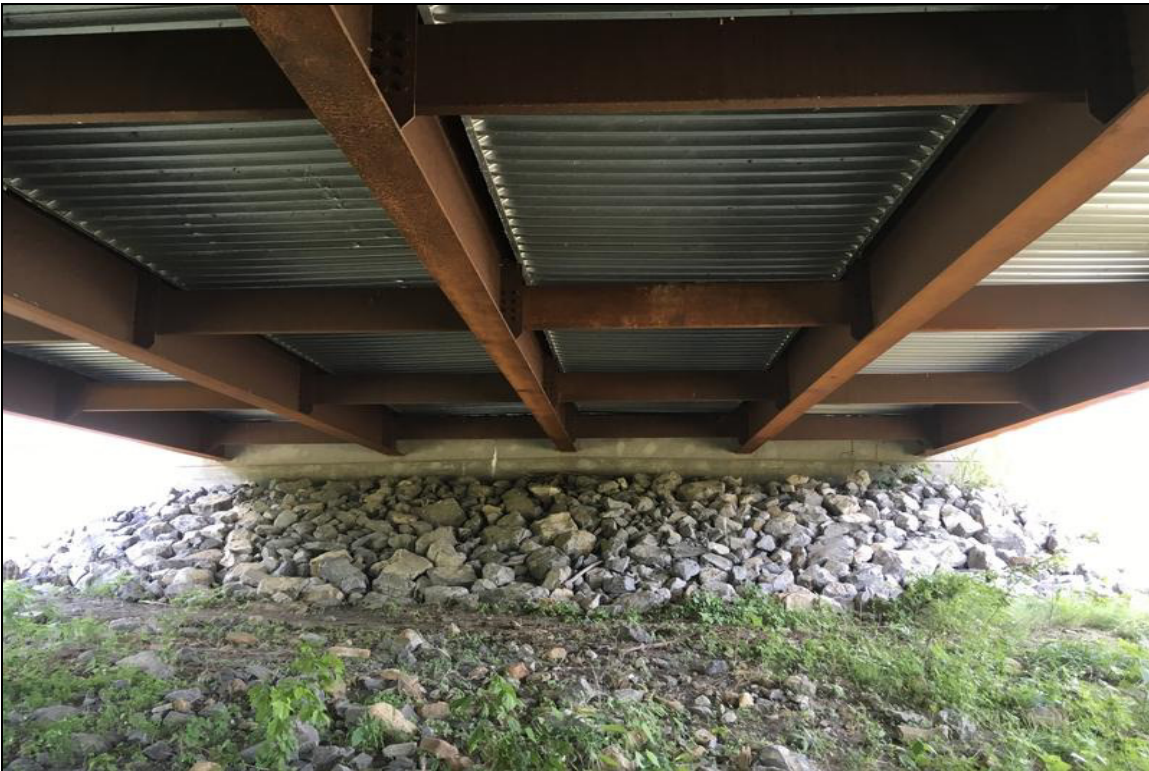
General view of abutment #1.

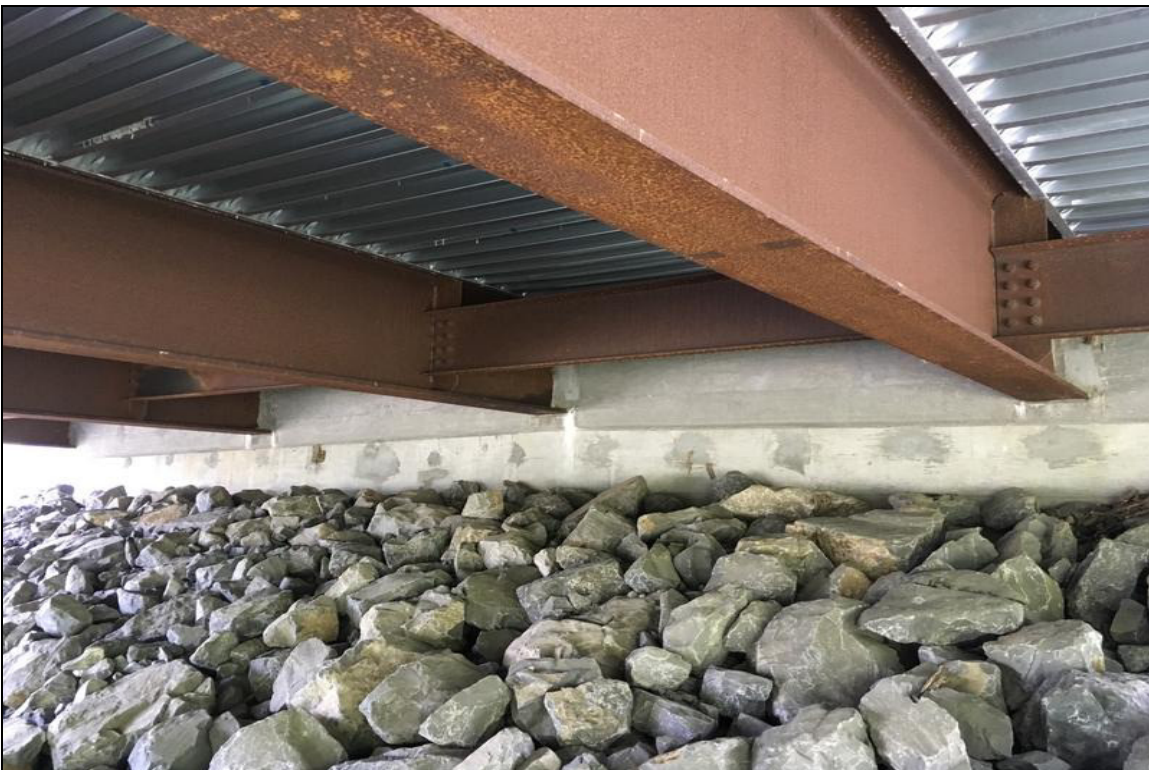
General View of abutment #2.

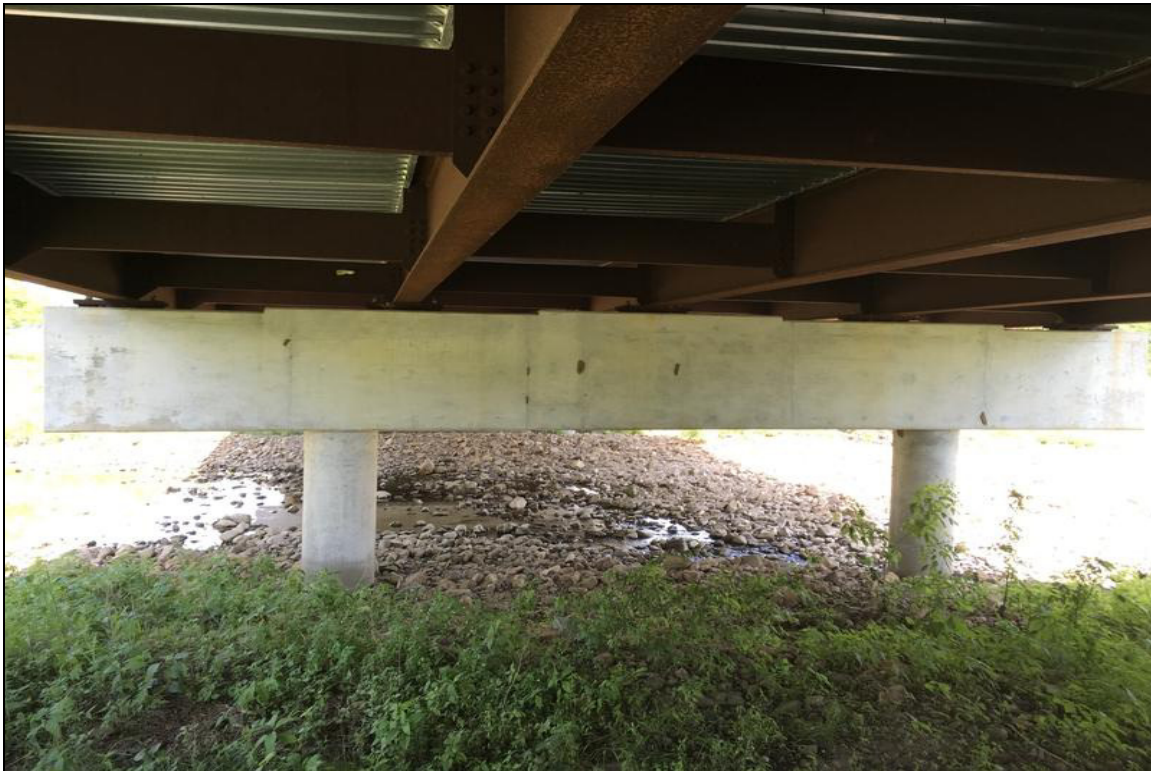
Typical view of bents.

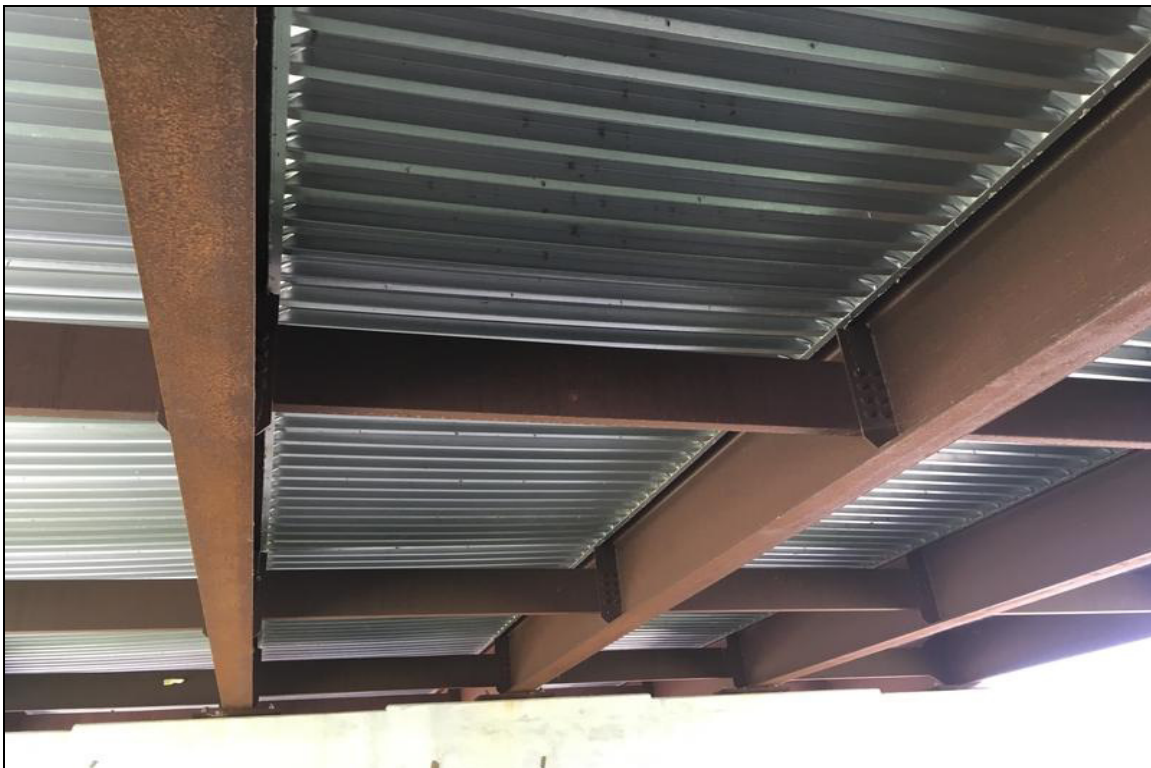
Typical view of the undersurface.

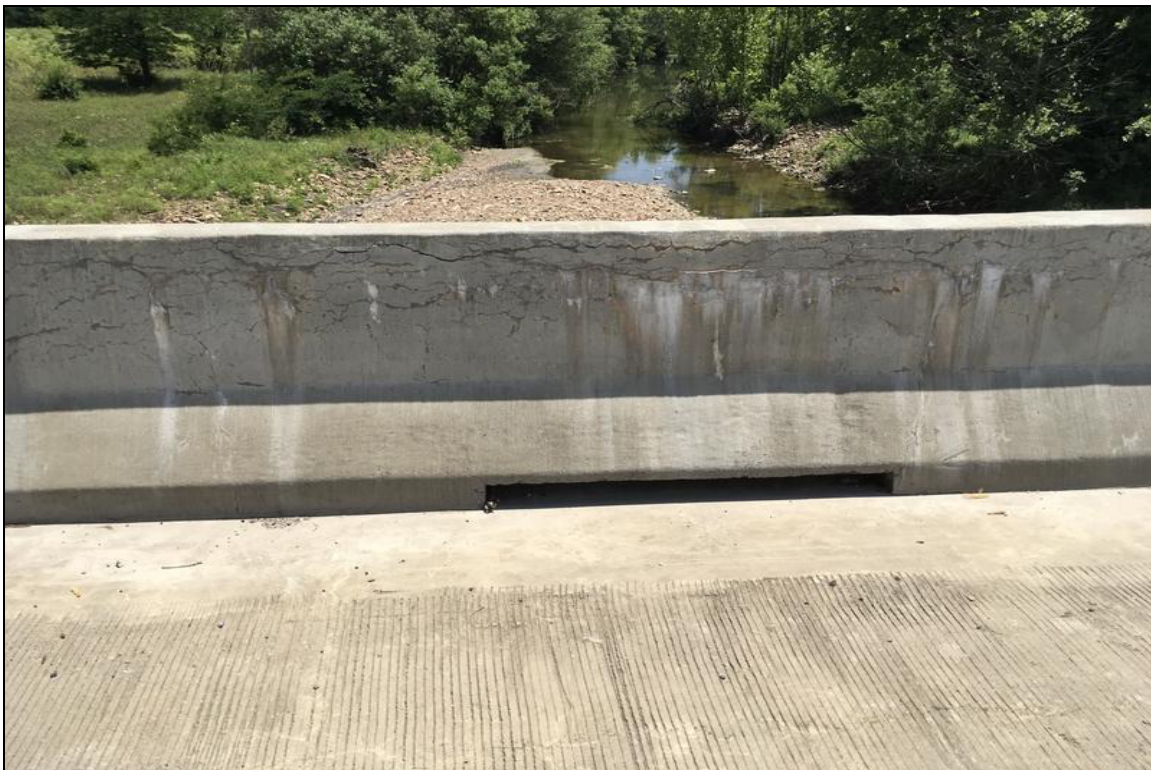
Several parapet sections on the right side have map cracking. Worst case condition.

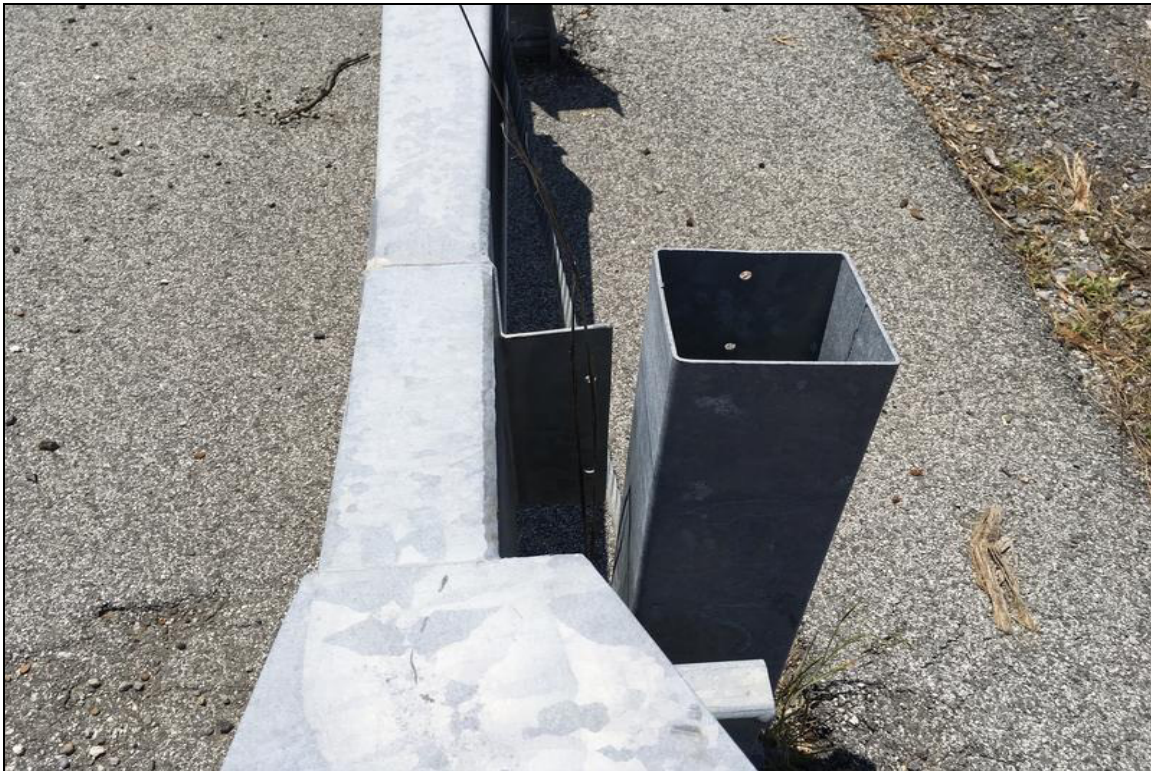
The Right beginning end treatment is not connected to the post
Typical also of the Left ending end treatment is not connected to the post.

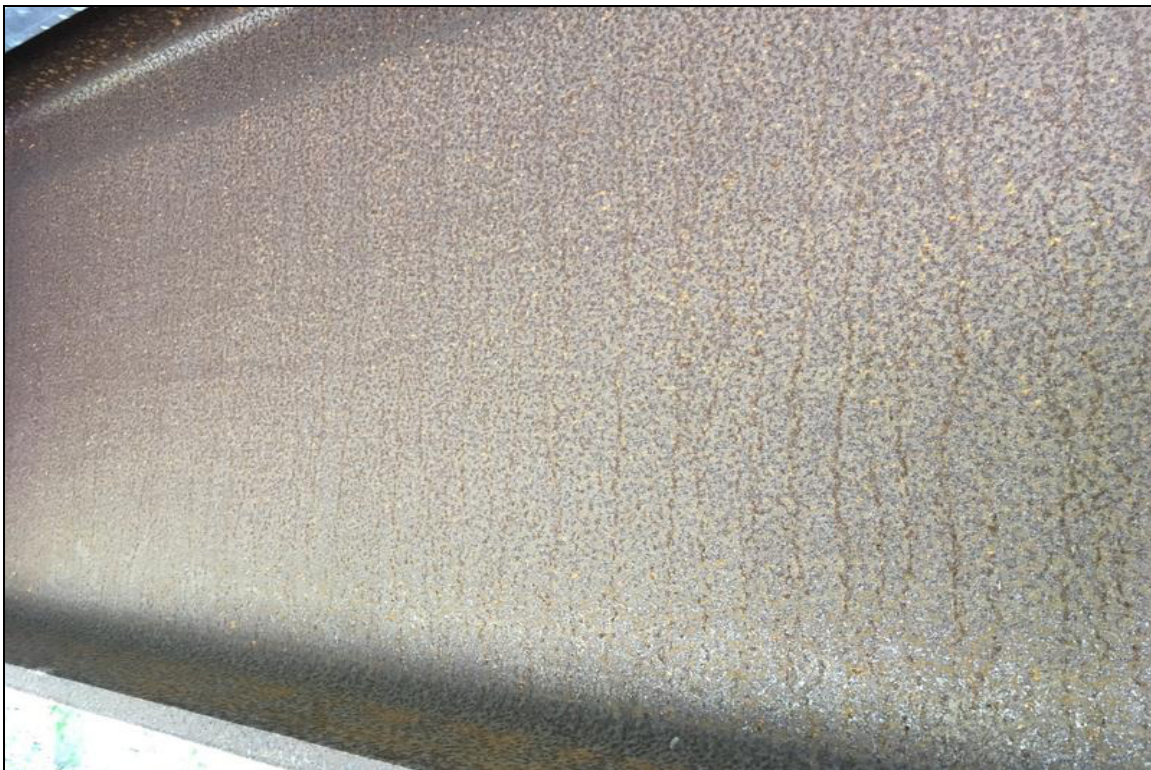
Typical condition of the weathering steel protective coating.

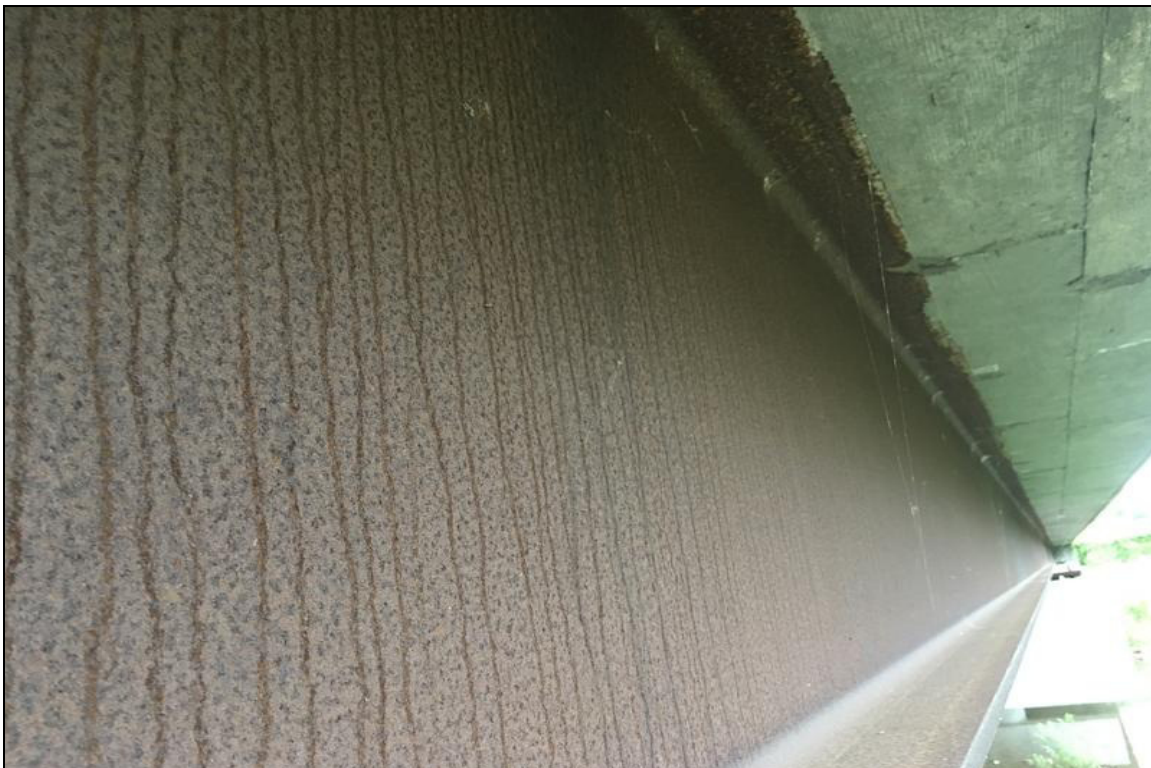
Typical view of the weathering steel protective coating condition.

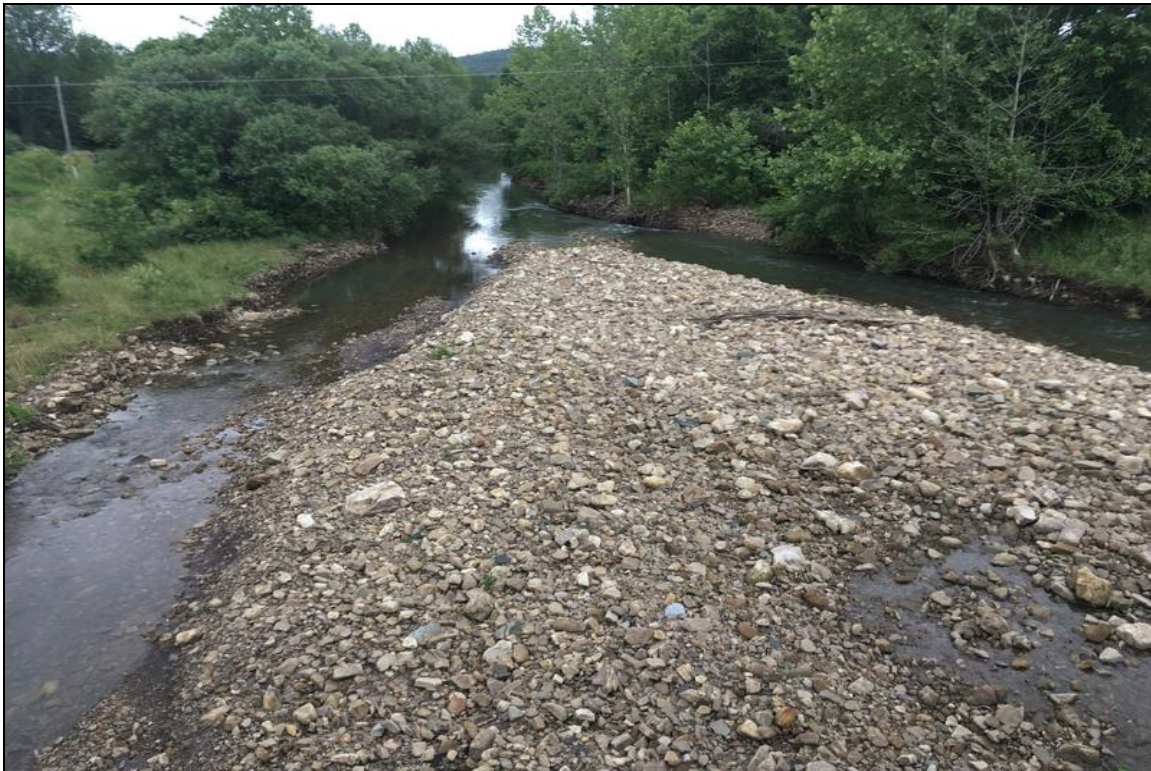
Downstream channel view.

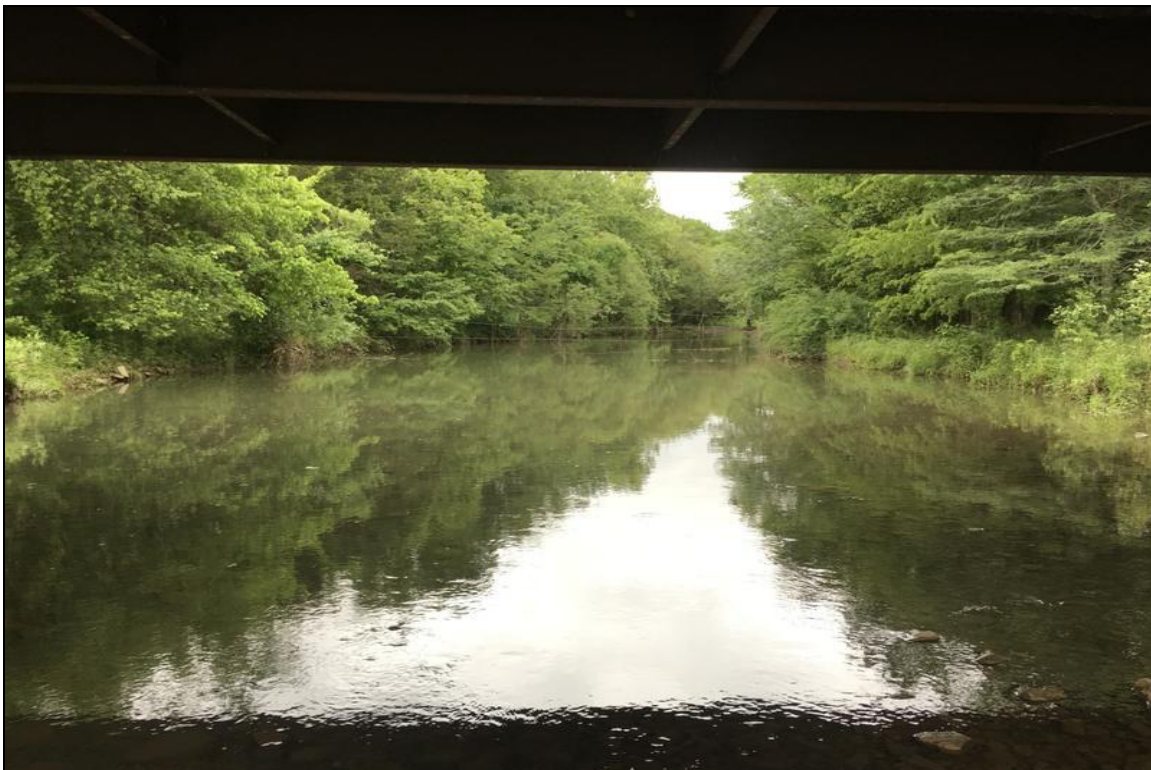
Upstream channel view.

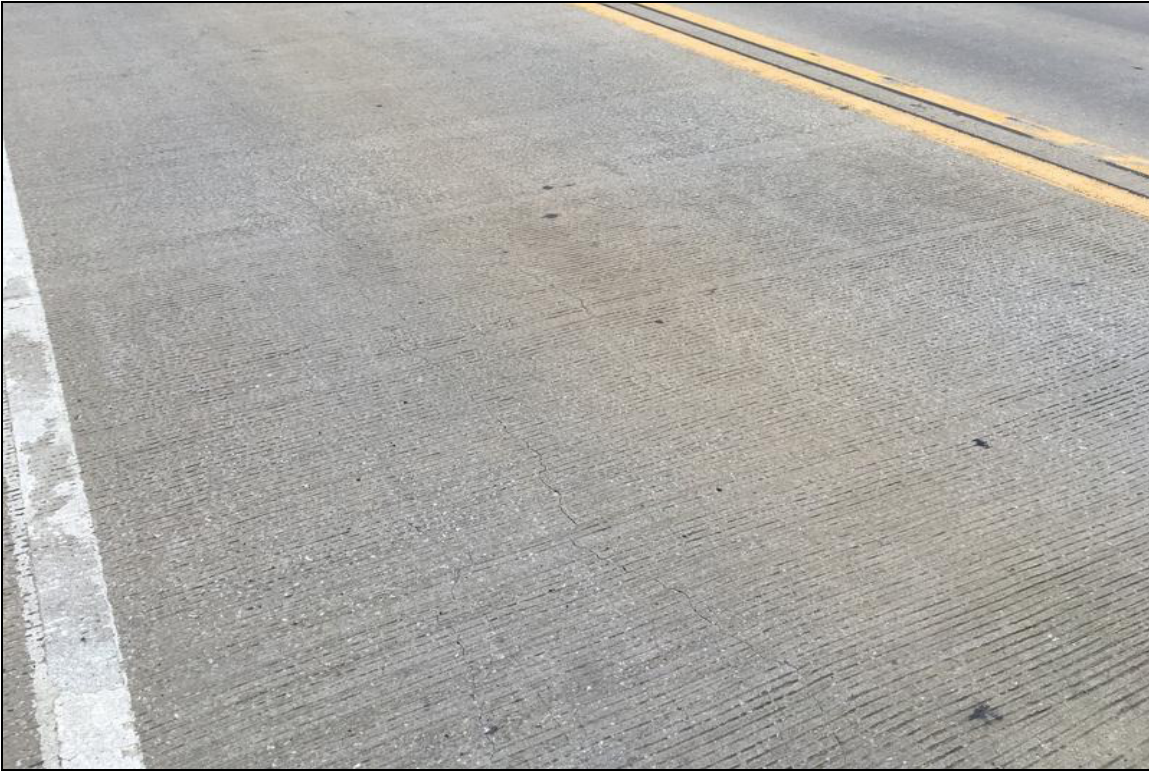
Typical view of driving surface.

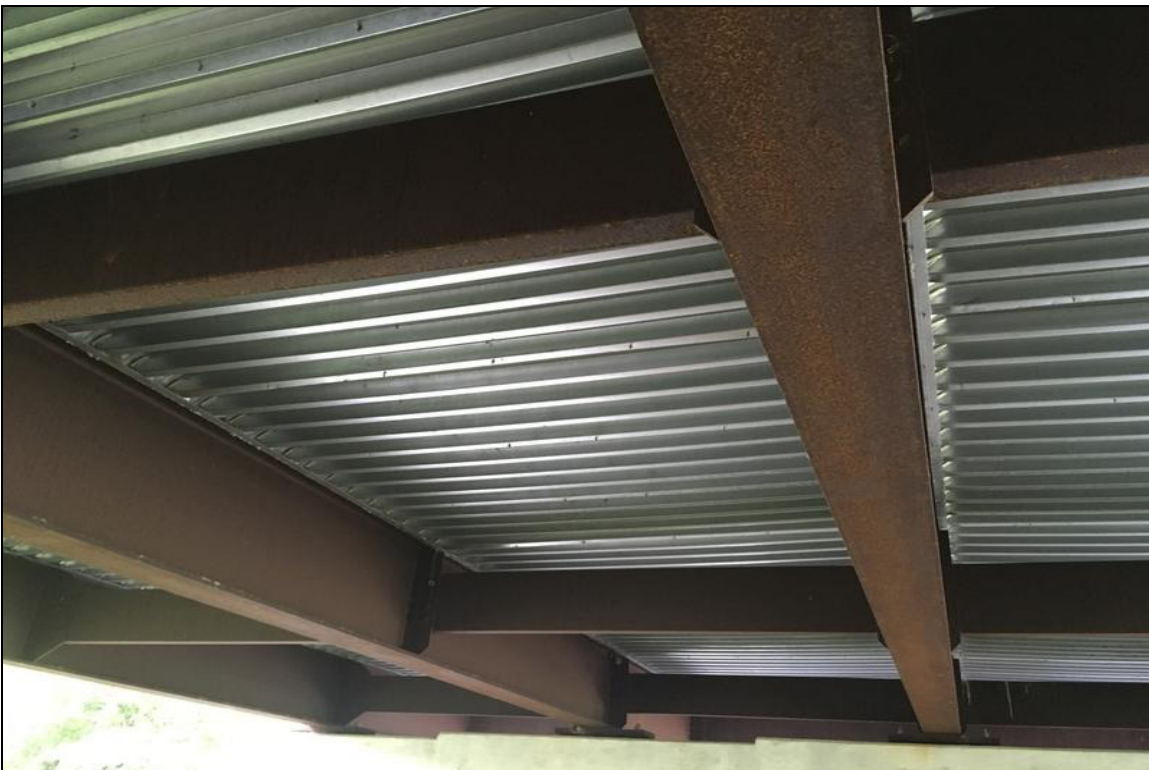
Typical view of the undersurface.

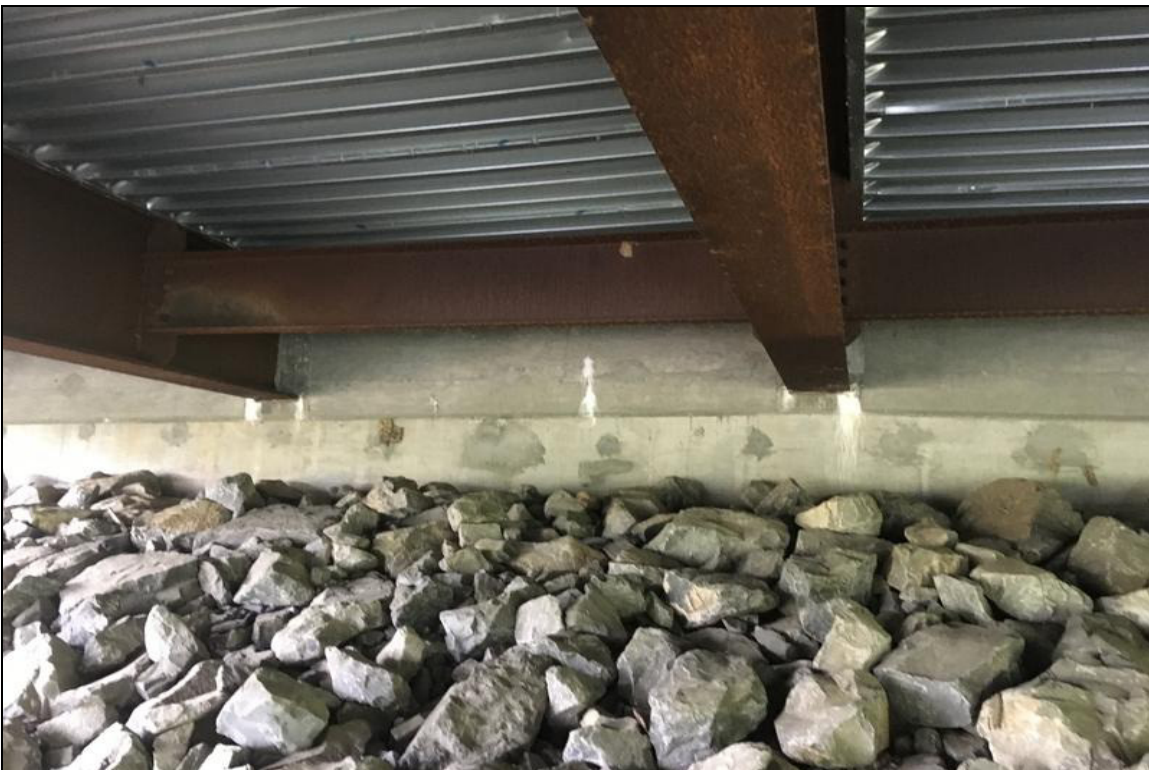
(215)							
<p>Abutment #1- has 3 vertical hairline cracks and 1 vertical hairline crack with efflorescence at the mid section. The rip rap is in place and functioning as intended.</p> <p>Abutment #2- has 8 vertical hairline cracks, and 4 hairline cracks with efflorescence at the corners of the beam bottom flanges of beams #2,3,4. The rip rap is in place and functioning as intended.</p>							
234	Reinforced Concrete Pier Cap	LF	82	74	8	0	0
1130	Cracking (RC and Other)	LF	8	0	8	0	0

Efflorescence at the beam corners of abutment 2.

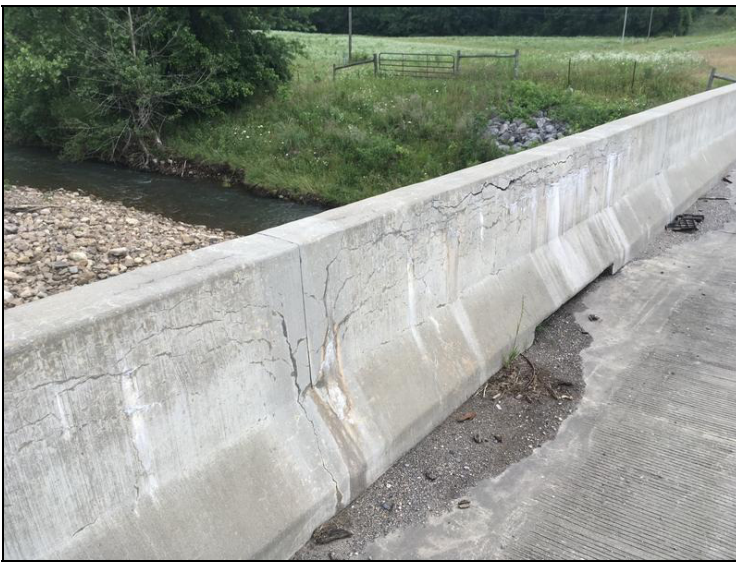
The left parapet wall in span 2 has a 16' area of map cracking with efflorescence.

Map cracking with efflorescence in the left parapet wall in span 2.
