Bridge #A0690(Underwater type 2, Routine)

US 65 Searcy over LITTLE RED RIVER

Location: 1.2 MI SE JCT 66 LESLIE

Team Lead: Benjamin Smith **Inspection Date:** September 19, 2022

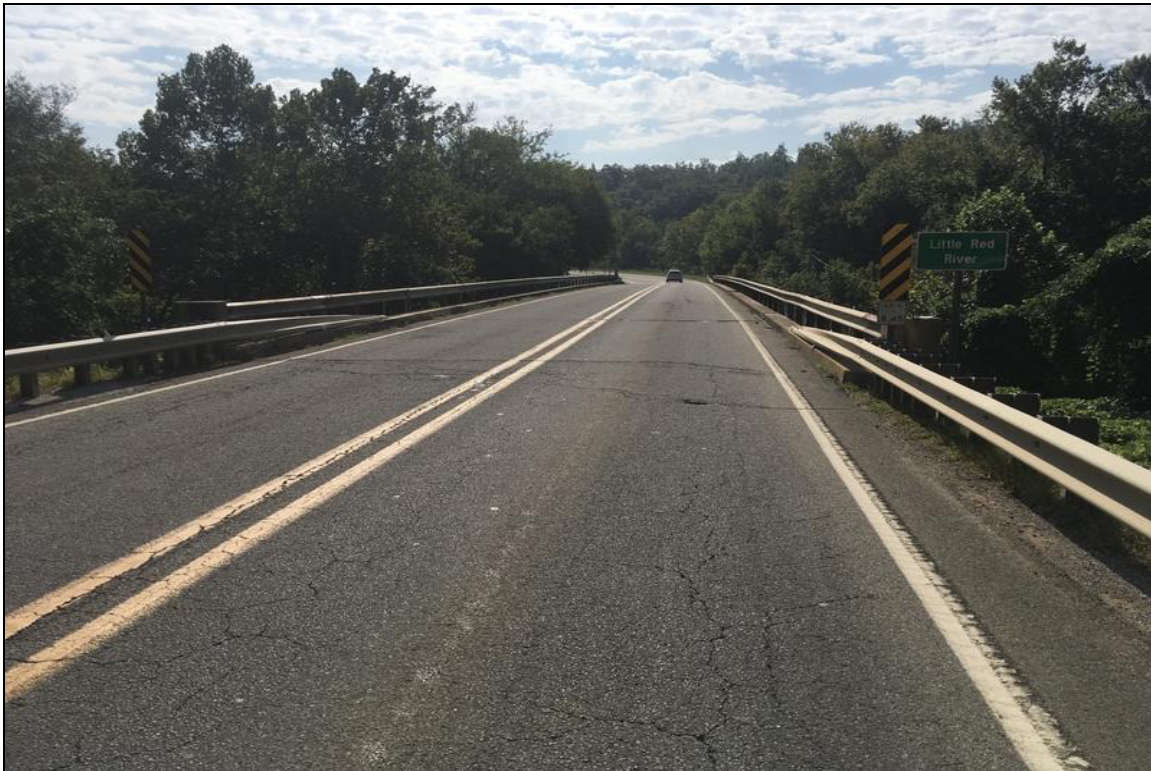
Approach view in direction of log mile.

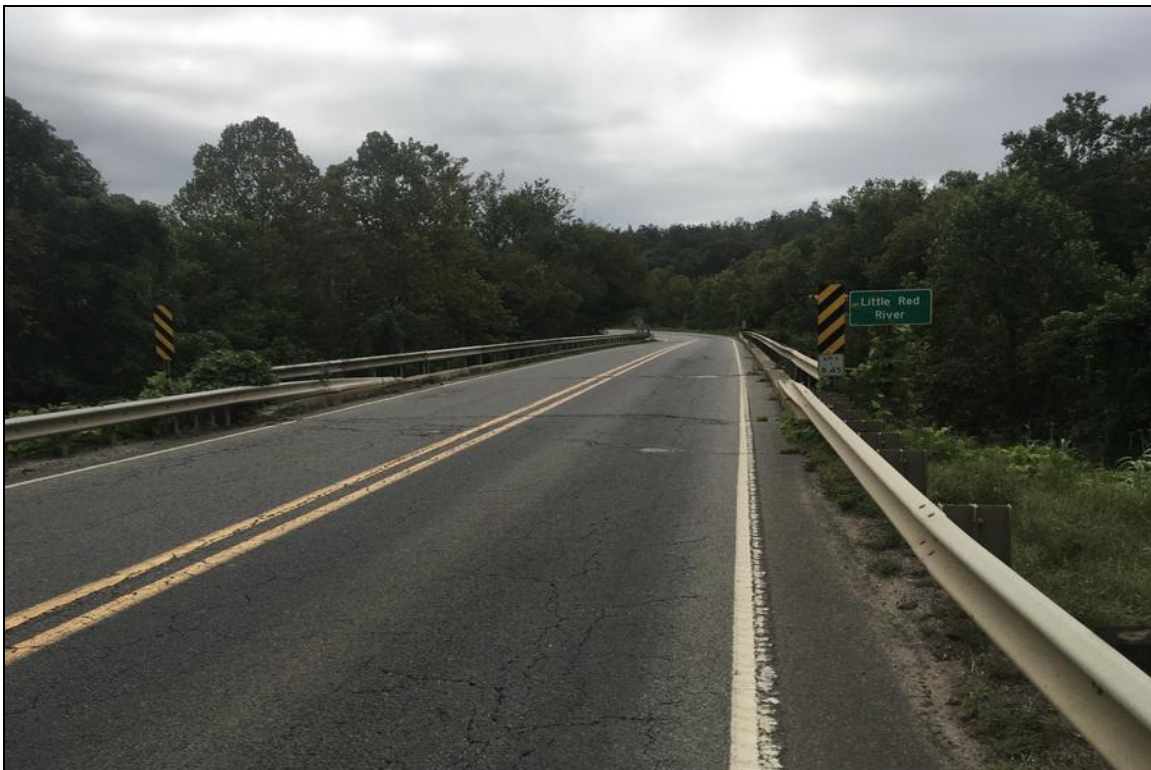
Approach view in direction of log mile.

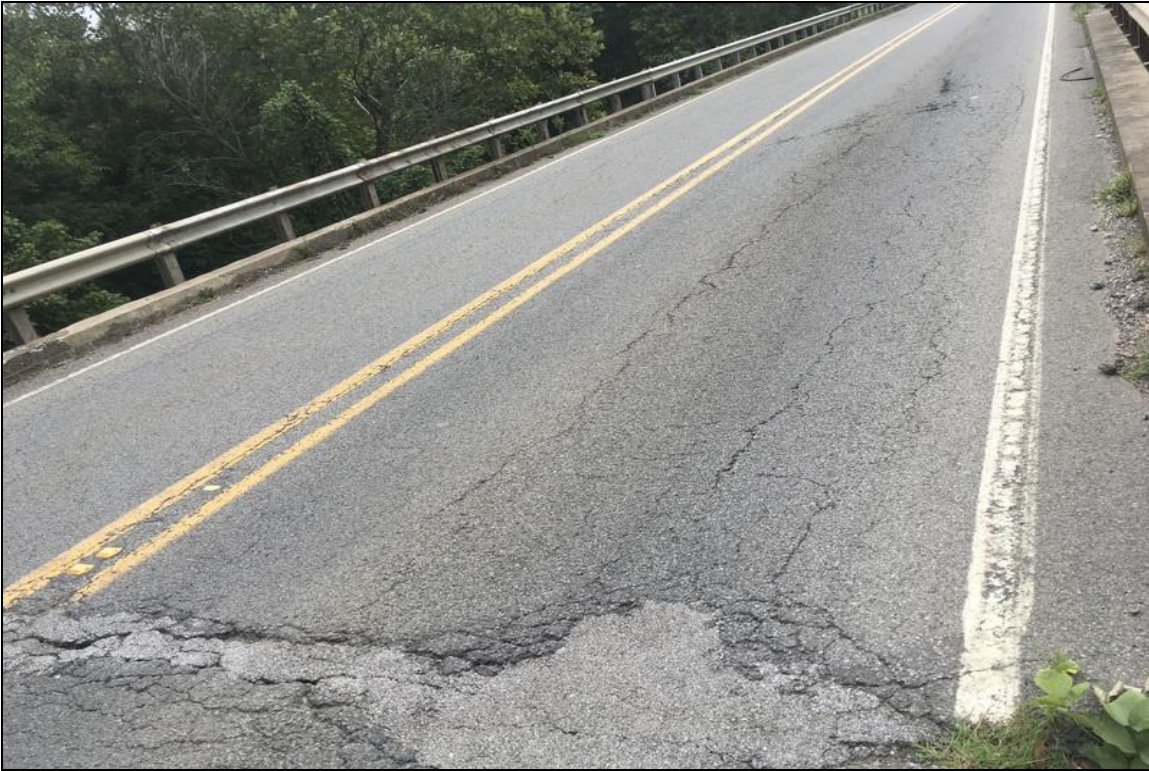
Typical view of driving surface.

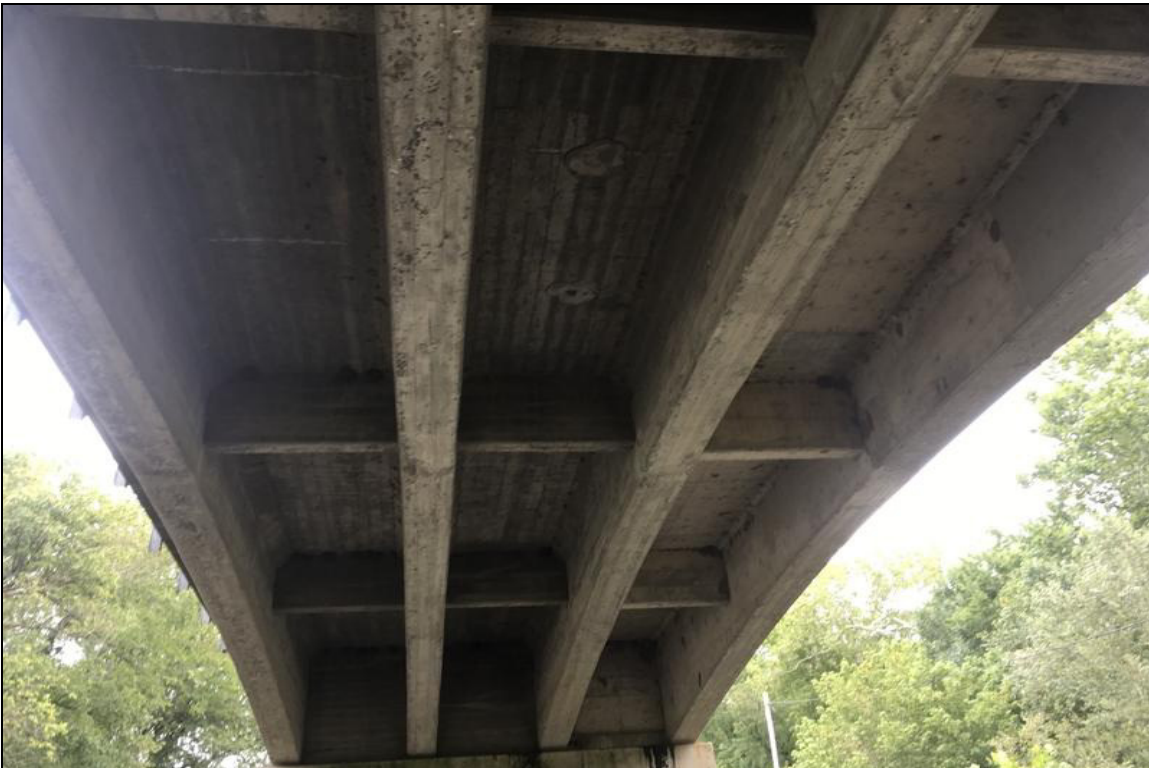
Typical view of undersurface.

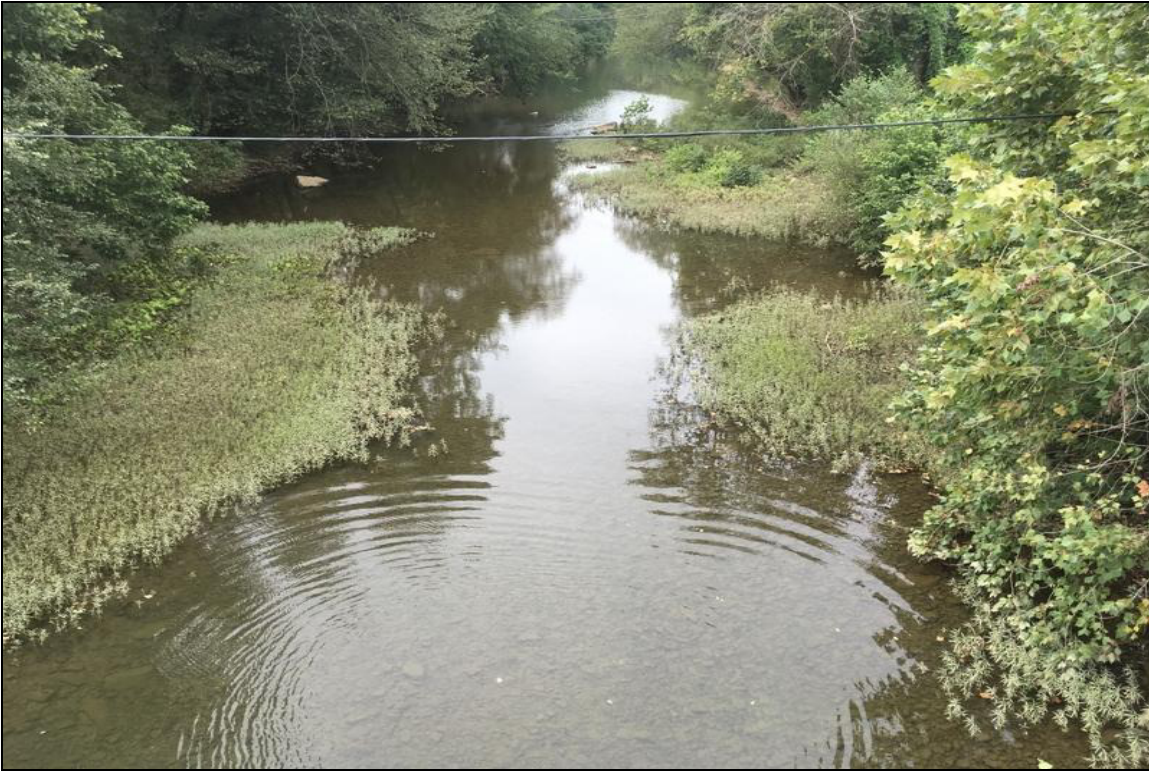
Upstream channel view.

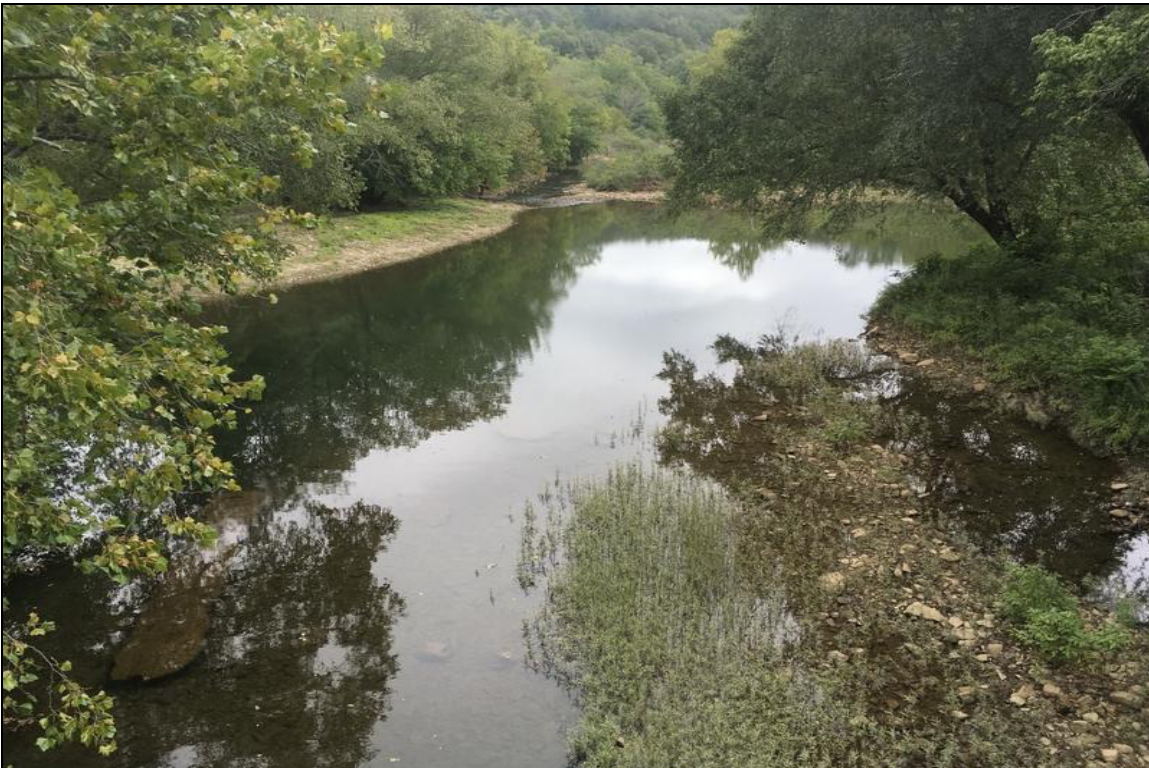
Downstream channel view.

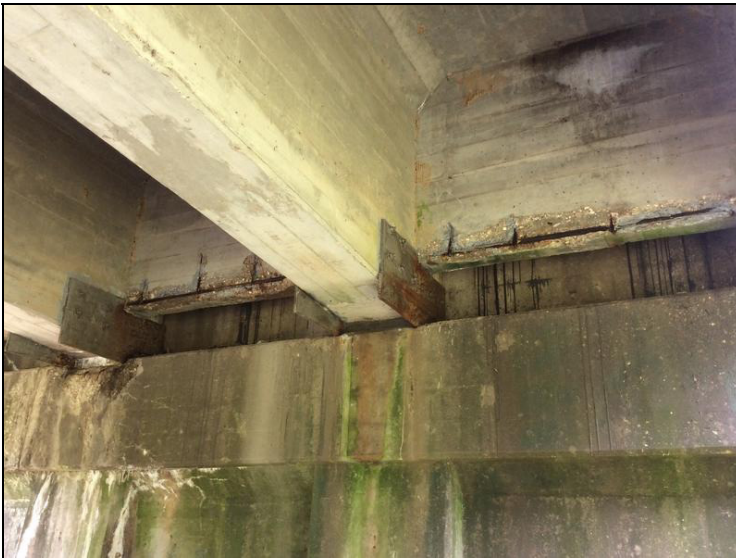
The bottoms of the diaphragms in span #2 between tee beams #1,#2 and #2,#3 and at tee beam #3 have spalling with rebar exposed.

Exposed rebar to diaphragms between girders
#1#2, & #2 #3 and under girder #3

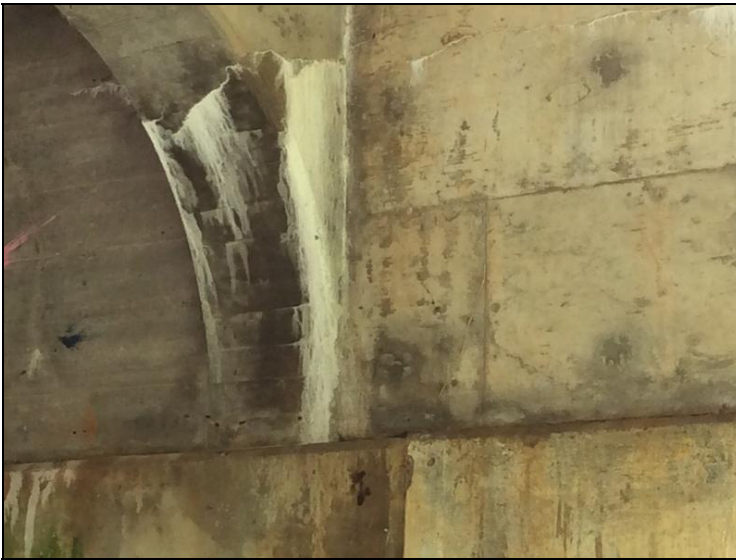
Tee beams #3,4 have cracks with efflorescence in span #1 at the haunch areas.

Span #1 over bent #2 efflorescence to haunch of girder #3

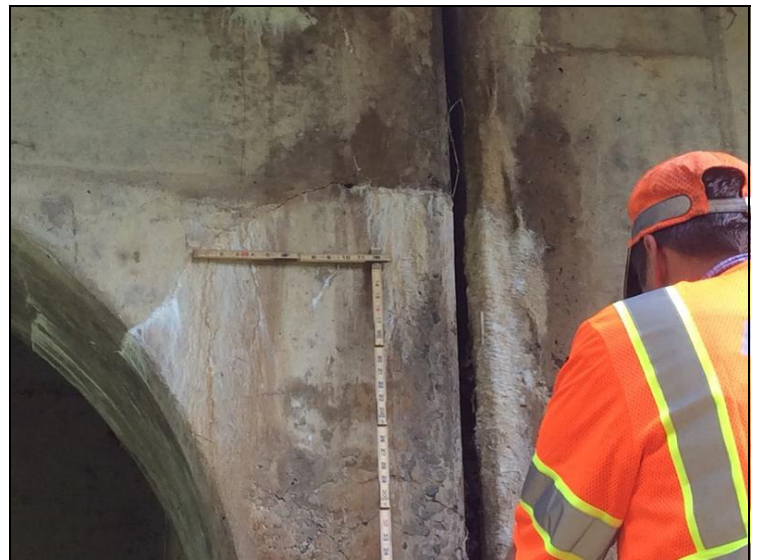
Cracking to haunch of girder #4 over bent #1

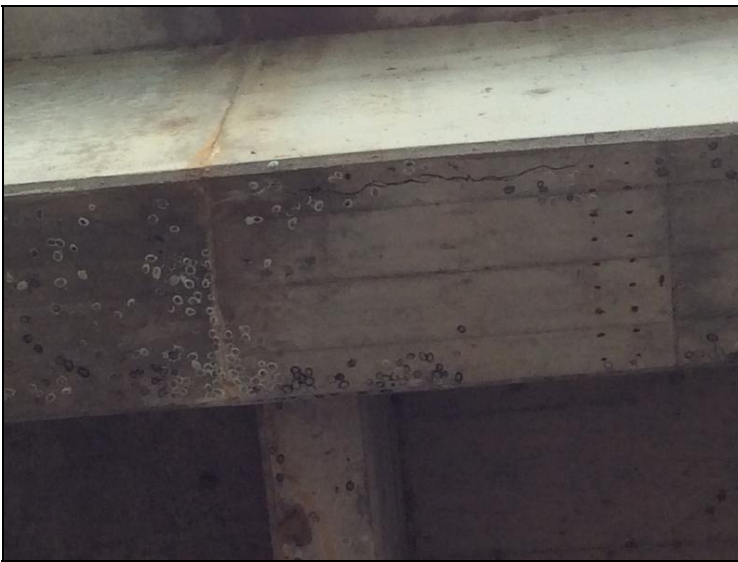
Tee beam #4 has a 3' delamination on the bottom edge of the beam at mid span of span #3.

Midspan crack in girder #4 of span #3

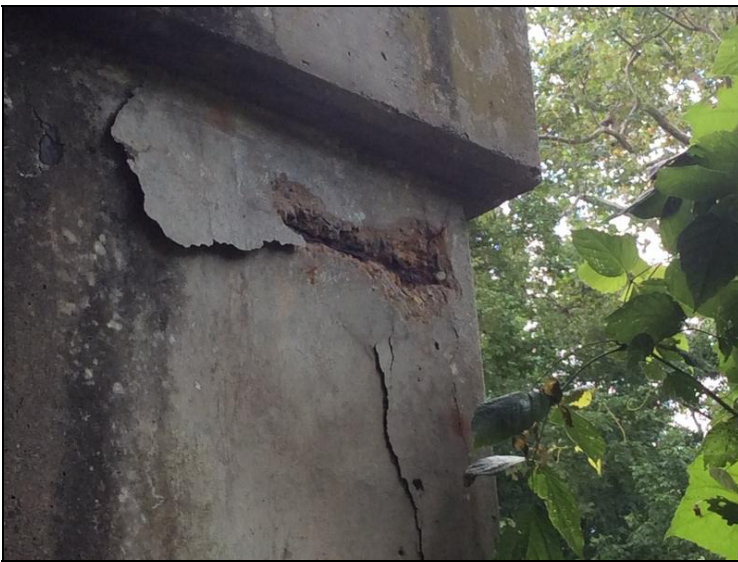
Bent #1 column #3 and Bent #4 columns #1,4 have rebar exposed.

Exposed rebar to right column of bent #5

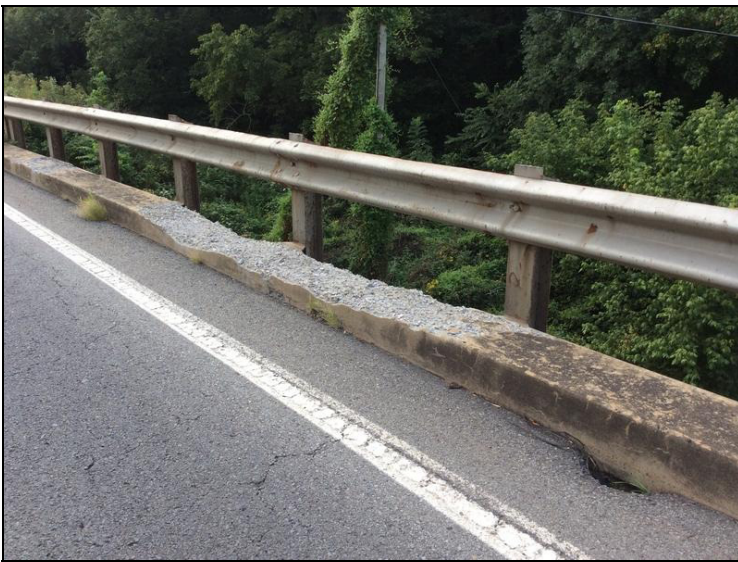
The right side curb has a total of 35' of delamination with 4' of exposed rebar in spans #2,3,4.

15' exposed rebar to right curb section in span #4

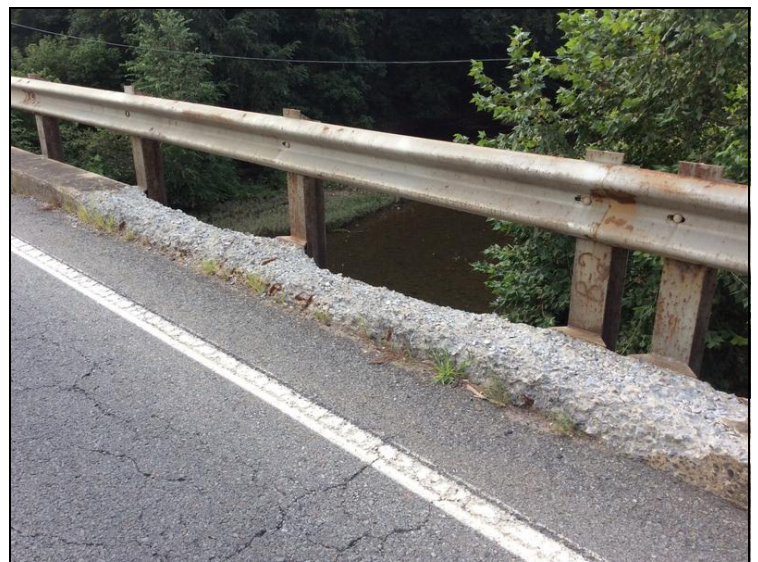
20' exposed rebar to right curb section of span #3
