Bridge #02469(Routine, Fracture Critical)

US 62/412 Marion over CROOKED CR & MO NA RR

Team Lead: Benjamin Smith **Inspection Date:** July 17, 2018

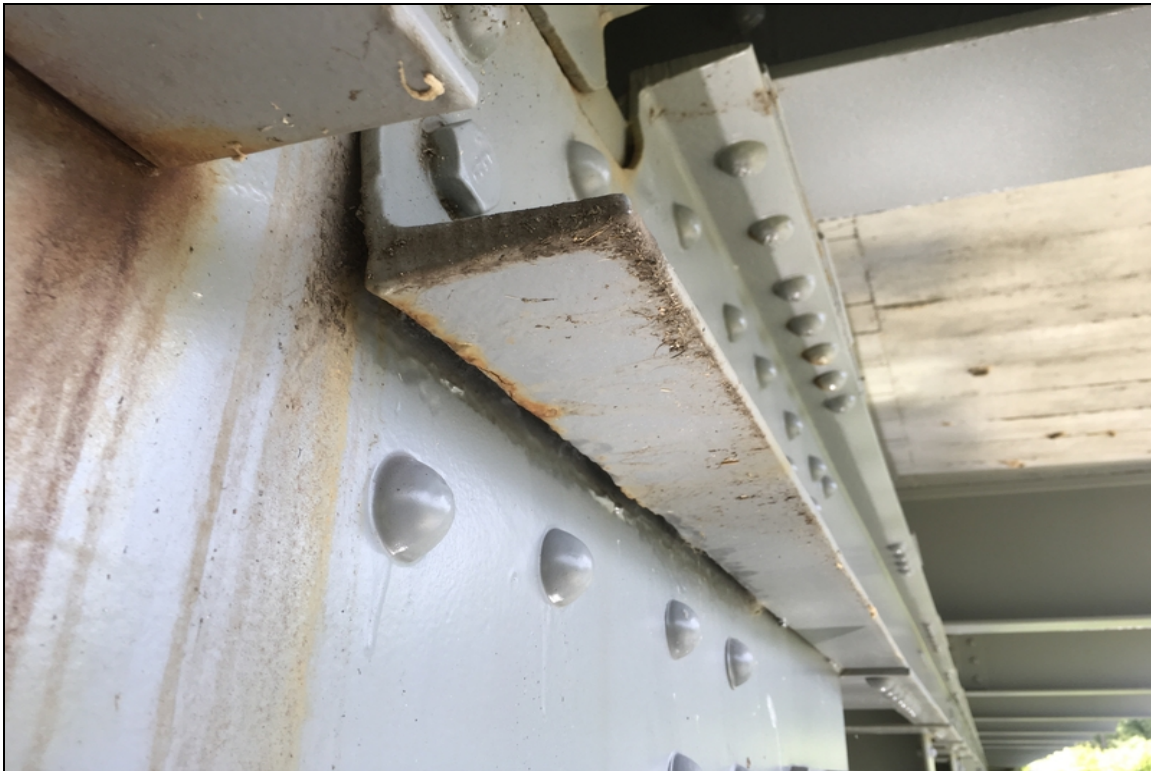
1/2" of distortion on the bottom flange of the exterior top chord connection at U26 right truss.

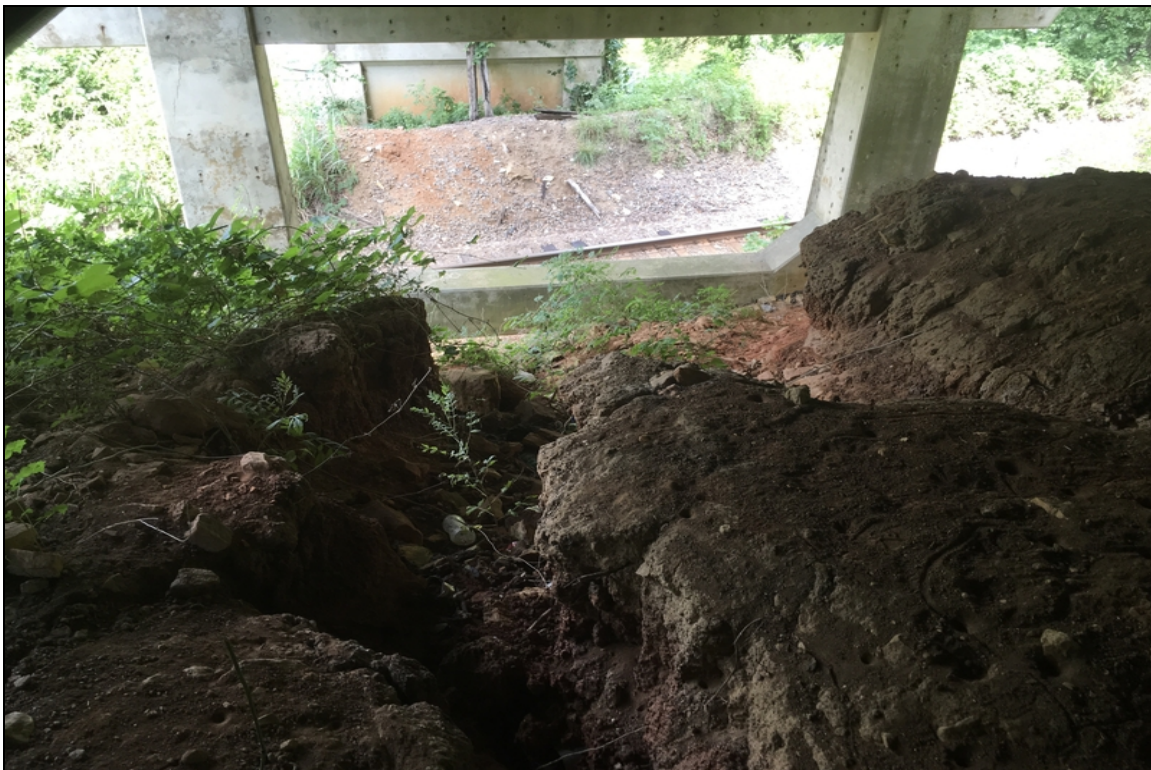
The abutment #2 embankment has erosion.

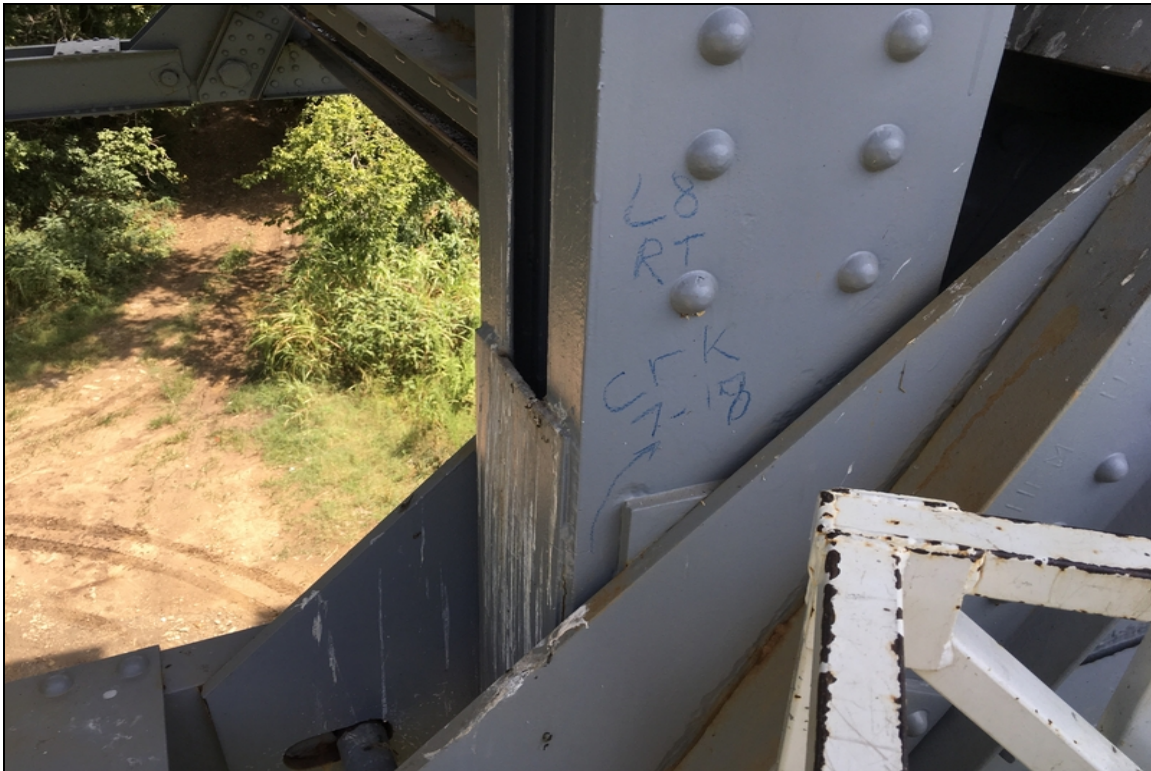
Crack location L8 right truss.

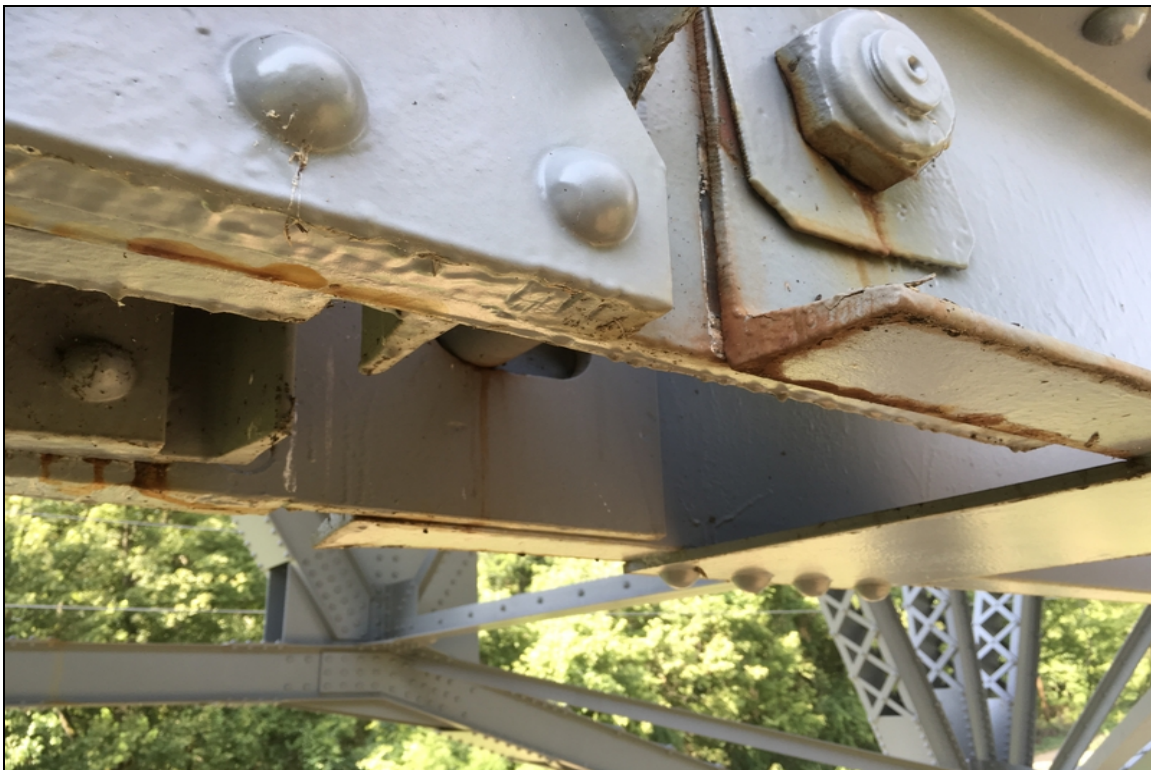
Lower pin area condition at L8 left truss.

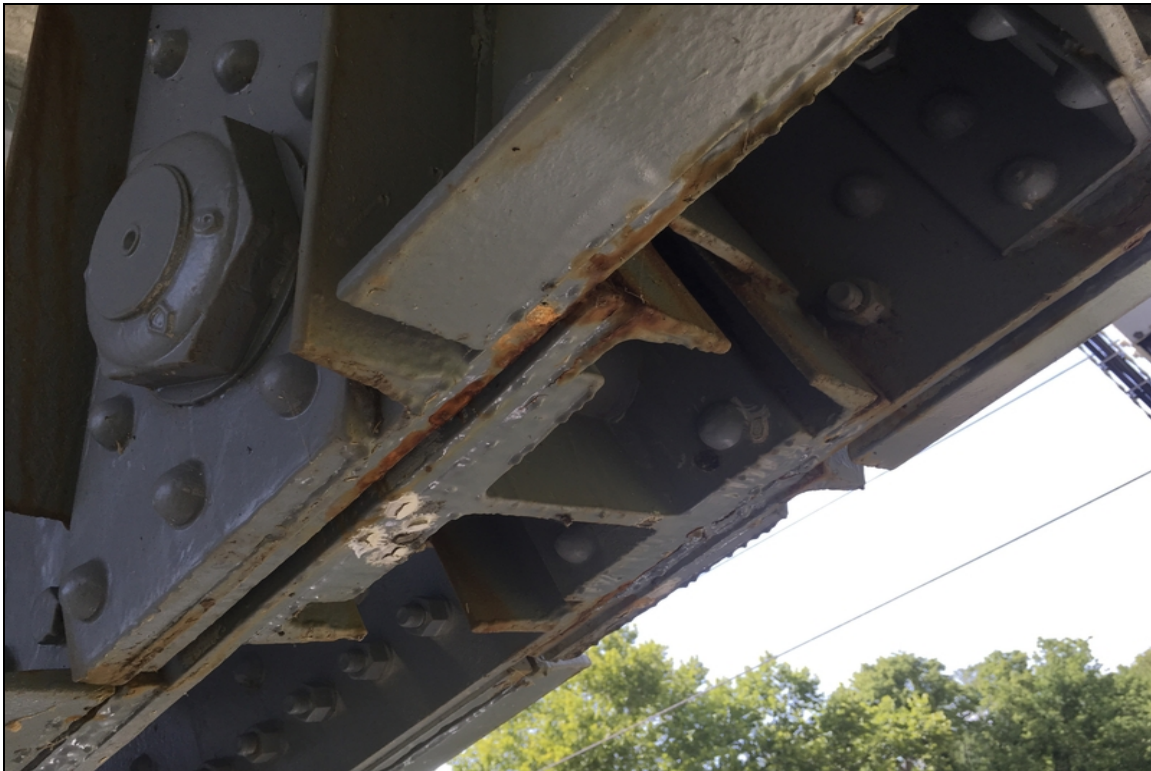
Lower pin connection area at L 13 right truss.

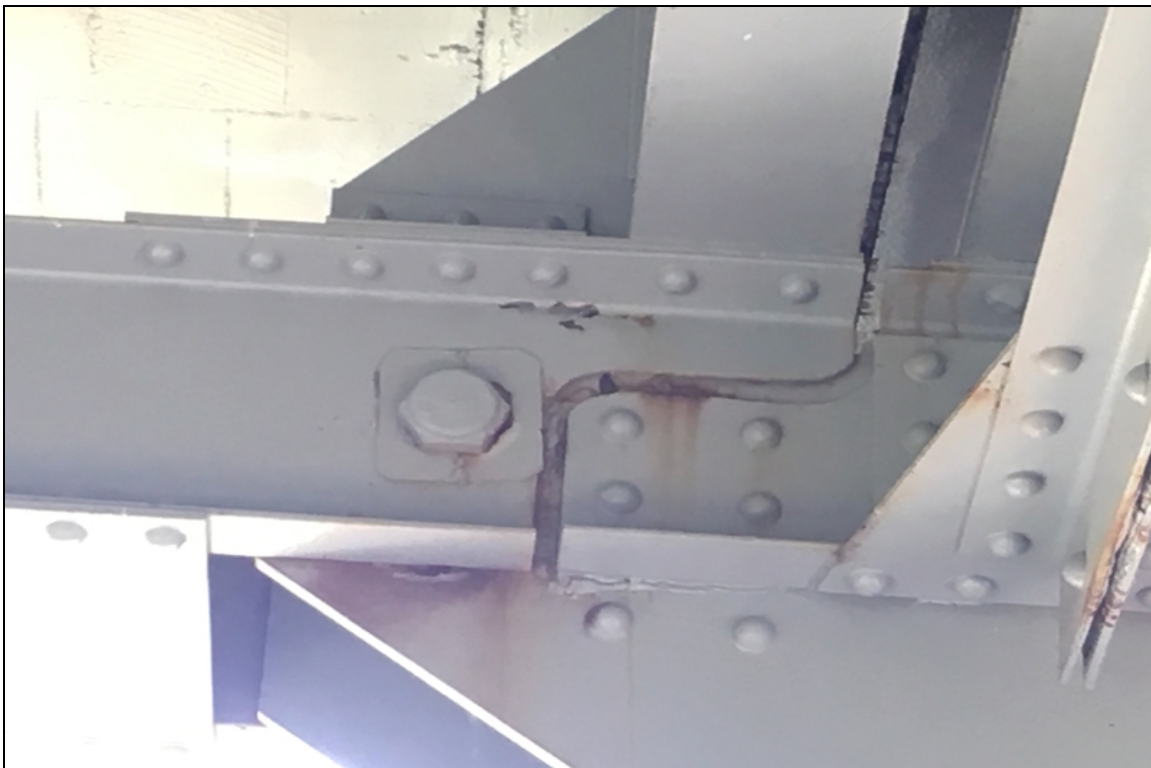
ELEM	DESCRIPTION	UNITS	TOTAL	CS1	CS2	CS3	CS4
<p>Top chord: RIGHT truss -U-16 has a hole rusted through the web section for 2 3/4" long x 1/2" wide near the pin connection on the exterior side, the interior side also has rust holes at the same location, this area of corrosion has been arrested with sand blasting and new paint system. This is a zero load location.</p> <p>U26 has a 3" long rust hole in the web of the interior top chord connection on the right truss.</p> <p>U42 right top chord pin connection at the approach span has distortion at the connection due to pack rust with up to 1/8" section loss.</p> <p>Top Chord LEFT truss- U-16 has a hole rusted through the web section near the pin connection on the exterior side, the interior side also has rust holes at the same location, this area of corrosion has been arrested with sand blasting and paint system, but the rust holes that appear to be cracking. This area is also bulging due to pack rust behind the web. This area is next to the upper pin location, this is a zero load location.</p> <p>U26 left truss has a 2 " long rust hole at the top of the web of the top chord on the interior connection.</p> <p>U42 left top chord pin connection at the approach span has distortion at the connection due to pack rust with up to 1/8" section loss.</p> <p>Bottom chord connections - Left truss- measurable section loss up to 1/2" (worst case condition) with distortion at LO, 1-9, 13-21.</p> <p>Bottom chord connections -Right truss - has a 8" long vertical crack in the batten plate weld at the L8 vertical tension member, the crack is not yet affecting the base metal, but this crack could extend into the vertical member. The area was tested with dye penetrant, the crack is not larger than was previously visible.</p> <p>Measurable section loss with distortion up to 1/2" (worst case condition) at L 21-19,15,13,12,10,8,7,6,3. mostly on the exterior connections. L17,16,14,5,4, 1 have cracked tack welds that are not affecting the base metal with very little pack rust at these locations.</p> <p>U42 right and left upper chord pin connection to approach span has distortion at the connections due to pack rust with up to 1/8" section loss.</p> <p>(120-515-3440)</p> <p>(120-515-3420)</p>

Interior connection at U16 on the right truss. Showing rust holes in the upper web.

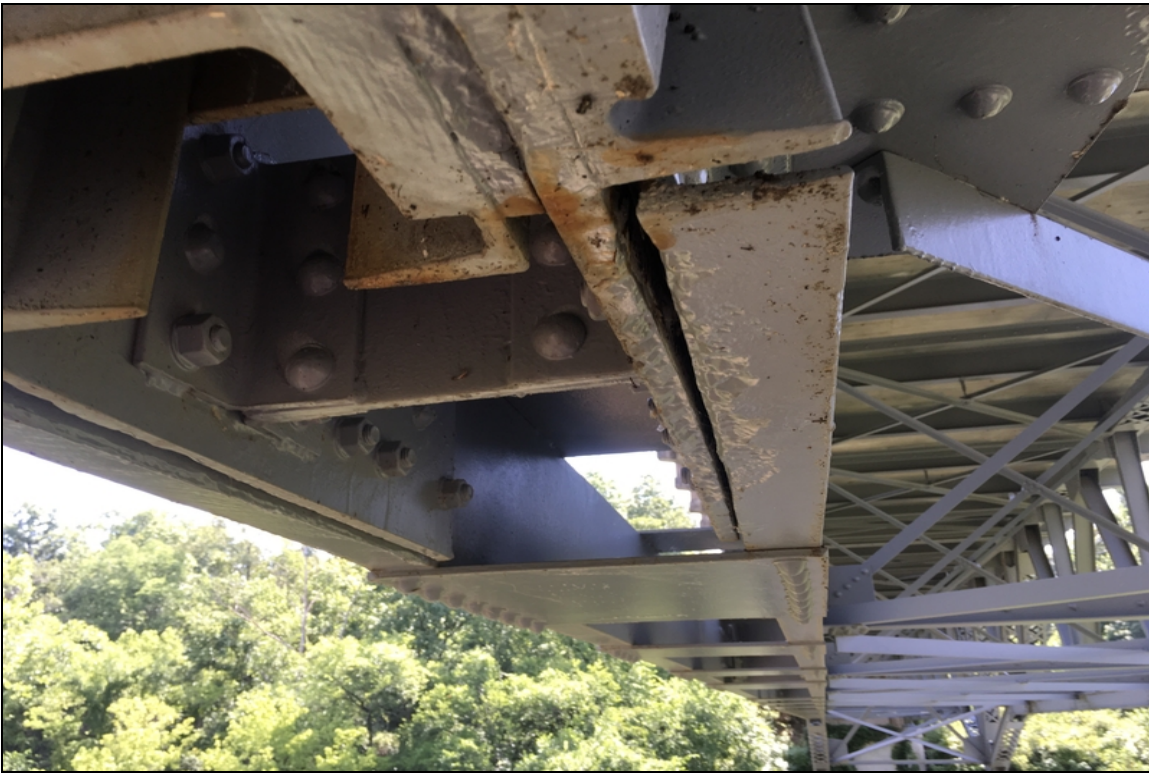
Pack rust with 1/2" of distortion on the interior lower chord connection at L8 It truss.

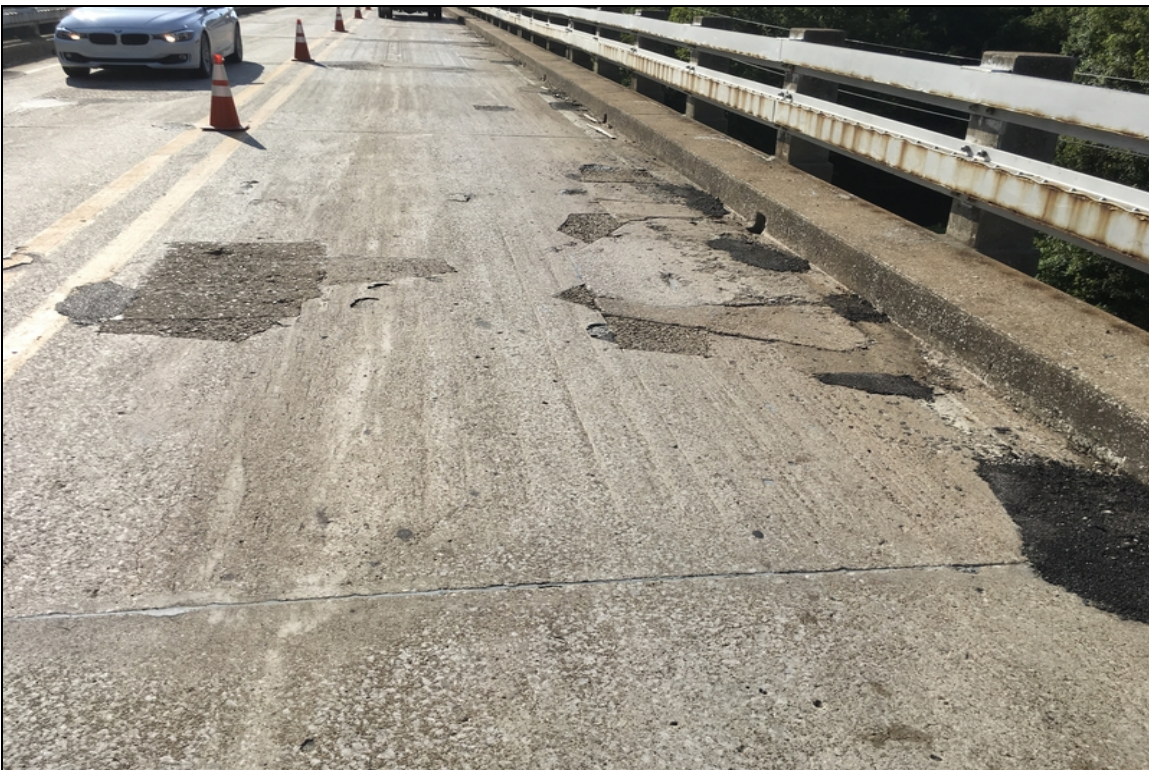
(12)							
Deck driving surface- is bare concrete and has numerous areas of spalls and delaminated areas located in the gutter lines and driving lanes. Transverse cracking was also noted in the driving surface.							
Left lane- has 1005' of delaminated or patched areas mostly in the gutter line and at the joint areas							
Right lane- has 947' of delaminated or patched areas mostly in the gutter lines and joint areas.							
The vertical face of the curb has 31' of shallow exposed rebar on the left and right sides.							
Undersurface- the left and right deck edges have spalling with rebar exposed and large delaminations at all drain areas on the left and right sides.							
Transverse and longitudinal hairline cracking was noted in the undersurface of all spans, very little efflorescence was noted in the cracks.							
Span #1- bay #4 has a large area of efflorescence map cracking at the end of the span that sounds dead under hammer blows.

Driving surface showing patched areas in the gutter lines.

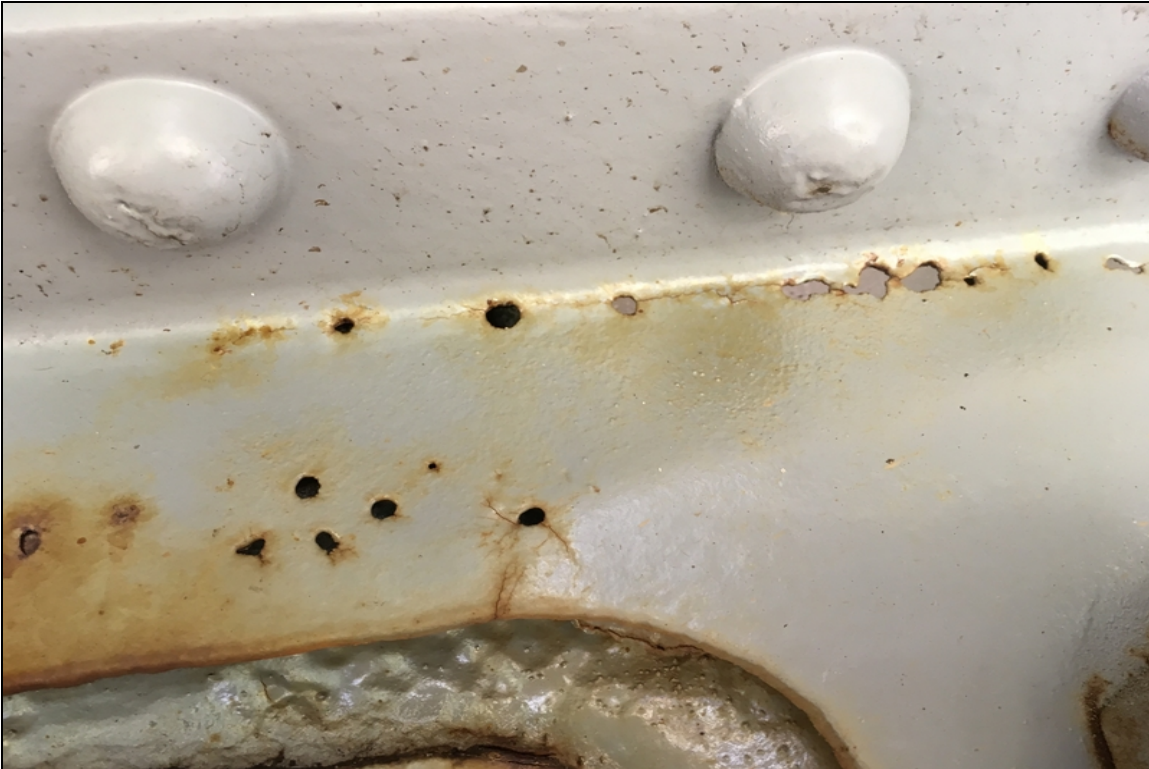
U16 left truss interior top chord connection has rust holes that appear to be cracking. This area is next to the upper pin location.

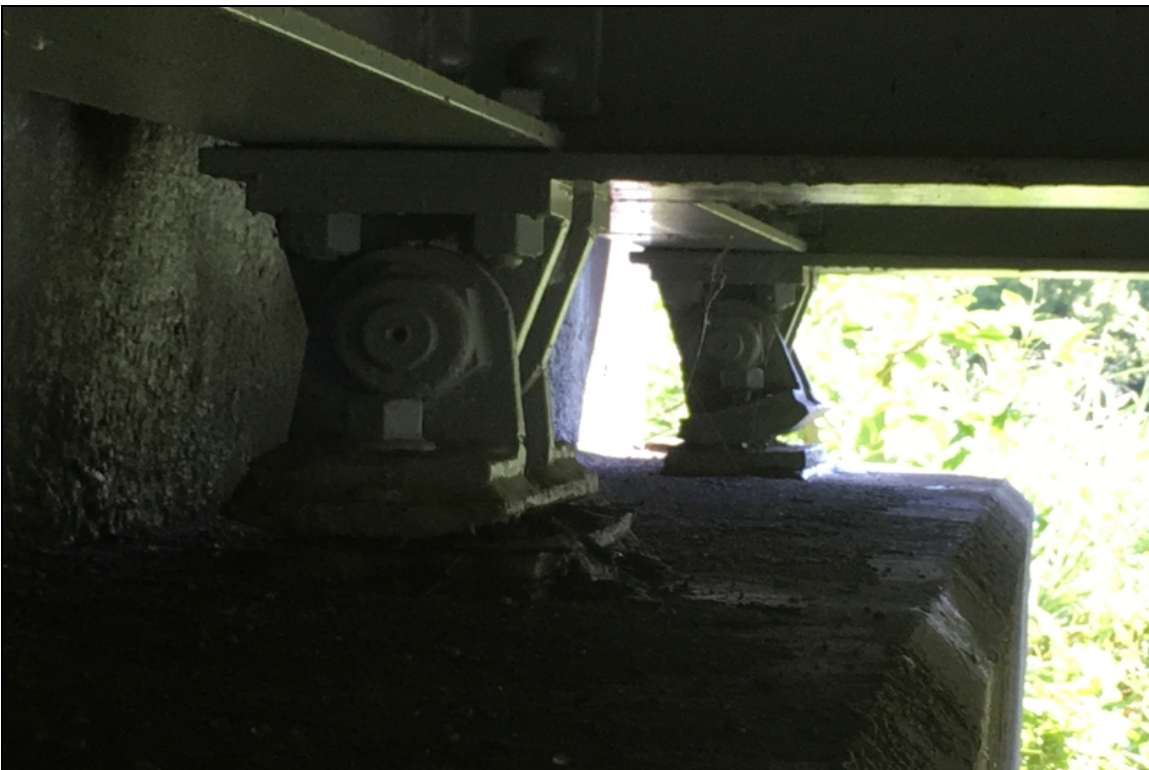
(311)							
Abutment #1 moveable bearings- bearings #1,3,4,5 are tilted excessively toward the back wall. Bearing #2 is not tilted at all. All 5 bearings have corrosion with pitting and flaking rust in the rocker areas.							
The outside temp at the 2018 inspection was 87 deg. F.							
Pier #1 moveable bearings- Both bearings have very minor small areas of corrosion on the masonry plate and rocker area.							
Pier #4 moveable bearings- Both bearings have very minor small areas of corrosion on the masonry plate and rocker area. The anchor bolts have section loss, but have been sand blasted and repainted.							
Pier #5 moveable bearings- All 10 at this location have corrosion with pack rust in the rocker areas.							
313	Fixed Bearing	EA	13	4	9	0	0
1000	Corrosion	EA	9	0	9	0	0

Excessive tilt of bearing #1 at abutment #1. One anchor bolt is missing.

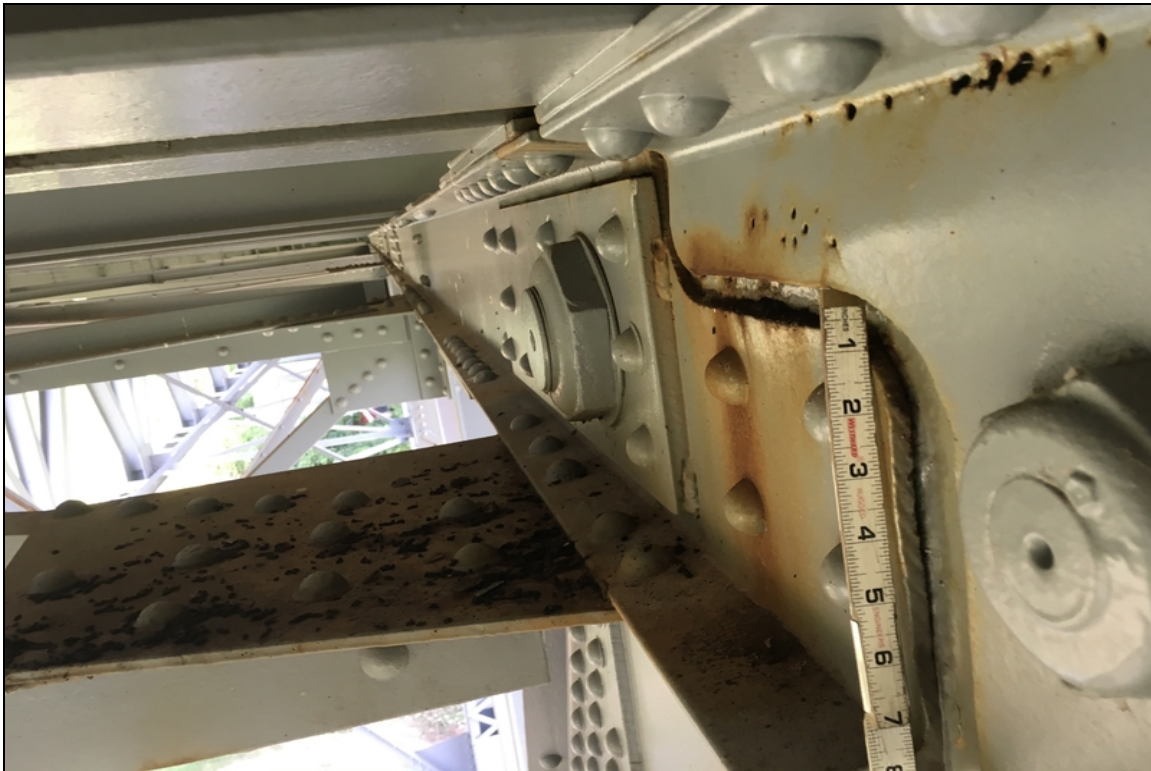
U16 connection on the interior left truss is distorted and bulging due to pack rust. The web has rust holes at this location on the interior and exterior top chord connection.

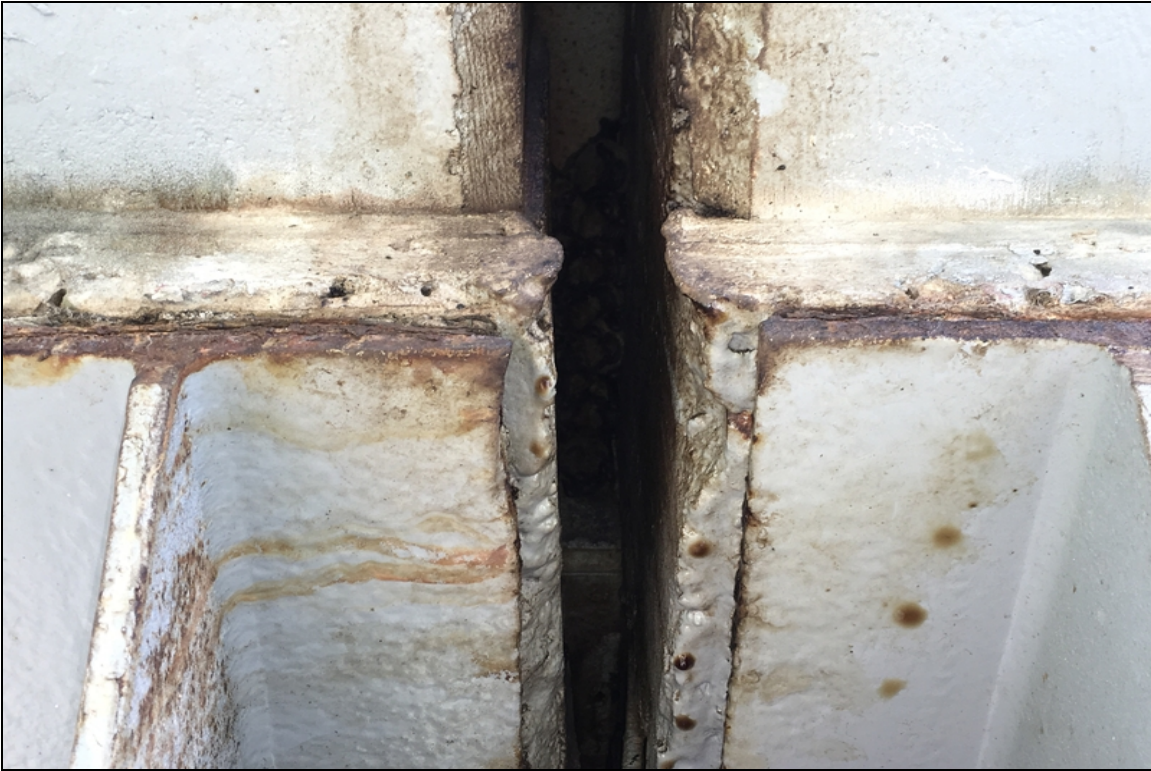
Brown bats in the joint area at the beginning of span #3.

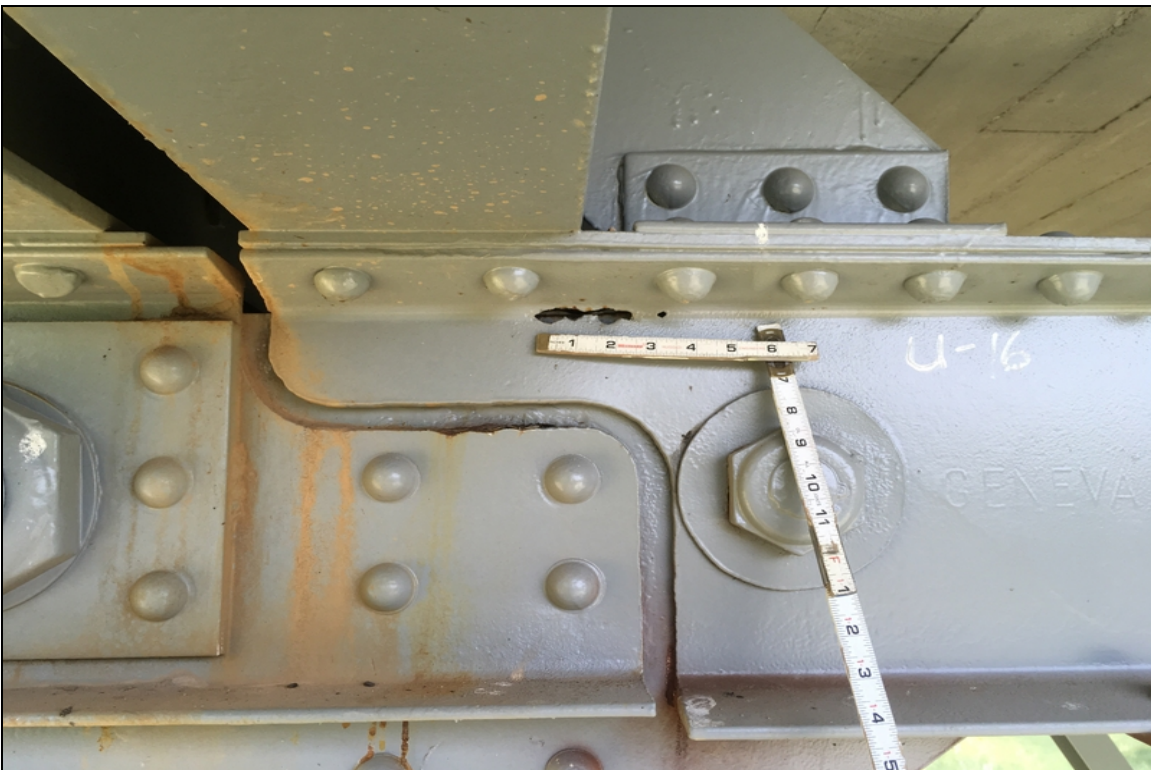
Rust holes in the web of the top chord at U16 right truss. 1/2" x 3" exterior connection. This is typical also of the interior connection at the same location.

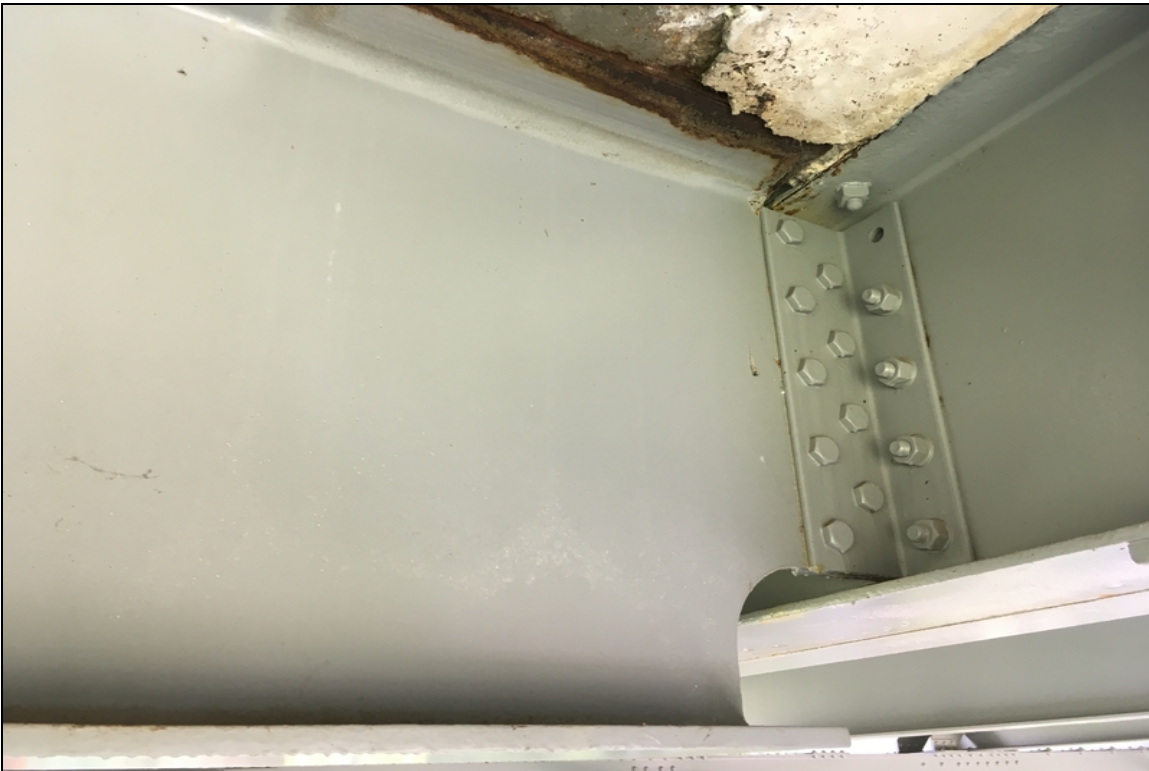
Bolt missing at beam #4 connection at the end of span #1. Typical of beams 2,3,4 at the same location.

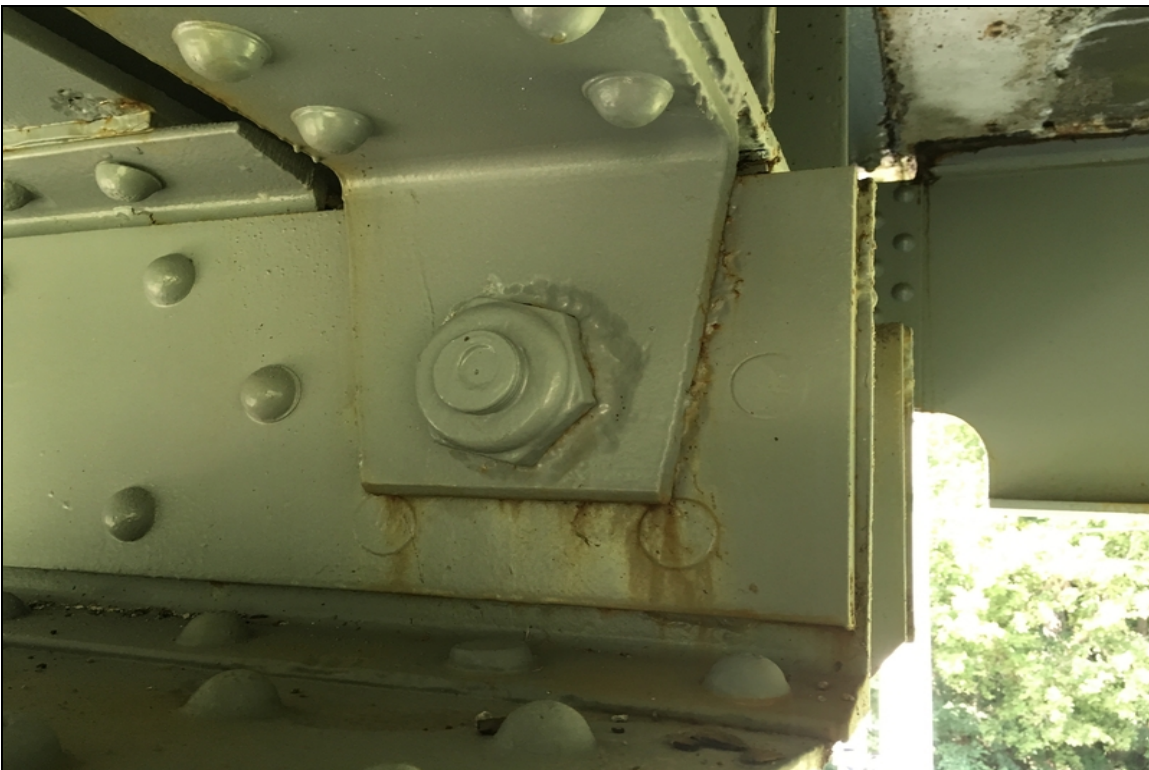
Plug welds at the upper pin location of both trusses at the beginning of the trusses.

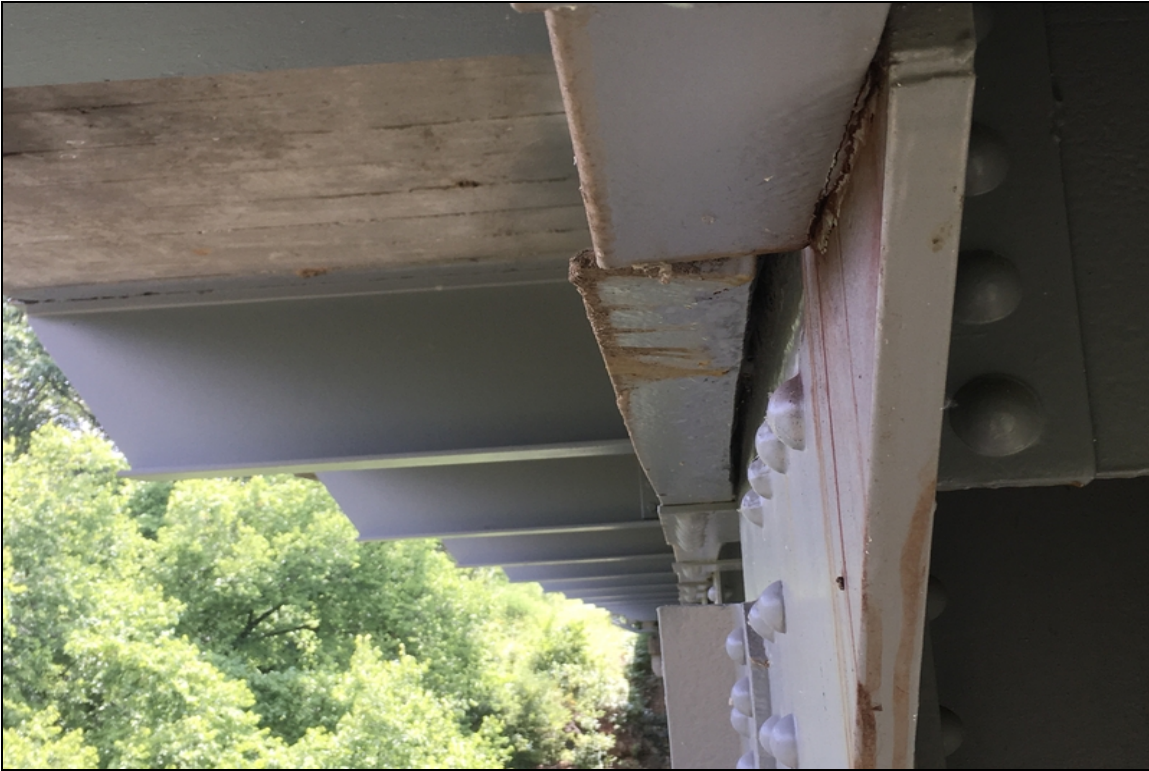
Exterior top chord connection at U 25 left truss showing pack rust with distortion on the bottom flange of the top chord.

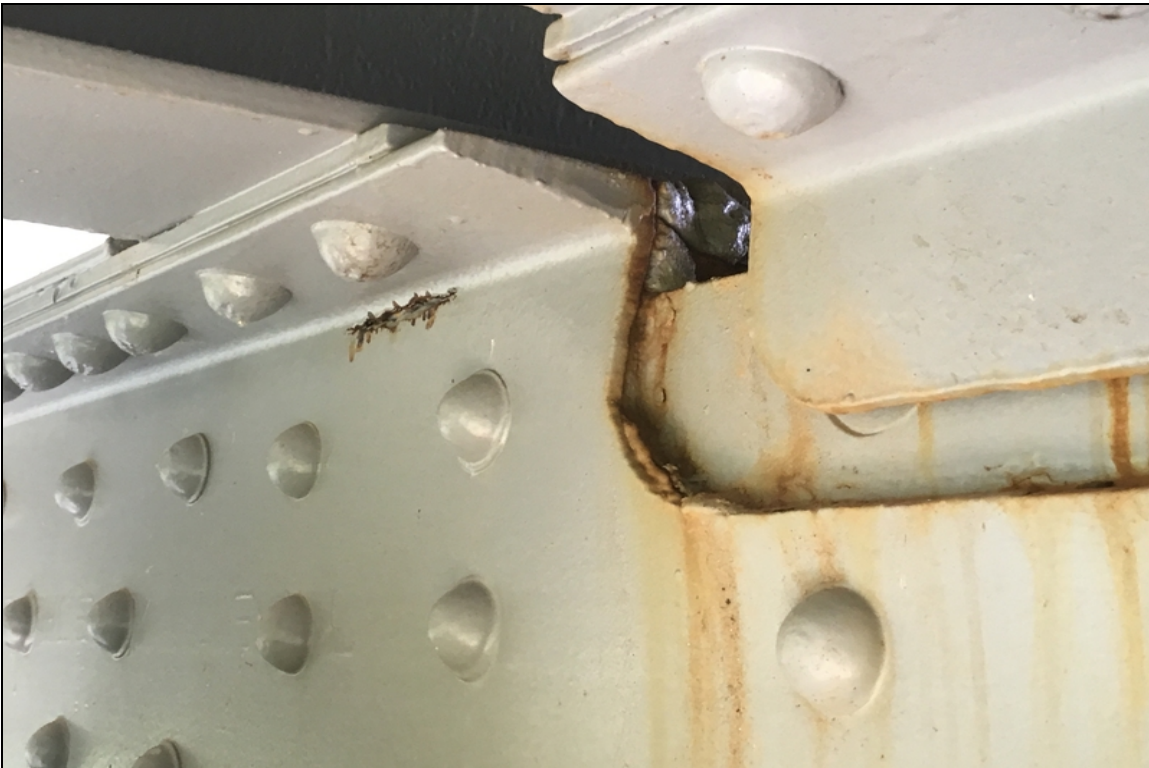
3" long rust hole on the web of the interior upper chord connection at U26 right truss.

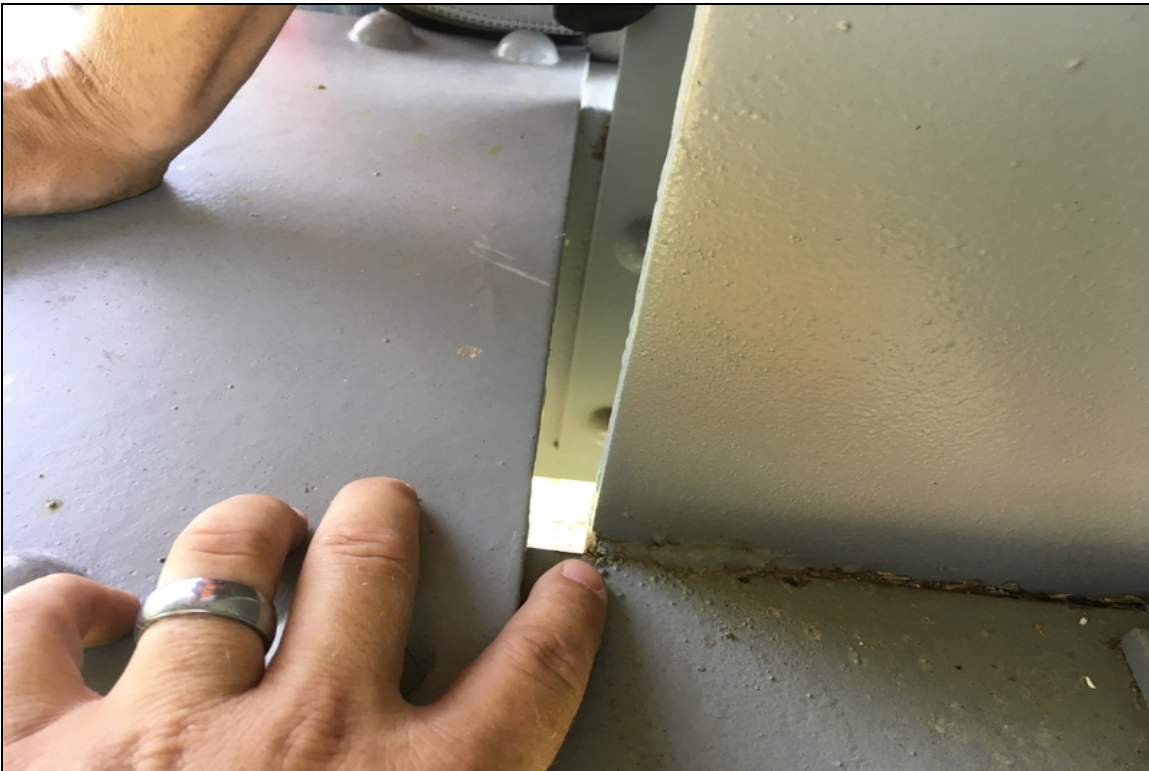
Cracked tack weld on the top of the bottom chord at L3 left truss.

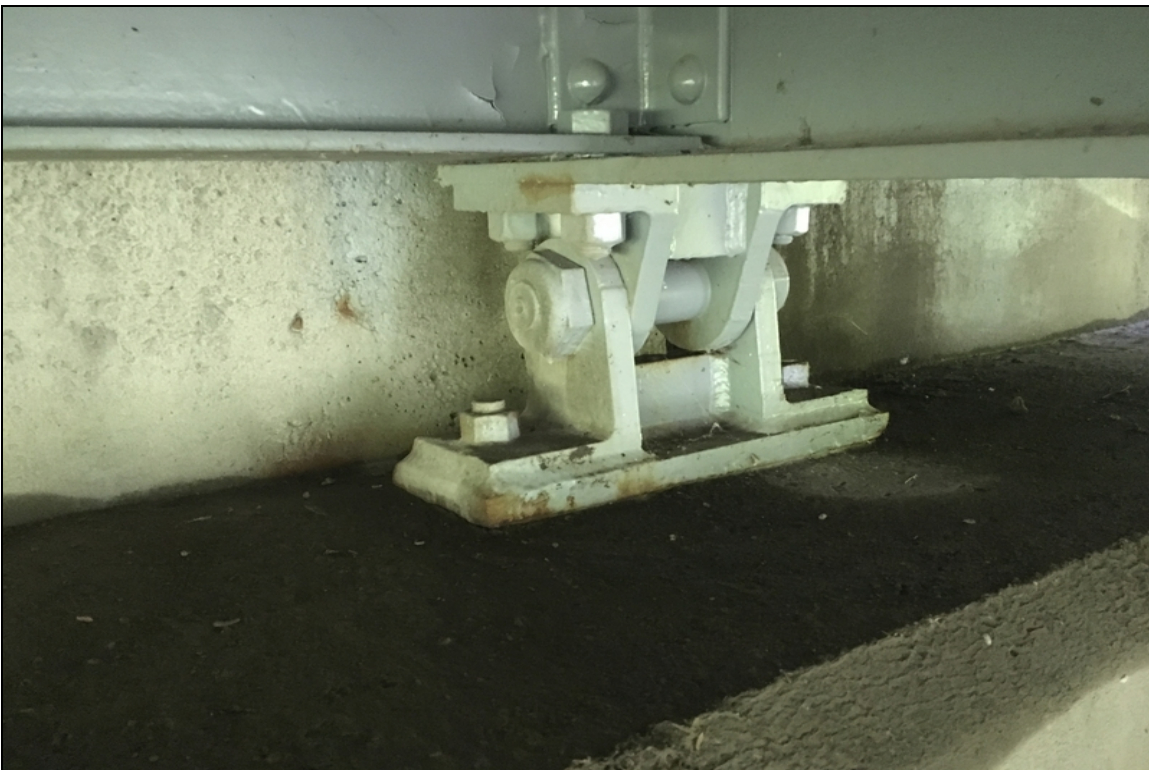
(313)							
The upper truss pin locations at the end of span #1 (fixed bearings)- both have minor corrosion.							
Pier #2 fixed bearings- both have minor corrosion at the bottom of the masonry plate.							
Pier #3 fixed bearings- both have minor corrosion at the bottom of the masonry plate.							
The upper truss pin locations at the beginning of span #5 (fixed bearings)- both have minor corrosion.							
Abutment #2 fixed bearings- all 5 have corrosion on the masonry plate.

Bearing condition at abutment #2. Typical of all 5 at this location.

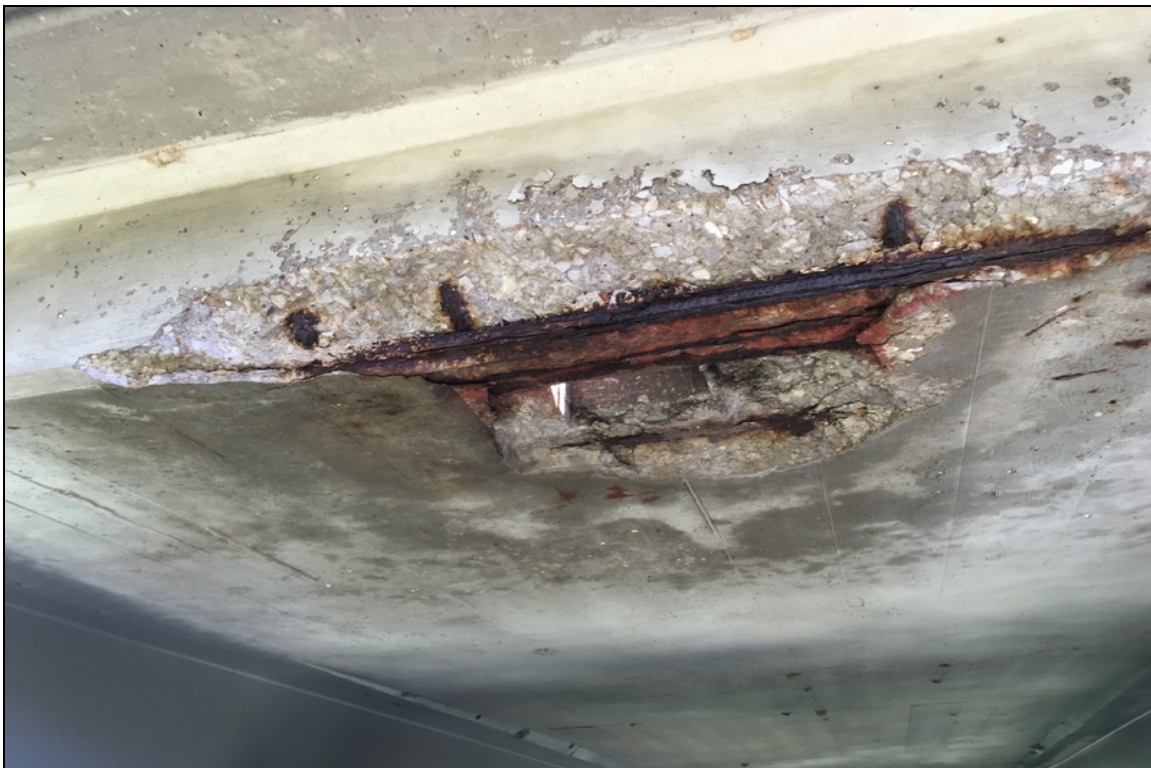
Spalls with exposed rebar at the drain areas. Typical.

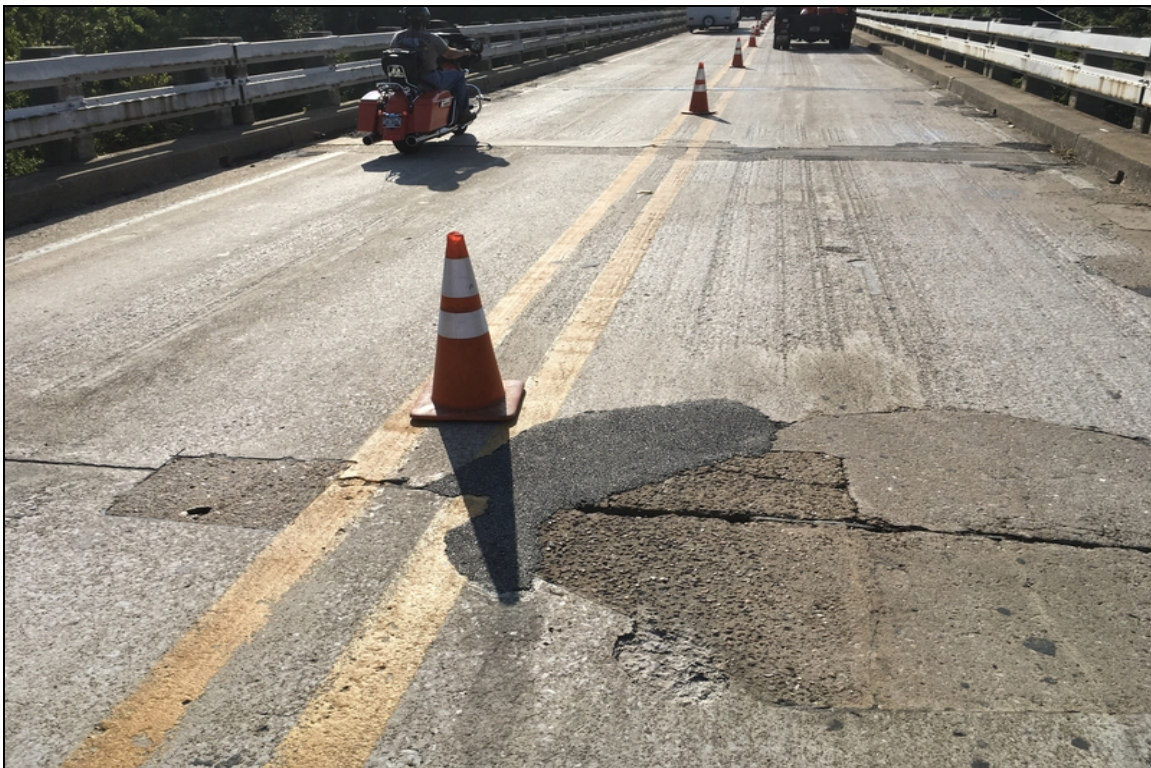
Driving surface showing patched areas at the joints.

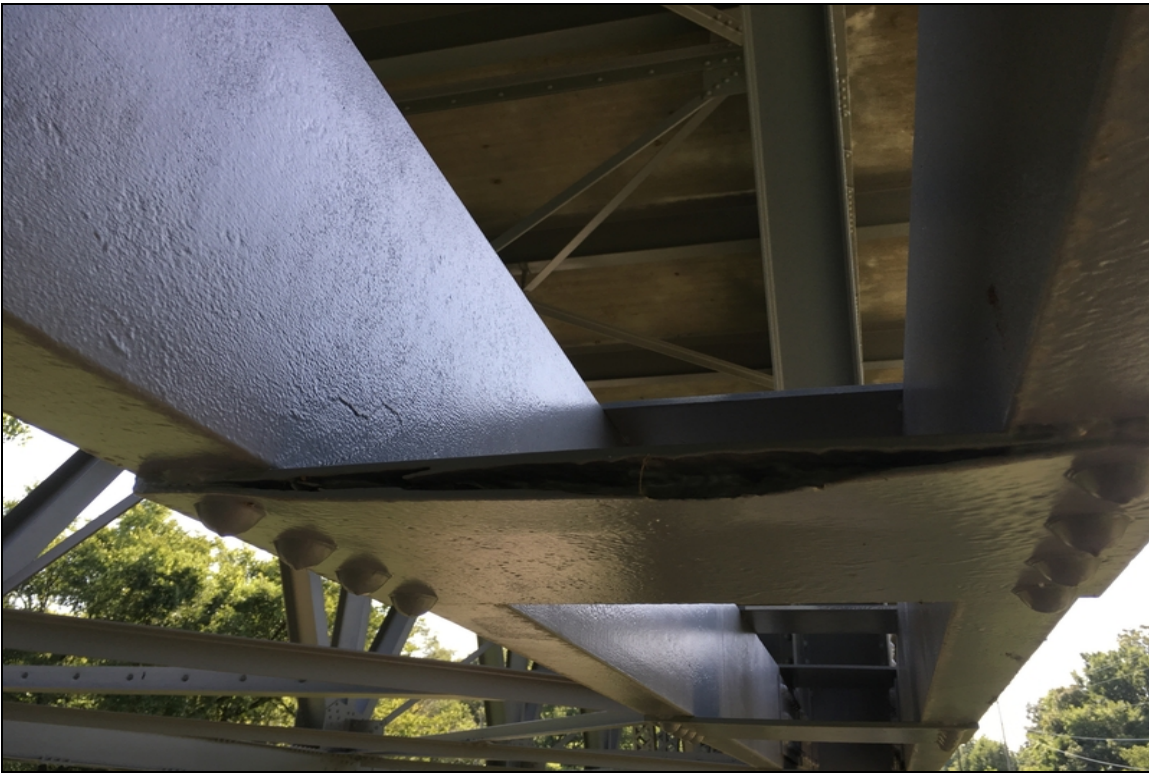
Laminar separation between a single plate just in front of L1 right truss bottom chord.

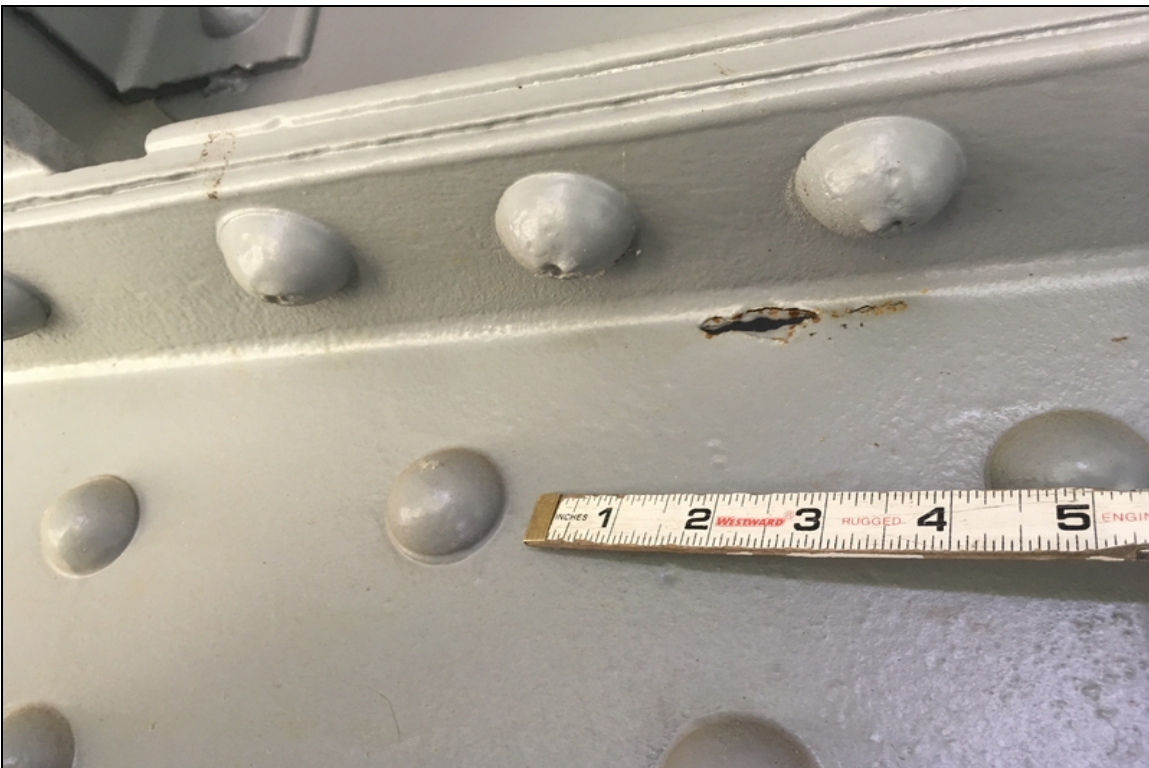
2 " long rust hole at the top of the web of the top chord on the interior connection at U26 left truss.

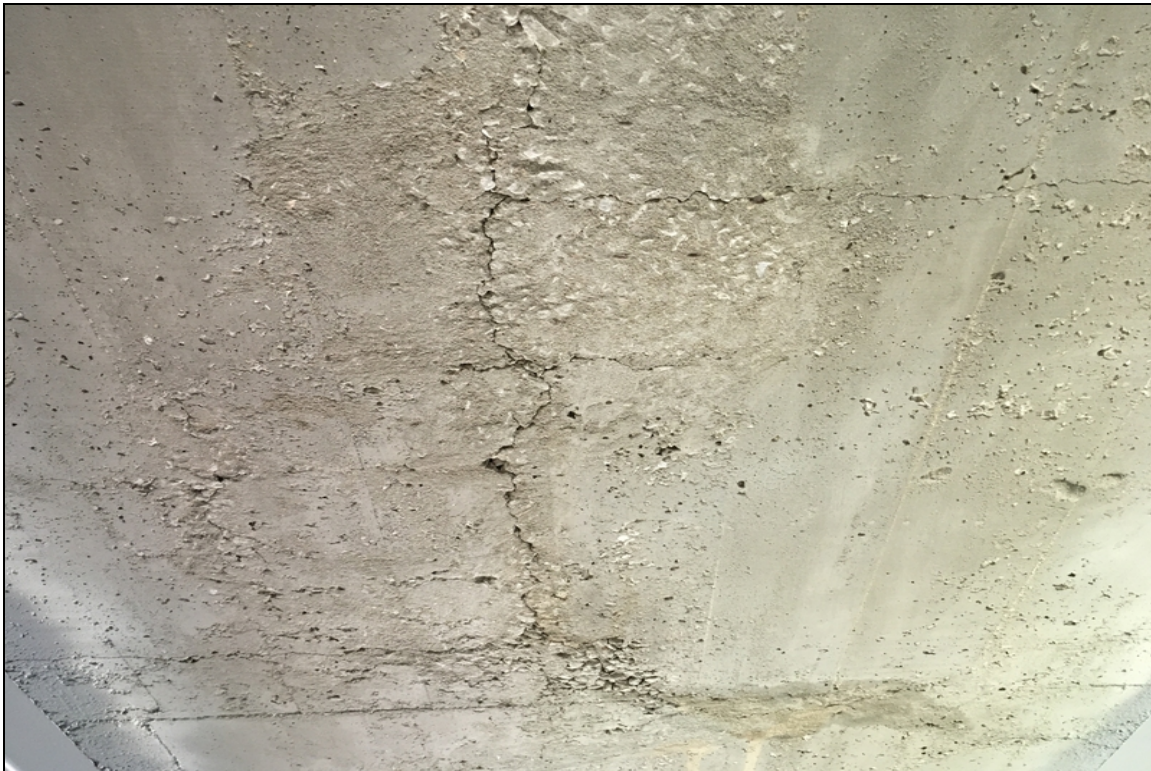
Deck undersurface condition showing cracking. Typical.
