Bridge #02469(Routine, Fracture Critical)

US 62/412 Marion over CROOKED CR & MO NA RR

Team Lead: Benjamin Smith **Inspection Date:** July 17, 2018

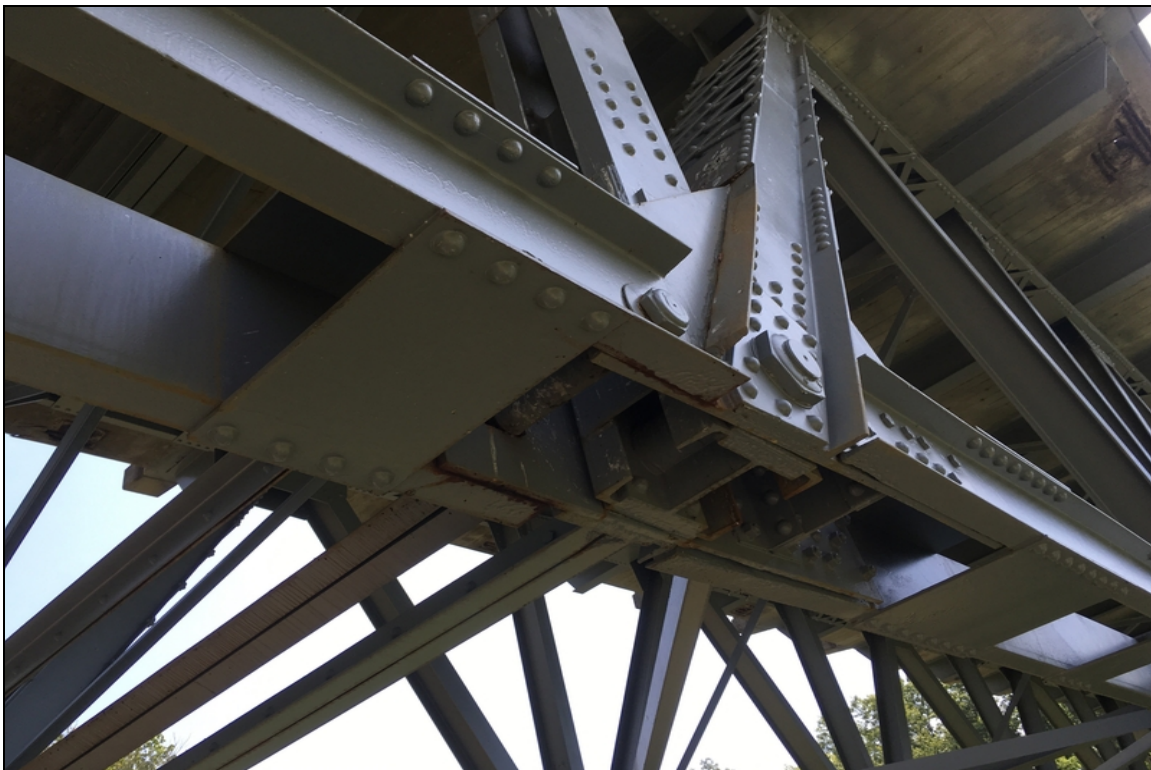
Lower pin area condition at L8 right truss.

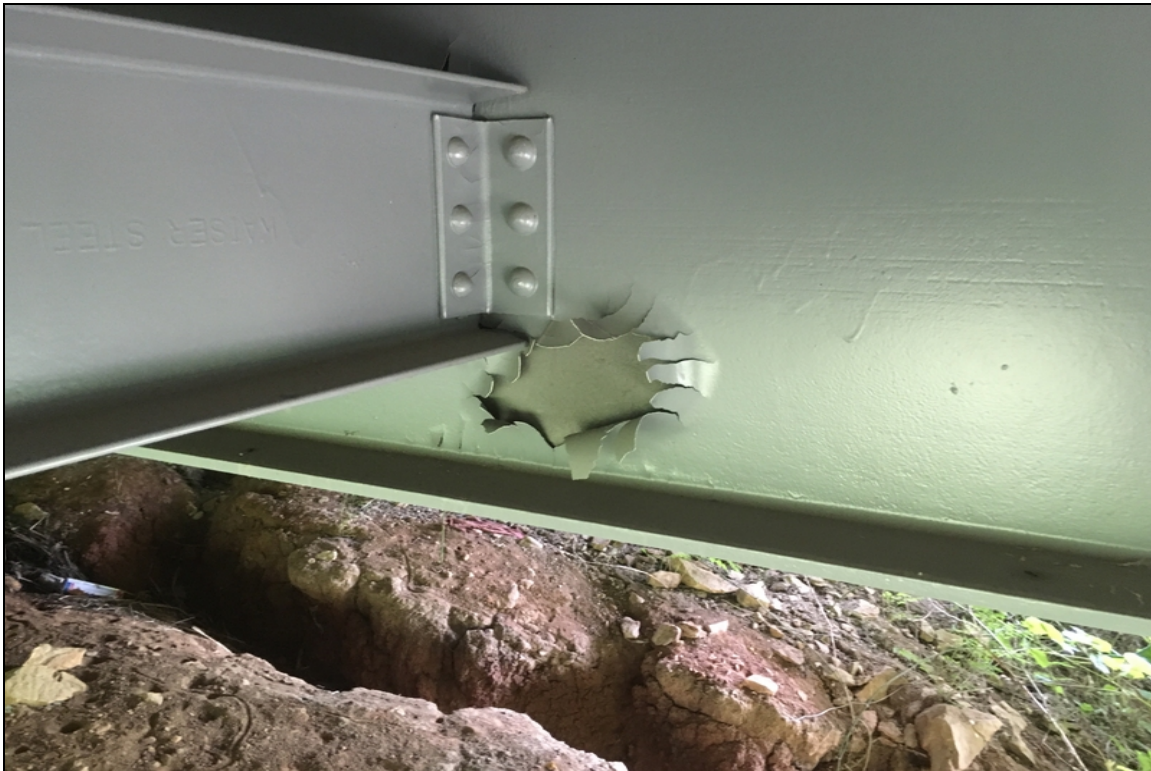
Paint has lost adhesion in span #6 on all 5 beams in the same location near mid span.

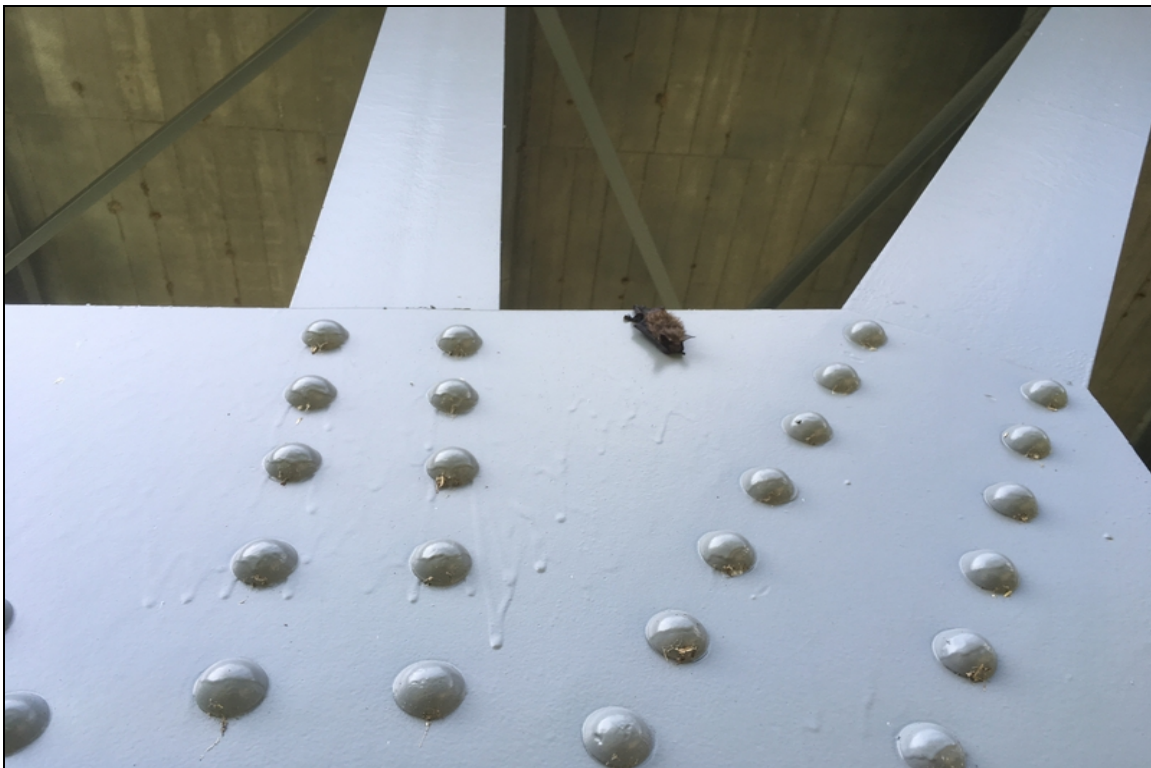
Brown bat at L9 left truss.

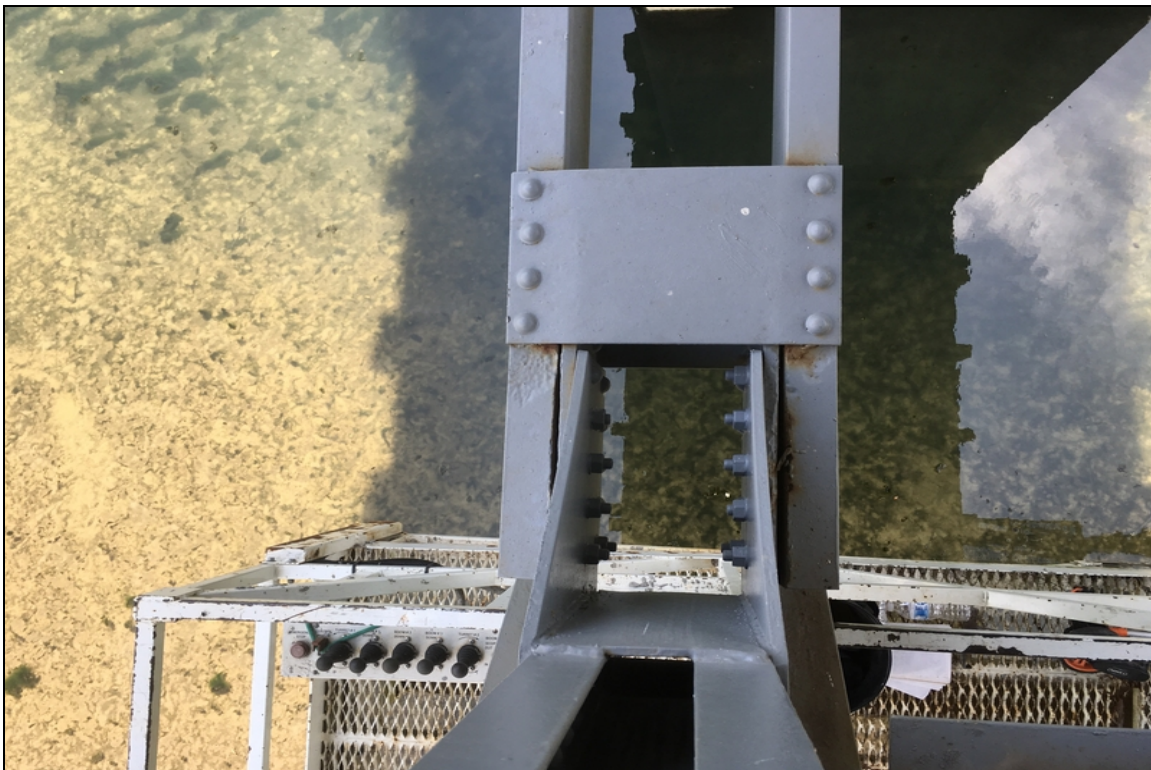
Pack rust with distortion on the bottom chord at L13 left truss.

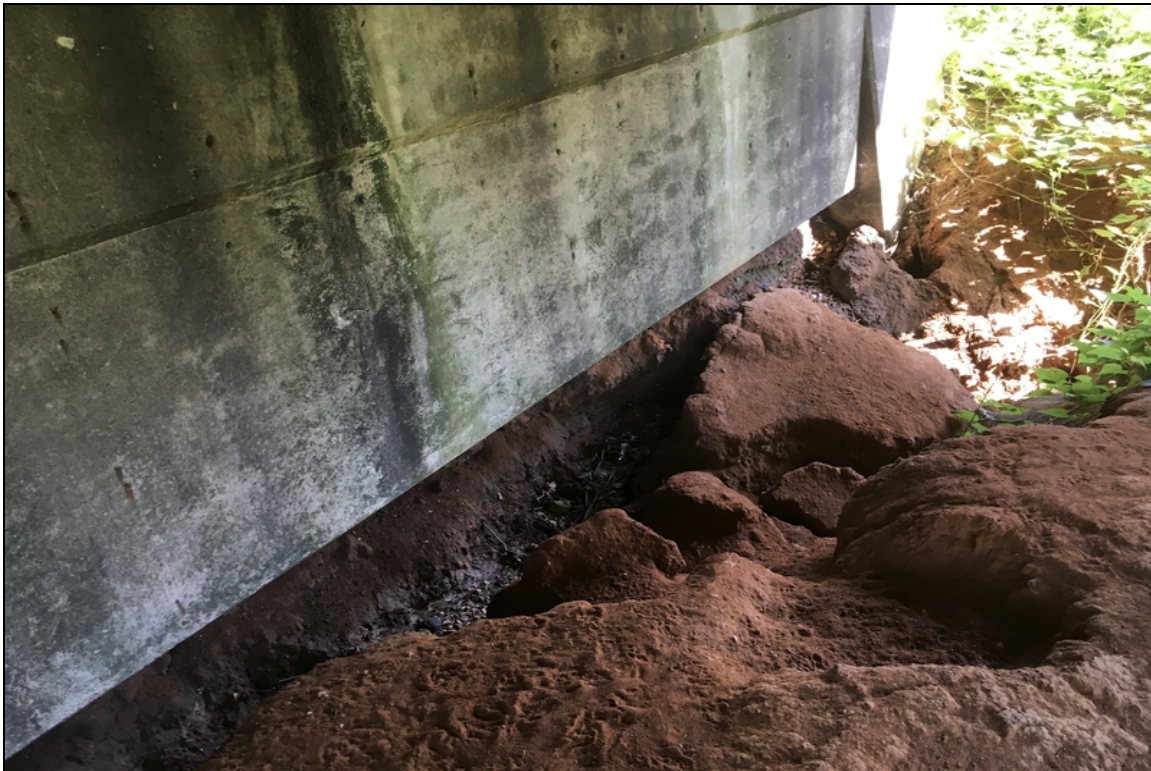
Embankment erosion at abutment #1 that extends under the web wall of the abutment.

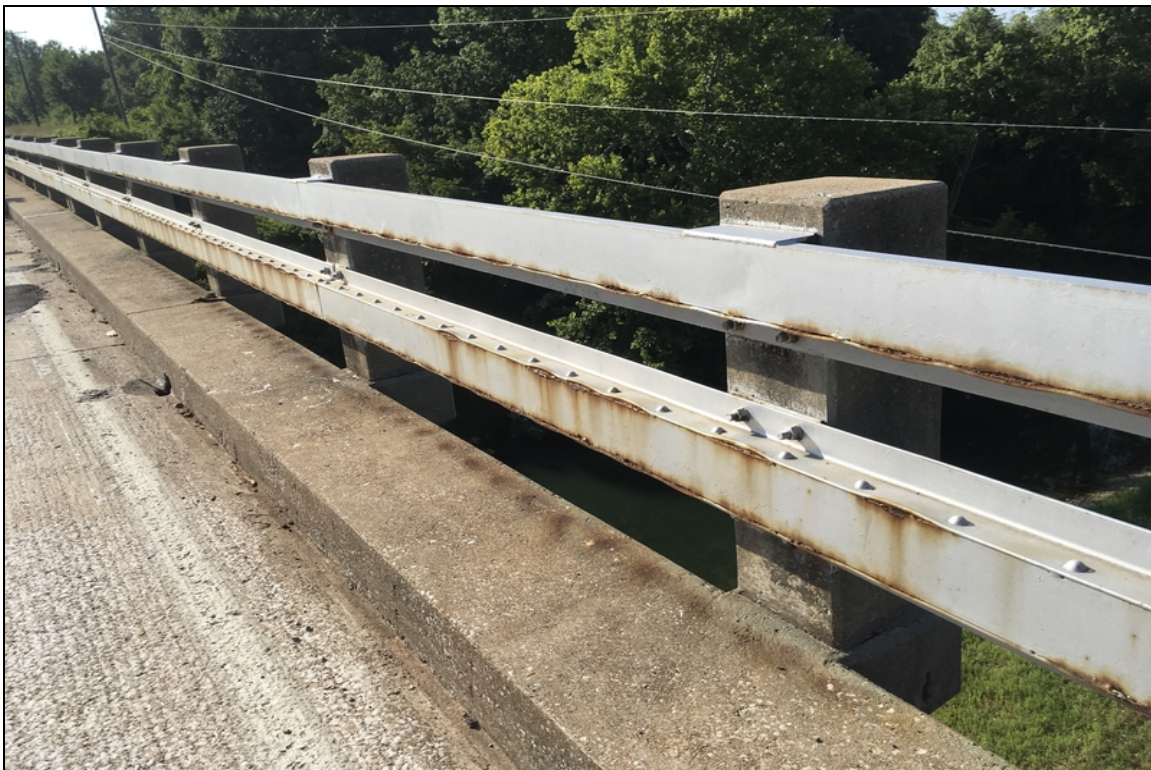
(330)							
The metal railing was hand painted in 2016, but the corrosion is bleeding back through on the front and back for the entire length of the railing.							
The railing surface including both rails is 4.6' per foot.							
331	Reinforced Concrete Bridge Railing	LF	942	859	70	13	0
1090	Exposed Rebar	LF	13	0	0	13	0
1130	Cracking (RC and Other)	LF	70	0	70	0	0

Metal rail condition. Typical

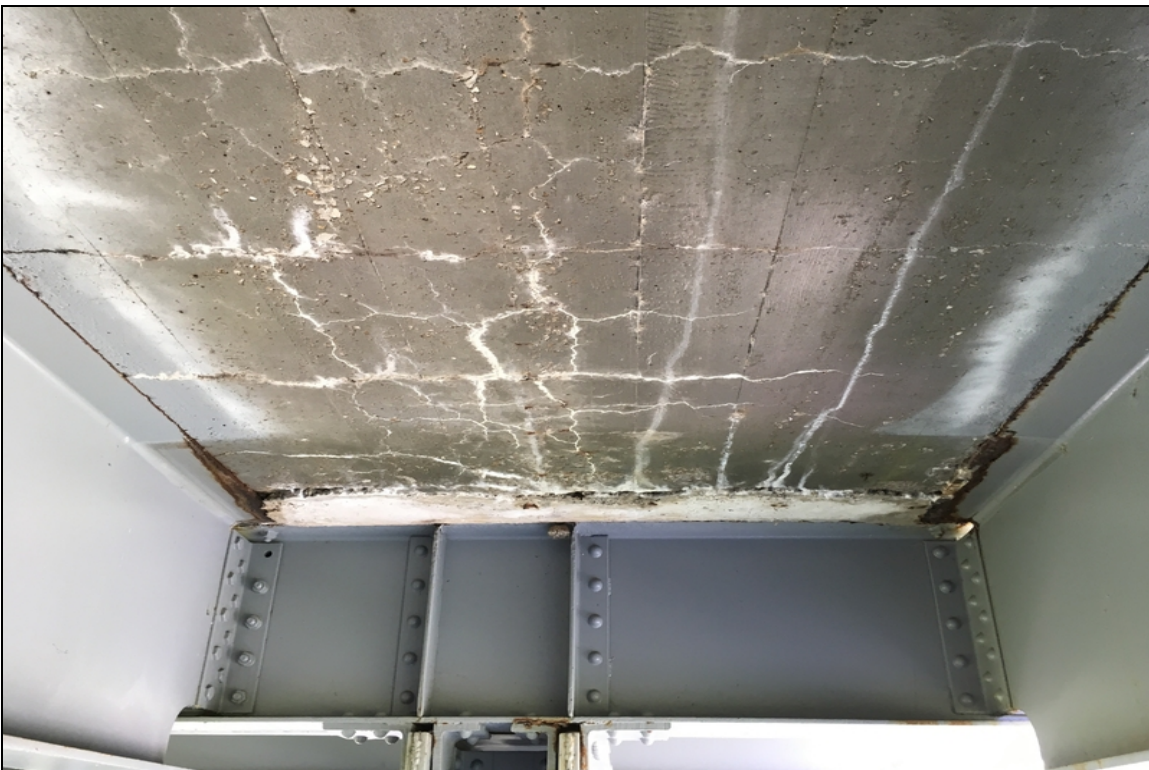
Efflorescence map cracking in bay #4 at the end of span #1. This area sounds dead under hammer blows.

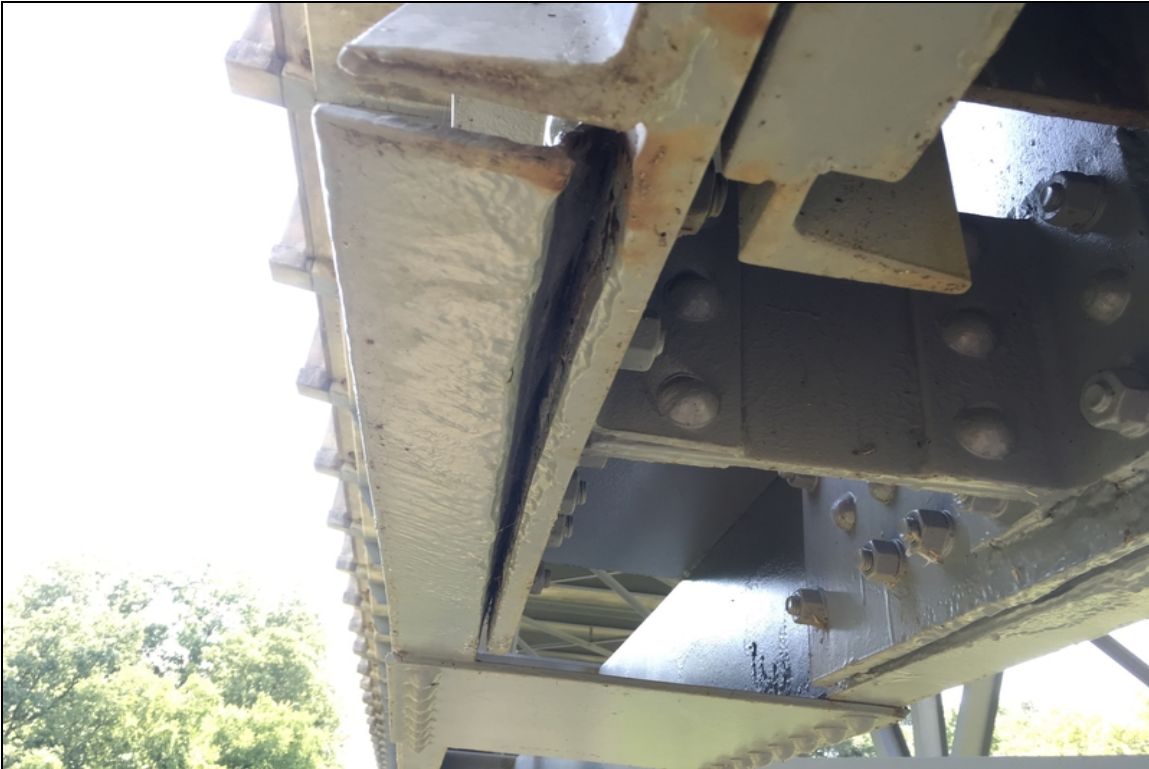
Pack rust with 1" of distortion on the bottom chord at L8 left truss on the exterior connection. This condition is also typical of the right bottom chord at the same location.

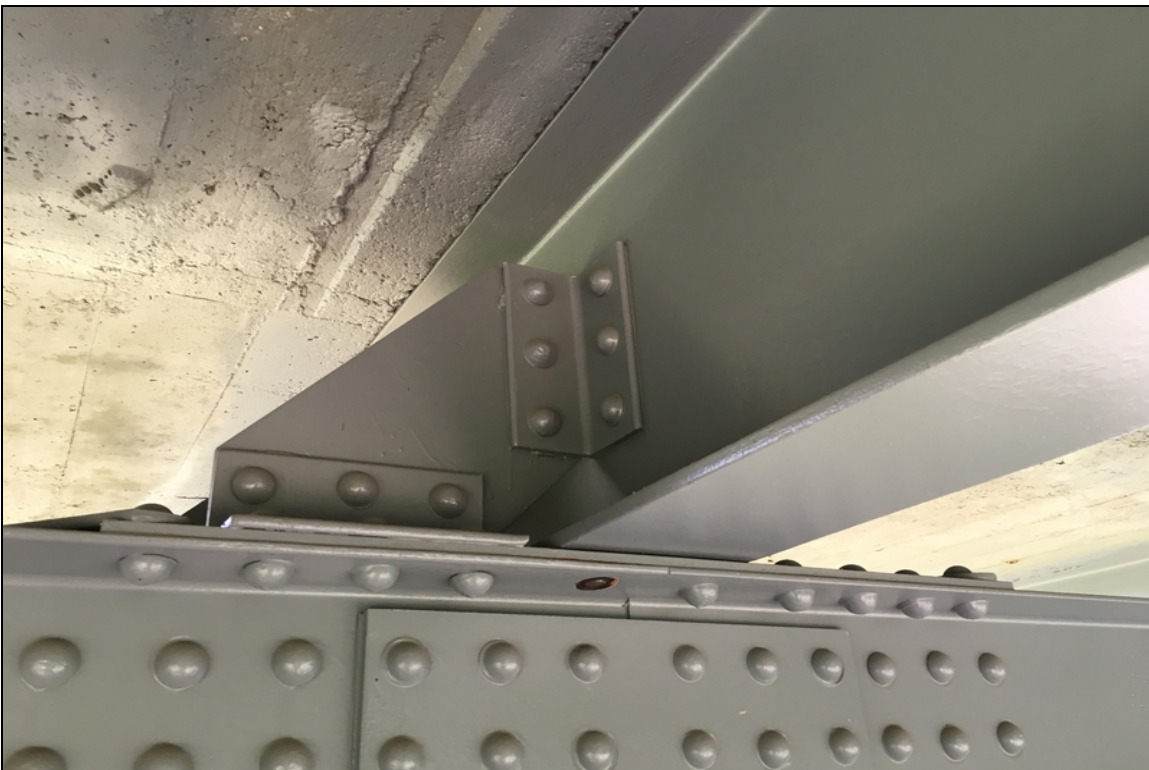
Sheared rivet at U6 left truss. The floor beam has an 1/8 gap between the bottom flange and top left chord.

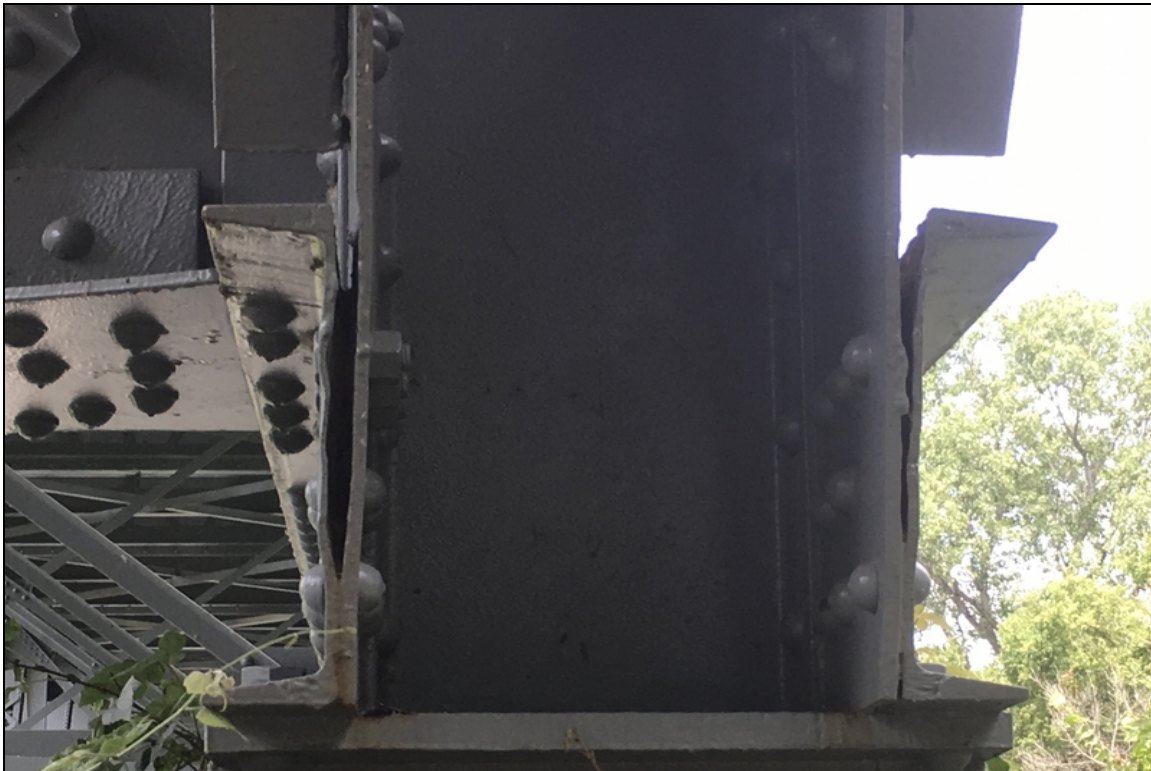
Truss end connection at L 21 left truss showing distortion. Typical of all 4 lower locations at the beginning and end of the trusses.

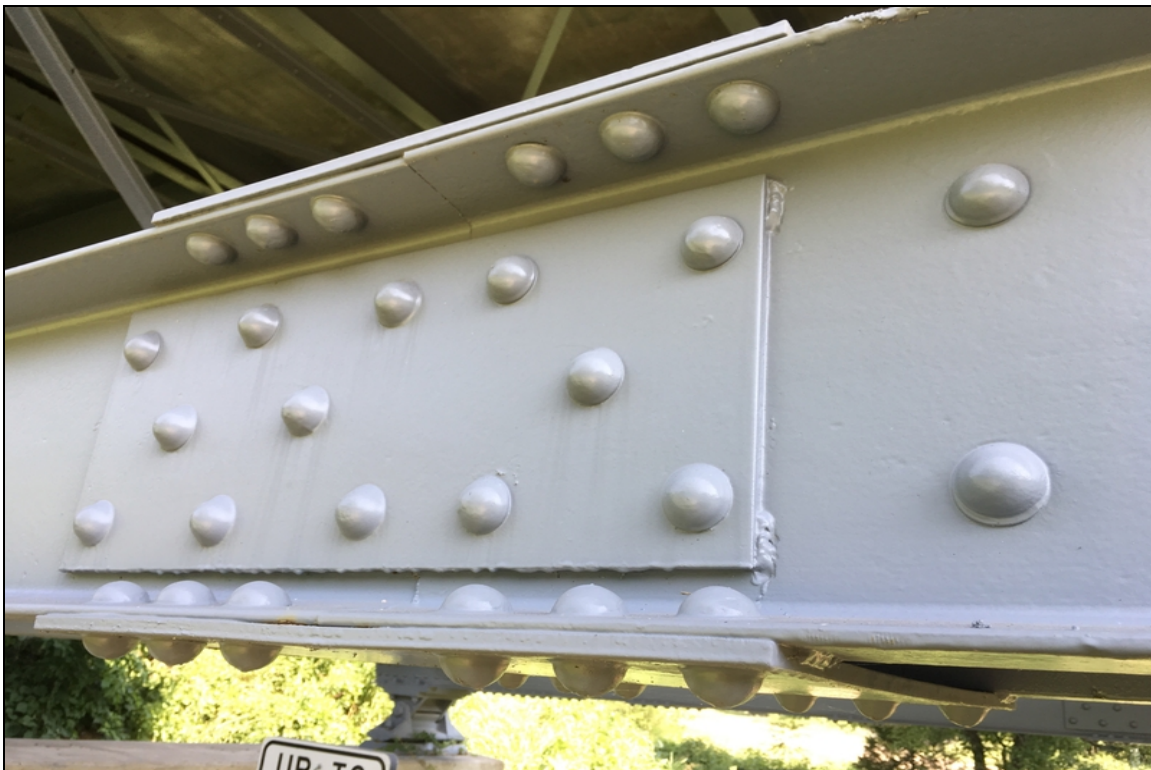
Numerous Tack welds on the splice plate at L1. Typical of the left and right sides.

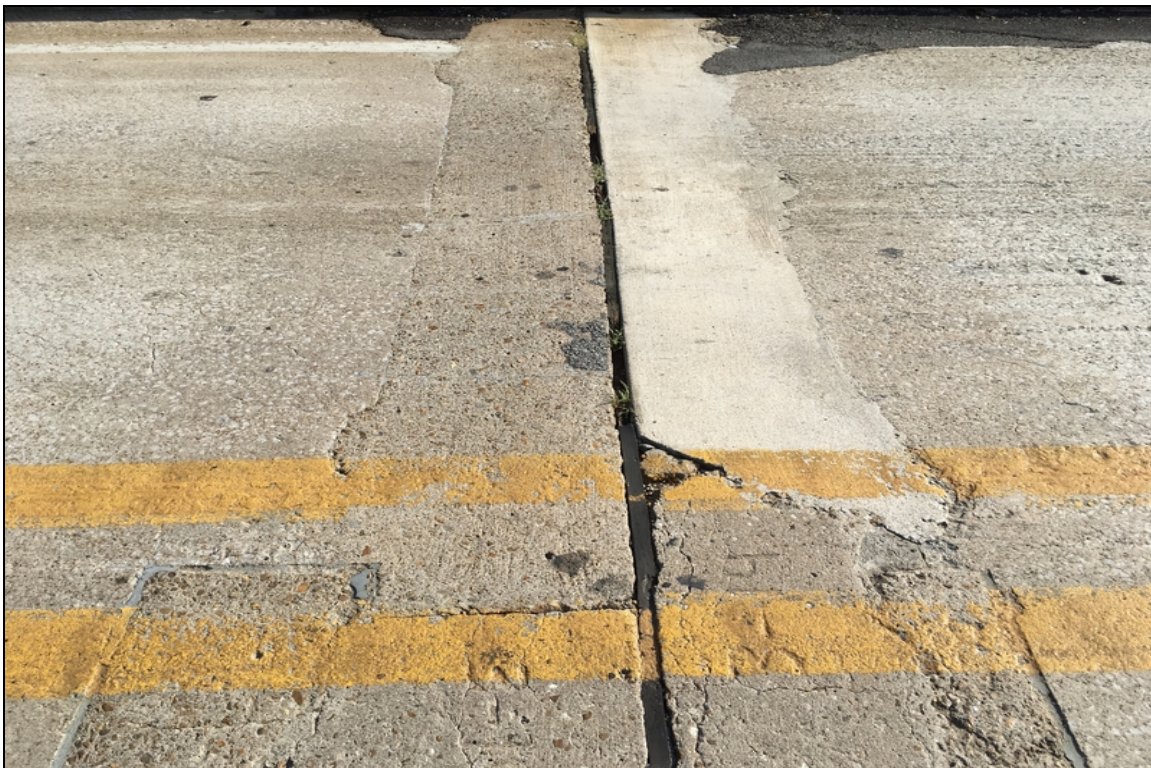
(301)							
All pourable joint seal locations have lost adhesion. Some areas have portions of the seals missing. The joint seals have been replaced in some areas with black fiber board due to deck repairs that affected the joint edges.							
305	Assembly Joint without Seal	LF	224	224	0	0	0

Typical joint seal condition.

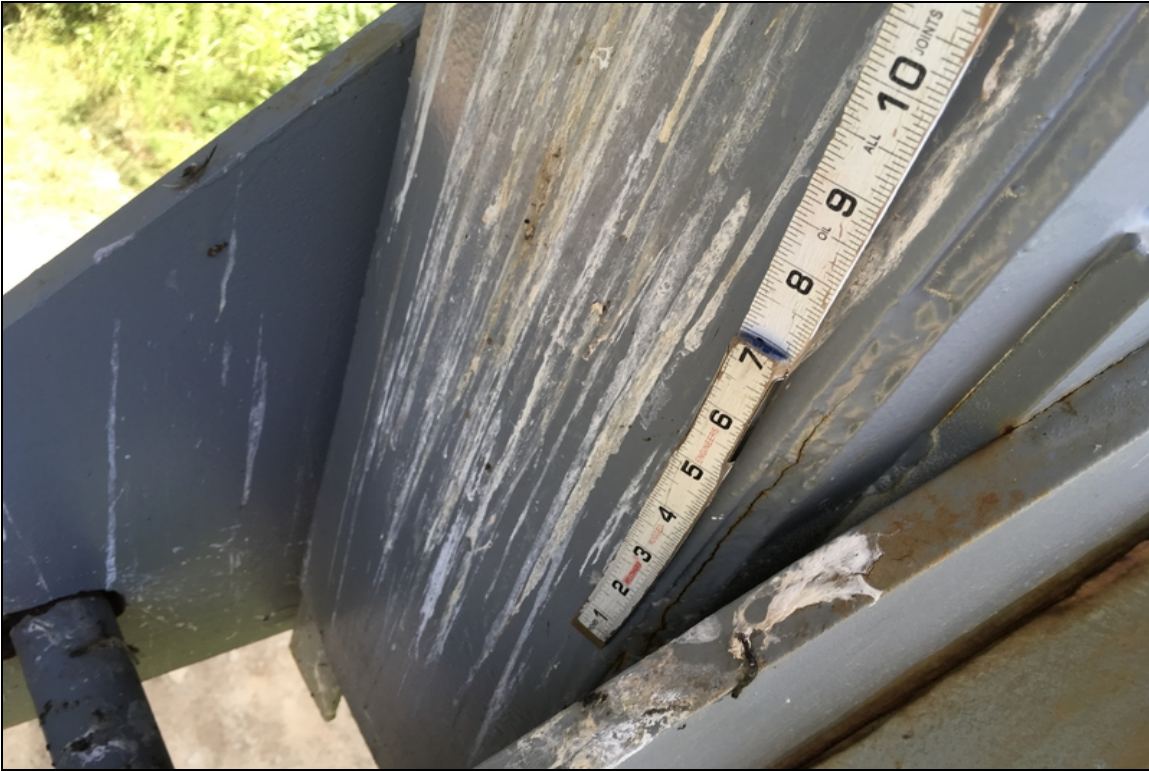
8" long vertical crack in the weld at the L 8 vertical member in the batten plate. This crack could extend into the vertical member.

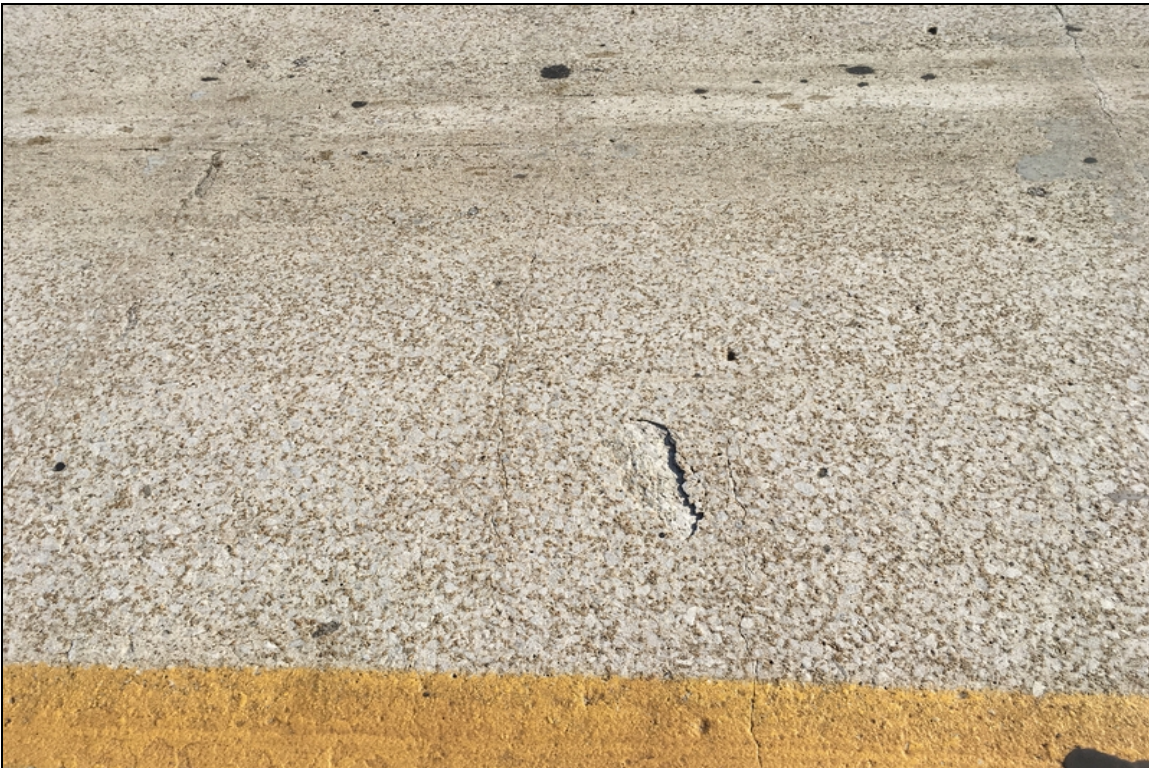
Driving surface showing delamination and cracking.

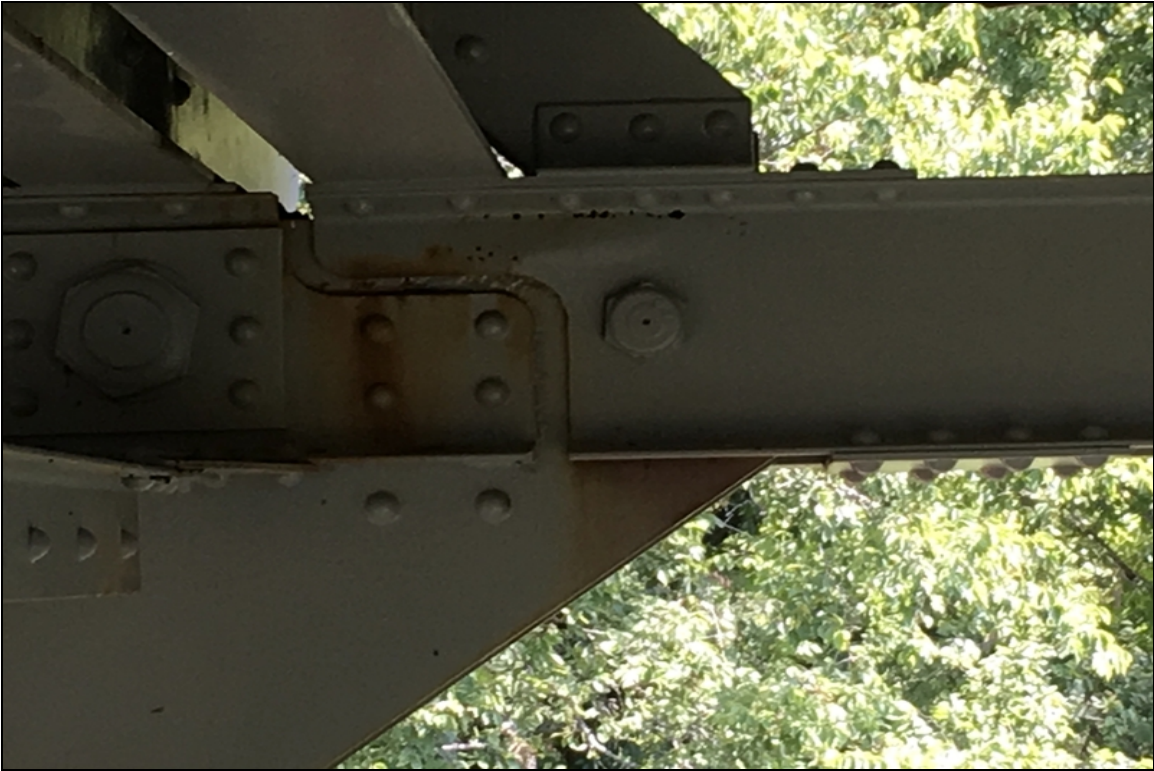
Rust holes on the interior top chord connection at U16 left truss.

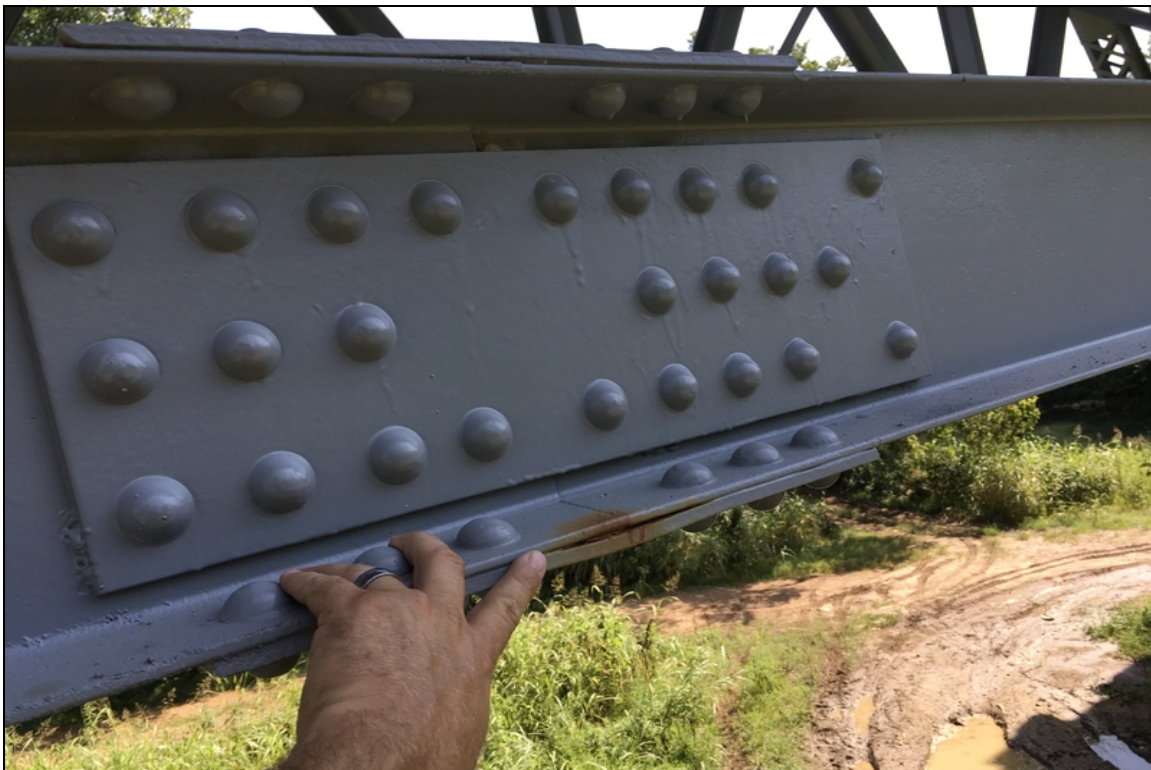
Corrosion with 3/16" distortion on the bottom batten plate of the right truss at L3 right truss.

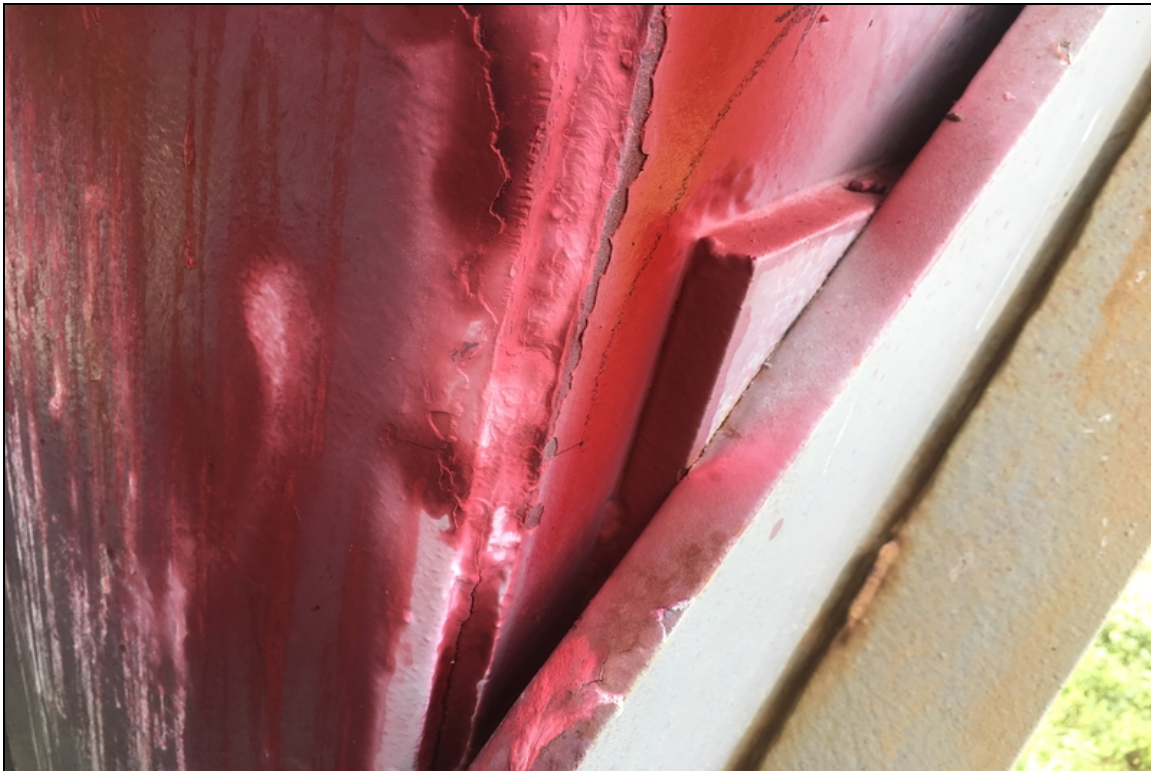
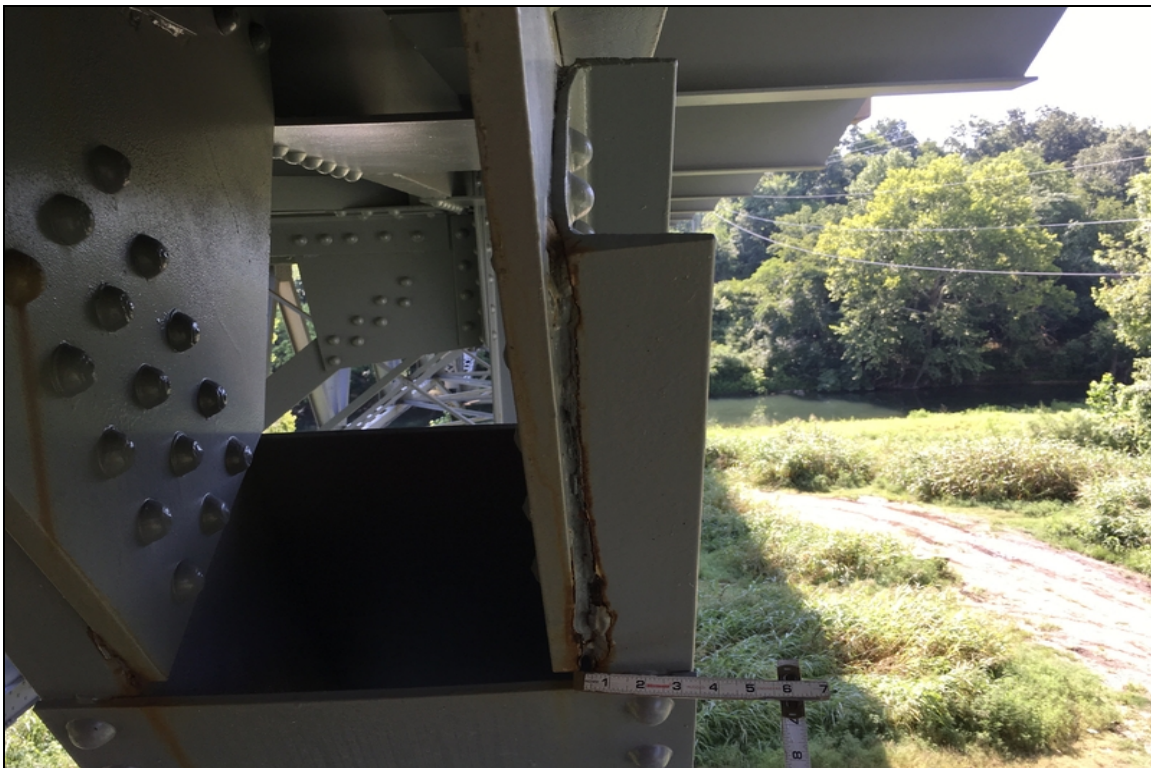
The upper connection of the exterior diagonal member at the beginning of the right truss.
Showing pack rust with 1/2" of distortion.

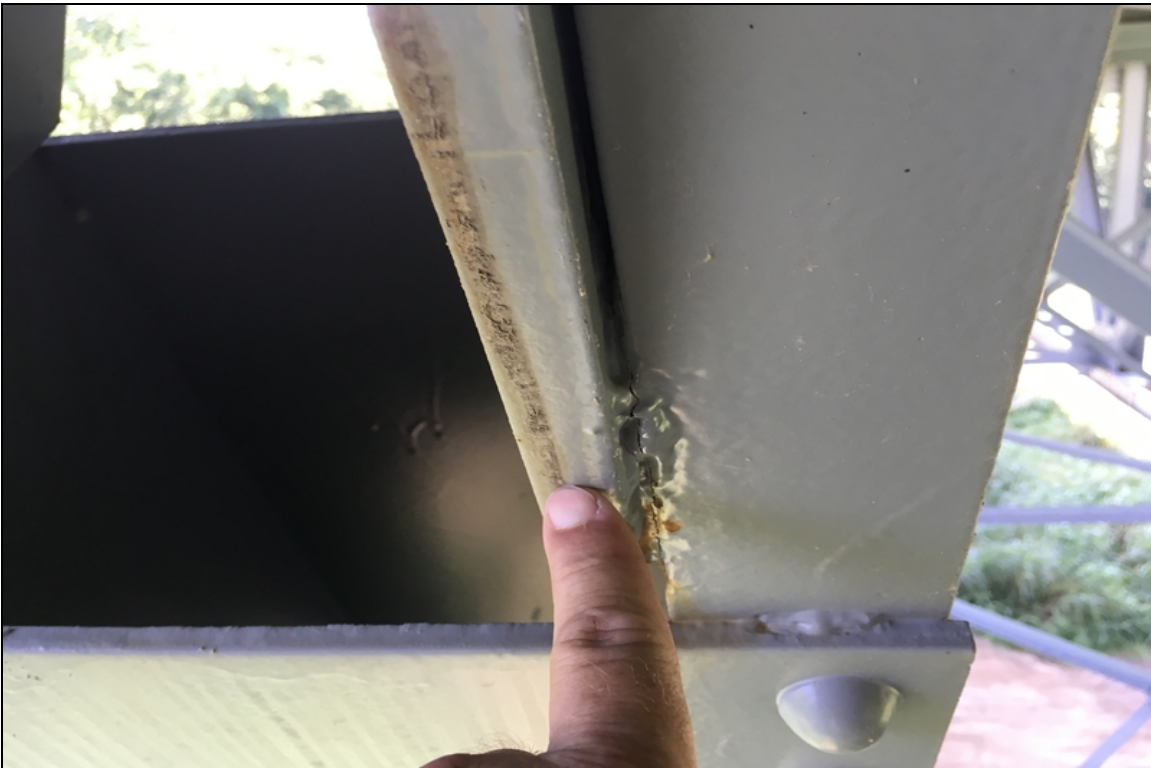
Cracked tack weld at the upper end of the beginning diagonal of the left truss. Typical of the left and right side of the left truss. This is typical is several locations throughout the structure, the cracking is not affecting the base metal.
